**DEVELOPMENT OF
HIGH STRENGTH COLUMBIUM
AND TANTALUM ALLOY TUBING**

THIRD QUARTERLY PROGRESS REPORT

JUNE 1, 1963 TO AUGUST 31, 1963

**Astronuclear Laboratory
Westinghouse Electric Corporation**

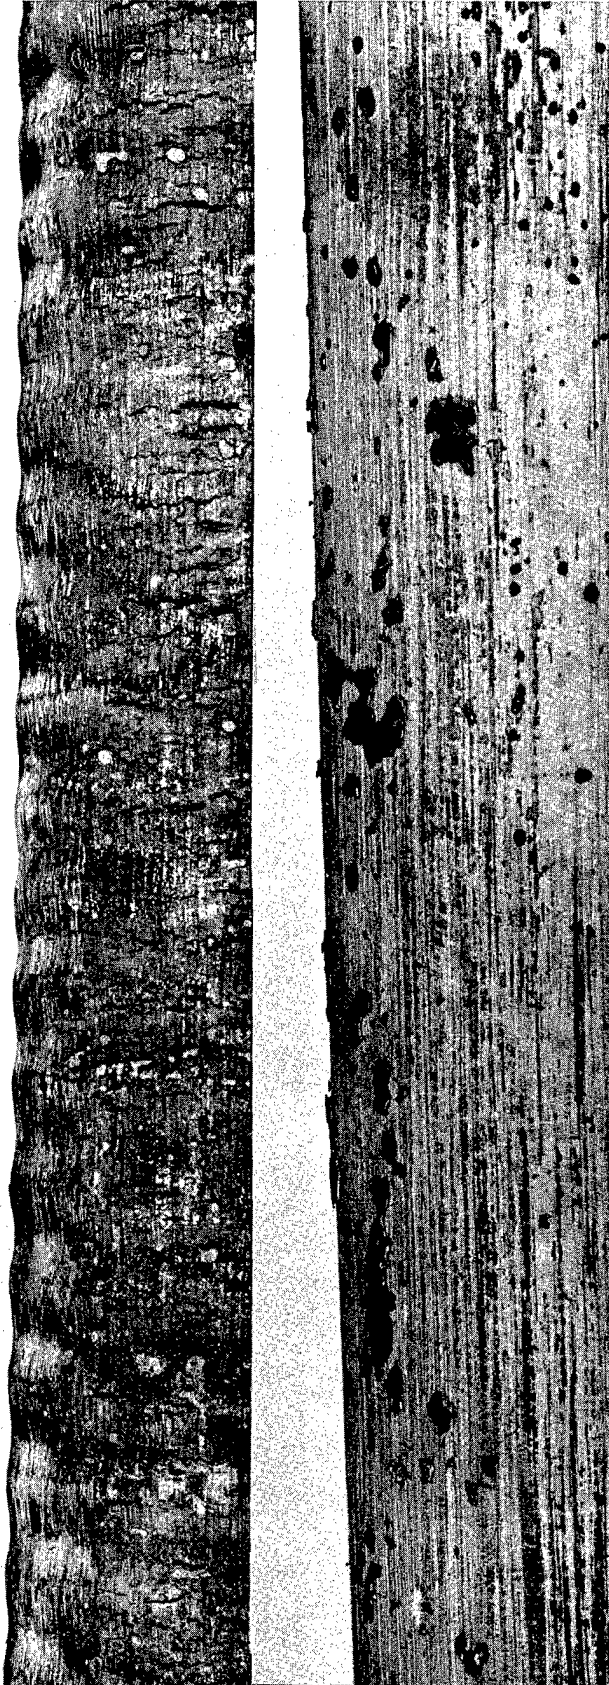
Figure 12 - B-66 As-Extruded Surfaces

cumferential cracking which was attributed to excessive extrusion speed. The rippling on the balance of B-66 and T-111 extrusions was confined to localized areas. Representative defective and satisfactory areas of the B-66 and T-111 extrusions are shown in Figures 11 and 12.

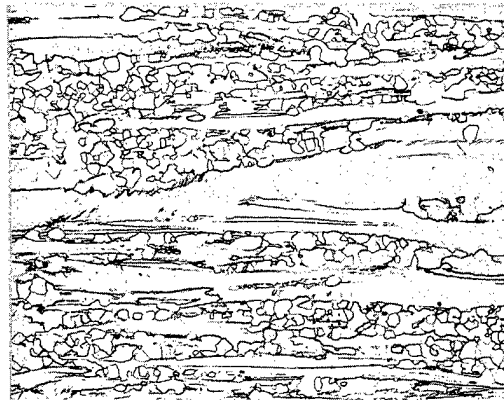
a. I.D. of B-66-II-1, 200X

b. Longitudinal Section From B-66-II-1, 200X

c. Longitudinal Section From B-66-II-2, 200X

Figure 13 - Microstructures of As-Extruded Phase II B-66

Photomicrographs from the as-extruded B-66 and T-111 are shown in Figures

13 and 14. The nose portion of the B-66 exhibited predominantly an elongated micro-structure although the hardness measurements indicated recovery of annealed mechanical properties.
