TECHNICAL NOTE
D-1882

AN EXPERIMENTAL INVESTIGATION OF CHEMICAL REACTION
BETWEEN PROPELLANT TANK MATERIAL AND ROCKET
FUELS OR OXIDIZERS WHEN IMPACTED BY SMALL
HIGH-VELOCITY PROJECTILES

By Robert P. Dengler
Lewis Research Center
Cleveland, Ohio

August 1963

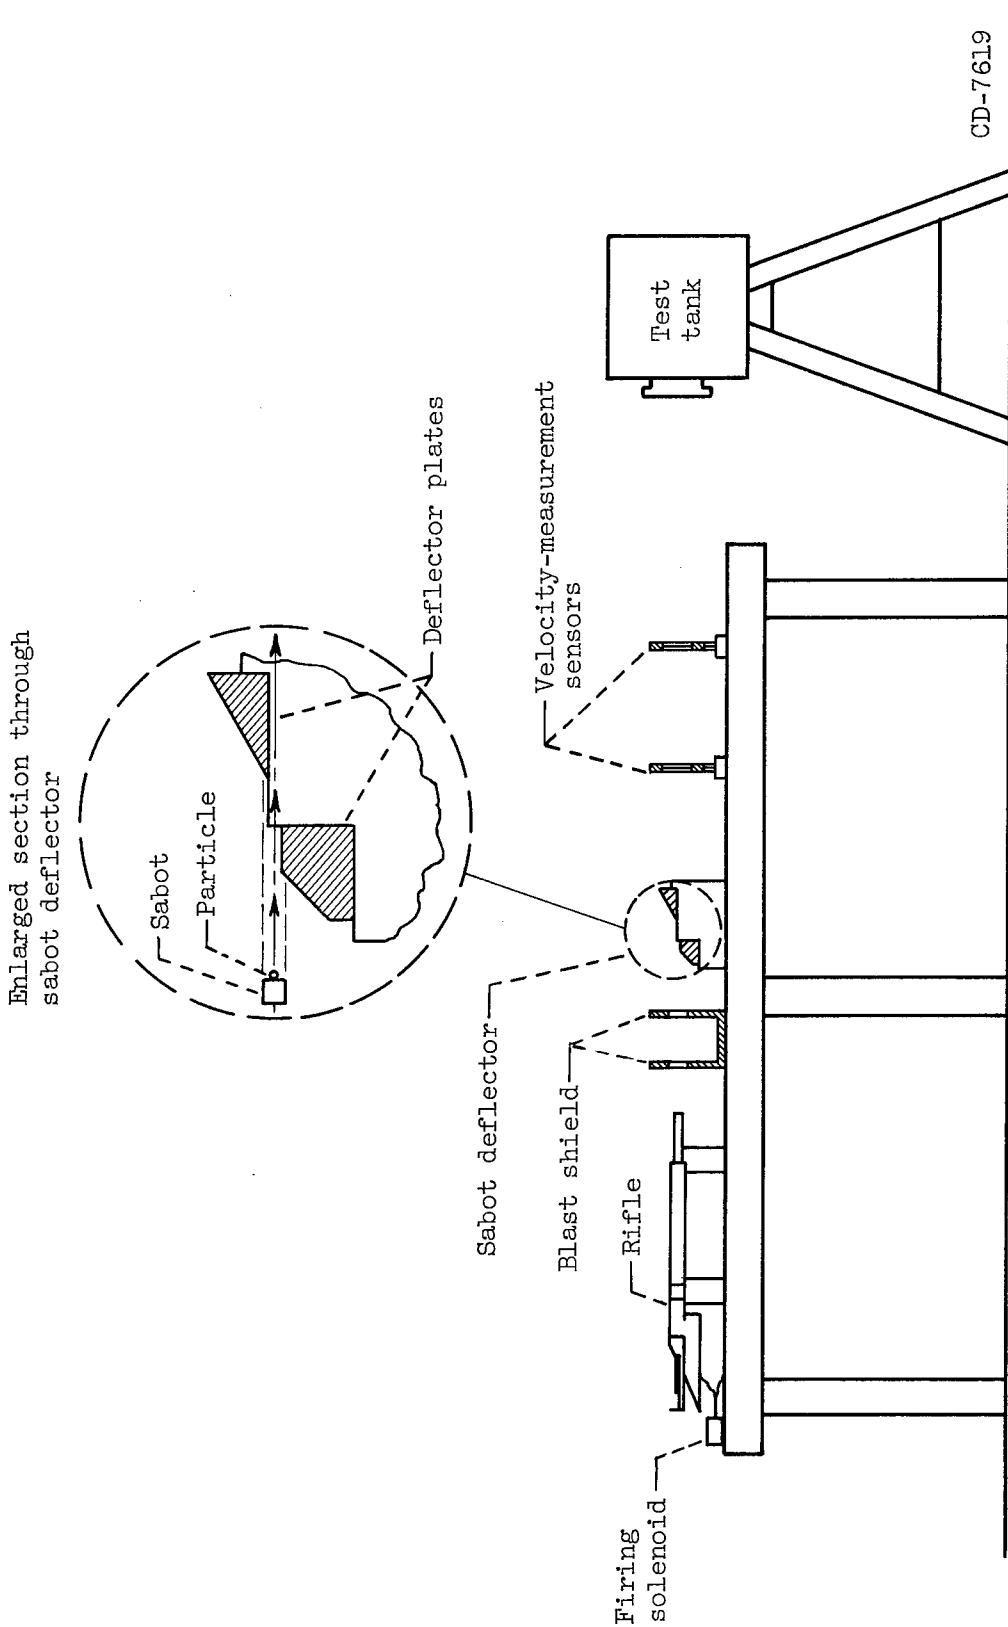
Figure 1. - Schematic drawing of apparatus for high velocity impact tests on simulated propellant tanks.

A 220 Swift rifle was used to propel spherical projectiles of various materials into simulated tanks filled with either solid or liquid propellant. The rifle was mounted on a stand and located about 4 feet from the target tank (fig. 1). The trigger mechanism of the rifle was operated by a solenoid so that the rifle could be fired remotely. For tests conducted in the test cell, the rifle was fired from an adjacent control room, which was separated from the test cell by a thick protective wall. For tests conducted in the remote location, the rifle was fired from behind a protective barrier approximately 120 feet from the test setup. The cartridges used with this rifle were hand loaded with specific amounts of gunpowder, and thus tests were made over a range of projectile velocities. Impact velocities as high as 6500 feet per second were obtained.

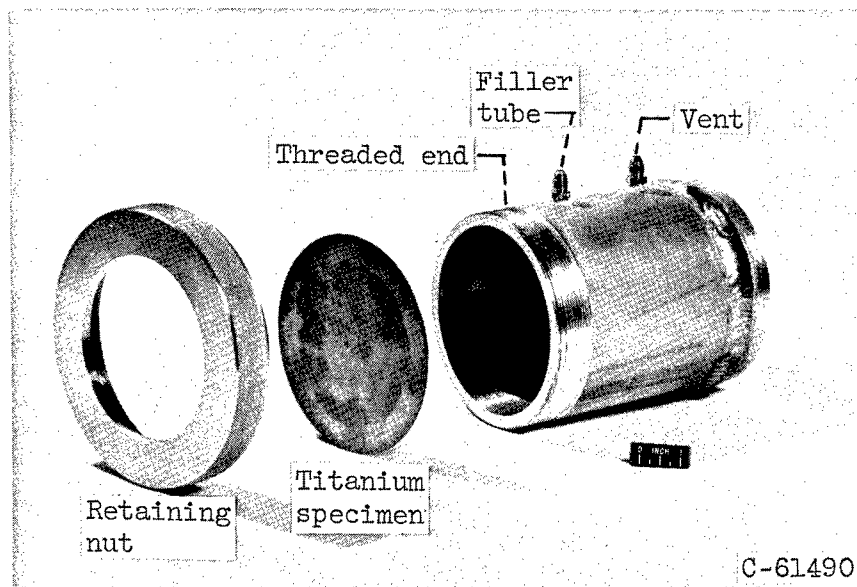
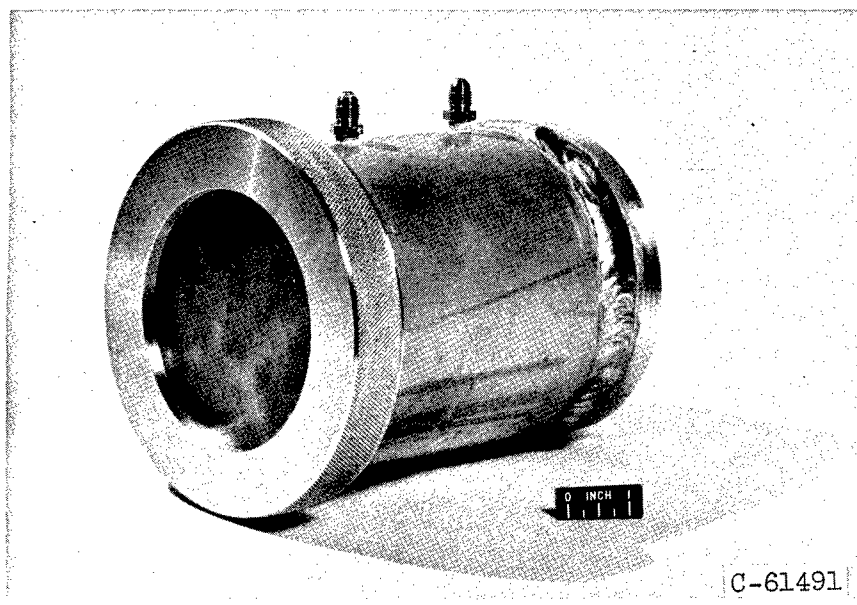
(a) Exploded view.

(b) Assembled view.

Figure 2. - Specially designed tank with titanium specimen.

The tank materials investigated were an aluminum alloy (6061-T3), a stainless steel (AISI 304), two titanium alloys (5Al-2.5Sn-Ti and 6Al-4V-Ti), and three reinforced plastics (Dacron-fiber-reinforced polyurethane, nylon-cloth-reinforced phenolic resin, and glass-cloth-reinforced epoxy resin). The aluminum and stainless-steel tank walls to be impacted were always 0.031 inch thick; the titanium specimens were 0.020, 0.025, or 0.063 inch thick; and the reinforced plastic specimens were either 0.063 or 0.125 inch thick. The tanks were all cylindrical in shape but varied in size from about 3.5 to 5.5 inches in diameter and from about 6 to 12 inches in length. The tests were conducted with the cylindrical axis of the tank in a horizontal position. All tests (with the exception of those made on the titanium tank containing Hercules CLW) were made with the projectiles impacting an end of the cylindrical tank. The impacted surface or end always constituted the thinnest wall of the tank. When the tank material to be investigated was either aluminum or stainless steel, the entire tank was fabricated from this material with the end or surface to be impacted being welded to the cylindrical portion. This cylindrical portion generally was a length of available tubing. For impacting titanium and reinforced plastic materials in contact with various propellants, a reusable tank was designed that would accommodate tank wall specimens of various materials and/or thicknesses. This special tank or cylinder was fabricated from thick-walled aluminum tubing, and one end was left open (fig. 2). The outside diameter of the open end of the cylinder was threaded to accommodate a retaining nut for securely clamping tank wall specimens.

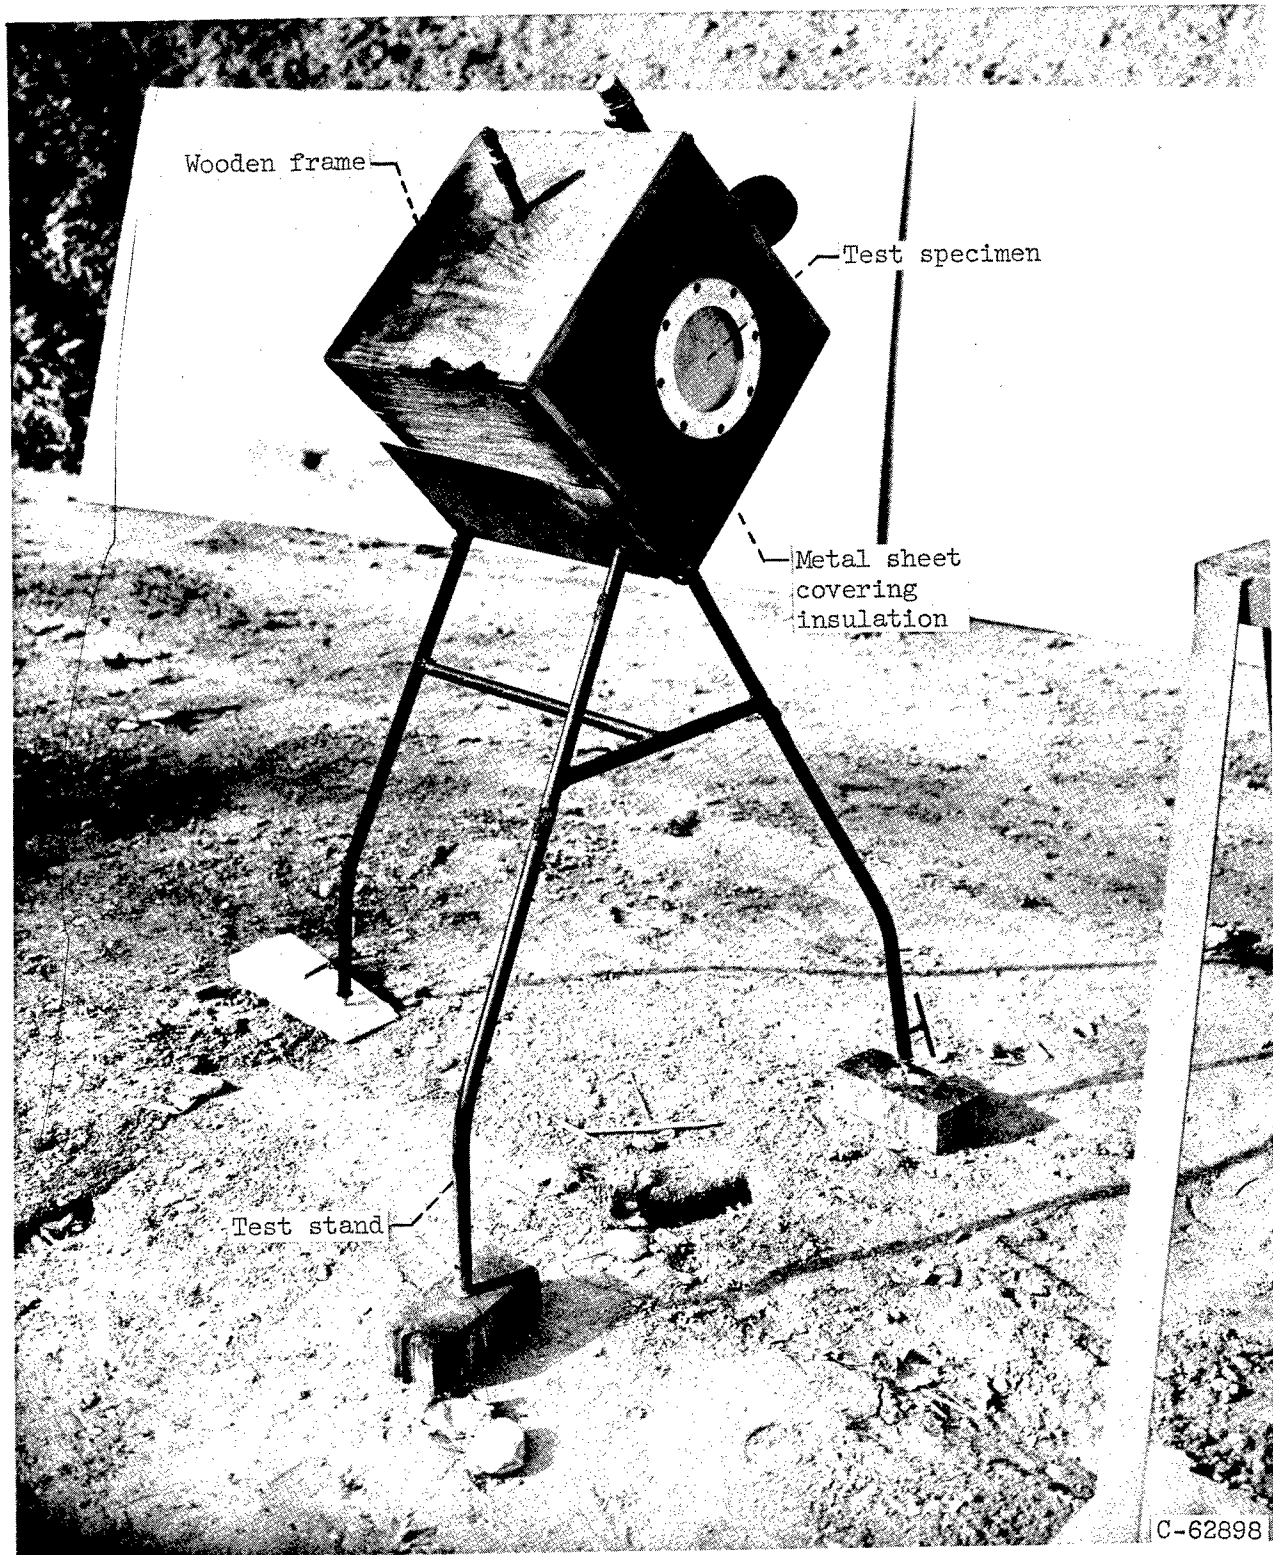
Figure 3. - Stand and typical insulated tank used for liquid-oxygen tests.

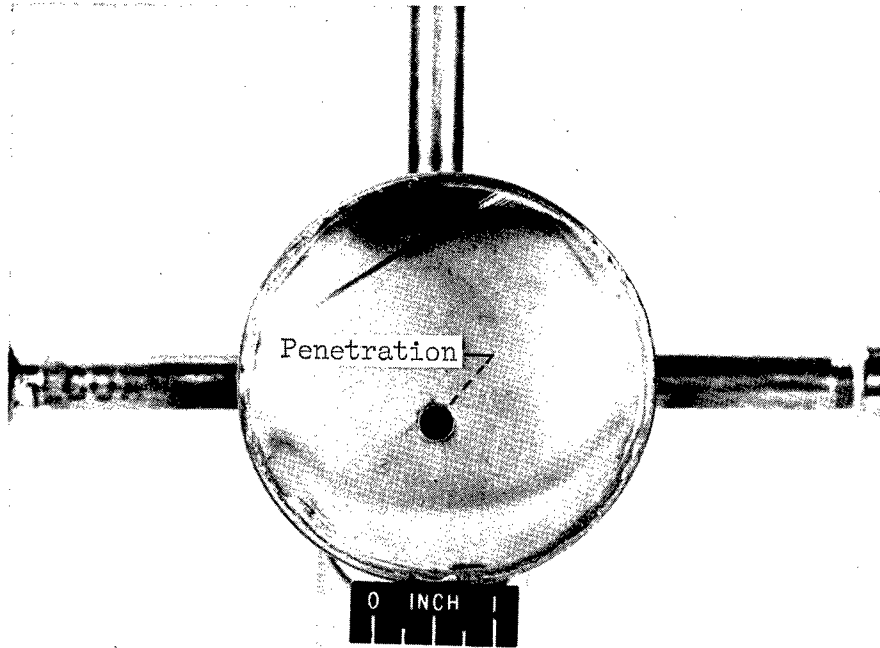
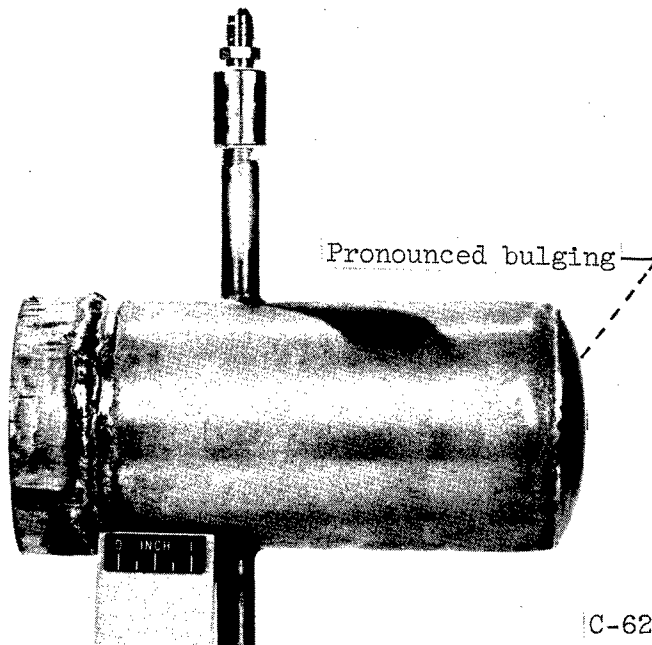
(a) End view.

(b) Side view.

Figure 4. - Results of impact of steel projectile into stainless-steel tank filled with hydrazine. Test 1.

Figure 4 shows the results of the impact on the stainless-steel tank. The steel sphere penetrated the tank wall and left a hole slightly larger (0.253 in.) than the original diameter of the impacting sphere. The impact caused pronounced bulging of the impacted end, which resulted from the extreme pressure forces generated against the tank walls by the shock wave that was formed by the action of the projectile being decelerated in the contained liquid. Reference 5 describes this phenomenon in detail.

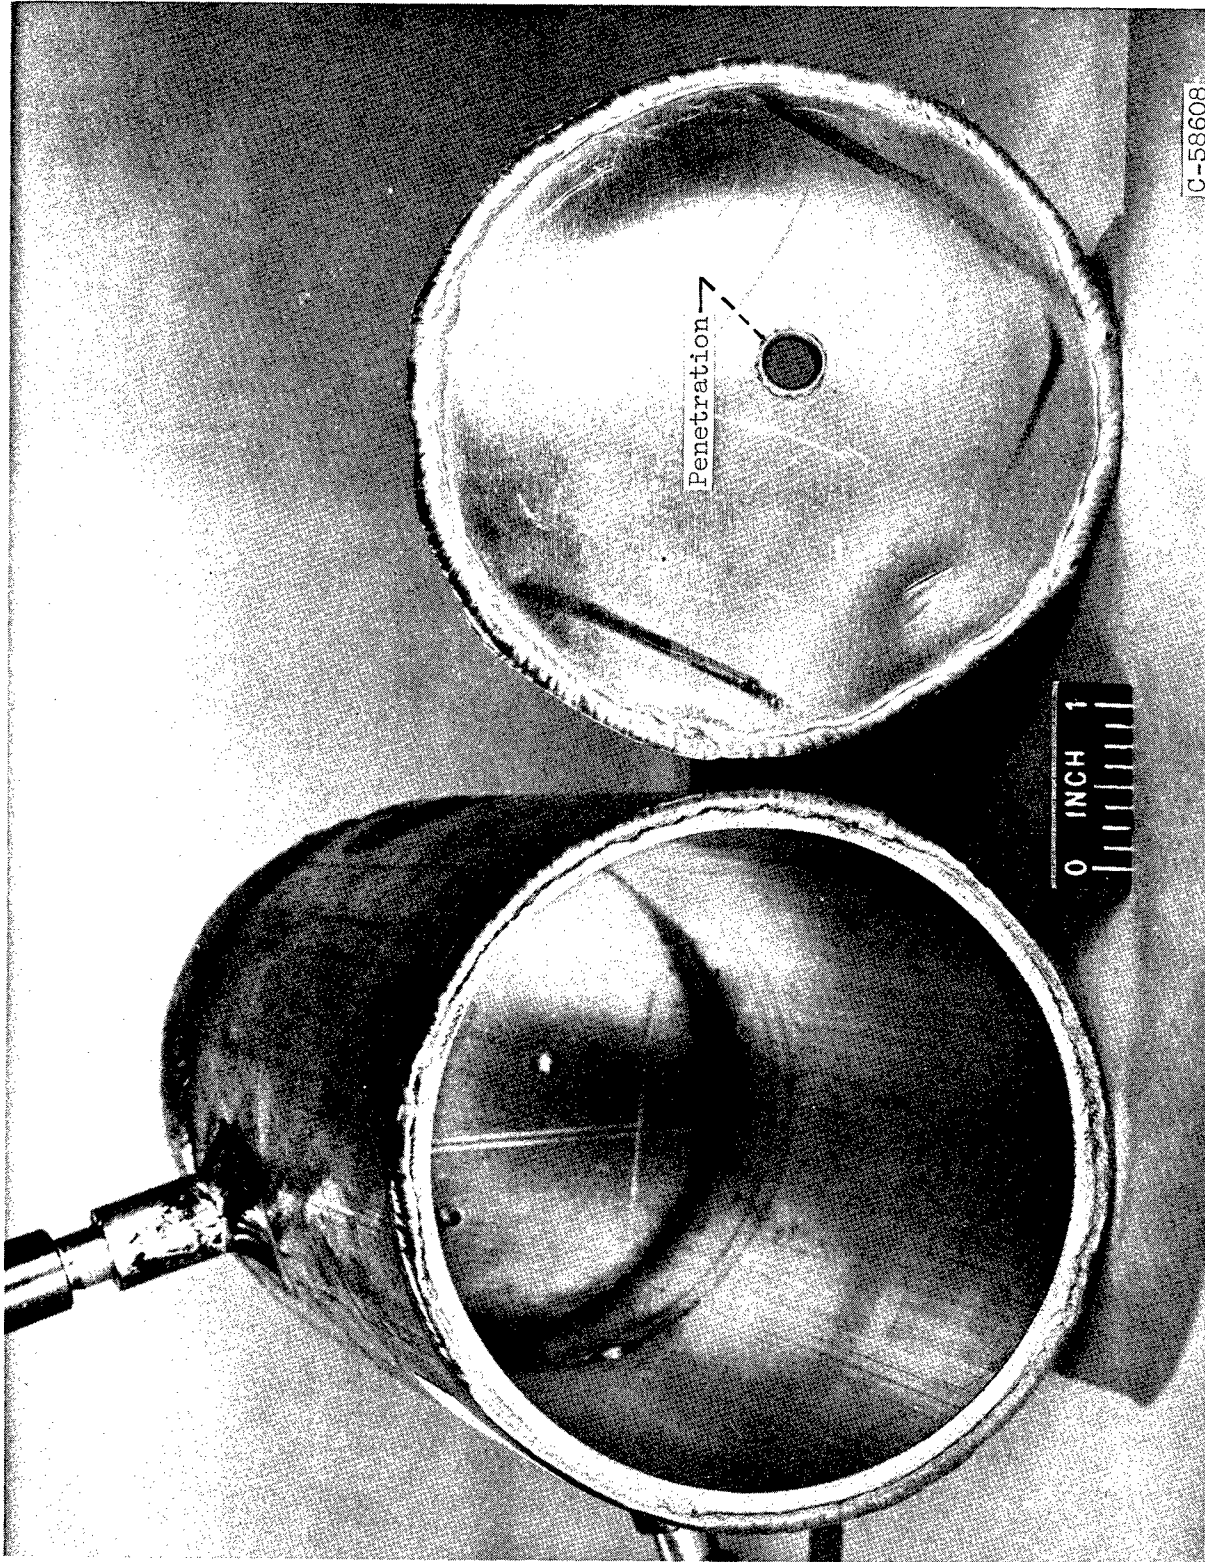
Figure 6. - Results of impact by steel projectile into aluminum tank filled with hydrazine. Test 2.

tank were large enough to cause the entire impacted tank end to be explosively detached from the tank. Figure 5 shows some selected frames taken from a movie sequence of the impact. Figure 6 reveals that a complete failure of the welded region, where the end cap was attached to the cylindrical portion of the tank, took place. The hole produced by the steel sphere penetrating the tank wall was somewhat larger (0.301 in.) than that produced in the stainless-steel tank; in addition, a rather pronounced cratering effect was produced around the edges of the penetration; a much greater effect than that on the stainless-steel tank.

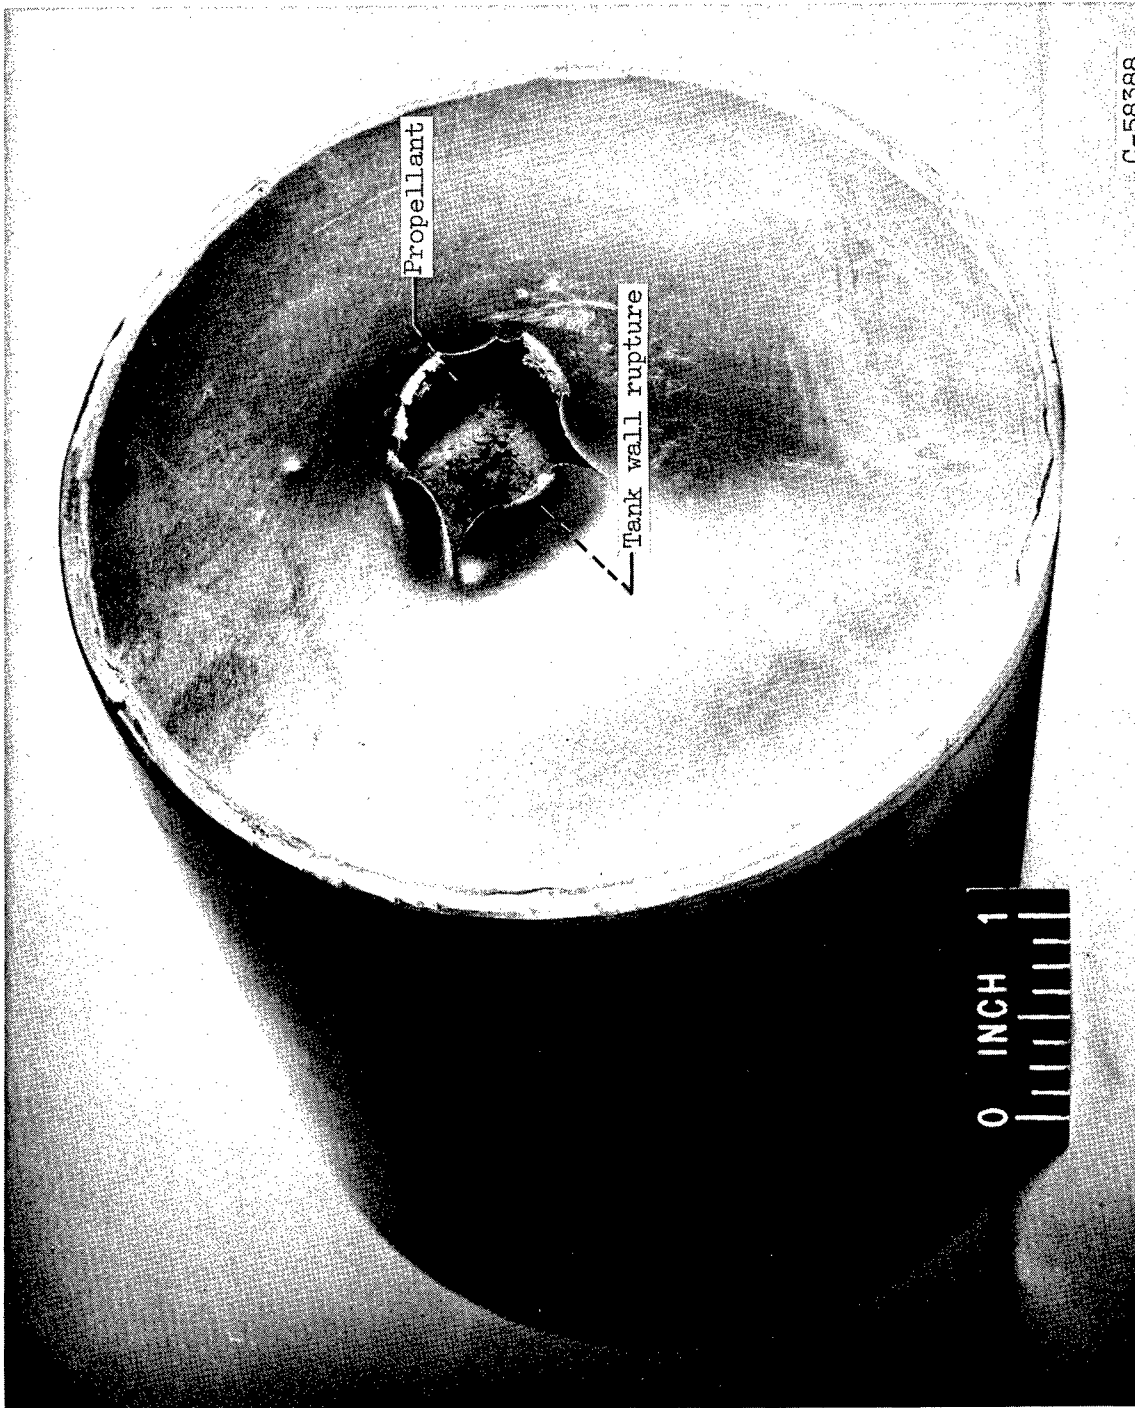
Figure 7. - Results of impact by steel projectile into aluminum tank filled with Arcite 373.
Test 6.

Solid propellants. - Test conditions for the impacts of solid propellants (tests 6 and 7) contained in aluminum cylinders were the same as in the previous test shots. Impact of the simulated rocket casing containing Arcite 373 resulted in a "blowout" in the general area of the impact. Figure 7 shows the impacted tank and reveals the curling and tearing of the 0.031-inch-thick tank wall and the 3/4-inch-diameter hole. The steel pellet penetrated the propellant grain to a depth of about $2\frac{1}{2}$ inches; there were no signs of an interaction between the tank wall and the propellant or evidence of ignition of the propellant itself.

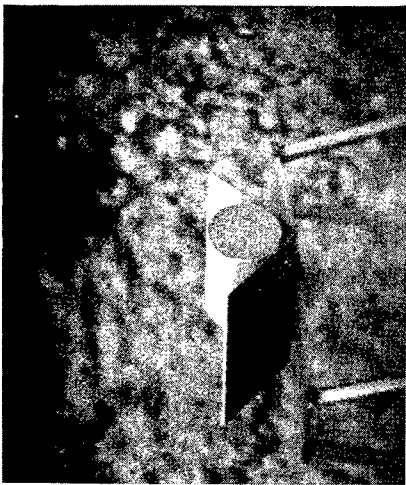
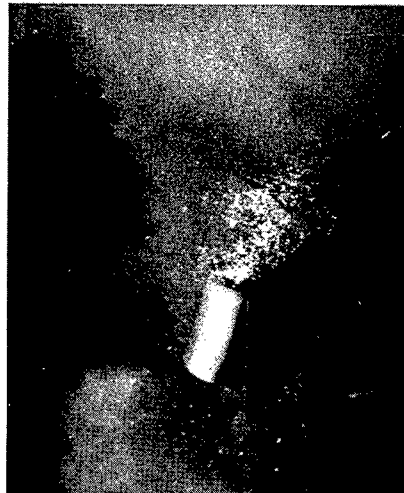
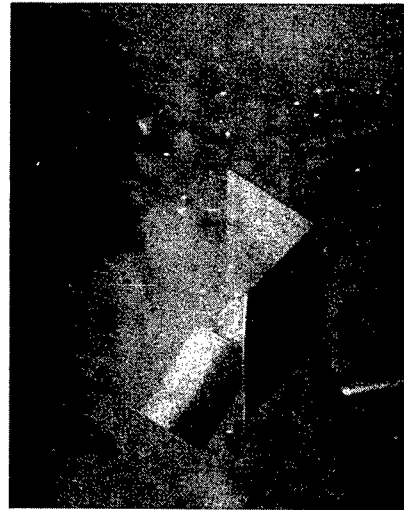
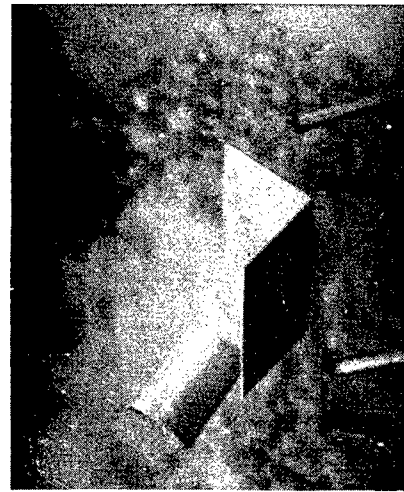
(a) Camera at left of test stand.

Figure 8. - Selected frames from motion picture taken of impact by steel projectile into aluminum tank filled with Hercules CLW. Test 7. (Time after impact given in milliseconds.)

The impact made on the simulated rocket casing containing the Hercules CLW propellant resulted in ignition of the propellant, the entire grain being consumed in flames. Figure 8(a) shows some frames taken from the movie sequence before, at, and after the impact. Figure 8(b) shows selected frames from a movie sequence of the same impact taken with another camera at a different angle and at times later than those indicated in figure 8(a). When the propellant was ignited by the impact, it acted much like a rocket motor exerting a thrust and lifted the tank off the test stand. The propellant apparently burned through to the other end of the grain, and flames shot out from both ends of the container. In the case of the solid propellants, no end cap was used for the rear or back end of the tank since the grain was bonded with an epoxy resin to the cylindrical portion and the front end cap. The pressures generated by the impact caused the impacted end cap to fracture in a catastrophic manner, the resulting pieces

being scattered about the immediate area.. The third frame of figure 8(a) (7 msec after impact) shows some of the pieces of the end cap being explosively detached from the tank. Figure 9 shows the extensive damage that resulted from the impact; the tearing or curling of the impacted surface resulted in the ultimate failure of the welded region joining the end cap to the cylinder. Despite the generally violent physical and chemical reactions, there were no signs of a specific interaction of the impacted end cap with the propellant.

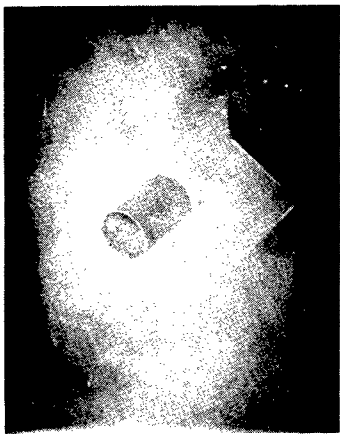
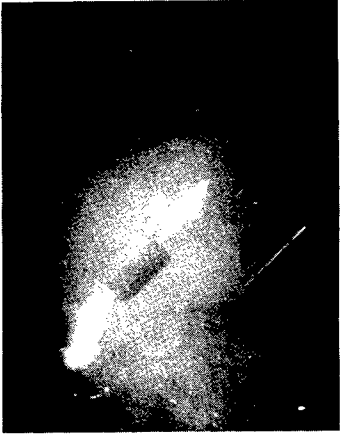
(b) Camera at right of test stand.

Figure 8. - Concluded. Selected frames from motion picture taken of impact by steel projectile into aluminum tank filled with Hercules CLW. Test 7. (Time after impact given in milliseconds.)

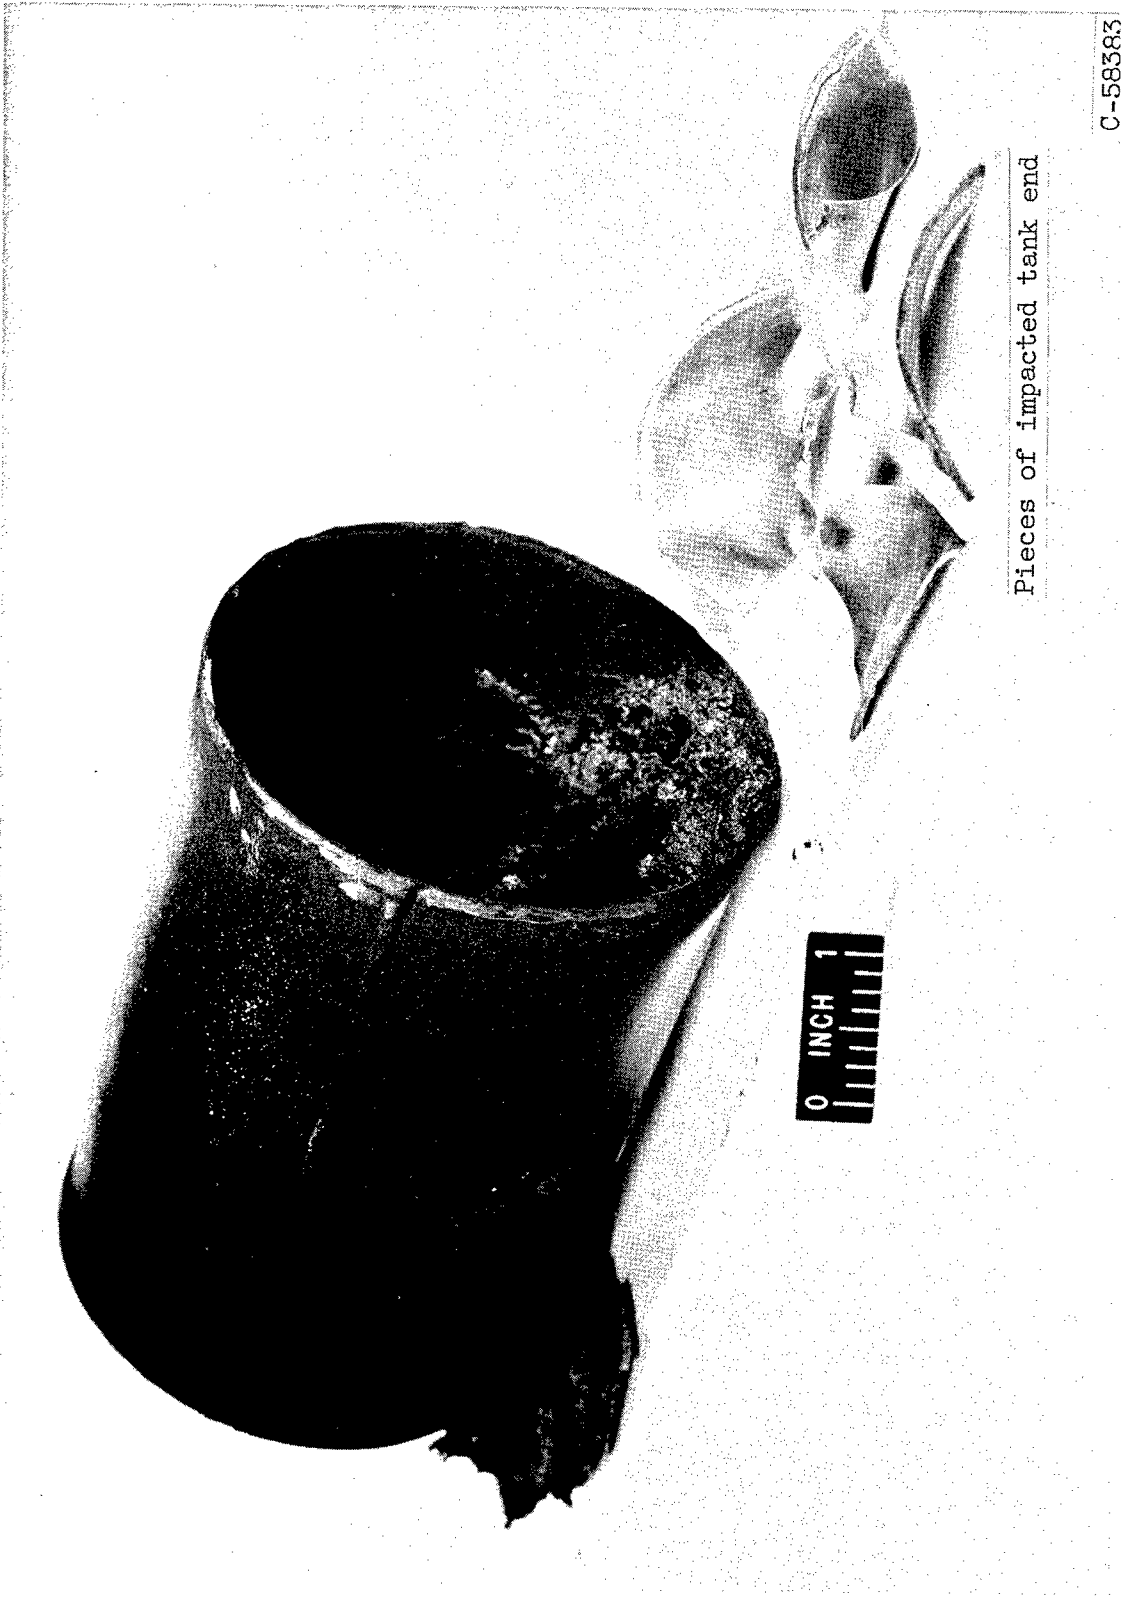
Pieces of impacted tank end

Figure 9. - Results of impact by steel projectile into aluminum tank filled with Hercules CLW.
Test 7.

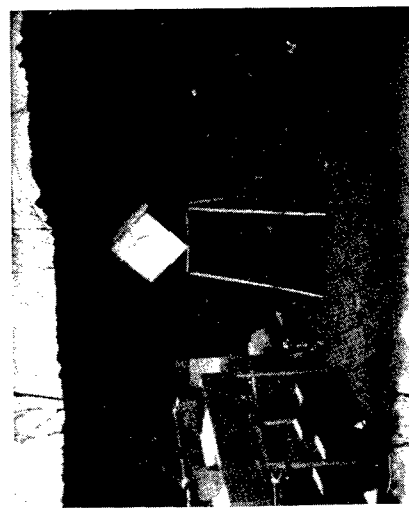
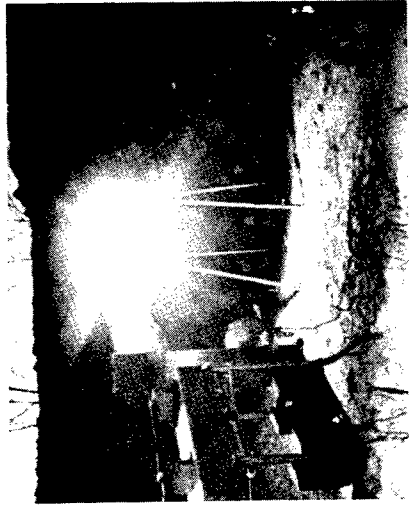
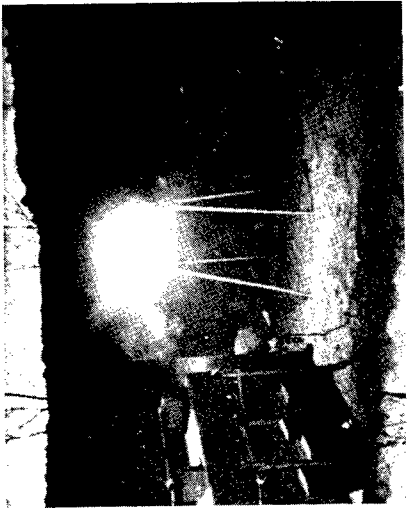
Figure 10. - Selected frames from motion picture taken of typical impact and penetration of titanium wall of tank filled with liquid oxygen. Test 14. (Time after impact given in milliseconds.)

Visual recordings of impacts: As an aid to further the study of the titanium - liquid-oxygen reaction, high-speed movies (with framing rates up to 6000 frames per sec) were taken of particle impacts and ensuing reactions. These movies do not indicate the source or the cause of the reaction between titanium and liquid oxygen, but they do show that the reaction produced is by no means in a steady-state condition. The quasi-steady-state burning of the titanium is interrupted periodically by a number of flareups, explosions, or sudden releases of energy. As many as five violent flareups were detected in one of the movies. The movies also reveal that, once the reaction is started, it becomes highly exothermic and provides ample heat for sustaining the reaction until either the test specimen is consumed or the supply of oxygen is exhausted.

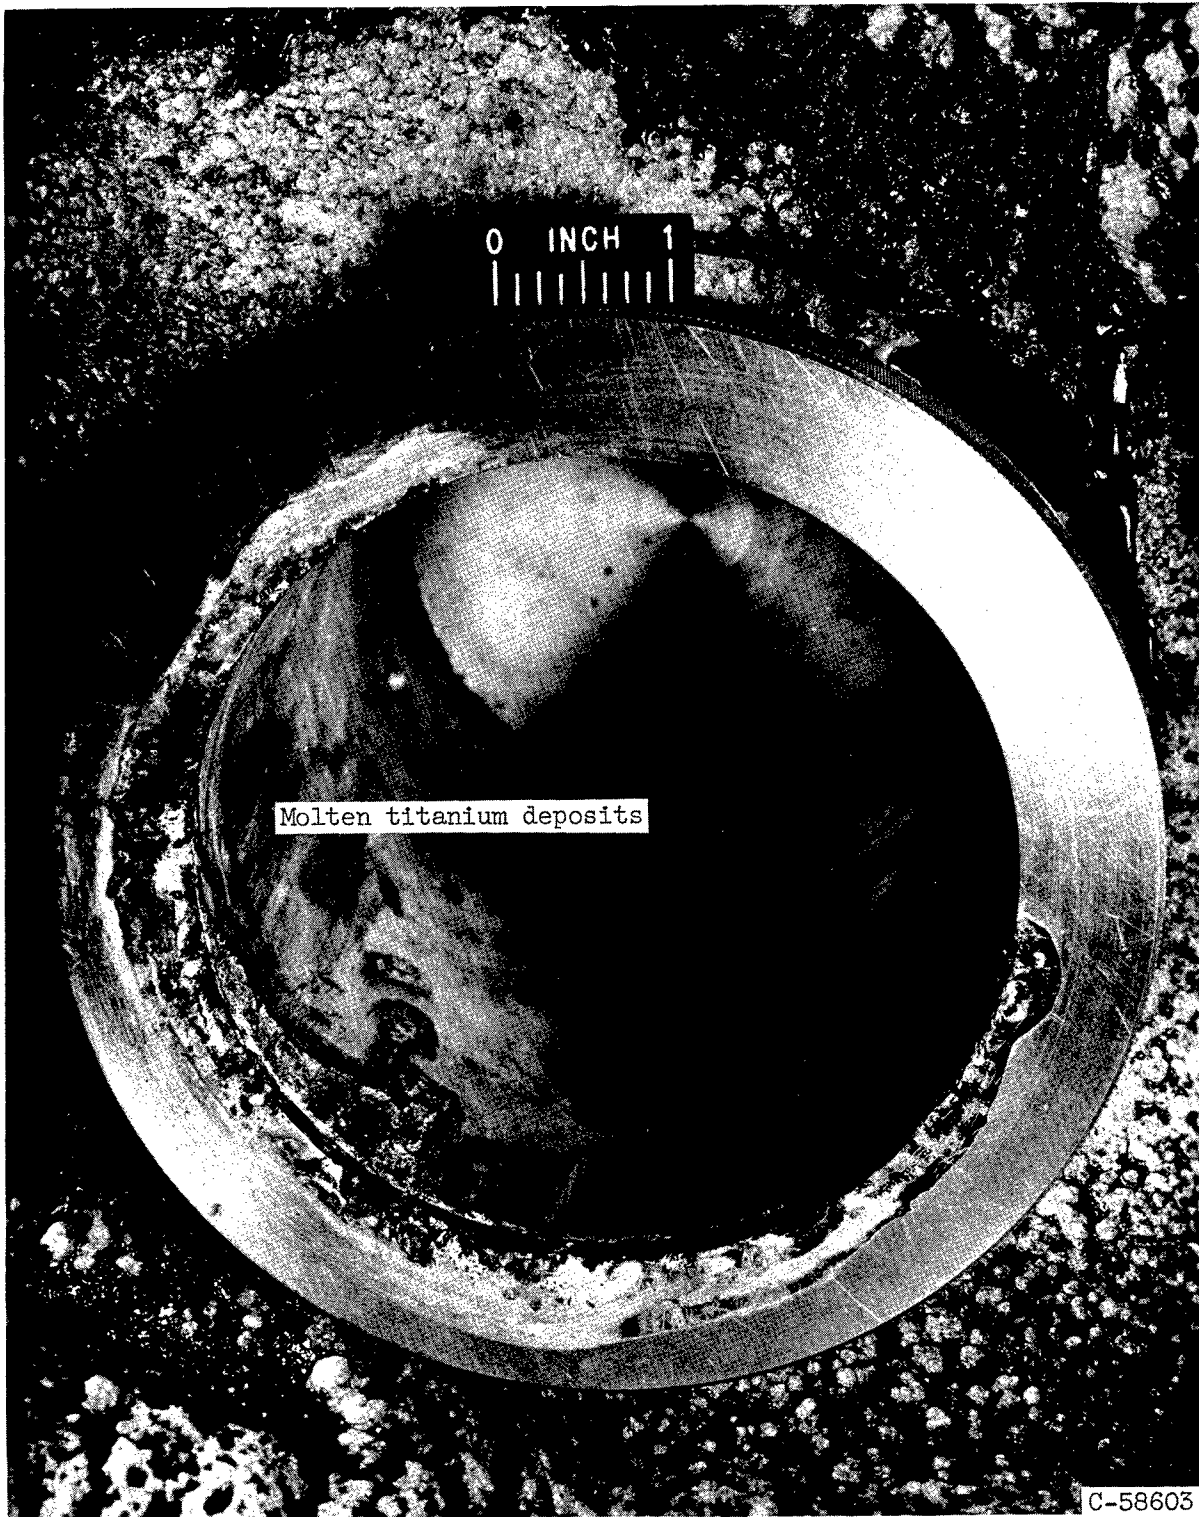
Figure 12. - Condition of tank after impact and penetration of titanium wall of tank filled with liquid oxygen. Test 8.

Impacting projectile material: The first impact of a titanium tank wall was made with a 0.219-inch-diameter steel sphere at a velocity of 5800 feet per second. The condition of the tank after the impact and the subsequent titanium - liquid-oxygen reaction is shown in figure 12. Molten titanium, produced during the violent reaction that resulted, deposited on the retaining nut and the inside of the tank and caused the damage shown in the figure. The insulation that surrounded the tank was slightly scorched as a result of the vigorous burning, and for all subsequent tests the insulation was covered with a thin stainless-steel sheet to prevent such damage.

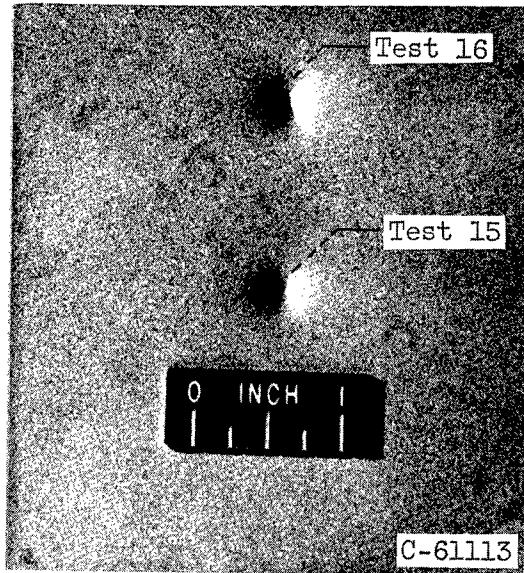
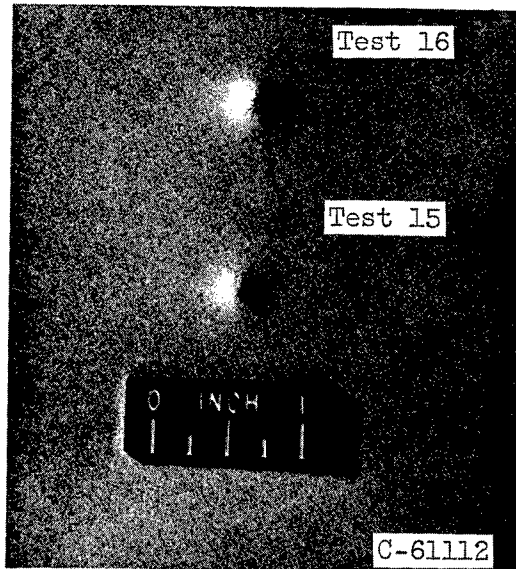
(a) Impacted surface.

(b) Surface in contact with liquid oxygen.

Figure 13. - Results of impacts without complete penetration of titanium wall of tank filled with liquid oxygen.

lish whether there was a critical energy level of impact required to initiate a reaction and also to determine whether an impact of the titanium wall without a penetration would result in a violent reaction. The titanium specimen shown in figure 13 was impacted twice by 0.219-inch-diameter nylon spheres (tests 15 and 16) without a reaction occurring. The indentation from test 15 was produced by an impact at an energy of 36.7 foot-pounds, the projectile velocity being 3200 feet per second. The impact resulted in very fine hairline cracks at the base of the indentation. The other indentation was produced by a nylon sphere having a kinetic energy of 46.5 foot-pounds at a velocity of 3600 feet per second. Figure 13(b) shows the side of the titanium wall that was exposed to the liquid oxygen, and, as can be seen, the impact of test 16 opened a crack about 3/16 inch long, from which liquid oxygen spurted profusely. The impact had exposed a fresh titanium surface to the liquid oxygen, but no reaction occurred.

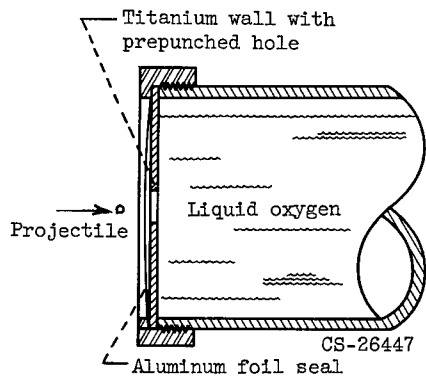
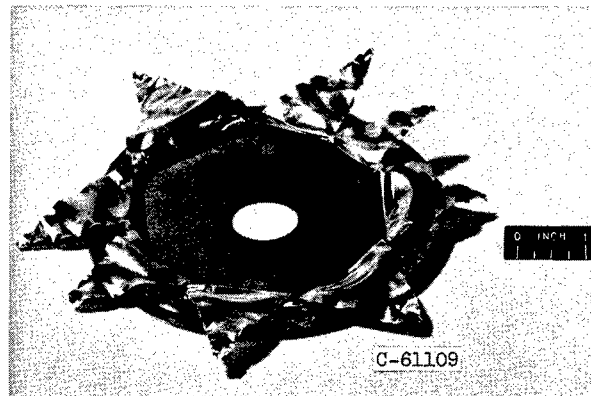
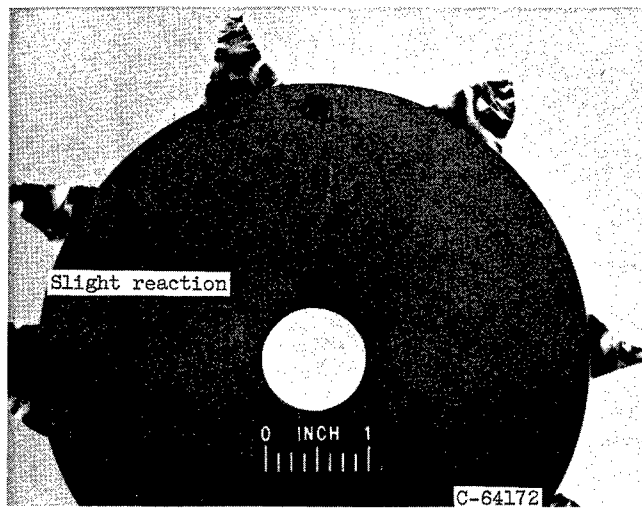
(a) Schematic of test tank.

(b) Front side of titanium disk after impact.

(c) Reverse side of titanium disk after impact.

Figure 14. - Impact test on prepunched titanium specimen covered with aluminum foil. Test 27.

Test 27 was conducted by using a titanium specimen with a 1-inch-diameter prepunched hole at the center (fig. 14). A 0.006-inch-thick sheet of aluminum foil was placed over the titanium disk, with both the aluminum and titanium being held in place by the retaining nut of the tank. This allowed the tank to be filled with liquid oxygen. The rifle was bore sighted to impact at the center of the prepunched hole, which was outlined in the thin aluminum foil. Impact by a steel sphere produced the results shown in figures 14(b) and (c). The aluminum foil ruptured and peeled back on itself (fig. 14(b)) as a result of the pressure forces generated in the liquid oxygen by the impact and penetration of the high-velocity sphere. It can be seen that the titanium test specimen was not consumed by any violent reaction with the liquid oxygen. It was noted, however, that on the reverse side of the specimen (fig. 14(c)) some slight reaction did occur in several areas of the specimen.

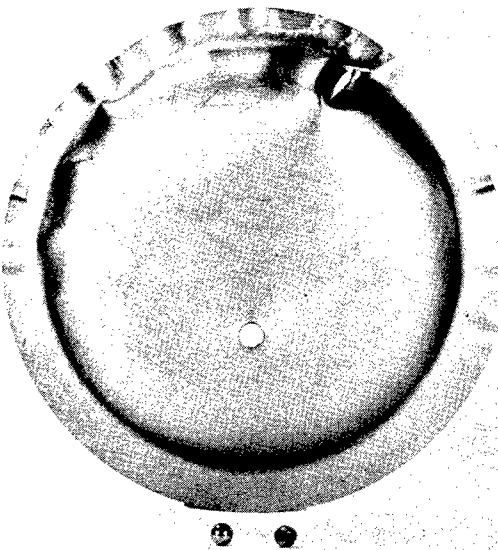
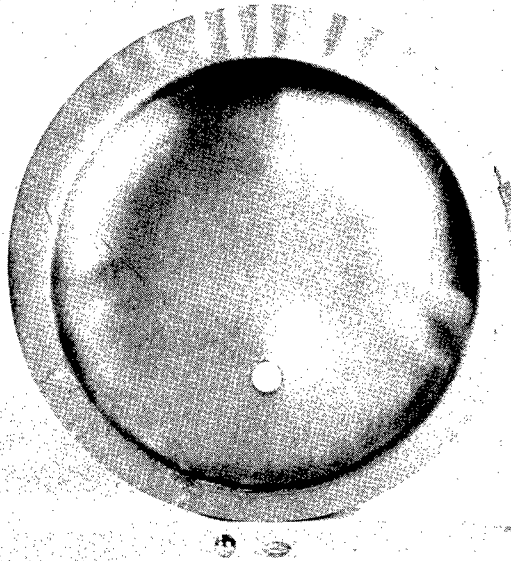
Wall impacted by steel sphere

Wall impacted by aluminum sphere

Figure 15. - Results of impacts and penetrations of titanium walls of tank filled with nitrogen tetroxide. (Impacted side of specimens shown.)

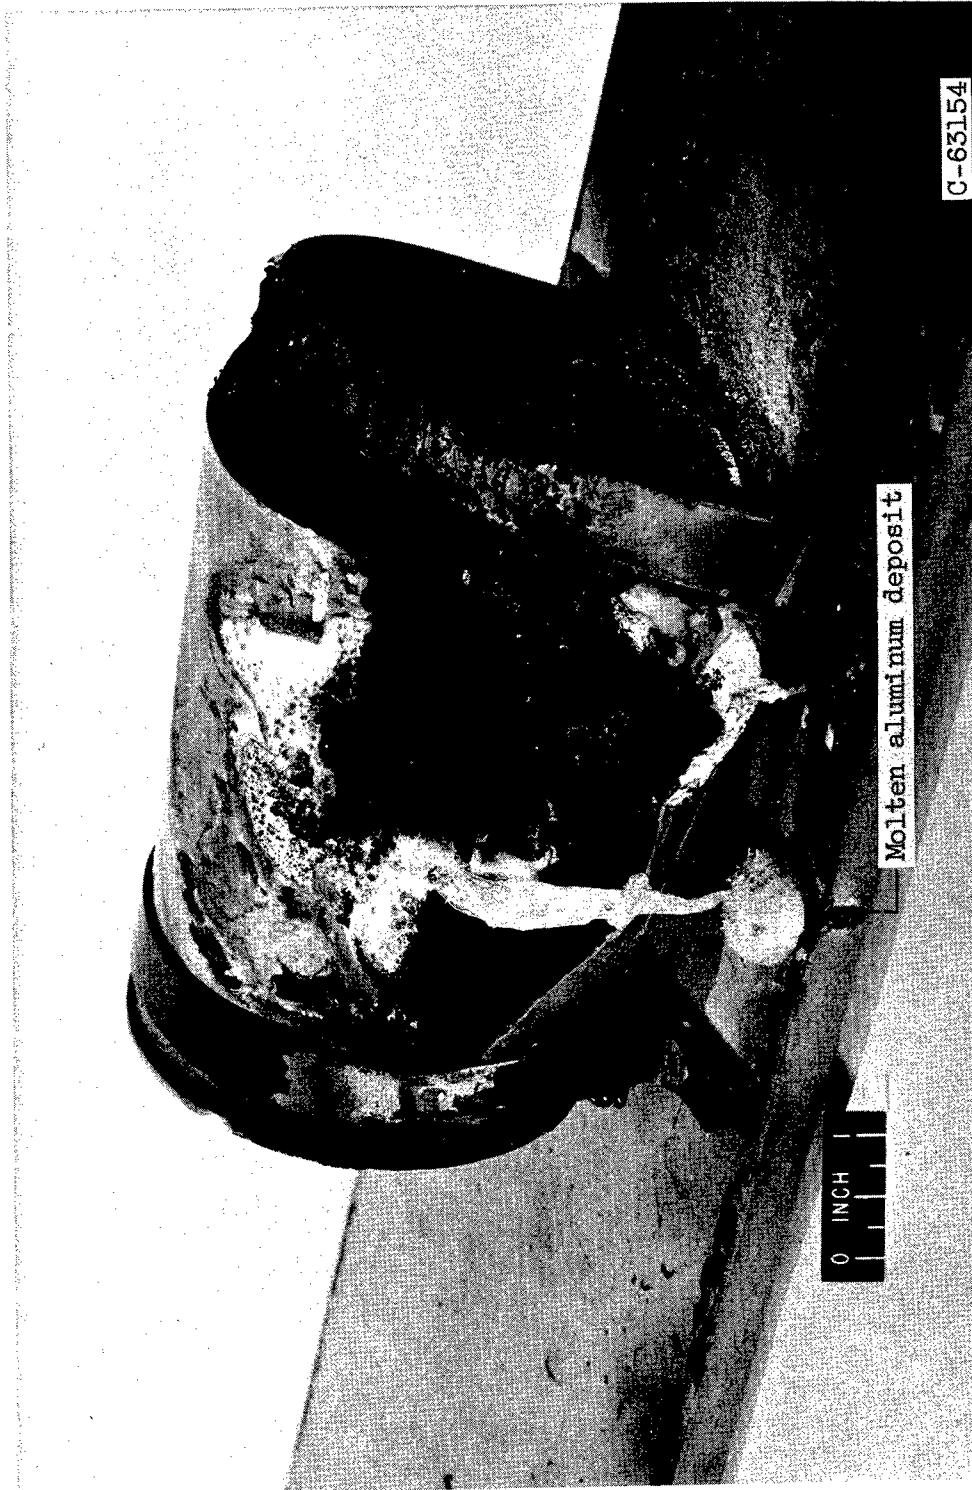
Figure 16. - Damage resulting from impact by steel projectile into titanium tank filled with Hercules CLW. Test 36.

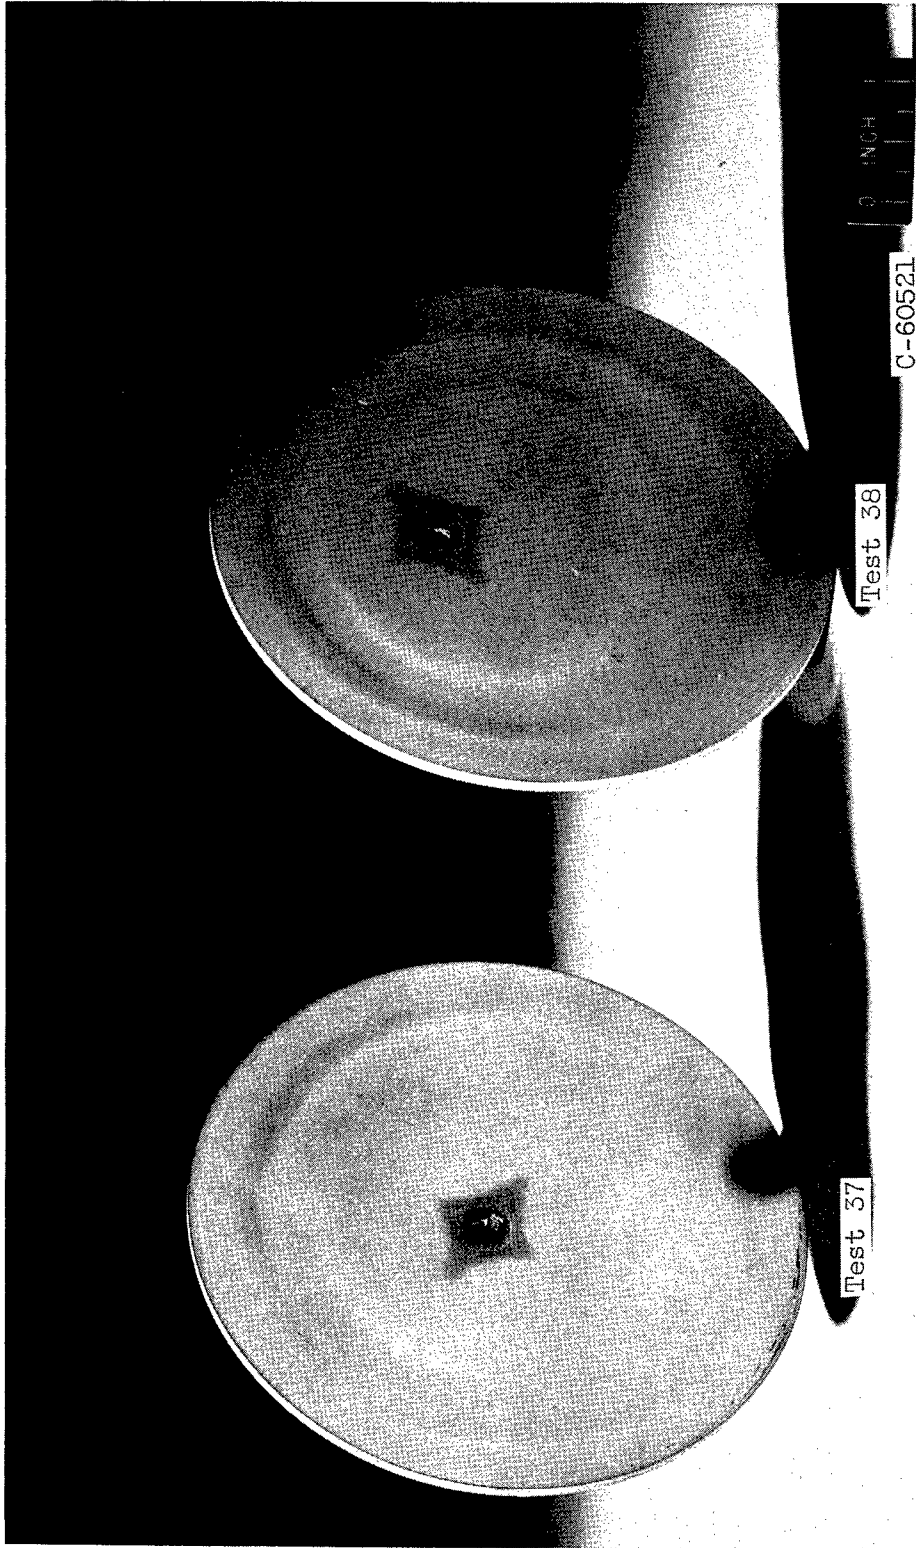
Figure 17. - Results of impacts and penetrations of glass-cloth-reinforced epoxy walls of tank filled with liquid oxygen.

Impacts made on two simulated glass-cloth-reinforced epoxy resin tank walls in contact with liquid oxygen resulted in mere penetrations of the specimens with no sustained burning or chemical reaction (fig. 17). The plastic or glass cloth fibers at the edges of the penetration have a dark appearance, which indicates that singeing may have taken place. In the area surrounding the hole left by the impact, a stress pattern approximately a diamond shape was produced. Other evidence of high stress appears toward the outer edges of the disk, that is, where the specimen was secured by the retaining nut.
