TECHNICAL NOTE
D-1882

AN EXPERIMENTAL INVESTIGATION OF CHEMICAL REACTION
BETWEEN PROPELLANT TANK MATERIAL AND ROCKET
FUELS OR OXIDIZERS WHEN IMPACTED BY SMALL
HIGH-VELOCITY PROJECTILES

By Robert P. Dengler
Lewis Research Center
Cleveland, Ohio

August 1963

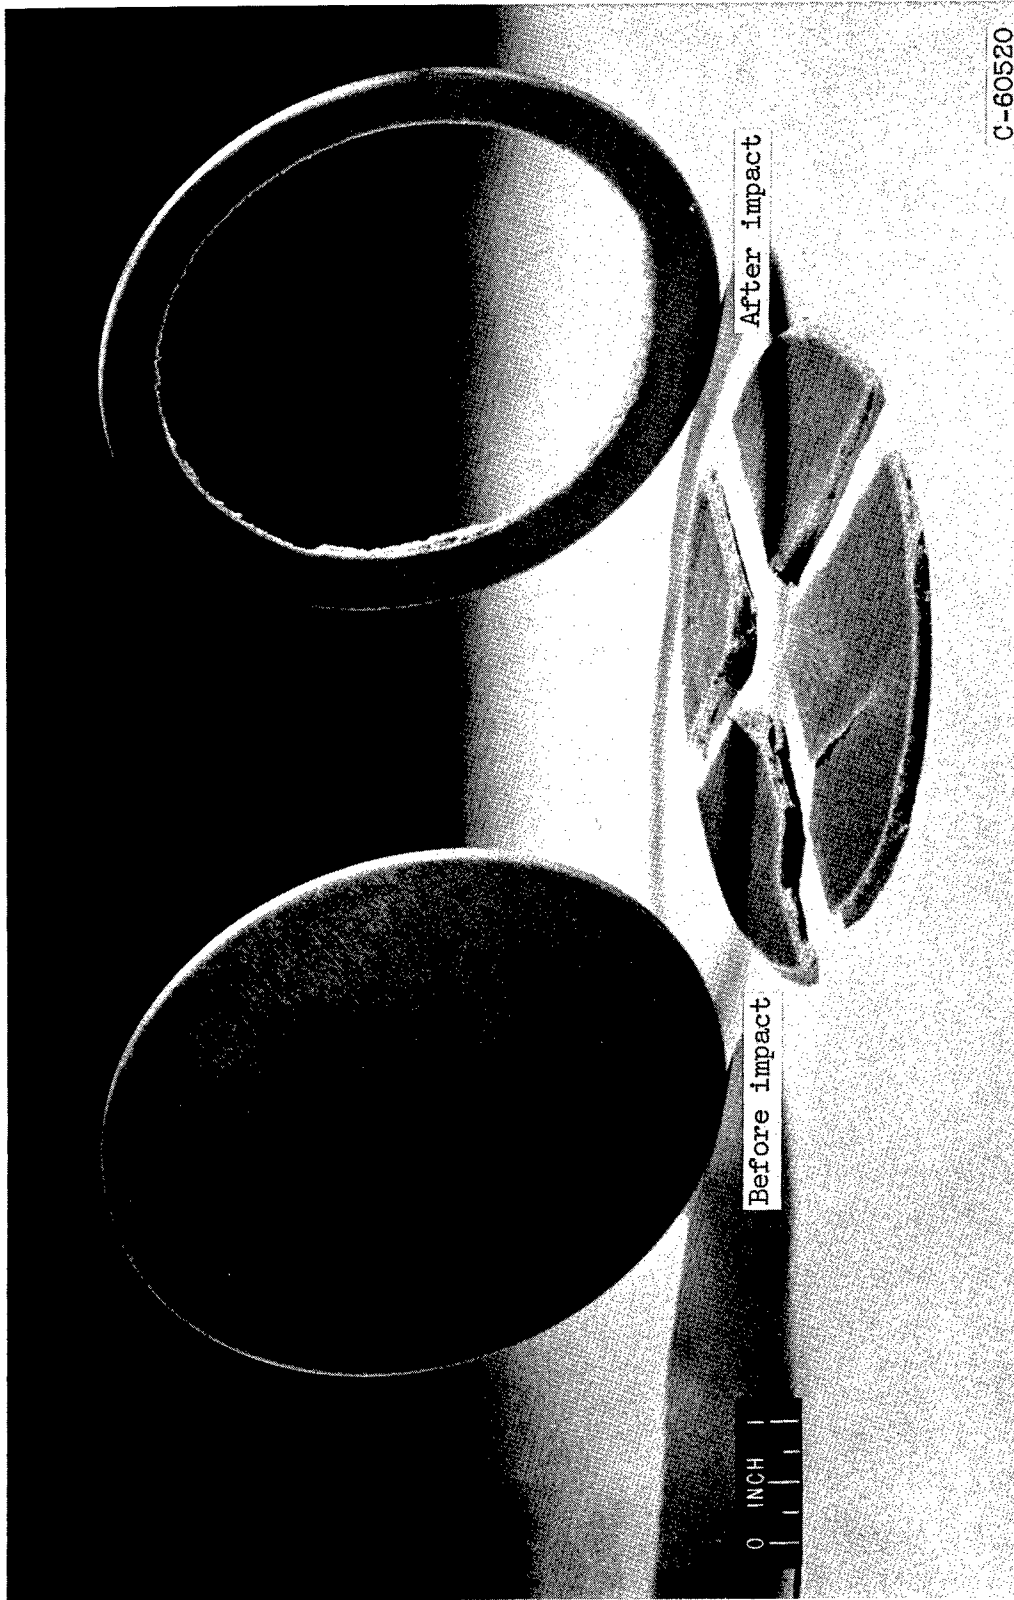
Figure 18. - Results of impact and penetration of nylon-cloth-reinforced phenolic wall of tank filled with liquid oxygen. Test 39.

Impacts on both the nylon-cloth-reinforced phenolic-resin specimen and the Dacron-fiber-reinforced polyurethane specimen resulted in catastrophic fracturing of the impacted wall, as shown in figures 18 and 19. The failure of the phenolic tank wall is representative of a brittle fracture, whereas the failure

of the polyurethane tank wall was more typical of a rupture of a flexible material. Neither impact resulted in any burning or chemical reaction; however, it was noted that a darkened appearance existed around the edges of the impact point of the polyurethane specimen, similar to that from the impacts on the glass-cloth - epoxy-resin specimens. All specimens were impacted at particle energy levels above 900 foot-pounds, and no chemical reaction resulted. Reference 6 reports that plastics, similar to those used as the binder in the reinforced plastic materials investigated herein, were impact sensitive to liquid oxygen under drop test conditions at energy levels of only 80 foot-pounds. It might be expected that the glass-reinforced material investigated (consisting of only 20 percent organic plastic material) might be less impact sensitive in a liquid-oxygen environment than the other materials, in which the reinforcing fibers as well as the binder were organic materials. For the energy levels investigated herein, no conclusions relative to this possibility could be made, but it is of interest to note that small high-velocity particle penetrations into materials that were 100 percent polymeric did not cause reactions with liquid oxygen even though the kinetic-energy levels were much higher than those employed in reference 6. It would seem that, based on the results of reference 6 and those obtained herein, the impact mode plus the size, velocity, and/or shape of the impacting particle may affect the reactivity of polymeric materials in the presence of liquid oxygen.

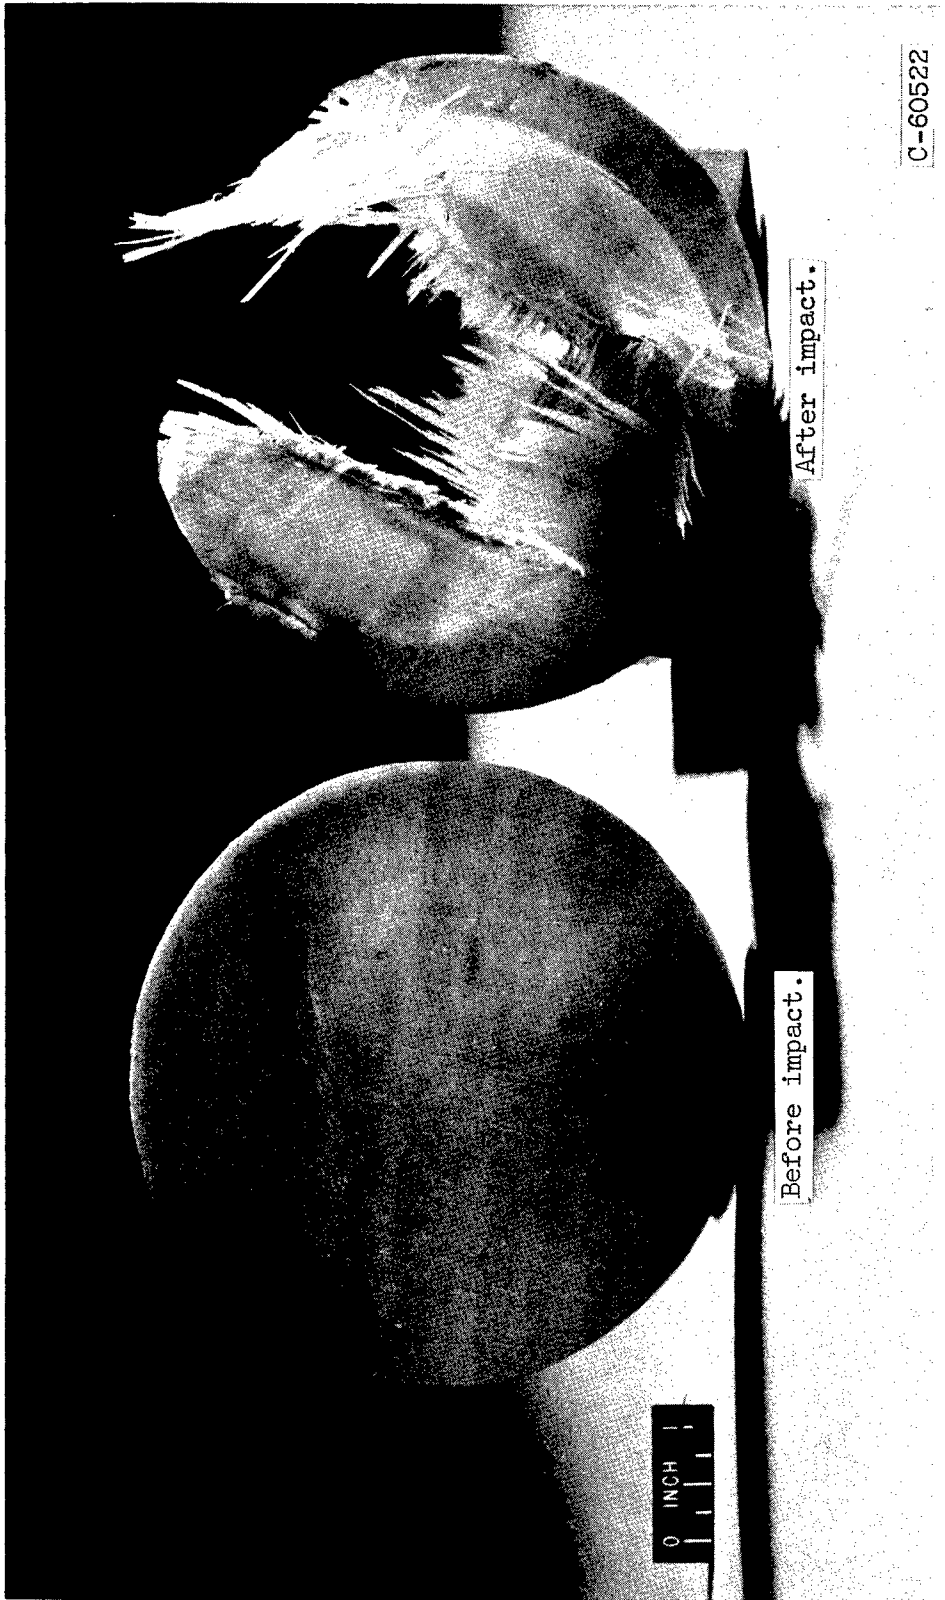
Figure 19. - Results of impact and penetration of Dacron-fiber-reinforced polyurethane wall of tank filled with liquid oxygen. Test 40.
