NASA TECHNICAL NOTE

NASA TN D-2040

A STUDY OF SEVERAL OXIDATION-RESISTANT COATINGS

ON Mo-0.5Ti ALLOY SHEET AT 2,500⁰ F

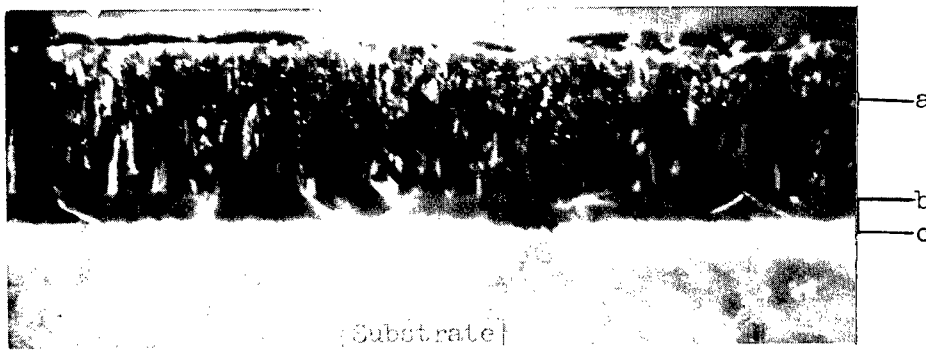
(a) As-coated appearance. X2.

(b) Cross section, bright field illumination. X500.

(c) Cross section, polarized light. X500.

Figure 4.- As-coated coating A(G) tumbled-edge oxidation specimen. I-63-4790

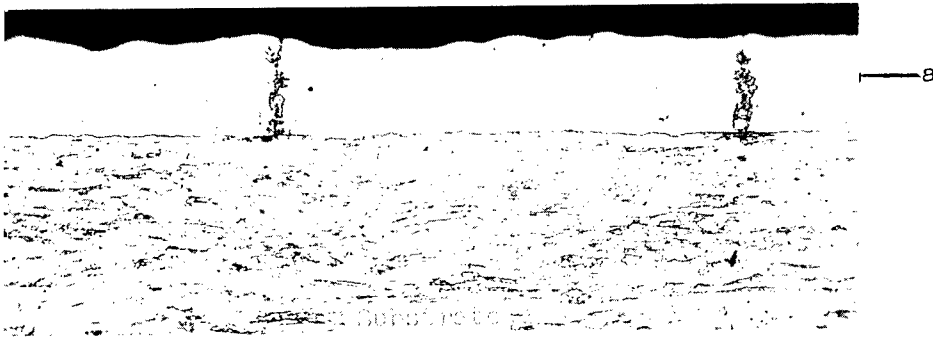
(a) As-coated appearance. X2.

(b) Cross section, bright field illumination. X500.

(c) Cross section, polarized light. X500.

Figure 5.- As-coated coating B broken-edge oxidation specimen.

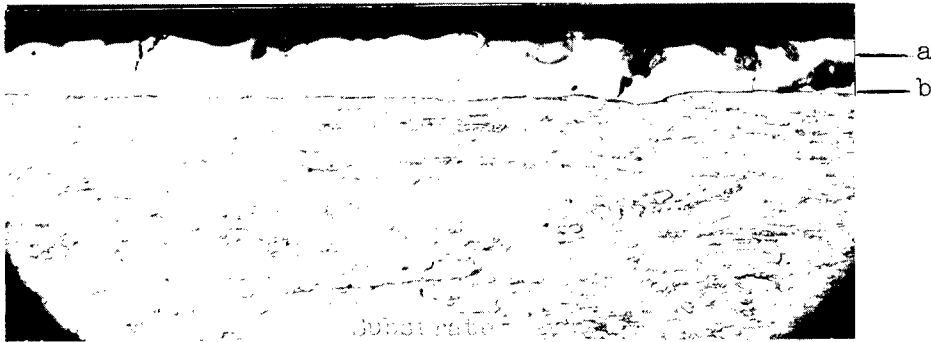
(a) As-coated appearance. X2.

(b) Cross section, bright field illumination. X500.

(c) Cross section, polarized light. X500.

Figure 6.- As-coated coating C broken-edge oxidation specimen.

Coating C: (The typical as-coated appearance of coating C (fig. 6(a)), although a highly modified disilicide coating, was characteristically dull gray with a matte texture. Some unevenness of color was noted near the edges but none of the specimens had the mottled appearance of other modified coatings.) When examined under bright light, a cross-sectioned specimen (fig. 6(b)) appeared to contain only two phases (a and b). However, when examined under polarized light (fig. 6(c)), the outer phase (a) contained two distinct grain structures (a and a'). Although both are columnar in form, the grain structure on the outer surface (a) consisted of larger grains which were less severely oriented than the inner grain structure (a'). Although it is not clearly apparent in the photomicrograph, the appearance of these two grain structures under polarized light differs considerably from that of the other coatings. In all the other coatings, the phase which was optically active under polarized light (assumed to be MoSi_2) appeared to be composed of varying shades of bluish gray. In coating C this phase was made up of various shades of pink and light gray. This coloring may be due to the $\text{Mo}(\text{Al},\text{Si})_2$ which was identified on the surface of the coating by X-ray diffraction. Although different in appearance, the two grain structures (a and a') exhibited the same Knoop hardness (ref. 6). There was also a thin phase (b) next to the molybdenum substrate which was not active under polarized light and revealed no grain structure with the etchant used. Coating C was the thinnest and most nonuniform of the coatings investigated.

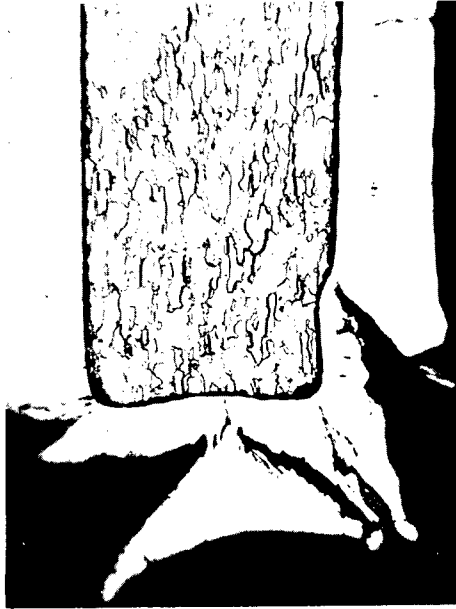
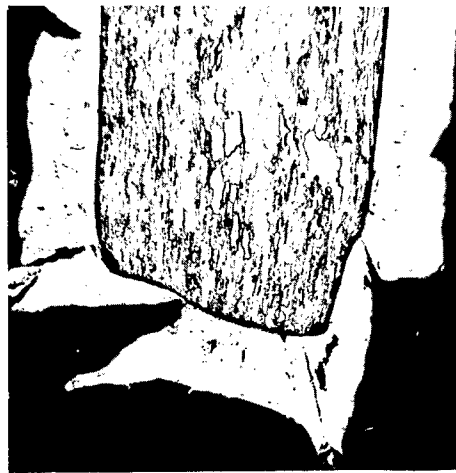
(b) Broken edge.

(a) Sheared edge.

Figure 10.- Appearance of a typical coating after application on 0.012-inch Mo and -0.5%Ti sheet specimens with three edge conditions. Approximately X150.

Edge preparation is generally considered an important factor in coating performance on sheet material. Photomicrographs (fig. 10) of one of the coatings before exposure are typical of the as-coated appearance for the three edge conditions under investigation. As expected, the coating on the tumbled edge appears superior to the other two. The partially recrystallized substrate of the tumbled-edge and the sheared-edge specimens would suggest that these two edge preparations are less severe than the broken-edge preparation which resulted in a fully recrystallized substrate. The lower recrystallization temperature of the broken-edge specimen, which may be the result of a more severe fabrication process and the accompanying higher residual stresses, could contribute to a shorter life for a coating applied to this edge condition.

The rounded edge of the tumbled-edge specimens, in addition to the lower residual stresses inherent with the tumbling operation, resulted in an even coating thickness and less severe radial cracking (fig. 10). This uniformity of coating thickness on the edges would be expected to produce a coating which is more reliable and less prone to edge failures.

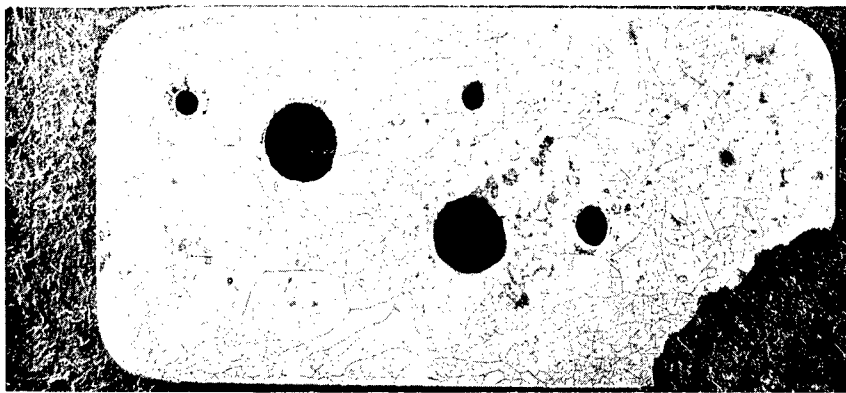
Figure 14.- Coating A(G) tumbled-edge oxidation specimen after 976.2 hours of continuous exposure at 2,500° F in air. L-63-4797

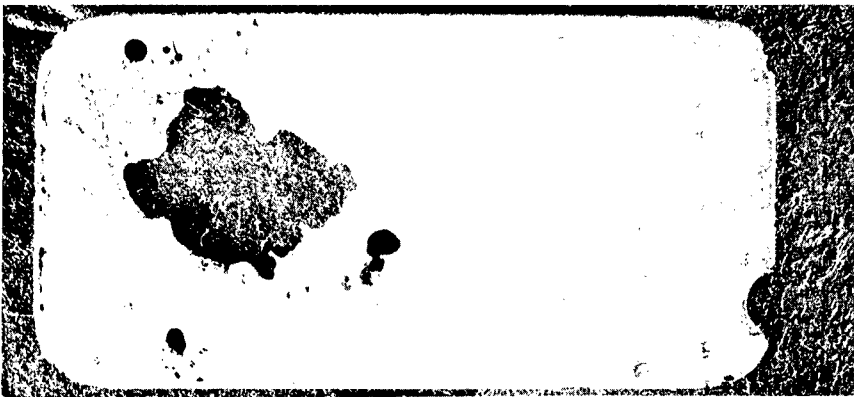
Figure 17.- Coating D tumbled-edge oxidation specimen after 18.4 hours of continuous exposure at 2,500° F in air. L-63-4800

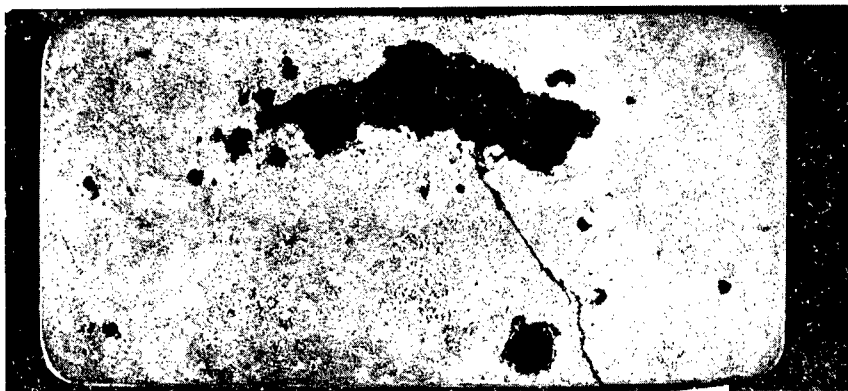
Figure 18.- Coating E broken-edge oxidation specimen after 0.1 hour of continuous exposure at 2,500° F in air. L-63-7501

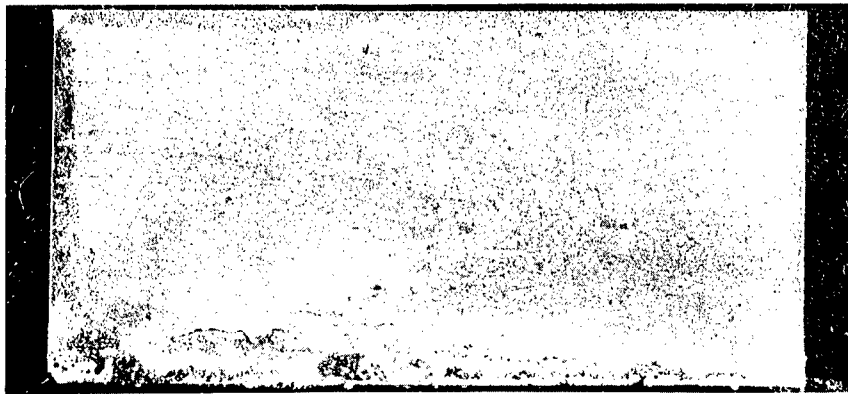
Figure 19.- Coating C broken-edge oxidation specimen after 5.0 hours of continuous exposure at 2,500° F in air.

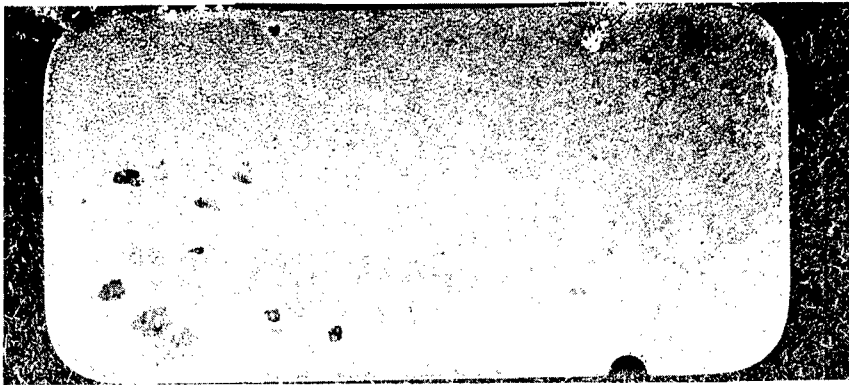
Figure 26.- Coating A tumbled-edge oxidation specimen after 0.1-hour cycles at 2,500° F in air. L-63-7504

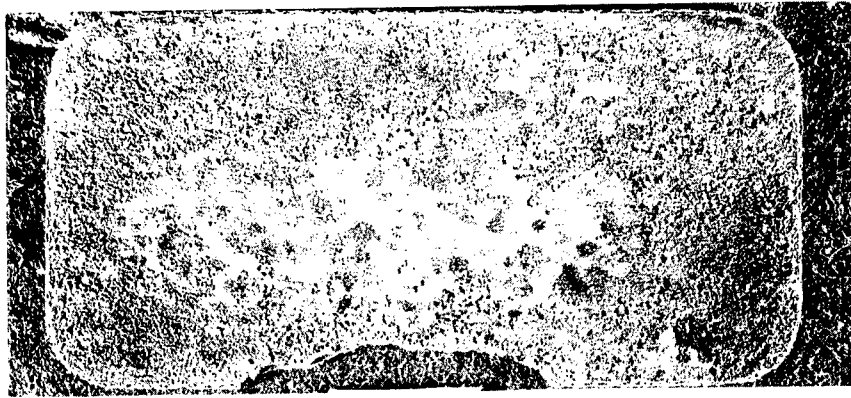
Figure 29.- Coating E tumbled-edge oxidation specimen after forty-four 0.1-hour cycles at 2,500° F in air.

The cyclic tests provided a good opportunity to observe the initiation of failure, and as previously mentioned, visual examination was an unreliable method of detection. After each cycle the specimens were inspected, and in some cases a weight loss of 3 percent did not produce a visible defect in the coating. When a visible defect was found, the specimen was probed to reveal the full extent of substrate damage. Some typical examples of these initial defect points are presented in figures 26(a), 27(a), and 28(a). Figures 26(b), 27(b), and 28(b) present these same specimens after failure. In figure 28 the final failure appears to be only an extension of the original defect. The continued oxidation of the initial defect to produce a 10-percent weight loss was not the only mode of failure. In most of the cycled specimens, other points of failure on the edges were initiated before a 10-percent weight loss terminated the test (figs. 26 and 27). These additional edge failures indicated that the edges of the cycled specimens were marginally protected by the coating when the specimens were subjected to thermal cycling. When the test was terminated, the full extent of substrate damage was not apparent until after the specimens were probed to remove unsound material. Figures 29, 30, and 31 show typical failed specimens before and after probing.
