**NASA CR-103**

**9½ FOOT DIAMETER  
MASTER AND MIRROR**

Prepared by **GENERAL ELECTRIC CO.**  
under Contract No. 950239 *for*  
**JET PROPULSION LABORATORY**  
under Contract No. NAS 7-100  
*for*

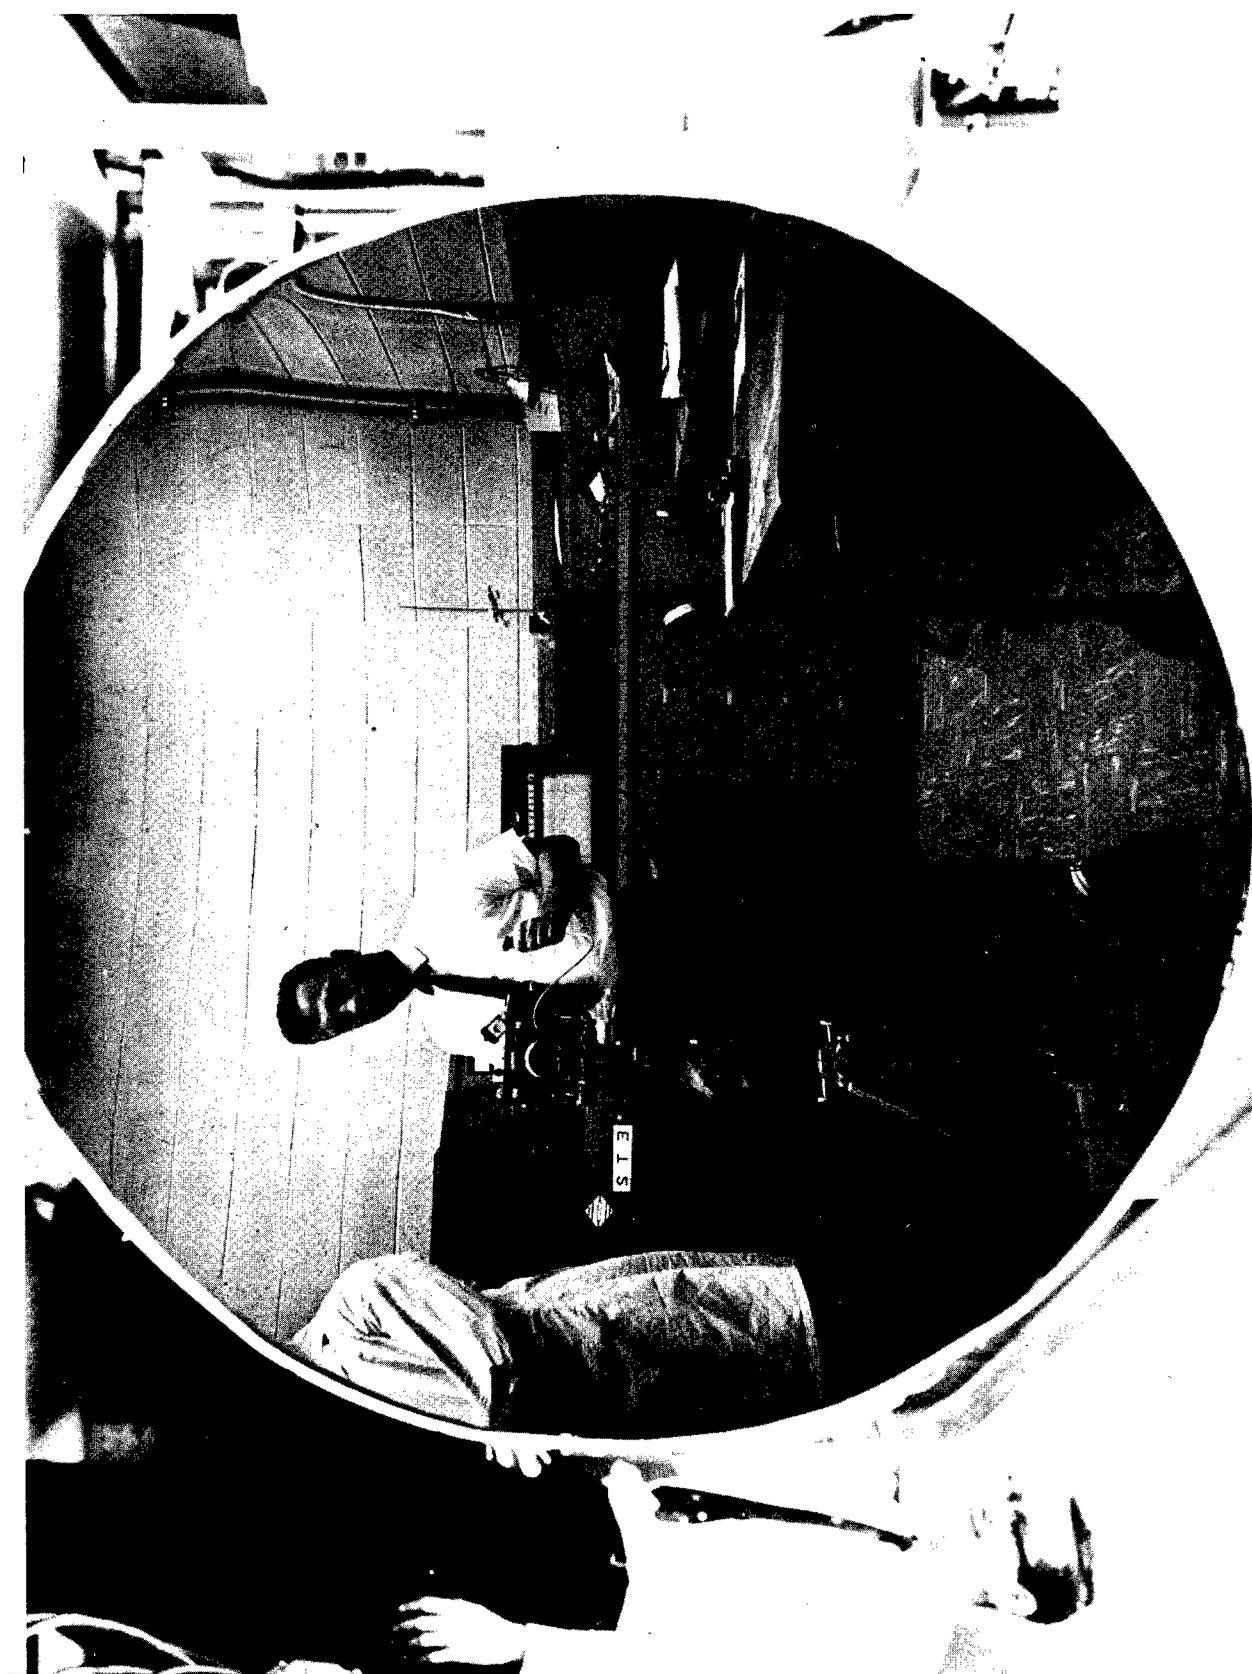
Figure 5.2-5. Five-foot Diameter Spincasting Made on Small Spintable
