**AFRL-VA-WP-TR-2001-3004**

**DC-9 AFT PRESSURE BULKHEAD  
RESIDUAL STRENGTH TEST**

**FINAL REPORT FOR PERIOD OF 01 JUNE 1999 – 01 APRIL 2000**

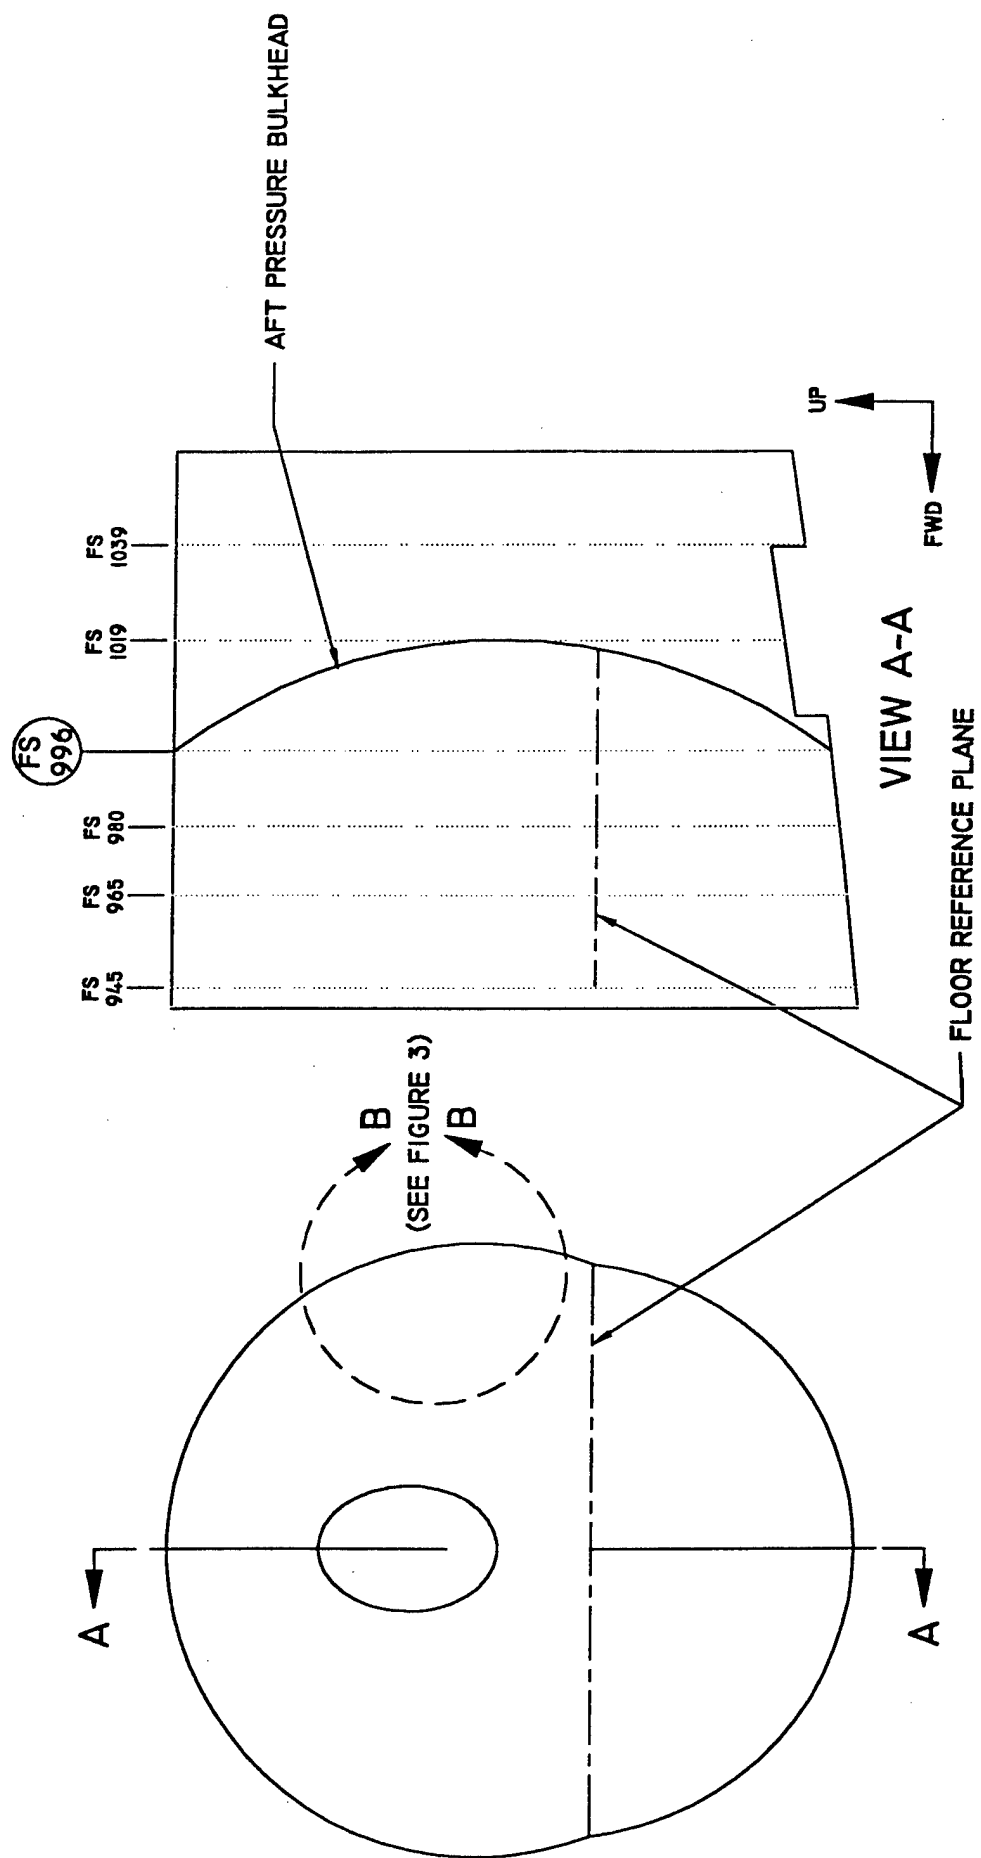
Figure 2. Aft Pressure Bulkhead Initial Damage Locations

The test article was approximately the aft 10 feet of a DC-9 fuselage incorporating the aft pressure bulkhead (Figure 1). This particular aircraft had 57,757 landings and 60,583 flight hours. When mounted on a fixture plate, the enclosed volume was approximately 700 ft<sup>3</sup>. The test article preparation by Boeing included a) cutting the fuselage section to a manageable size, b) installing a structure forward of the bulkhead to facilitate mounting the test article and c) creating the MSD and lead crack in the pressure web (Figures 2 and 3). The AFRL/VASV at Building 65, WPAFB received the prepared test article and mounted it to a fixture plate fabricated locally. Government technicians installed all instrumentation and completed the mechanical, electrical and pneumatic systems installations as required (Figures 4 and 5).

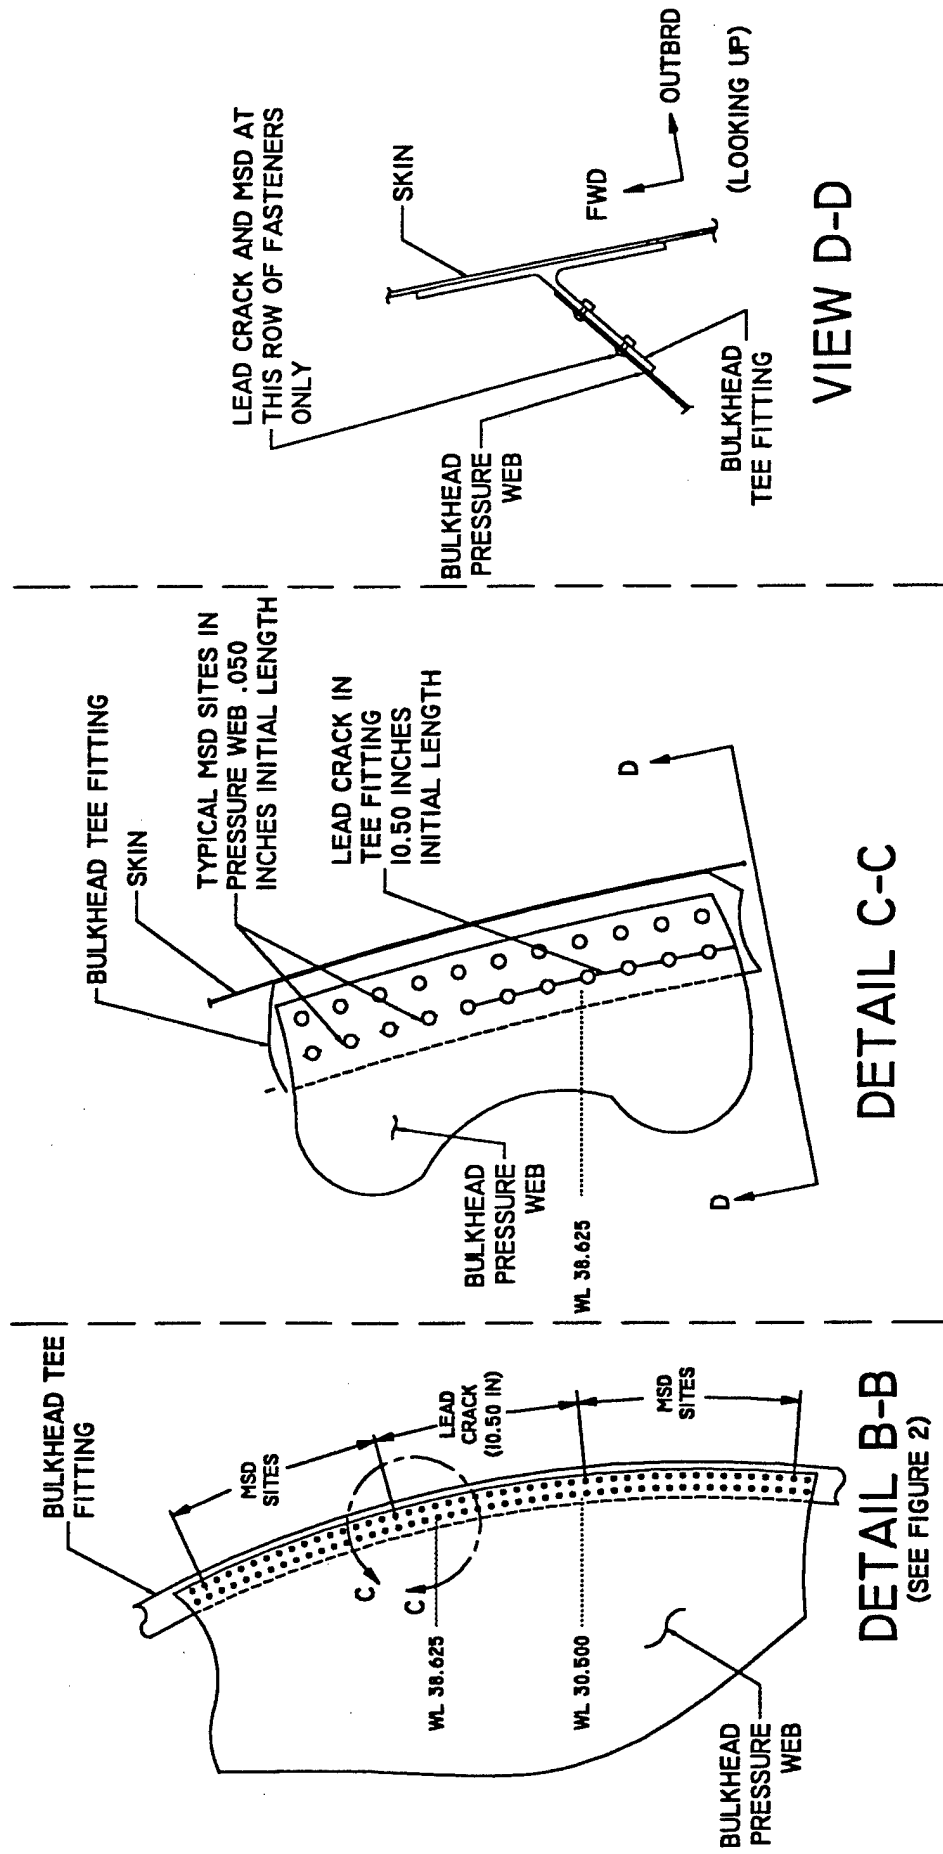
Figure 3. Aft Pressure Bulkhead Initial Damage Detail

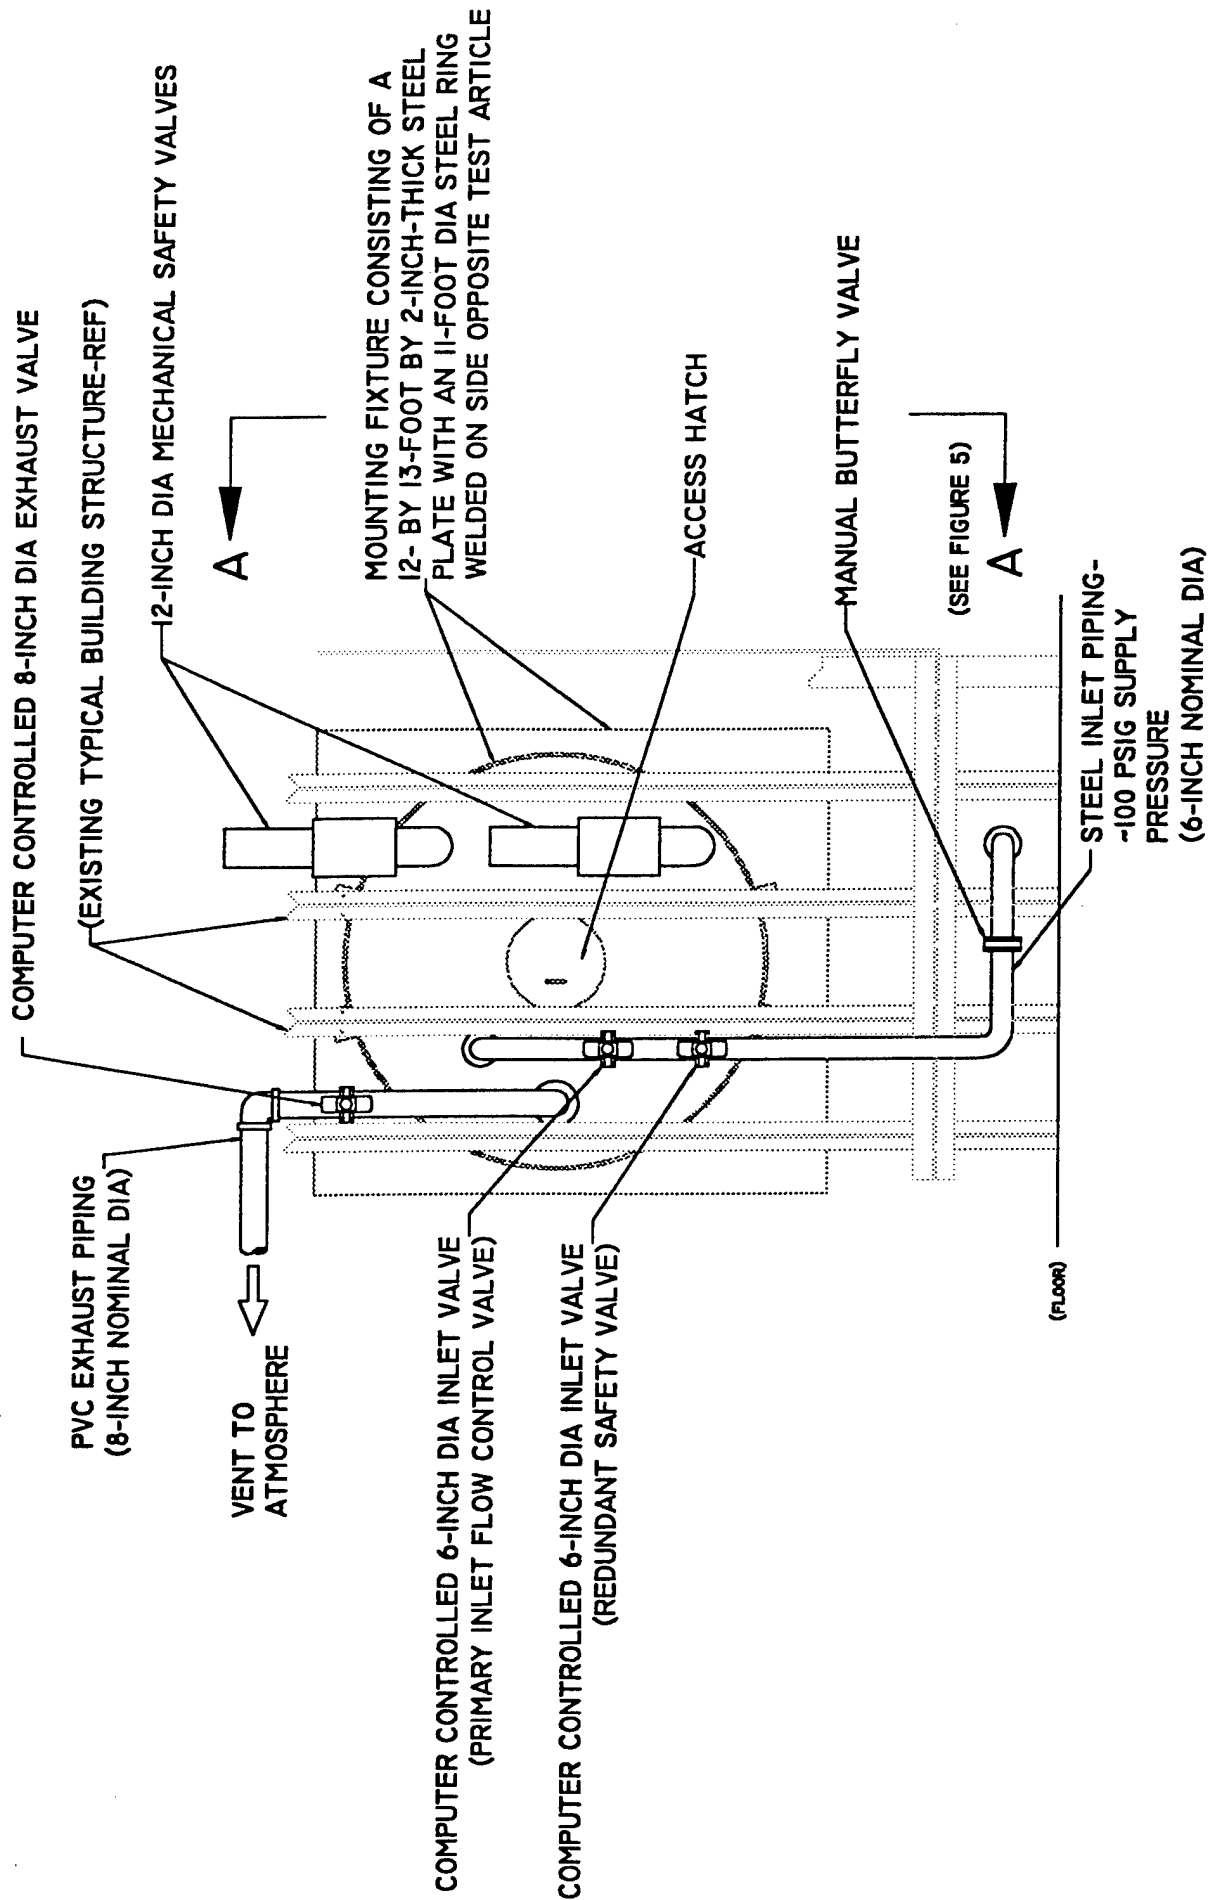
Figure 4. Test Setup, Front View

In this program, the aforementioned DC-9 fuselage section was fastened to the mounting fixture. This fixture consisted of a 2-inch by 12- by 13-foot American Society for Testing and Materials (ASTM) A-36 steel plate with a 1-inch thick by 11-foot-diameter ASTM A-36 steel ring welded to the side opposite the test article. This ring had four brackets welded onto its periphery to mount the entire assembly to Building 65's existing test support structure using eight 3/4-inch-diameter bolts (AN12-27). Two 12-inch diameter mechanical safety valves, the 6-inch-diameter inlet port, the 8-inch-diameter outlet port, various data and power feed-throughs, and a hinged access hatch were also incorporated into the plate. The test article was mounted via 360 3/8-inch diameter Society of Automotive Engineers (SAE) grade 5 bolts. These fasteners clamped the fuselage transition structure installed by Boeing to the 2-inch-thick steel mounting plate. To minimize air pressure loss, the fasteners passing through to the inside of the test article were installed wet with Dow Corning 733 RTV Sealant. The pilot holes for these fasteners were drilled in the test article transition structure by Boeing-Long Beach. These hole locations were then transferred to the mounting plate and drilled and tapped as necessary.

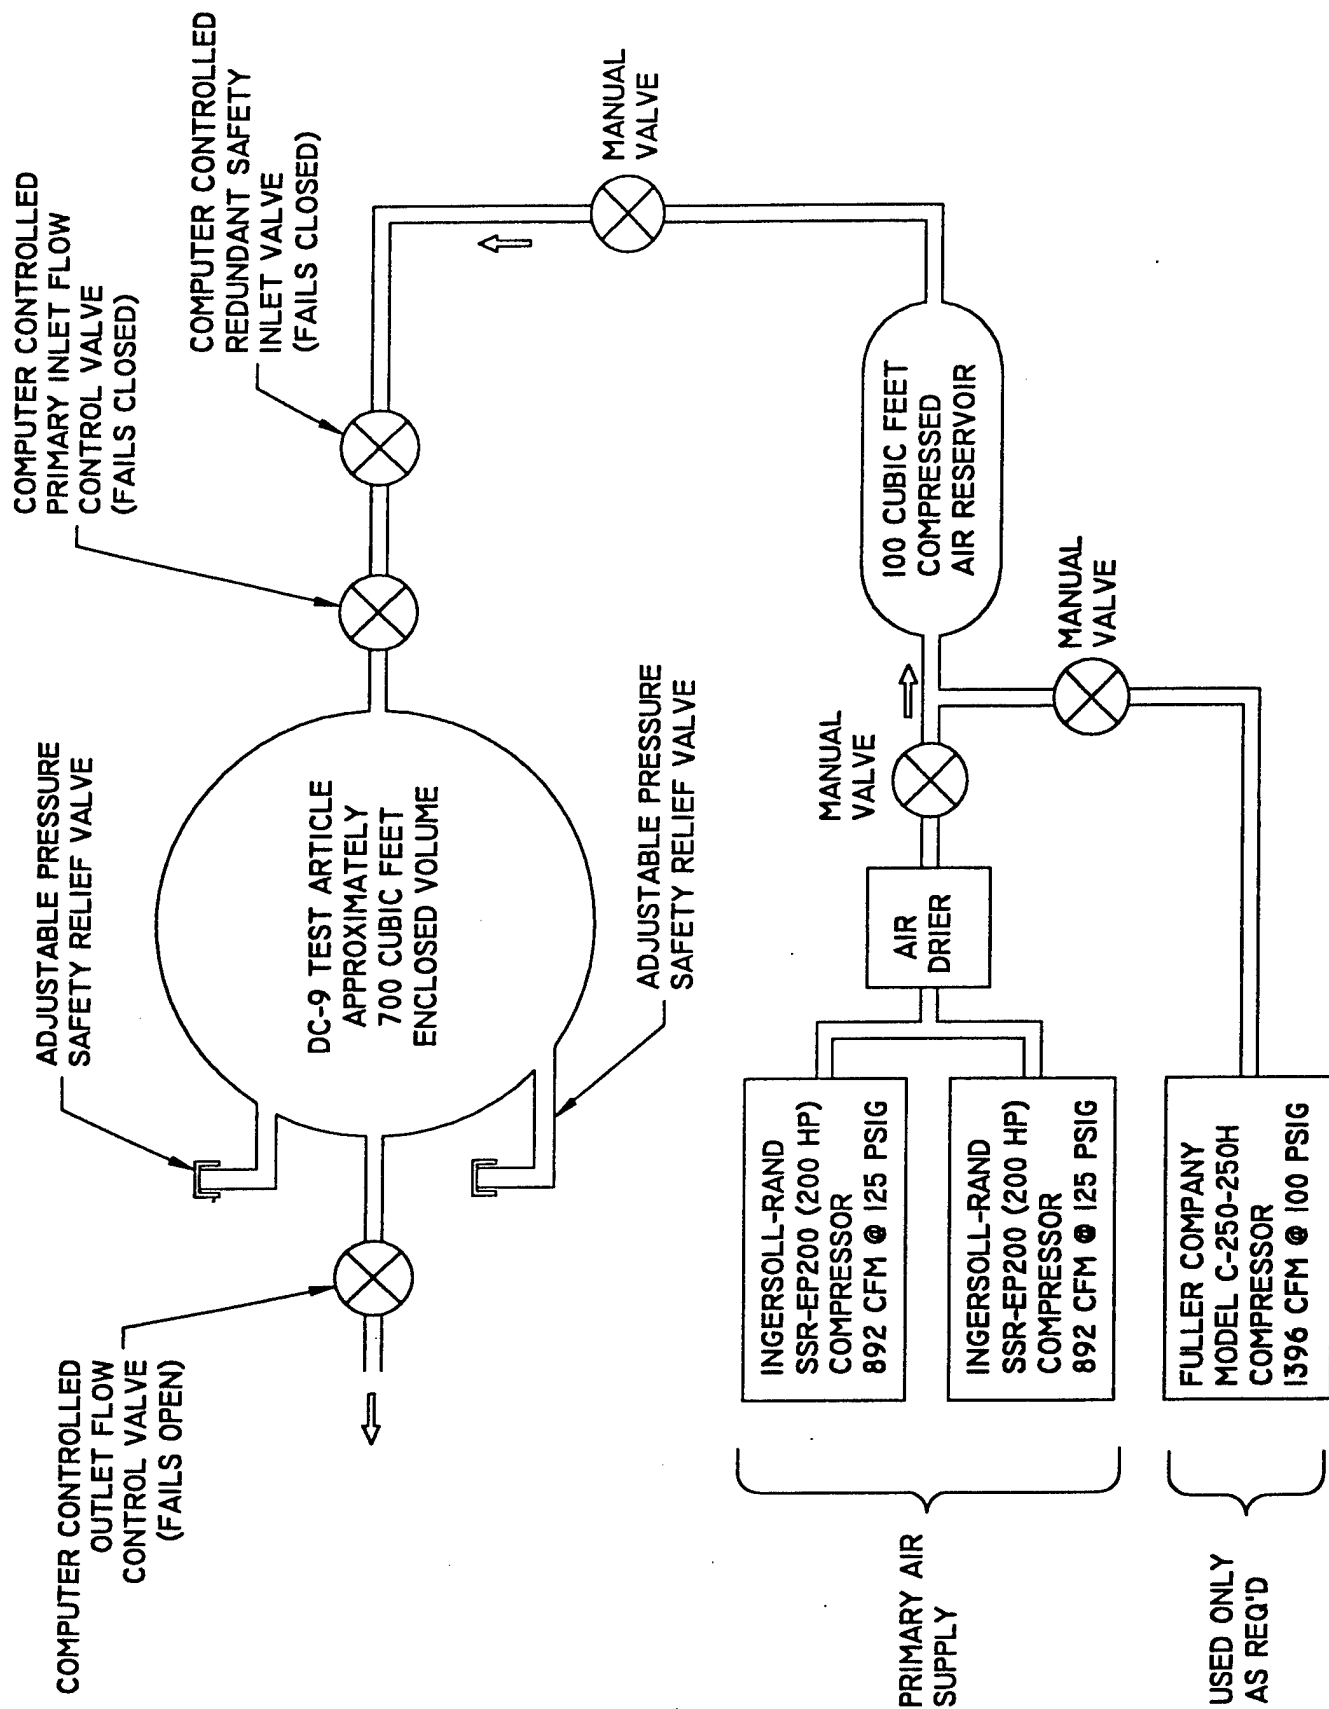
Figure 7. Test Pneumatic System Schematic

Refer to figure 7. The shop air system at Building 65 consisted of two Ingersoll-Rand SSR-EP200 (200 HP) air compressors with a nominal output of 892 cubic feet per minute (CFM) @ 125 psi each. These fed a 100  $\text{ft}^3$  accumulator via a filter/drier unit. Air inlet to the test article was accomplished by a 6-inch-diameter, schedule 40 steel airline from the accumulator to the 2-inch-thick mounting plate. In this airline, two electronically controlled, pneumatically operated, 6-inch-diameter butterfly valves were placed in series. One of these was the primary inlet flow control valve while the second one was used as a redundant safety valve. These inlet valves were sized based on the preliminary understanding that the test article would have an enclosed volume of approximately 2000  $\text{ft}^3$ . They were ordered and received prior to the delivery of the test article, which actually had a volume nearer to 700  $\text{ft}^3$ .

These Flowserve Corp. Automax valves are normally closed. In the event of an electrical power loss or pneumatic control failure, these valves would automatically return to a closed position, thus shutting off the inlet air supply. The electronically controlled, pneumatically operated, 8-inch-diameter butterfly outlet valve was plumbed to exhaust the test article air up and away from the test control center. This Flowserve Corp. Automax valve is normally open. In the event of an electrical power loss or pneumatic control failure, this valve would automatically return to an open position, thus releasing all pressure from the test article. Eight-inch-diameter, schedule 40 polyvinyl chloride (PVC) pipe was used for the exhaust line. Two short, 12-inch-diameter steel lines were used with calibrated weights as mechanical safety valves. These weights were adjustable to permit variable pressures within the test article.

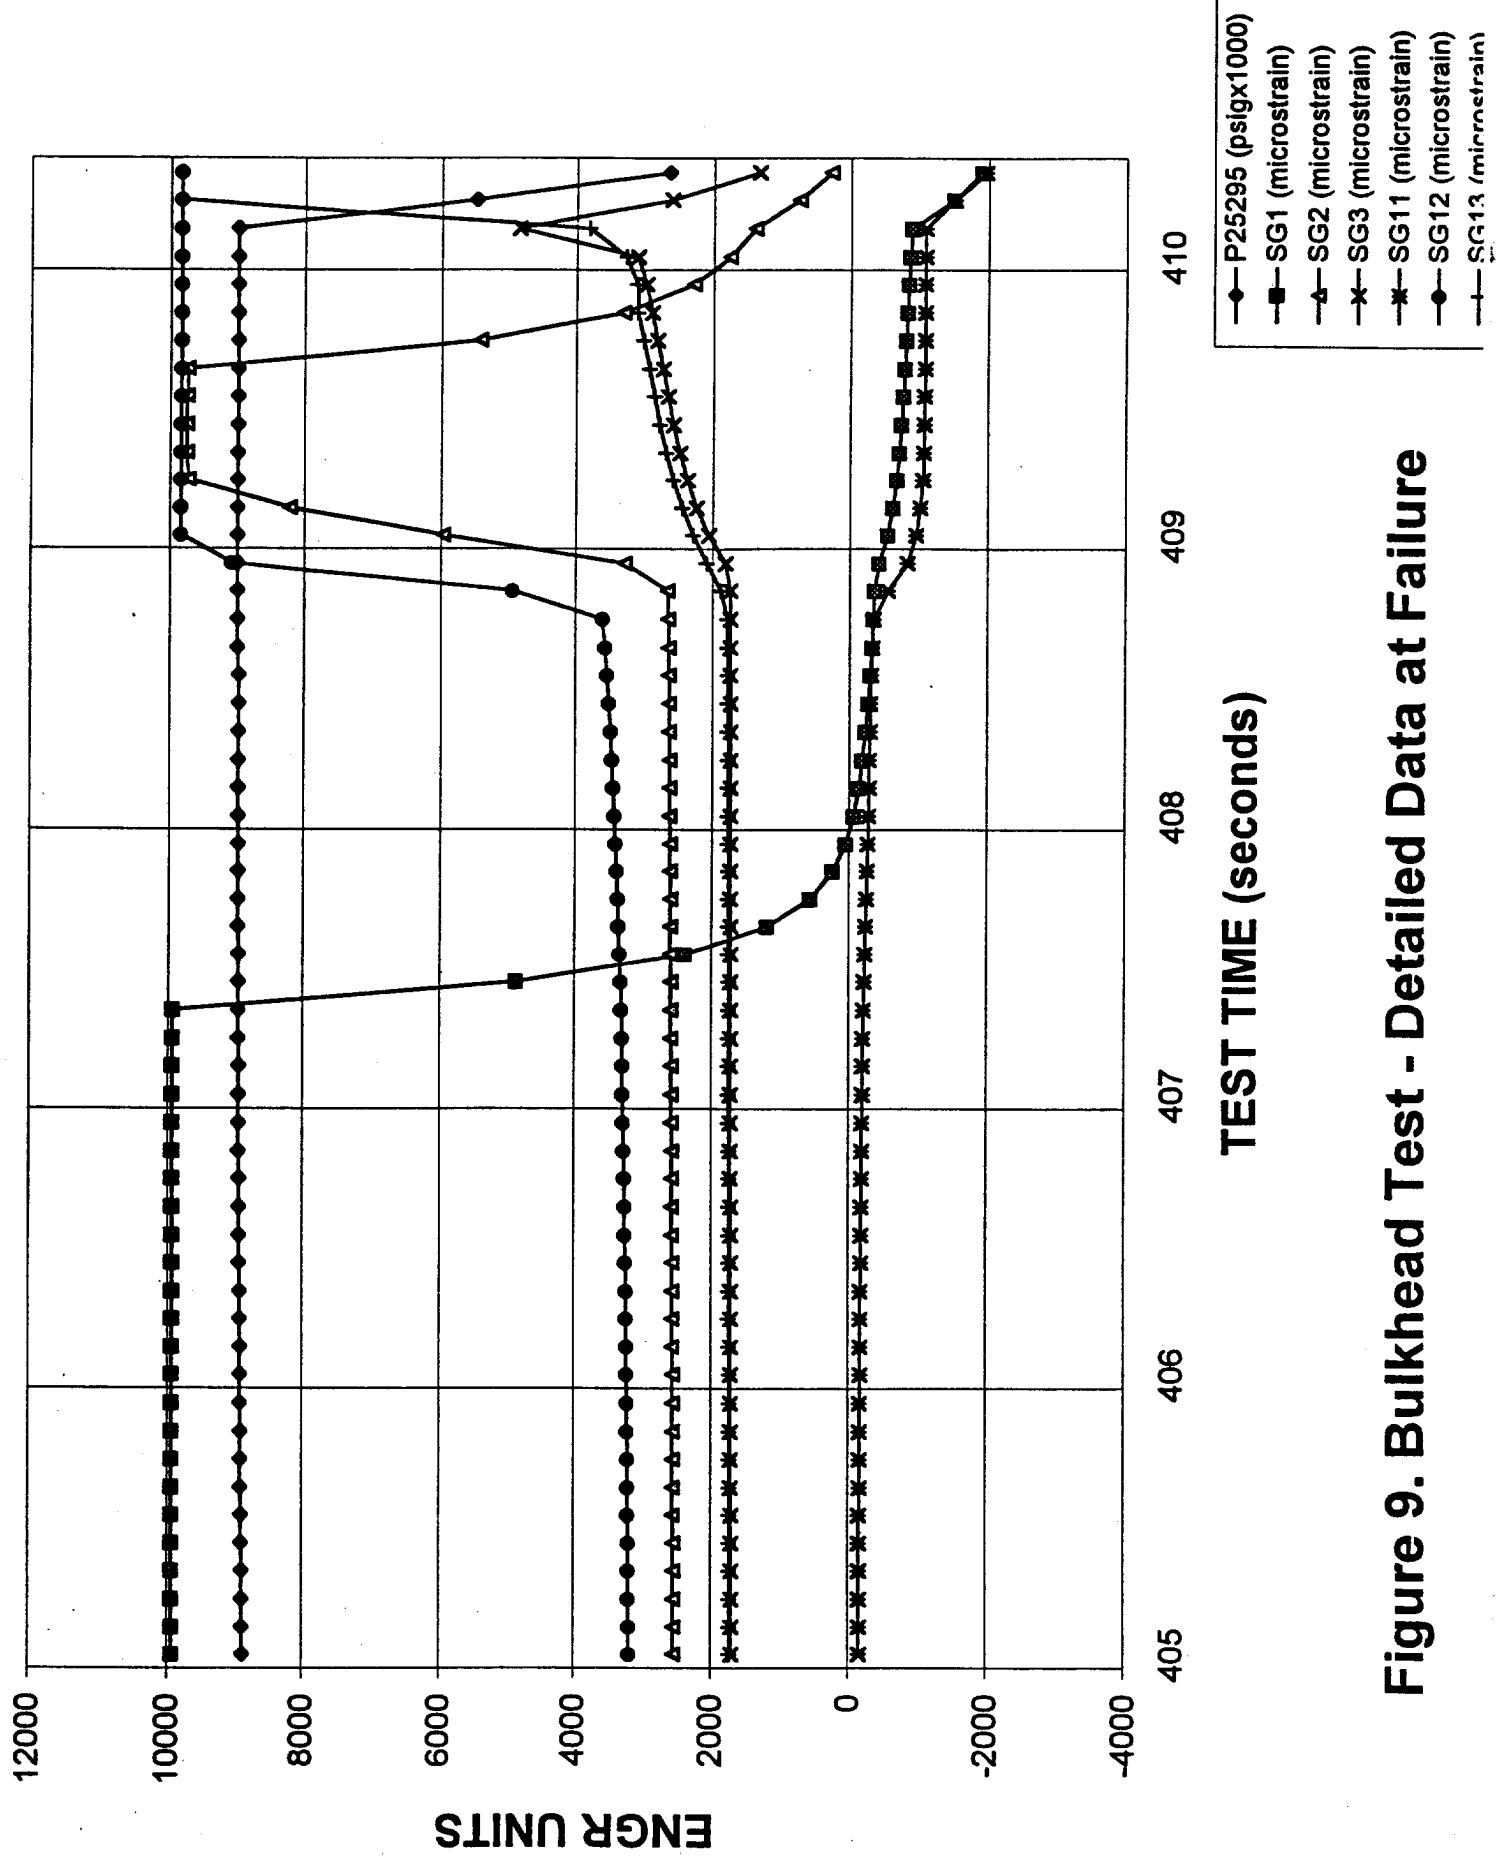
Figure 9. Bulkhead Test - Detailed Data at Failure

As evident from Table 1 and by the graphs in Figures 8 and 9, up to a test time of approximately 300 seconds at a pressure of 7.94 psig, strain gages SG1, SG2, SG3,

SG11, SG12, and SG13 recorded a strain level mirroring test article pressure. These strain gages are of particular interest since SG1 through SG3 were in sequential order from the top end of the lead crack tip and SG11 through SG13 were in sequential order from the bottom end of the lead crack tip. At a test time of approximately 300 seconds, the output of SG1 indicated a strain level rising much quicker than the test article pressure. Approximately 10 seconds later at a pressure of 8.11 psig, SG11 reached its maximum value and failed. Gage SG1 failed at 407.45. The final bulkhead failure sequence began at time 408.80 at a pressure of 8.99 psig when SG12 began a rapid rise, followed by SG2 at time 408.90. At test time 409.95, SG2 failed and the upper lead crack tip extended to the next rivet hole, followed rapidly by SG3 and SG13 at 410.10. At test time 410.15, the test article pressure began to fall as the crack extended and vented the compressed air faster than the control system could accommodate the loss. Finally, at test time 410.20, the pressure dropped rapidly, indicating total failure of the bulkhead structure.
