Akutan Harbor Project: Delineation of Wetlands on Akutan Island, Alaska

by James S. Wakeley, Chris V. Noble, and Michael J. Bishop

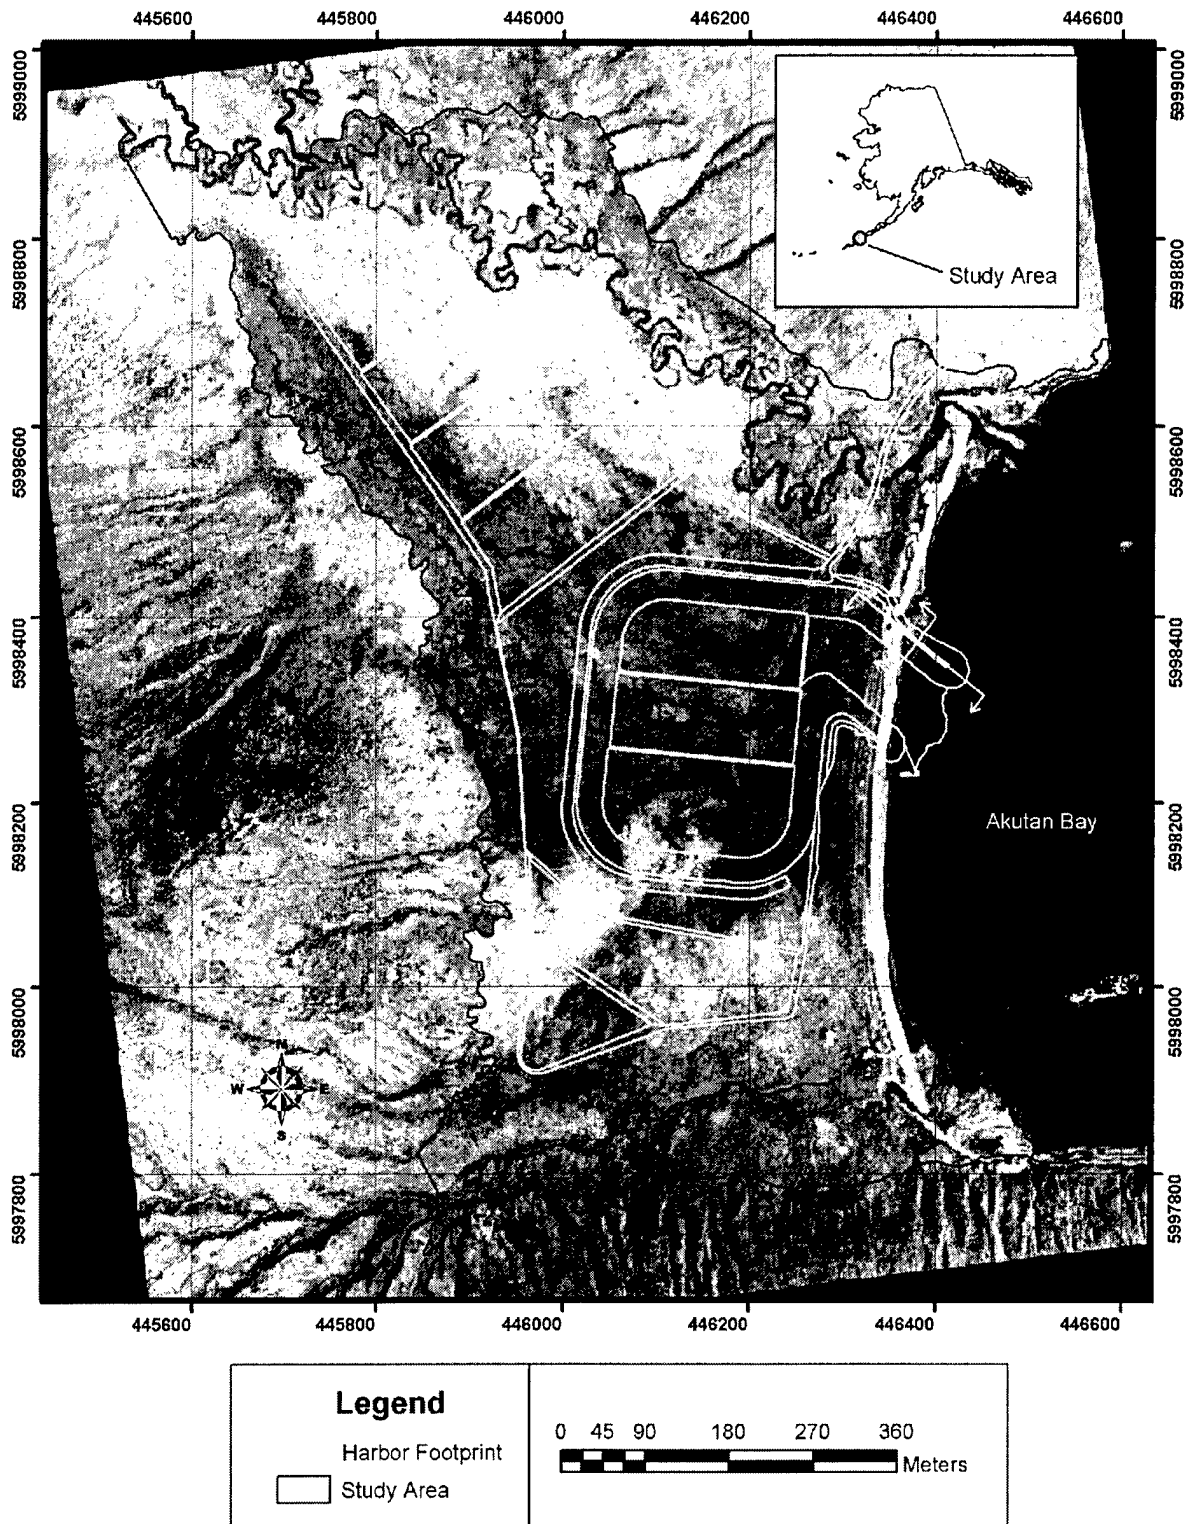
Figure 1. Study area at the western end of Akutan Bay, Akutan Island, Alaska, with the current design for Akutan Harbor and its associated fill area superimposed. Coordinates are based on 200-m Universal Transverse Mercator (UTM) grid ticks. The background photographic image was provided by AeroMap US, Anchorage, AK, and the harbor design by Tryck, Nyman, and Hayes, Inc., Anchorage

At the time the field work was done in August 2000, three project alternatives had been proposed, differing in basin size (12, 15, or 20 acres [4.9, 6.1, or 8.1 ha]) and in the extent of filling for berms and graded areas. In all three plans, the harbor basin would be excavated behind the existing natural beach ridge and would open to the sea by an excavated channel roughly through the middle of that ridge. All three designs included an access road from the north. Later, in April 2001, a modified 12-acre-basin alternative was proposed, which took advantage of detailed topographic data gathered during the field studies. Figure 1 shows the outline of this alternative, which included approximately 55 acres (22 ha) of associated fill.

There were 58 acres (23.5 ha) of wetlands within the footprint of the most recently proposed design for Akutan Harbor and its associated fill area (Figure 1). Placing the proposed harbor in the approximate center of the alluvial plain would result in a considerable impact to the surrounding wetlands. One option to reduce wetland impacts, and perhaps lessen the threat to the north creek complex and its salmon runs, would be to shift the project toward the south and take advantage of upland areas there, particularly to the southeast.

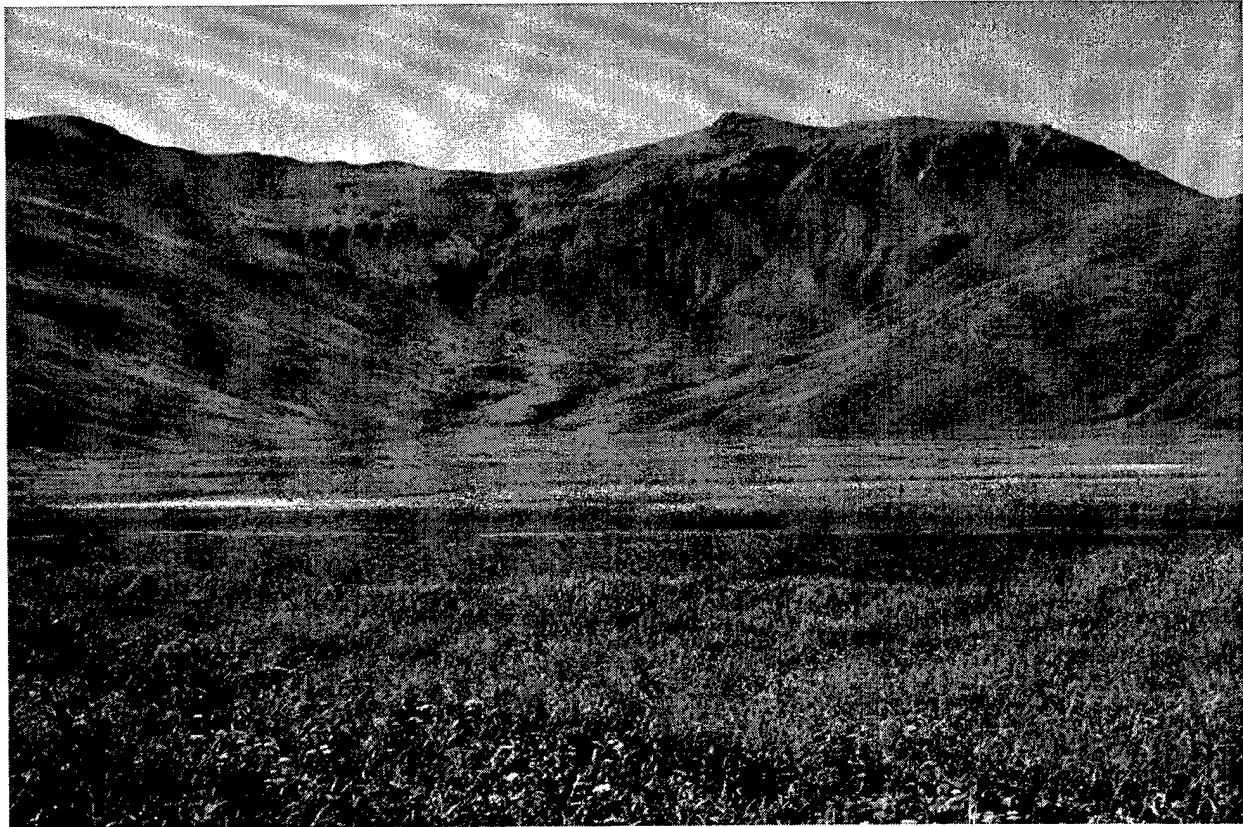
Figure 2. The proposed project area on Akutan Island. Photo was taken looking southwest from the natural beach ridge adjacent to Akutan Bay. The alluvial plain at this point extends approximately 400 m to the toe of the hill slopes in the background

STUDY AREA: The study area for the wetland delineation consisted of the broad, relatively flat plain at the head of Akutan Bay (Figure 2). The area was bounded by the bay on the east and by the lower slopes of the hills to the north and south. On the west, the study area extended inland approximately 1,650 ft (500 m) from the mouth of the south creek and 2,000 ft (600 m) from the mouth of the north creek. In the west-central portion of the site, the study area was bounded by hill slopes. The study area was approximately 150 acres (60 ha) in size and encompassed all of the proposed alternative designs for Akutan Harbor, its related infrastructure, and access road.

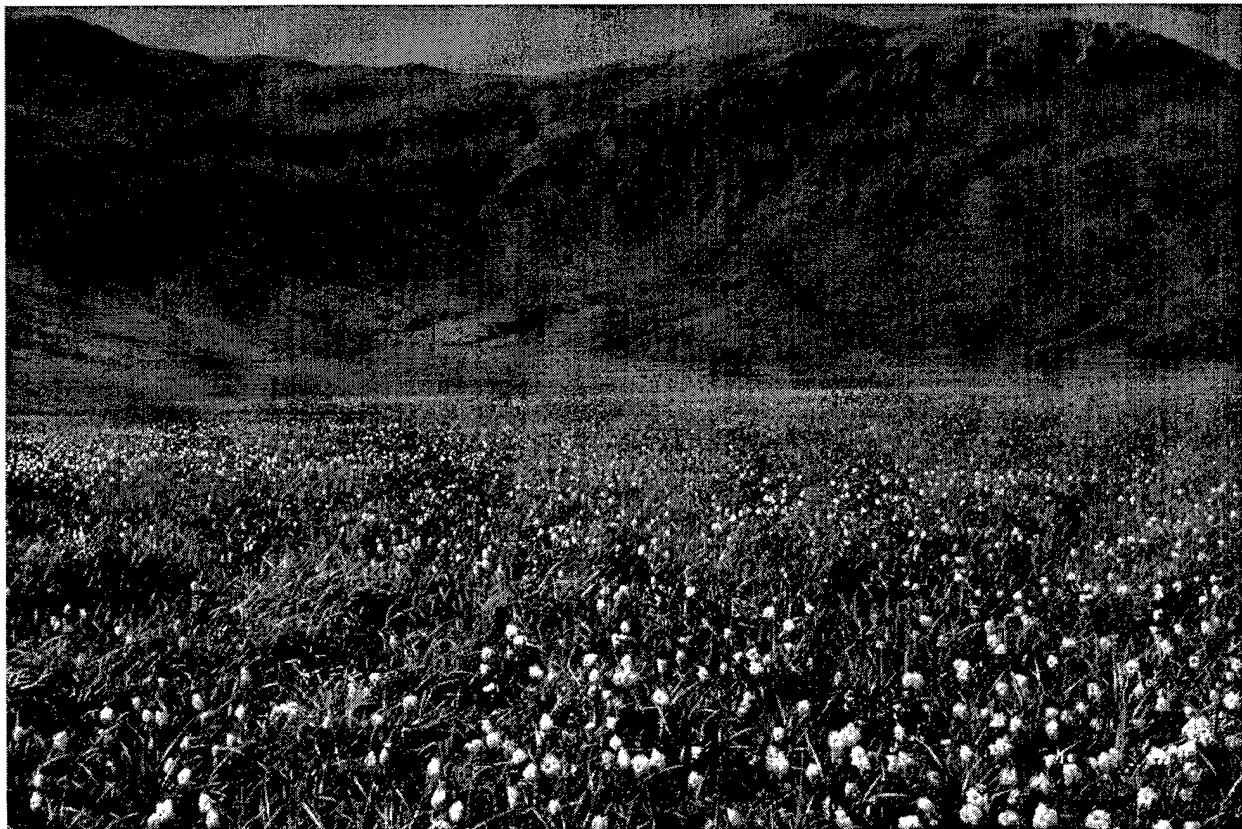
Figure 3. Sedge-dominated community containing cotton-grass as a subdominant

Sedge-dominated communities (Figure 3) ranged from pure stands of Lyngbye's sedge (*Carex lyngbyei*) (OBL) in areas that contained standing water during the site visit to diverse communities of sedges, grasses, broad-leaf herbs, and low shrubs on somewhat drier sites. Depending upon the location, dominant species included Lyngbye's sedge, several-flowered sedge (*C. pluriflora*) (OBL), chestnut rush (*Juncus castaneus*) (FACW), common marsh-marigold (*Caltha palustris*) (OBL), meadow horsetail (*Equisetum pratense*) (FACW), black crowberry (*Empetrum nigrum*) (FAC), hooded ladies'-tresses (*Spiranthes romanzoffiana*) (OBL), seawatch angelica (*Angelica lucida*) (FACU), under-green willow (*Salix commutata*) (FAC) and others. Narrow-leaf and russet cotton-grasses (*Eriophorum angustifolium* [OBL] and *E. chamissonis* [OBL]) were showy subdominants in many sedge-dominated areas.

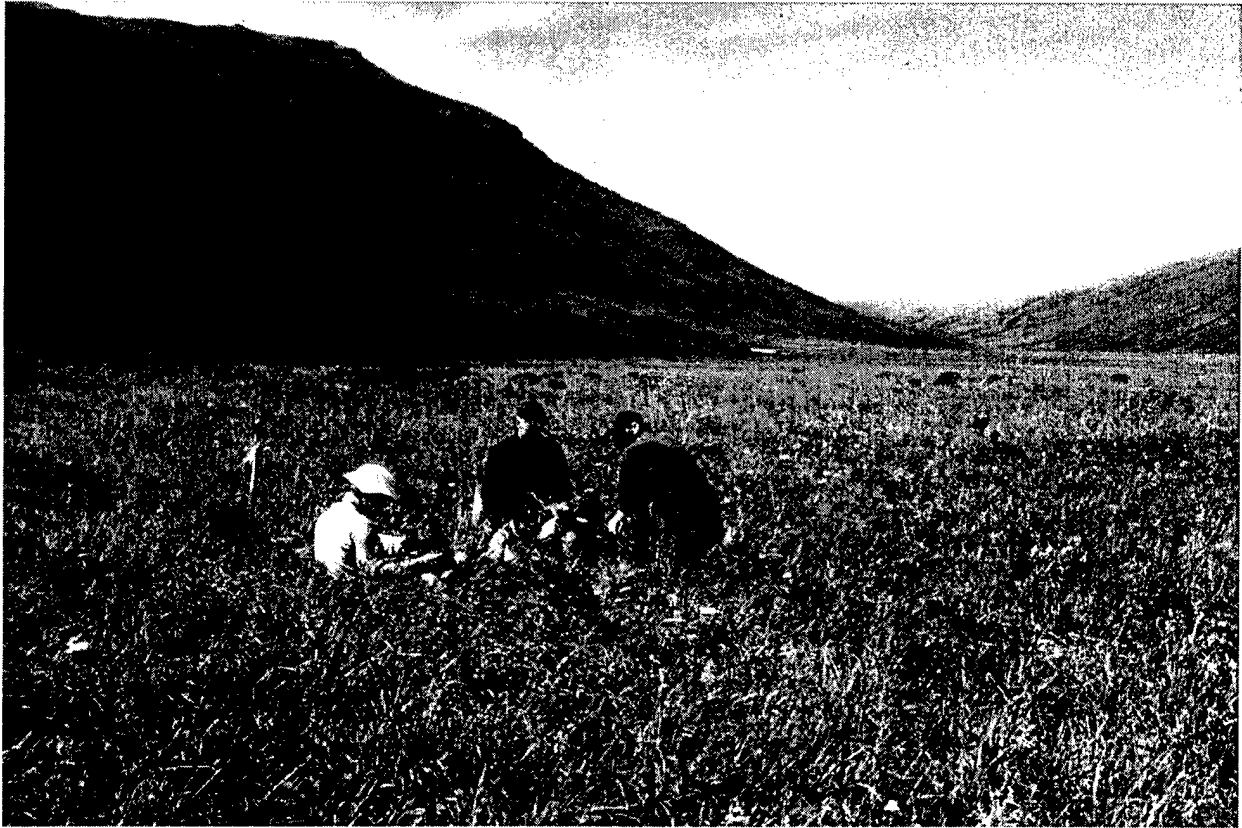
Figure 4. Grass-dominated community

Grass-dominated communities (Figure 4) generally occupied topographically higher and somewhat drier sites than the sedge-dominated communities, but many of the grass-dominated areas still met all three wetland criteria. The predominant grasses were blue-joint reedgrass (*Calamagrostis canadensis*) (FAC) and tufted hairgrass (*Deschampsia cespitosa*) (FAC). Another grass species was dominant at several sampling points but could not be identified due to the lack of an inflorescence at the time of sampling. Other dominant plants in grass-dominated wetland communities included
