NASA CR-515

INDUCTION PROCESSED SEPARABLE TUBULAR BRAZED CONNECTORS

Prepared by
AEROJET-GENERAL CORPORATION
Sacramento, Calif.
for Lewis Research Center

NATIONAL AERONAUTICS AND SPACE ADMINISTRATION • WASHINGTON, D. C. • ⁽¹⁰⁾ JULY 1966

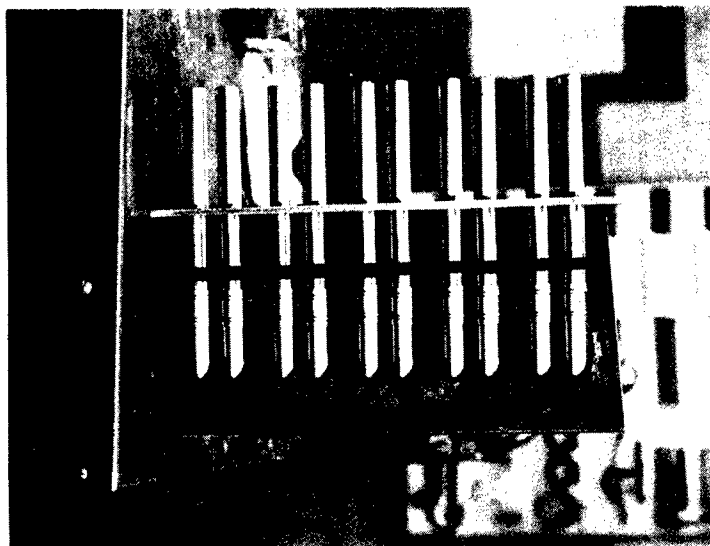
FIGURE 9

An end view of the tube-locating fixture which was used to qualify the special plier type brazing tools. The braze tool access area simulated the M-1 torus to thrust chamber area.

A front view of the tube locating fixture holding the tube spacing the same as on the M-1 torus to thrust chamber transition joints prior to brazing.

Multiple Tube Holding Fixture

Two views of the multiple tube holding fixture used to qualify the special braze plier-type tools is shown in Figure 9. Accessibility to the joints with the braze tool simulates the condition of the M-1 thrust chamber-to-torus transition joint, including the tube spacing and the clearance between the tubes and thrust chamber. The tubes are located in pairs on 1.134-in. centers. The spacing between the pairs is 1.71-in. on centers and the outside tube diameter is 0.760-in.

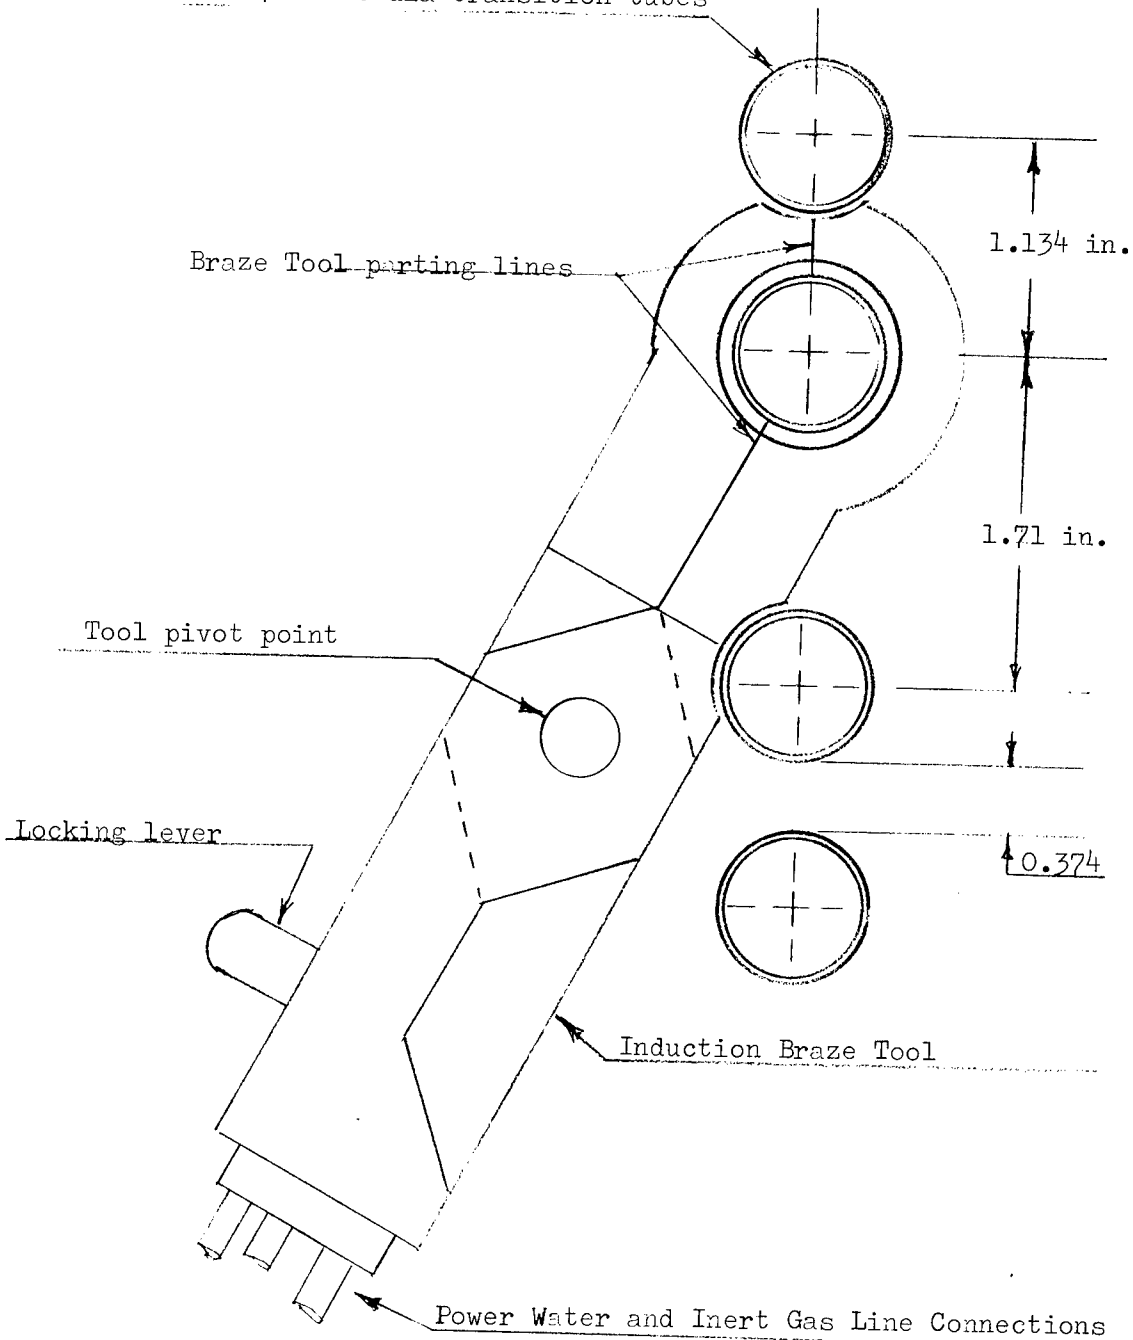
FIGURE 10

0.032 in. wall 0.760 in. dia transition tubes

Sectional view of transition tubes showing special braze tool design to provide accessibility.

Sectional View of Transition Tubes

A sketch of the special design brazing tool is shown in Figure 10, which also illustrates the relative positions of the tubes. The design clearly shows how accessibility was obtained.

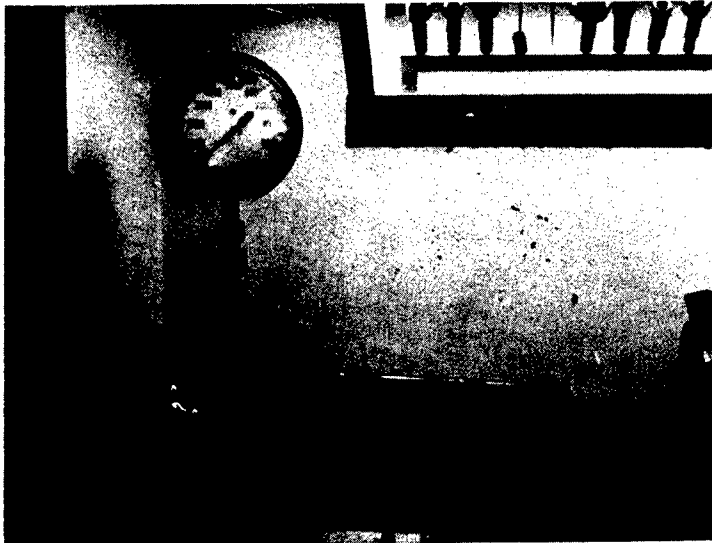
FIGURE 12

This view shows a brazed tube fixtured for hydrostatic testing. The hydrostatic test cycle used was 2350 psi for five minutes then pressure increased until failure occurred. There was no leakage of the brazed joint. All failures occurred in the tubes in the range of 7800 to 8000 psi.

Brazed Tube Joint
Connected for Hydrostatic Testing

A brazed tube joint connected for hydrostatic testing is shown in Figure 12. The testing cycle for 10 brazed tube joints was 2350 psi for five minutes. The pressure was then gradually increased until failure occurred. All failures were to the tube parent material in the range of 7800 to 8000 psi.
