**TECHNICAL REPORT  
NATICK/TR-02/017**

# **EVALUATION OF COMMERCIAL NONSTICK COATINGS FOR U.S. ARMY FIELD-FEEDING COOKWARE**

**U.S. Army Soldier and Biological Chemical Command  
Soldier Systems Center  
Natick, Massachusetts 01760-5018**

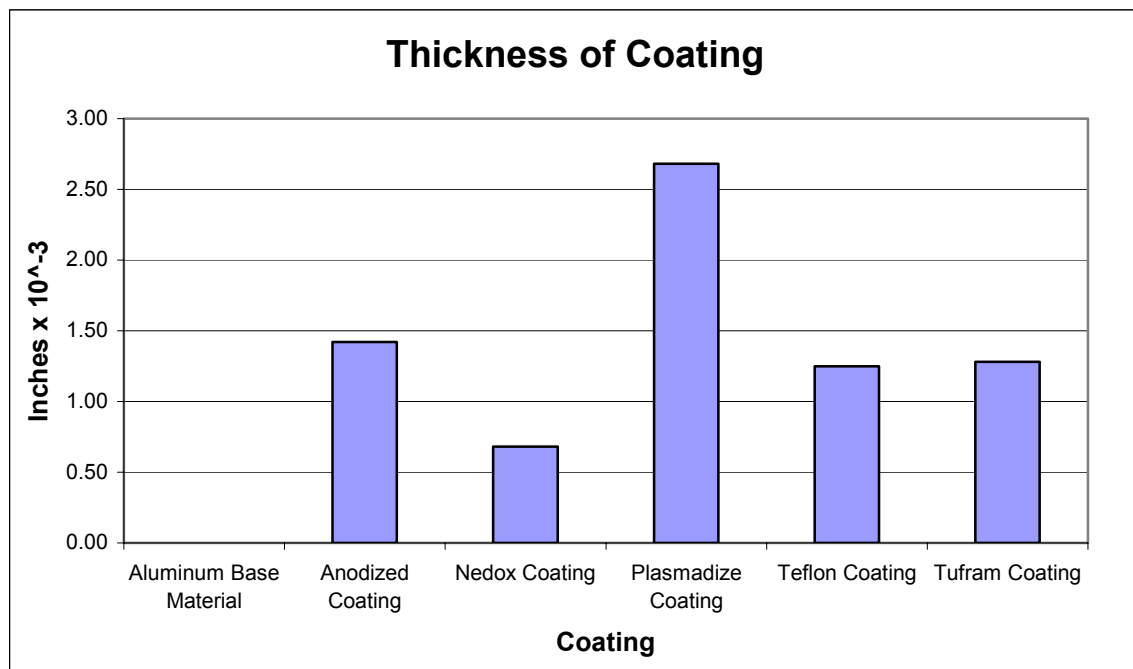
**Figure 1. Thickness of Coating Materials**

Coating thickness is measured by viewing a cross-section of the material under a microscope according to ASTM B487-85. The thickness of a coating is important for several reasons. A thin coating may have excellent hardness and wear properties but may not endure because of the lack of material. Very thick coatings, however, can disturb the tolerances of a part. The thickness of a coating also affects its strength, what was originally plane strain can become complicated by plane stress. The thickness also determines the type of hardness test that must be performed; each test's indenter is rated for a different thickness.

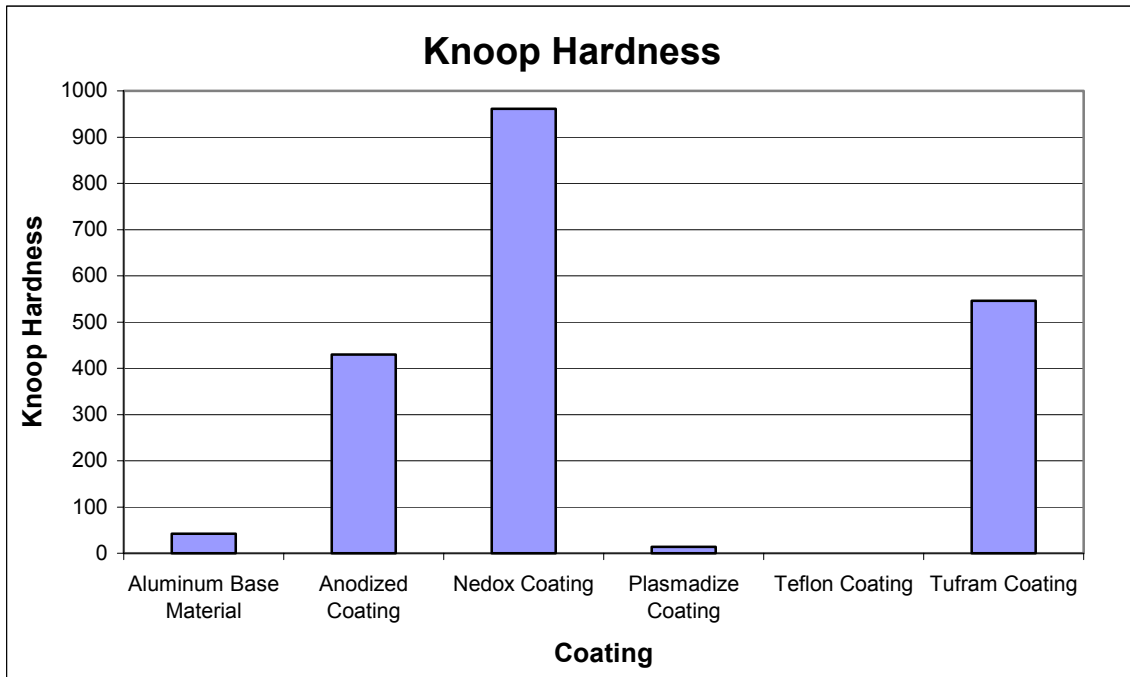
**Figure 2. Knoop Hardness**

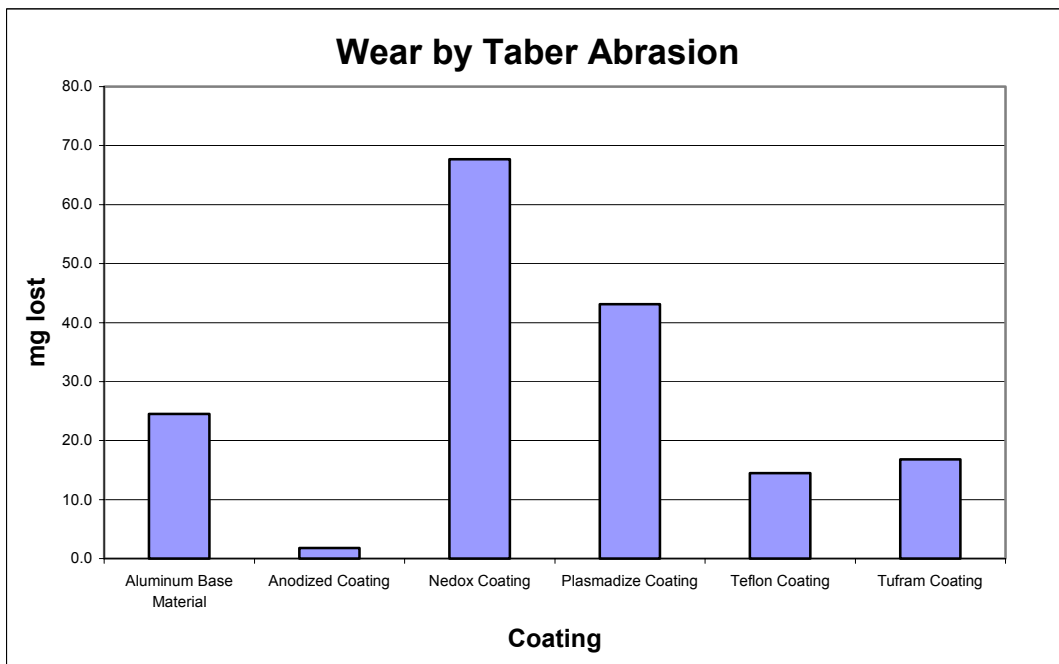
**Figure 3. Taber Abrasion**

Taber abrasion measures a material's resistance to wear by measuring the amount of material scraped off a flat surface subjected to an abrasive rotating disk. The disk is rotated for 1000 cycles under a 1000g weight according to ASTM B137-95 and IAW Fed-Std-141.1.

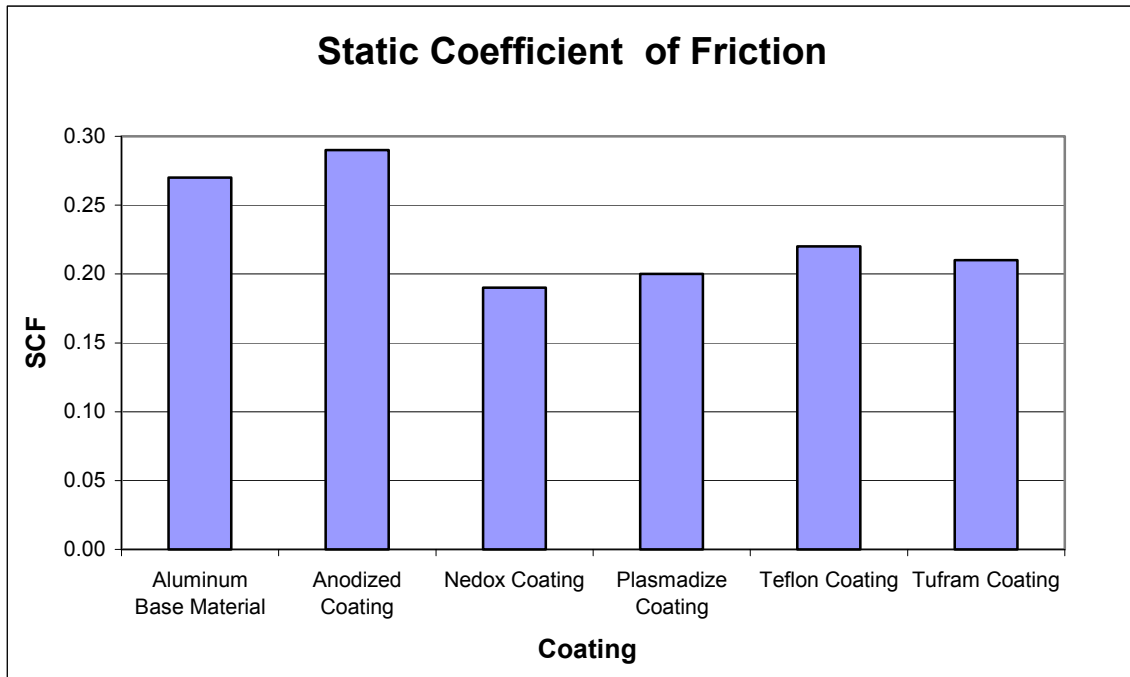
Figure 4. Static COF

The coefficient of friction is a dimensionless parameter that determines how slippery a surface is. ASTM D1894-95 gives guidelines for determining both the static and kinetic friction coefficients. The force required to slide stainless steel across the coating is measured. General Magnaplate's coating friction data is shown in Table 1. While a low friction coefficient does not necessarily mean that a surface is nonstick because food can adhere to a surface at the microscopic level, rendering the friction coefficient unimportant, the friction coefficient is involved with non-stick on the macro level and can be an indicator as to the coating's non-stick properties.

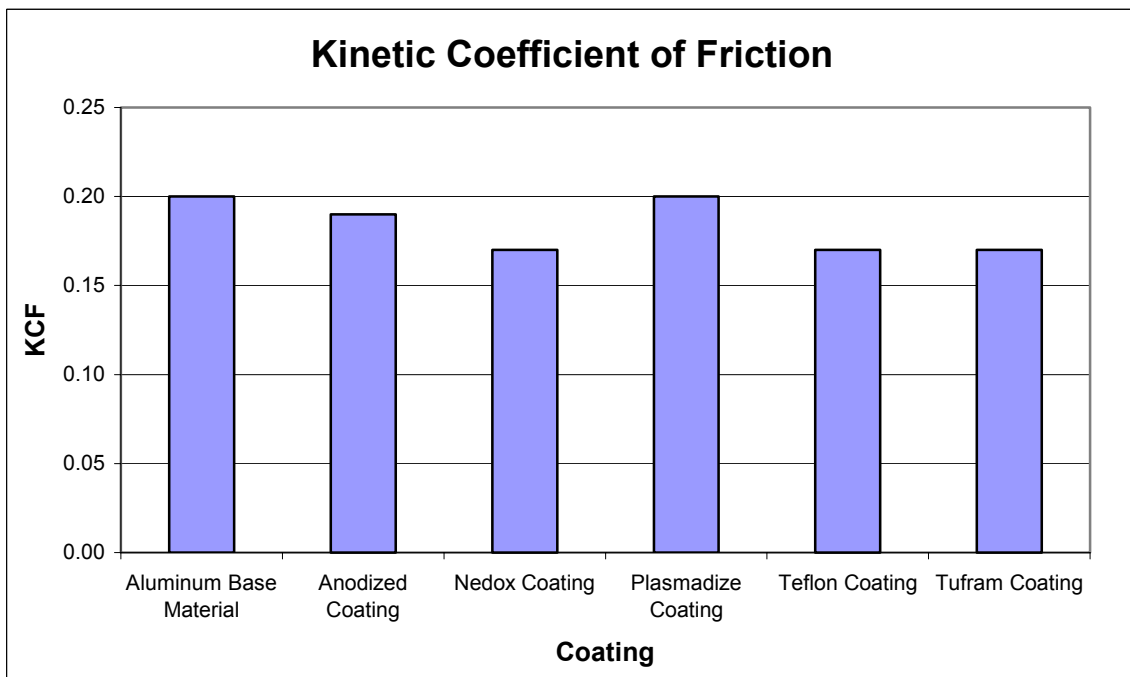
Figure 5. Kinetic COF

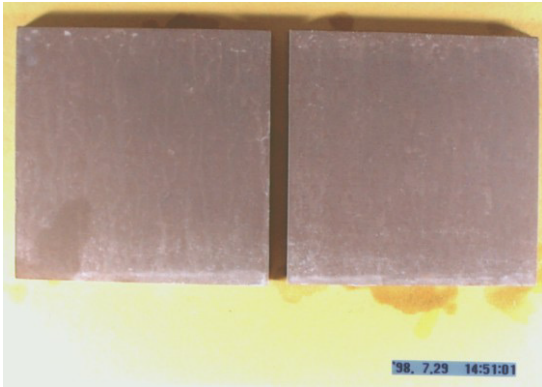
**Figure 6. Base Aluminum after Salt Spray**

| | Salt Spray Exposure** | Thermal Shock | Thermal Shock |
|---|---|---|---|
| Aluminum Base Material | Pass<br>(extensive AlO <sub>2</sub> ) | No Damage to surface | No Damage to surface |

It was decided that corrosion resistance is the most important factor in the success of a coating in the field, because wear and tear experienced in the field will contribute to degradation of the aluminum over time. (In this study, the bare aluminum did not corrode as much as expected. Instead, an aluminum oxide layer was formed, protecting the aluminum underneath. But under actual field conditions, this oxide layer would be removed by scrubbing with steel wool after each meal, exposing the aluminum again to the elements.) Anecdotal evidence and data on the quantity of cookware procured each year shows that, indeed, bare aluminum pans have short lifespans in the field.

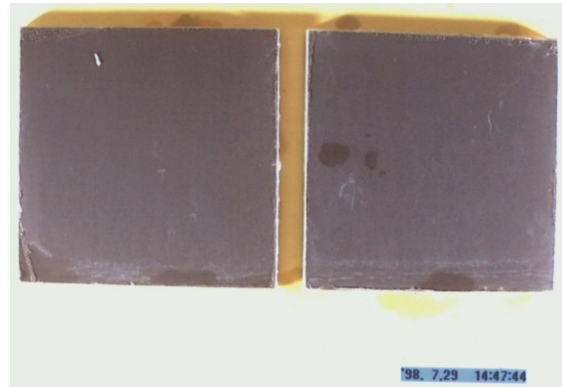
**Figure 7. Hard Anodized after Salt Spray**

In these tests, only the two anodized coatings, appeared to resist corrosion altogether. The plain hard anodized coating and the Tuftram® resist corrosion because they are more a surface treatment than a coating. In the anodizing process, a chemical reaction occurs between the aluminum and a chemical bath that changes the properties of a thin layer of aluminum at the surface to be extra hard. Their surfaces are very hard and non-porous. The Plasmadize® coating performed well overall in the tests. Even though it allowed some corrosion after 1000 hours of salt spray, its friction coefficients were on par with the Teflon® coating. It was, however, so thick that the coating interfered with the tolerances of the pan. This resulted in a lid that would not fit on the pan.

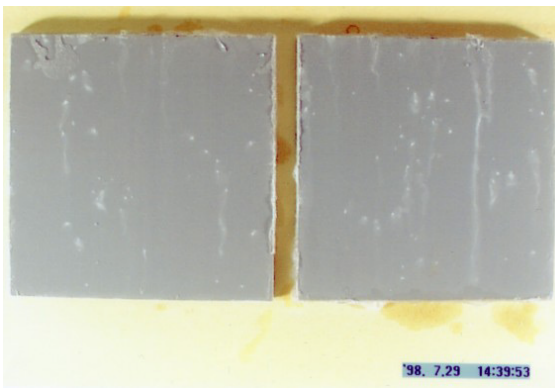
**Figure 8. Plasmadize® after Salt Spray**

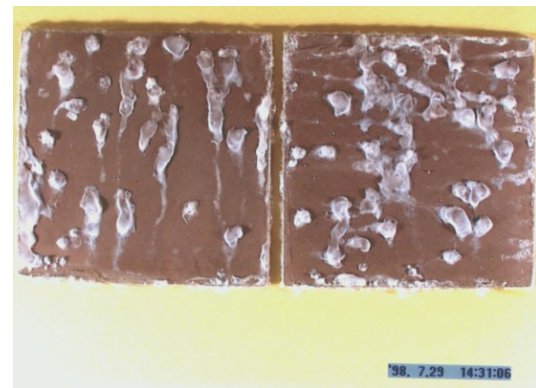
**Figure 9. Nedox® after Salt Spray**

Each of the other coatings, except for the Tufram® coating, were discounted by a significant shortcomings in at least one performance criteria. The Nedox® failed the salt spray test, the Plazmadize® coating was too thick, and the friction coefficient of the anodized coating was too high. The qualitative tests discounted the plasma spray coating because of its tendency for becoming stained as well as showing signs of pitting.

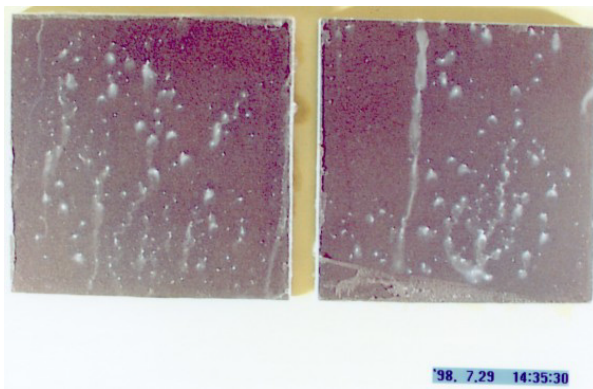
**Figure 10. Teflon® after Salt Spray**

All other samples, including Teflon®, corroded noticeably. The Teflon® coating exhibits sites where salt migrated through the coating and began to corrode the base metal.

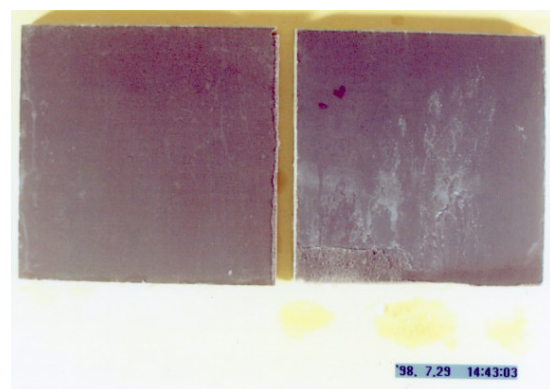
**Figure 11. Tufram® after Salt Spray**

| | Salt Spray Exposure** | Thermal Shock | Thermal Shock |
|---|---|---|---|
| Tufram® Coating | Pass | Less than 5% removed | Less than 5% removed |

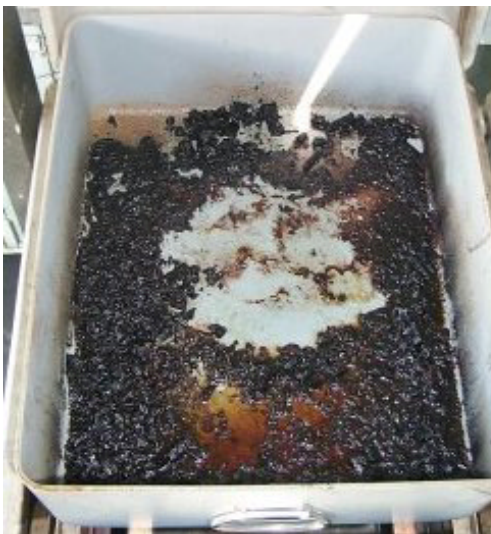
**Figure 15. Food burned on Plasmadize®**

Figure 12-Figure 20 depict the results of Meal 1 with the pans starting brand new. Figure 15, Figure 16, and Figure 17 show the aftermath of cooking roasts. The Teflon® in Figure 16 had a handicap; the carrots and onions were added too early, so they ended up burning and becoming charred. The sugars became mixed with juices from the beef to form a layer of sticky carbon on the bottom of the pan. In other cases, such as the

Plasmadize® in Figure 15 this sugary mix had the effect of leaving the carbon layer covering almost the whole bottom of the pan with the exception of where the roasts had been. After cooking was complete, each pan was pre-washed by adding water directly to the hot pan as shown in Figure 17. This pretreatment dissolved much of the carbon immediately, allowing for easier cleaning and sanitizing. Whether or not this practice is performed in the field is unclear, but most cooks should know it is a reliable way to remove burned food from pans. The pre-wash did not influence longevity data on the coating because any damage to the coating had already taken place. Though it could be argued that pre-washing, which allows for slightly easier cleaning, would reduce the necessity to scrape the pans. At any rate, the procedure was carried out identically for each pan. Figures 18-20 show the condition of the pans after the pre-wash. Comparing Figure 19 and Figure 20, it can be seen that a significant portion of the carbon remained stuck to the uncoated pan versus the Teflon®, while almost none stuck to the Plasmadize® in Figure 18. The Plasmadize® was, however, significantly stained by these carbon deposits.

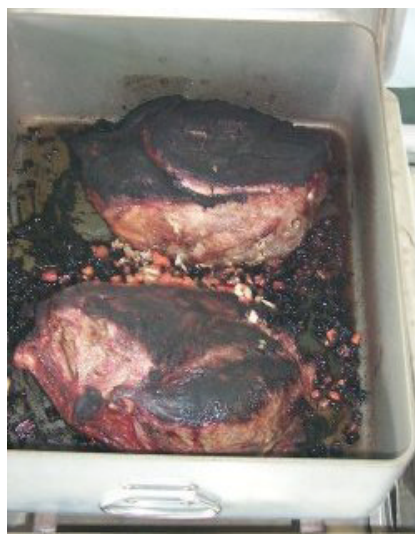
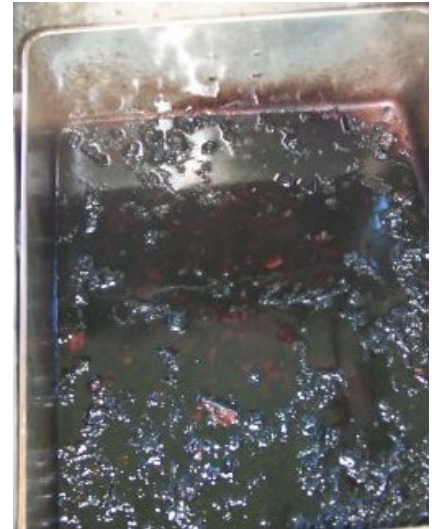
**Figure 16. Food burned on Teflon®**

**Figure 17. Food burned on Teflon® with water added**

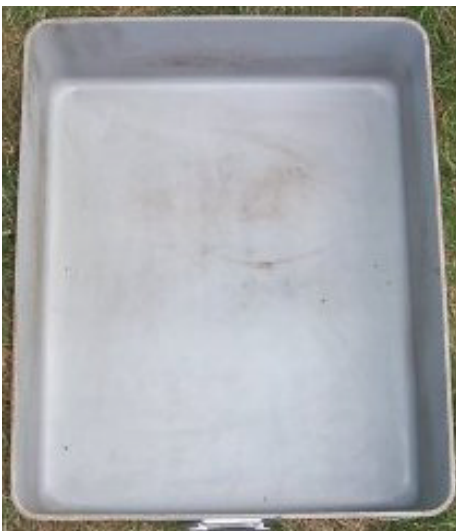
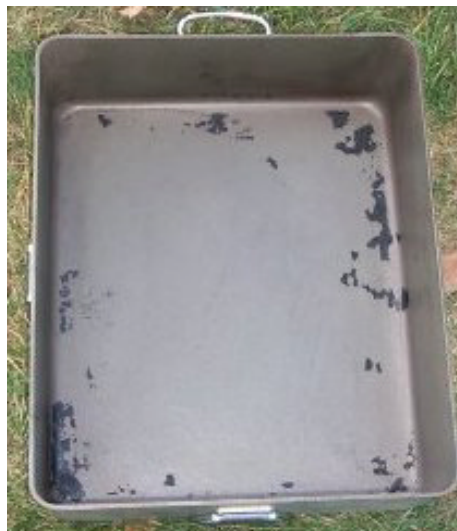
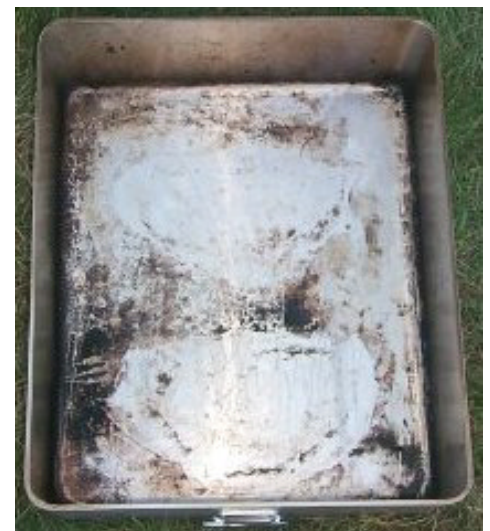
**Figure 18. Plasmadize® (R), pre-washed**

**Figure 19. Teflon®, pre washed**

**Figure 20. Uncoated, pre-washed**

The cleaning and sanitizing process was performed manually, per field regulations. The hands on nature had the added benefit of allowing us to subjectively gauge which coating exhibited the best release properties. After Meal 1, cleaning the Plasmadize® coating was very easy. No food stuck to the pan and only a small layer of grease had to be washed off. The stains could not be removed from the coating. There was no evidence of peeling, or cracking of the coating but some evidence of slight pitting. These pits were hard to document with the camera used so a description will have to suffice. The pitting action was not the same as experienced in Figure 8. Plasmadize® after Salt Spray, rather these were small craters that seemed to form without the migration of metal through the coating. It is not clear if this was due to a loss in coating material, a collapse or denting of the base material under the coating or pores in the base metal that were simply filled by the coating during the coating process.

The Teflon® coating was also easy to clean. There were some solids loosely stuck to the coating but a soft sponge was enough to release them. There were no stains, but some discoloration was observed. There was no evidence of peeling, pitting or cracking of the coating.

The uncoated pan was very difficult to clean. The surface was firmly coated with carbon deposits from burned food. Some of carbon became impregnated in pits in the metal and could not be removed at all. It took significantly more time and effort to clean this pan

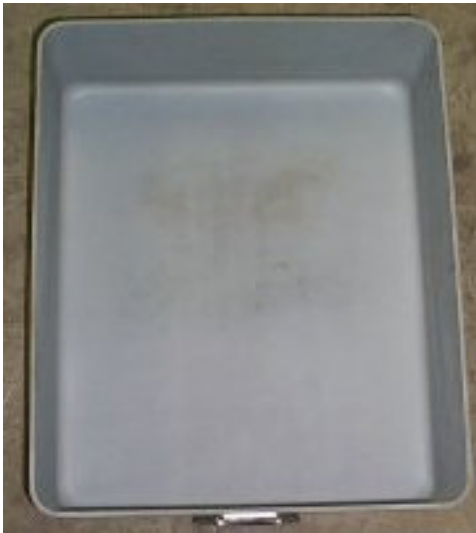
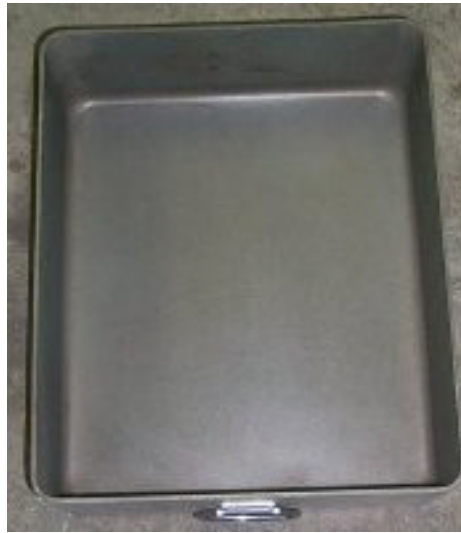
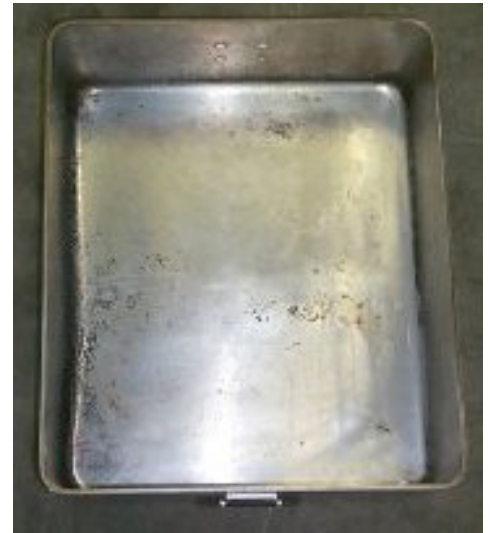
Figure 21. Plasmadize® initial condition

Figure 22. Teflon® initial condition

Figure 23. Uncoated initial condition

Figure 21, Figure 22 and Figure 23 show initial condition of the pans. It is clear the pans did not become completely clean from the prior meal, particularly the Plasmadize® and uncoated pan. The black spots in Figure 23 indicate carbon deposits embedded in pores of the aluminum. In a field situation, a soldier would be told to scrape the pan with hard steel wool or a steel mesh pad until the metal shined. This scraping procedure was not followed because the coatings should not be intentionally scratched and it was important to the results use the same technique on each of the pans. The Plasmadize® pan is showing significant discoloration and evidence of forming pits.

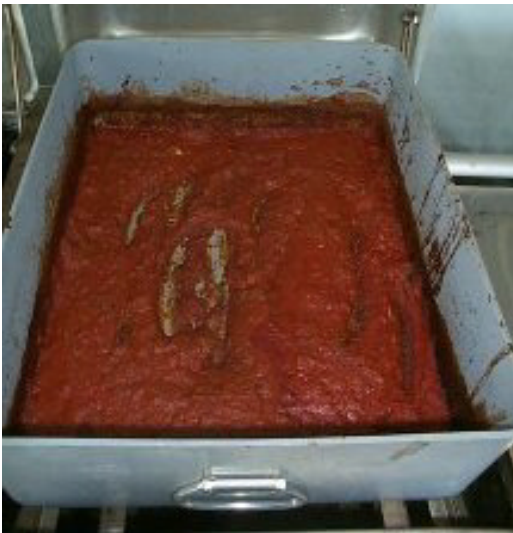
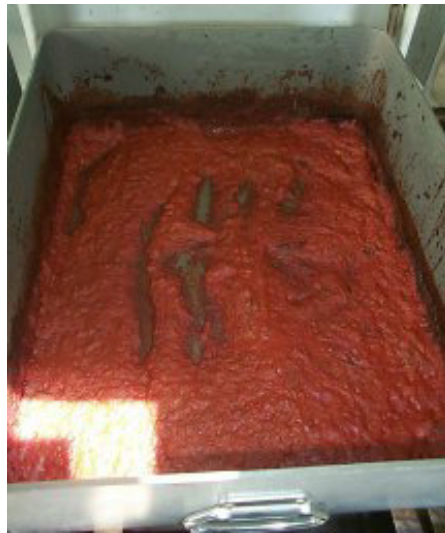
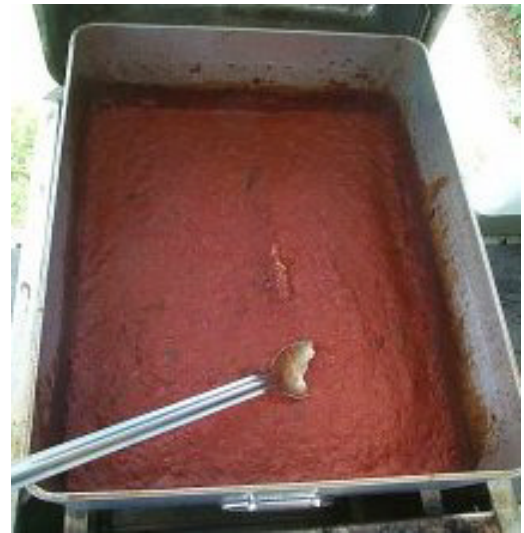
Figure 24. Plasmadize® w/ baked on sauce

Figure 25. Teflon® w/ baked on sauce

Figure 26. Uncoated w/ baked on sauce

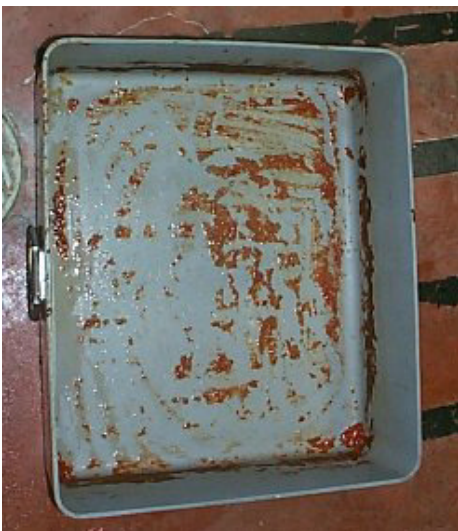
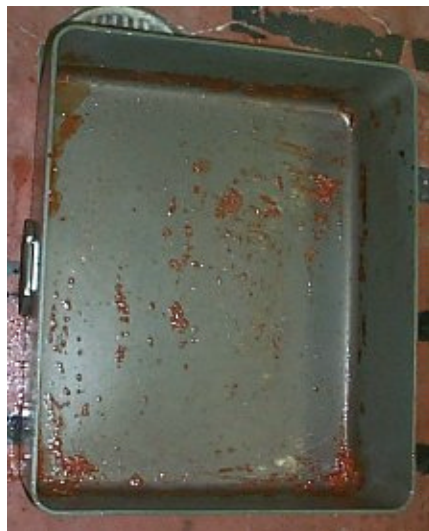
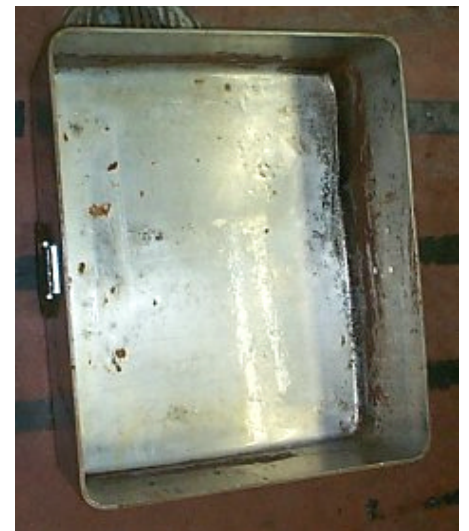
Figure 27. Gently rinsed Plasmadize®

Figure 28. Gently rinsed Teflon®

Figure 29. Gently rinsed uncoated

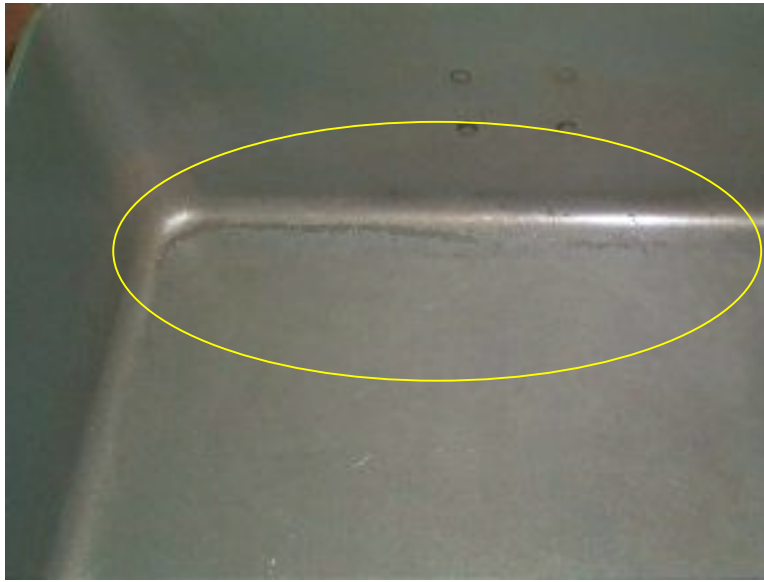
**Figure 30. Teflon® peeling away at the corners and fillets**

It was following this test that the Teflon® was observed peeling away from the corners (Figure 30). It cannot be determined whether this was related to stirring with a metal utensil, the attack of the hot tomato sauce or scrubbing action. It is anticipated all of these factors may have played a part. Instead of ending the test at this point, another meal was planned to observe the effects of the peeling and whether or not the condition would worsen.

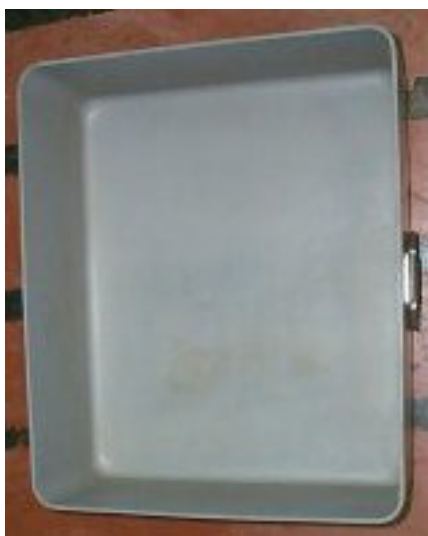
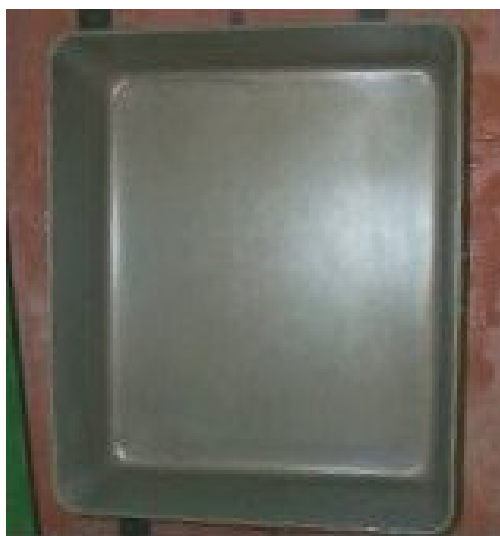
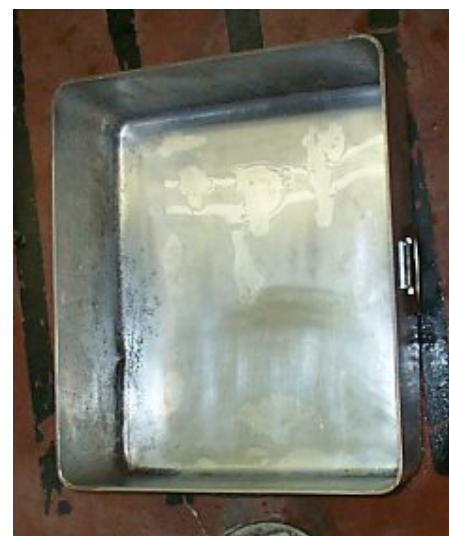
Figure 31. Plasmadize® initial condition

Figure 32. Teflon® initial condition

Figure 33. Uncoated initial condition

The third meal consisted of chili con carne, also a food known to be high in fats and acids. Figure 31-Figure 39 show results for this meal. Figure 31-Figure 33 show that though the pans are clean, the Plasmadize® coating is still stained, the Teflon® coating is peeling in the corners and the uncoated pan has almost irremovable carbon deposits.

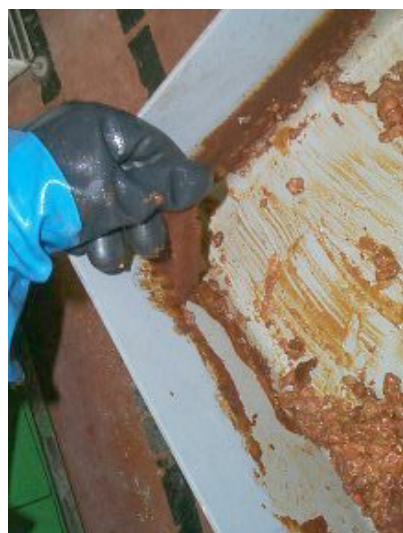
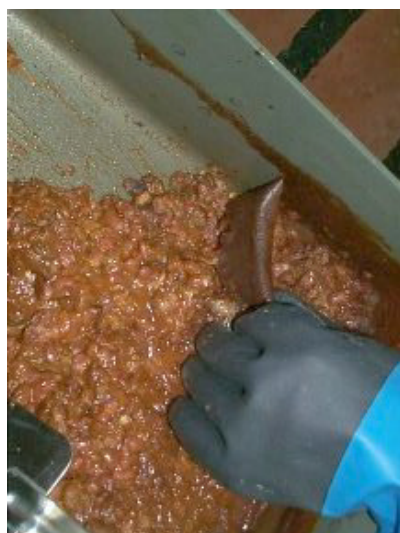
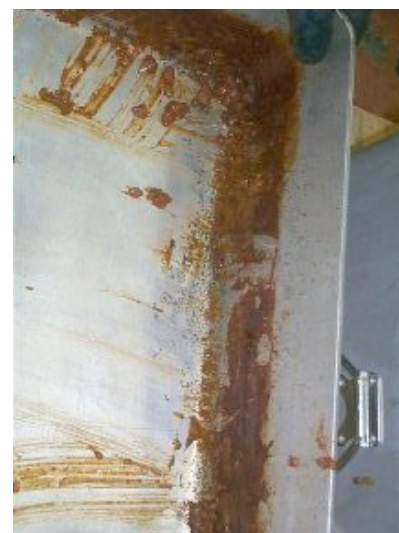
Figure 34. Congealed food peels off

Figure 35. Congealed food lifts off

Figure 36. Food is stuck on

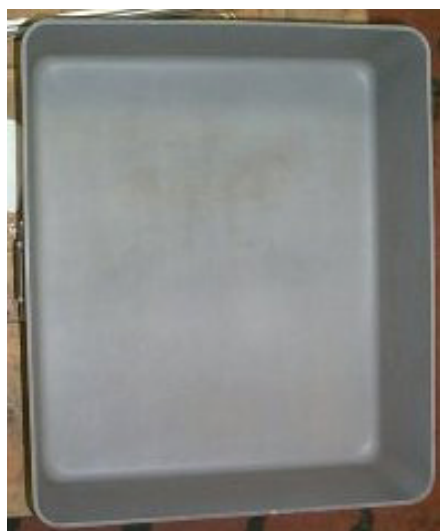
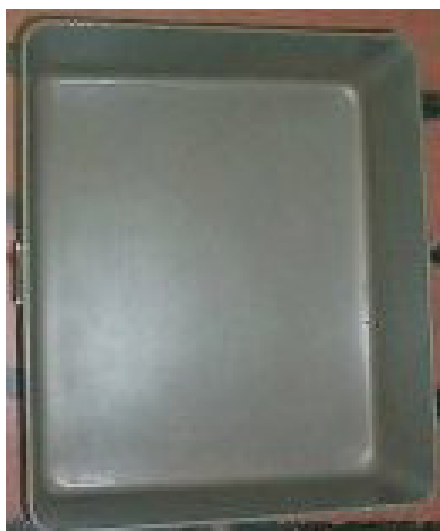
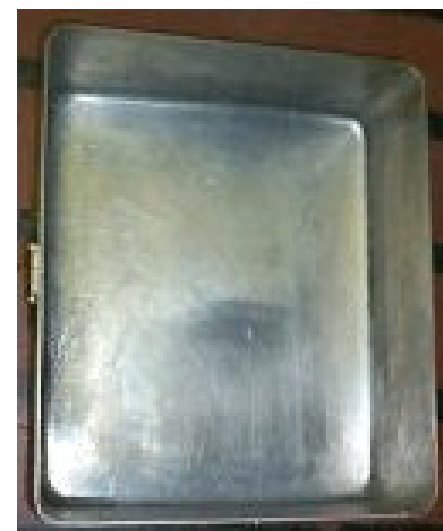
Figure 37. Cleaned Plasmadize®

Figure 38. Cleaned Teflon®

Figure 39. Cleaned uncoated

Figure 37 and Figure 39 show the pans after cleaning; The Teflon® and Plasmadize® pans were effortless to clean. On the uncoated pan, chili residue was stubbornly fused to the sidewalls and took significantly more time and effort to remove. Figure 38 shows that enough time and effort were eventually spent on the pan over the three cleanings to remove most of the burned on food from the first meal.
