**AFRL-ML-WP-TR-2001-4139**

**EFFECTS OF COMPRESSIVE STRESS  
ON FLUORESCENT PENETRANT  
INDICATIONS OF FATIGUE CRACKS IN  
TITANIUM**

**March 2001**

**FINAL REPORT FOR PERIOD 01 OCTOBER 1998 – 31 MARCH 2001**

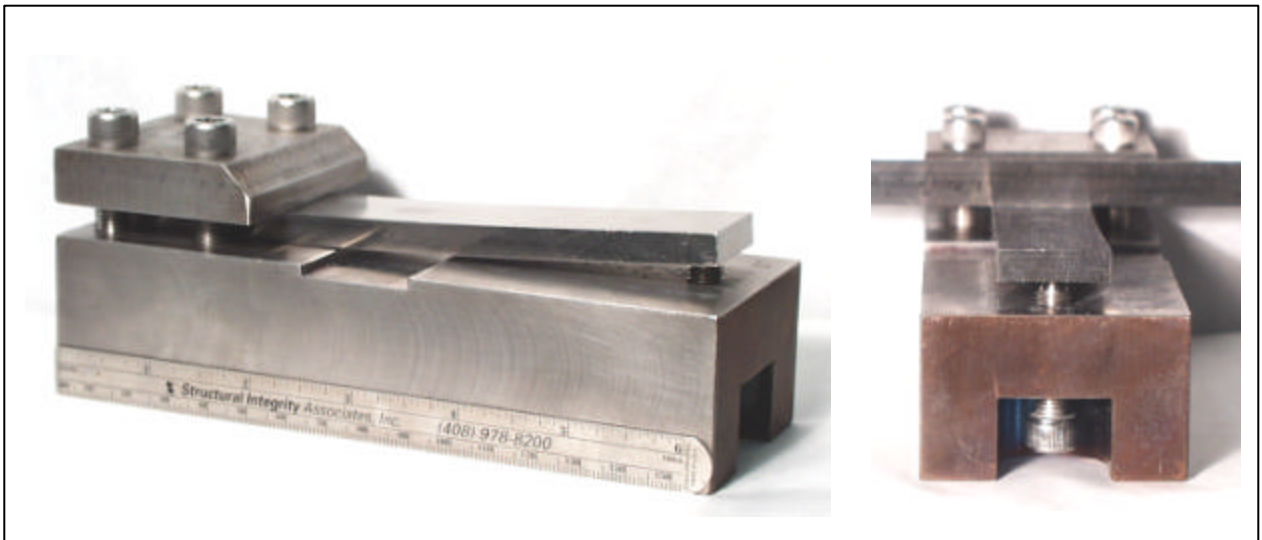
**Figure 2. Loading fixture with compressive stress applied to a specimen.**

A stainless steel loading fixture (figure 2) was designed so that compressive stress could be easily applied to the cracked surface of a specimen and the stressed specimen could be processed with fluorescent penetrant materials in accordance with the standardized processing procedure. It was desired to apply the maximum possible stress at the crack location while not exceeding the elastic limit load (90 ksi) at any point on the specimen. The fixture allows each specimen to be clamped in place so that the fatigue crack on the upper surface is one inch away from the beveled edge of the clamping plate. This spacing and the bevel were designed to allow access with an X-ray beam if it was desired to make residual stress measurements at the crack location with the specimen in the fixture under stress. The end view of the fixture in figure 2 shows

the cap screw used to bend the specimen and apply compressive stress to the upper surface of the specimen.
