NRL Report 6698

**Subcritical Flaw Growth in 9Ni-4Co-0.25C
Steel - A Fatigue and Fractographic
Investigation and Its Relationship to
Plane Strain Fracture Toughness**

T. W. CROOKER, L. A. COOLEY, E. A. LANGE, AND C. N. FREED

**NAVAL RESEARCH LABORATORY
Washington, D.C.**

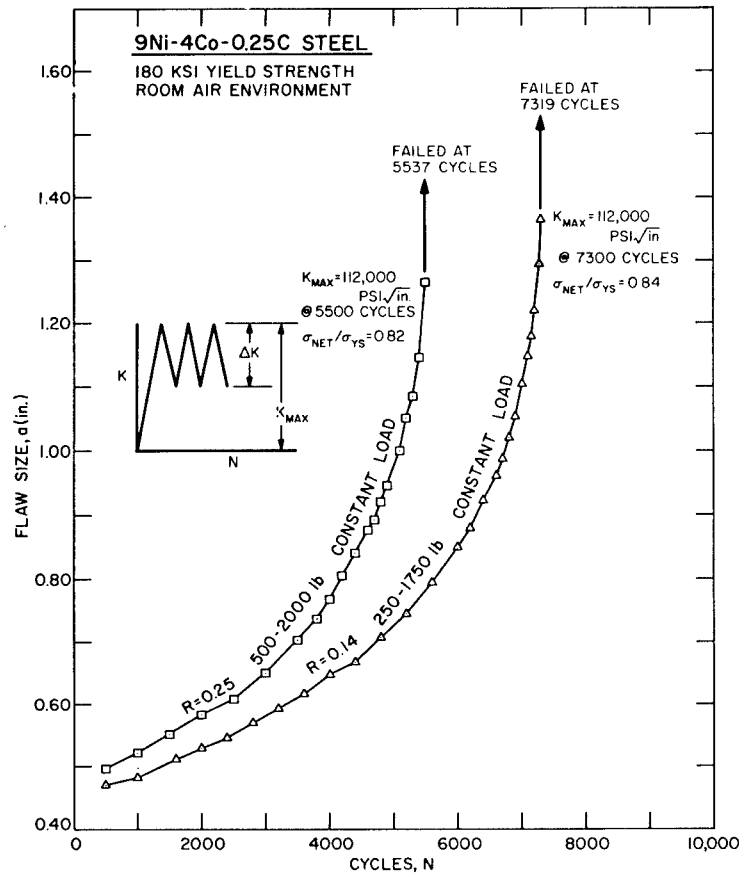
Fig. 5 - Fatigue crack propagation data for specimens cycled tension-to-tension ($R = 0.14$ and $R = 0.25$)

The results of these tests are shown in Figs. 4 and 5, which are plots of flaw size versus cycles of repeated load. The slope of these curves is the fatigue crack growth rate. Load, flaw size, and specimen geometry define the stress-intensity factor. These parameters are displayed in Fig. 6, which is the conventional log-log plot of fatigue crack growth rate versus stress-intensity-factor range. Fatigue crack growth rates plotted as a function of stress-intensity-factor range provide a generalized means of displaying experimental results.

The results shown in Figs. 4 through 6 suggest the following observations on the growth of fatigue cracks. Although the tensile cyclic load range was held constant at 1500 lb, a significant reduction in the number of cycles required to cause specimen failure resulted from the application of tensile mean loads. Terminal fracture is determined by the maximum tensile load; therefore, the critical flaw size becomes smaller as mean loads are added. Additionally, the crack growth rates become greater as tensile mean load increases, even though the cyclic load remains constant. The crack growth rate data shown on Fig. 6 are grouped with the positive R values occupying the upper region of the scatter limits. These results strongly suggest that mean loads cannot safely be ignored in structural fatigue design situations where high strength materials are being employed.

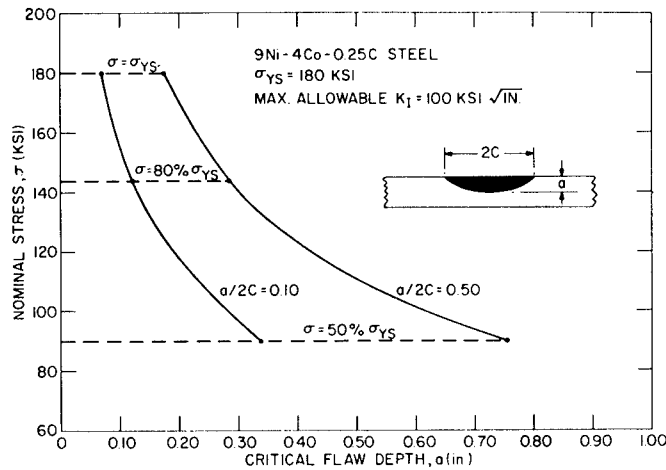
Fig. 7 - Relationships between nominal stress and critical flaw depth for 9Ni-4Co-0.25C steel at 180 ksi YS. The curves are computed from the equation for an embedded surface flaw in a large tension-loaded plate (12).

The stress levels shown on Fig. 7 range from 50 to 100 percent of yield strength stress. Flaw sizes which would be sufficient to initiate rapid fatigue failure in this material are shown to range from <0.10 to 0.75 in. Thus, the service performance limitations of this high-strength steel become more apparent.

Structural fatigue life for this material can be computed by means of the fatigue crack growth rate relationship given in Fig. 6, starting with an assumed or measured initial flaw size as the lower limit and growing the crack by fatigue to a critical flaw size determined from Fig. 7.

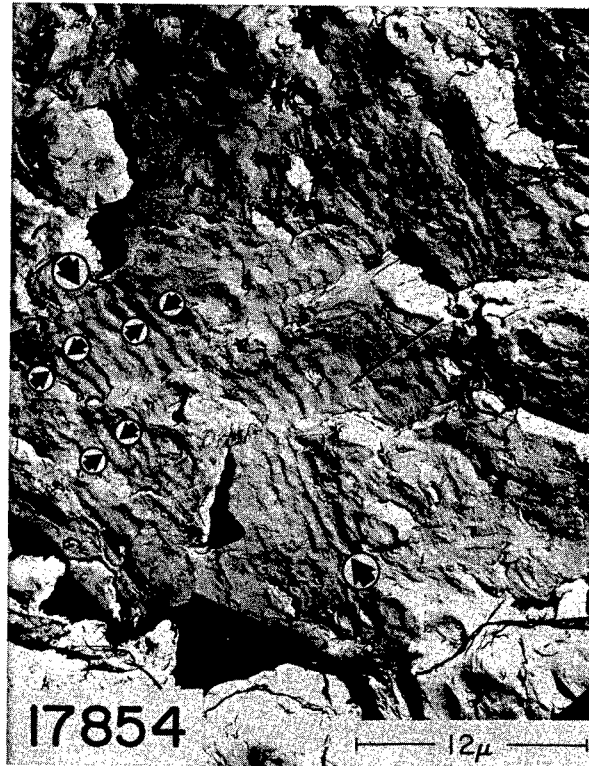
Fig. 9 - Tension-to-tension fatigue markings in a specimen loaded from 250 to 1750 lb. A packet of striations is shown between the large arrows while individual striations appear between the small arrows.

The first region studied encompasses the first 0.1 in. of crack growth, where $a = 0.50$ in. and $\Delta K = 36$ ksi $\sqrt{\text{in}}$. Figures 9 and 10 are from the specimen loaded 250 to 1750 lb. The ruptured surface consists of broad, shallow striations (between the small arrows in

Fig. 9) or tongues and ridges as seen in Fig. 10. The broad, shallow striations comprised 40 to 60 percent of the surface examined. At higher magnifications (Fig. 11) fatigue striations in the specimen loaded 500 to 2000 lb are broad and shallow with the edges of the individual striations outlined by discontinuous tongues. A further illustration of the surface complexity in this region is shown in Fig. 12. Shallow striations appear in the upper left, with shallow, equiaxed dimples in the lower left portions of the fractograph.

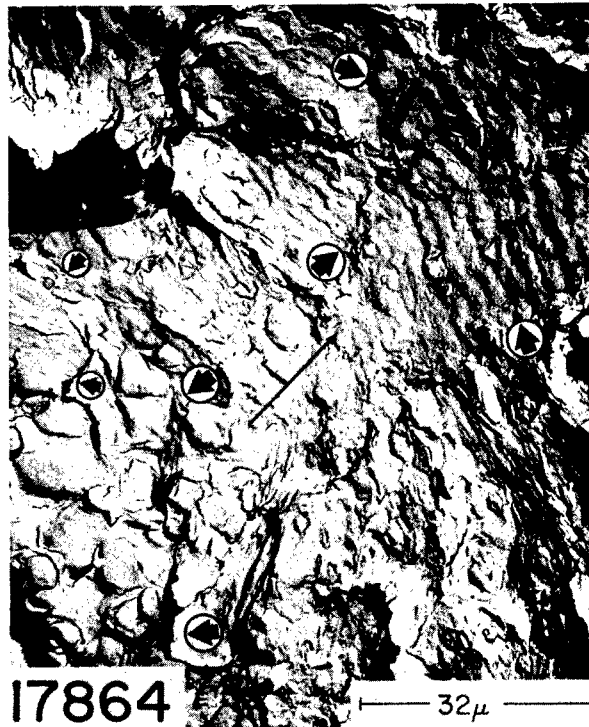
Fig. 12 - Tension-to-tension fatigue markings in a specimen loaded from 250 to 1750 lb. The surface consists of broad, shallow striations (upper right), shallow equiaxed dimples (lower left), and ridges (left center).

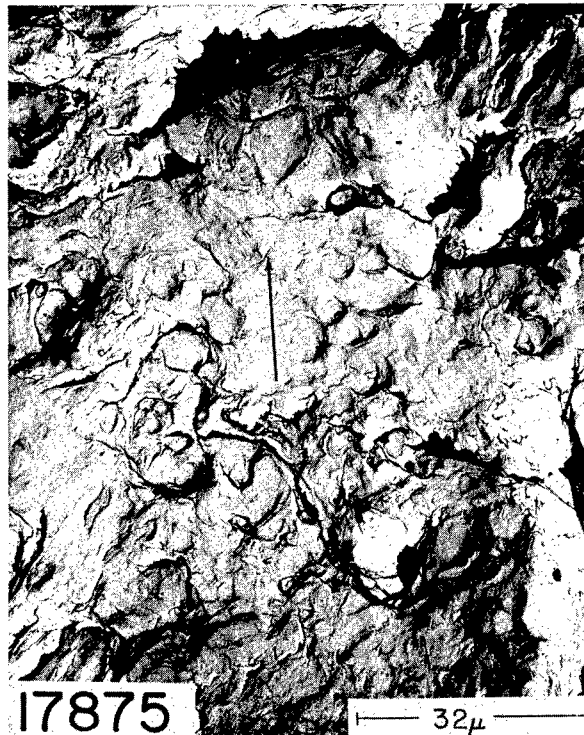
Fig. 13 - Tension-to-tension fatigue markings in a specimen loaded from 250 to 1750 lb. The surface consists of shallow dimples and tear ridges orientated in a random fashion to the fracture path.

As the crack front advances to the second area studied, the broad, shallow striations disappear. For flaw sizes ranging from 0.7 to 0.9 in., the surface of the specimen loaded 250 to 1750 lb consists of shallow dimples and random tear ridges as in Fig. 13 or shallow, equiaxed dimples as in Fig. 14. These features comprised approximately 80 percent of the areas examined.

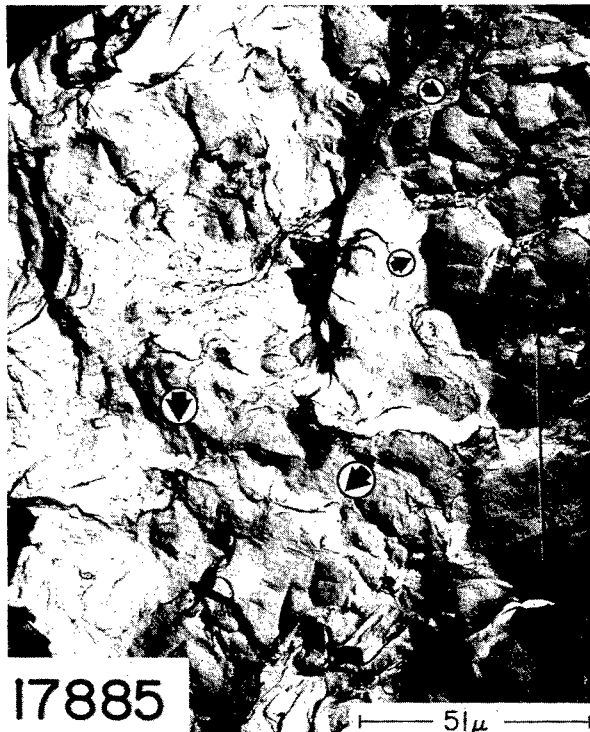
Fig. 14 - Tension-to-tension fatigue markings in a specimen loaded from 250 to 1750 lb. The surface consists of shallow dimples.

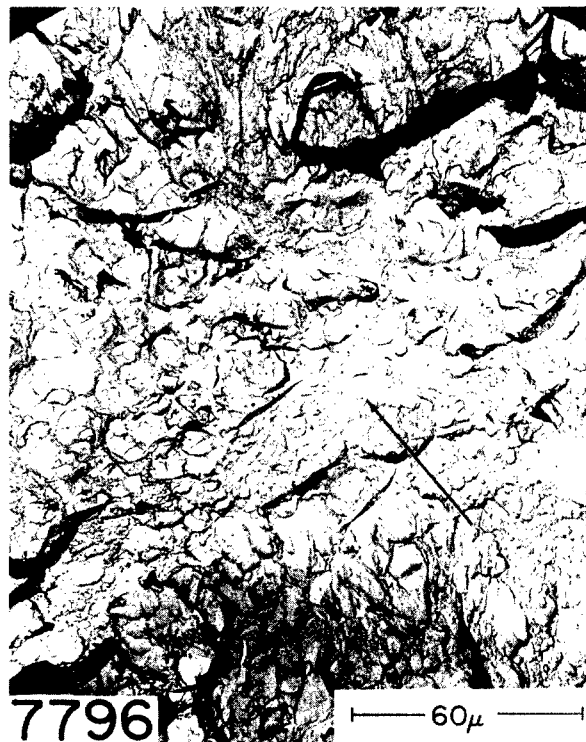
Fig. 16 - Region of fast fracture for a specimen loaded from 500 to 2000 lb. The surface consists of large and small dimples.

The final area studied lies within the region of fast, terminal fracture. The separation consists exclusively of dimpled rupture. Figure 16 illustrates this feature obtained from the specimen loaded 500 to 2000 lb. The microfracture mode is dimpled rupture with no single dimple size predominating.
