AI-AEC-12670

HELIUM EMBRITTLEMENT  
OF  
TYPE 316 STAINLESS STEEL

CONTRACT: AT(04-3)-701  
ISSUED: APRIL 30, 1968

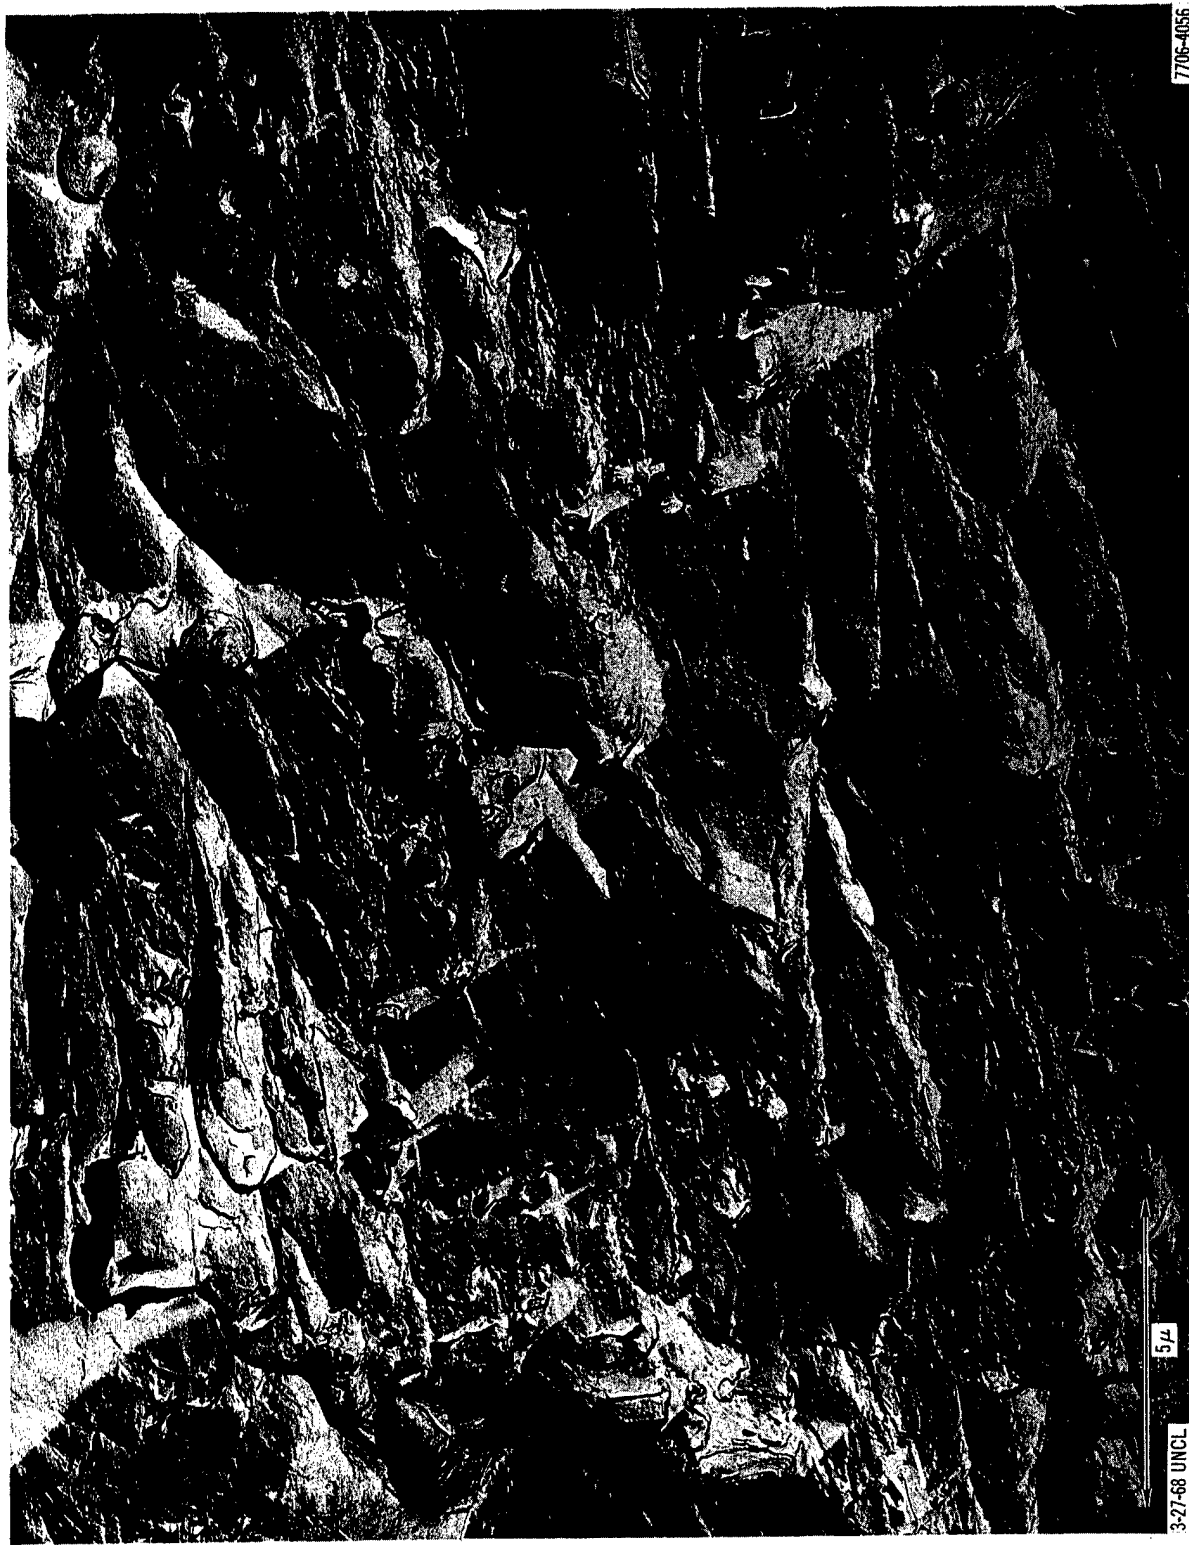
Figure 5. Fractograph of Type 316 Stainless Steel Without Helium  
Tested at 540°C, Showing Shear-Rupture Dimples

At 540°C all samples given either treatment with or without He failed transgranularly. The mechanism of shear-rupture was operating as evidenced by the shear-rupture dimples in Figure 5 which typifies all fractographs of samples tested at this temperature. The mode of failure of samples given Treatment 13 with or without He, and of samples given Treatment 6 without He was transgranular at 650°C. However, samples given Treatment 6 with He showed a mixture of transgranular and intergranular failure.

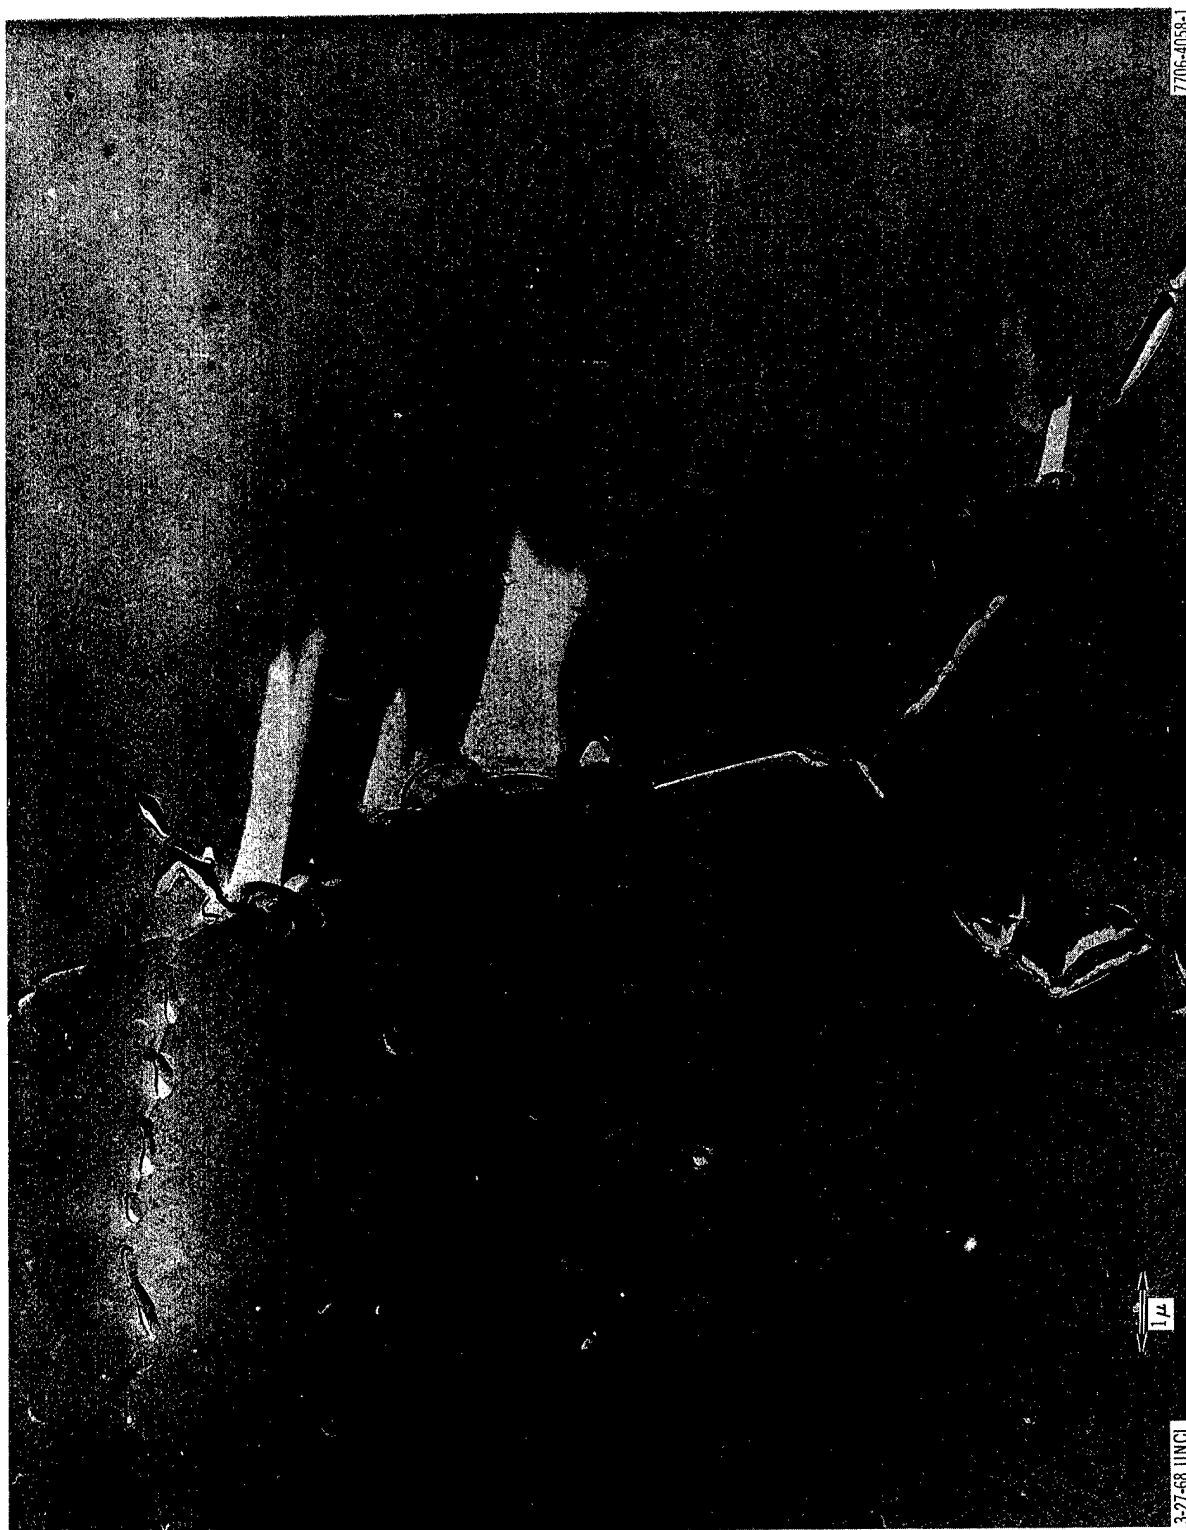
Figure 7a. Replica Electron Micrograph of Type 316 Stainless Steel  
With  $4 \times 10^{-5}$  Atom Fraction Helium Tested at  $760^{\circ}\text{C}$ , Showing  
Voids Adjacent to Grain-Boundary Carbides, Treatment 6

Figure 7 shows voids in samples with He tested at 760°C. They are situated on grain boundaries adjacent to carbide particles. The tensile axis is parallel to the direction of the white shadow. The relative frequency of these voids parallels that of grain-boundary cracks as stated above. The great majority of voids were associated with grain-boundary carbide particles, and even those which appear isolated on a grain boundary may be next to a carbide particle in another plane.

Loss of ductility due to helium is always accompanied by a failure that is partially or completely intergranular and by the presence of intergranular cracks along the gauge length. These cracks in their incipient state are located adjacent to grain-boundary carbide particles (Figure 7). Grain-boundary sliding, which probably occurs during testing, is obstructed by the presence of these carbide particles. In this situation voids are nucleated at the particle-matrix interface, and the mechanism has been described for a variety of alloys.<sup>(8-10)</sup>

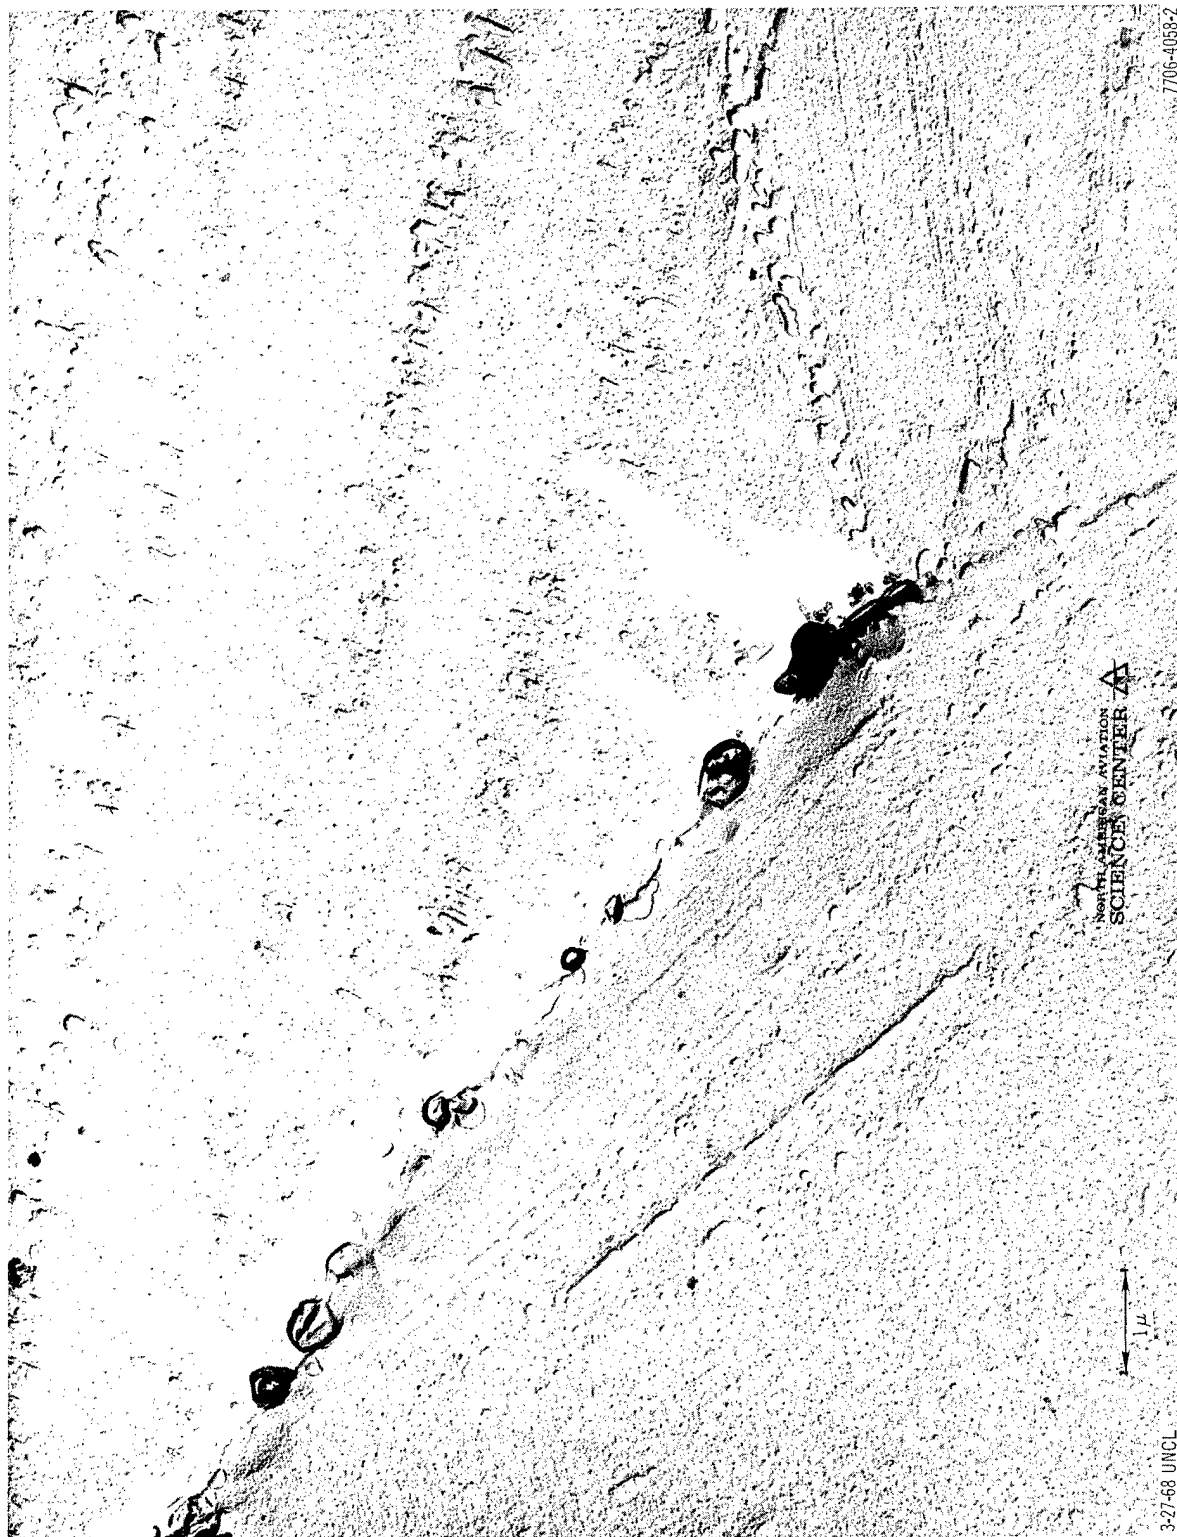
Figure 7b. Replica Electron Micrograph of Type 316 Stainless Steel  
 With 4 x 10<sup>-5</sup> Atom Fraction Helium Tested at 760°C, Showing  
 Voids Adjacent to Grain-Boundary Carbides, Treatment 13

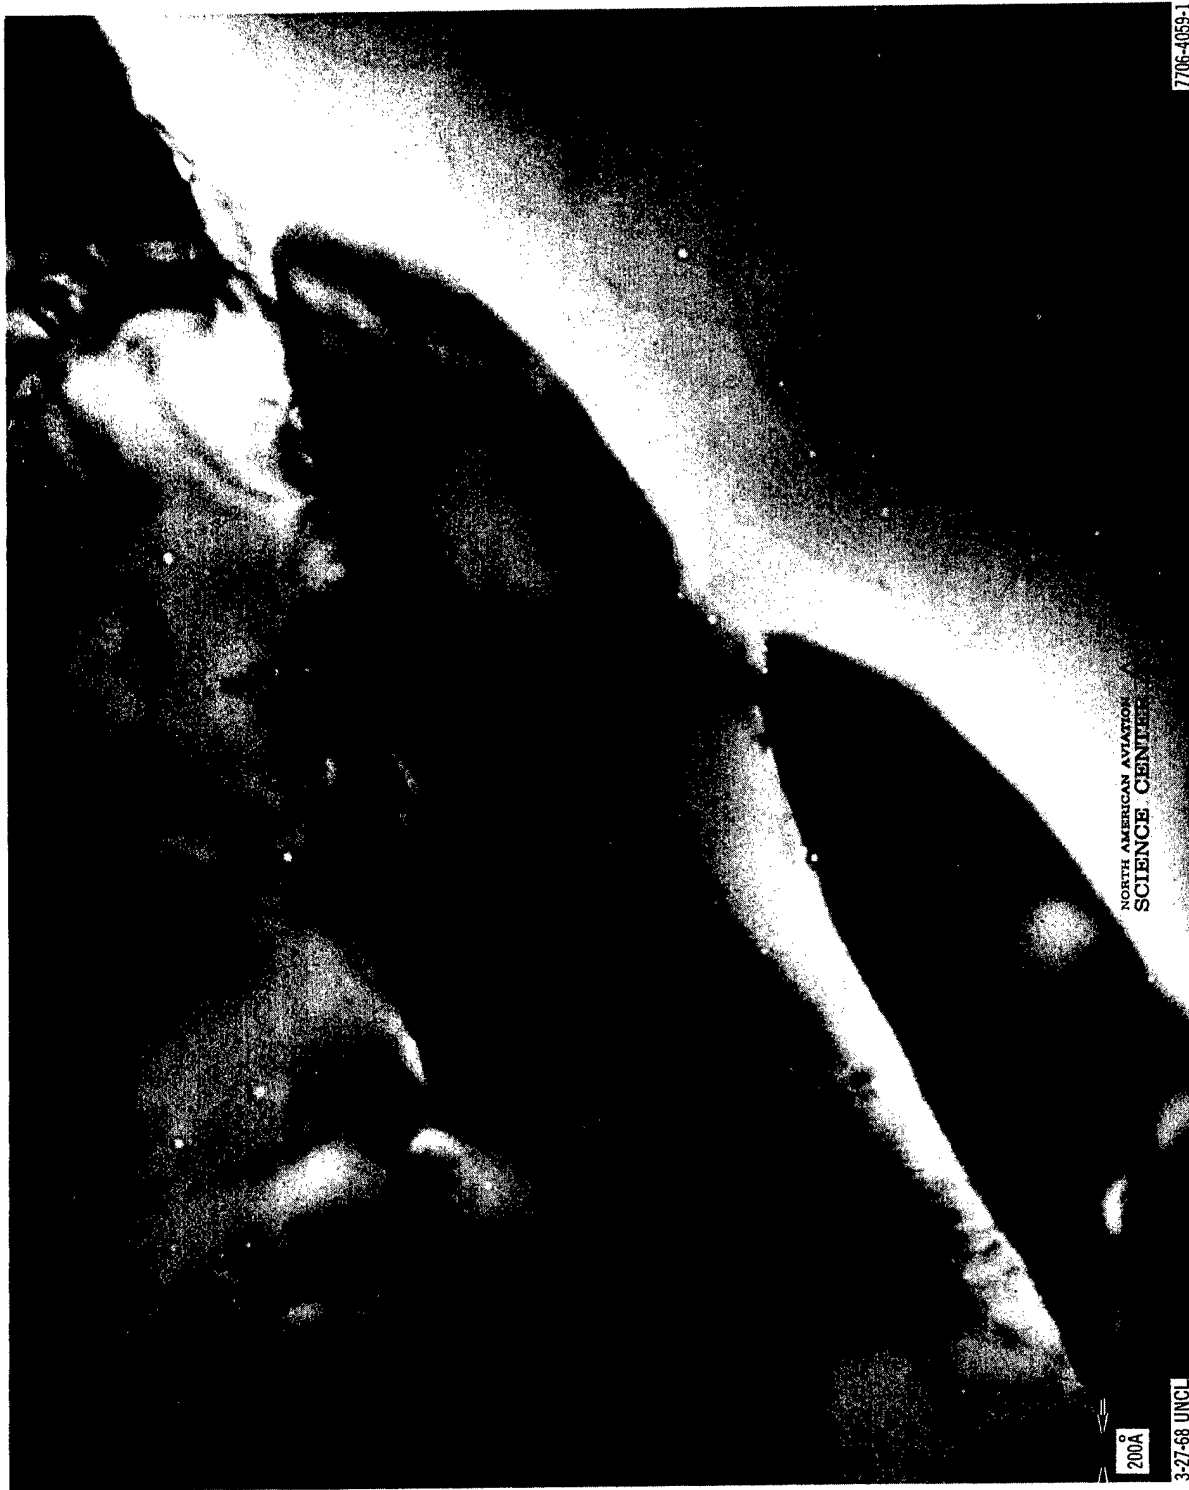
Figure 8a. Transmission Electron Micrograph Showing Helium Bubbles  
in Type 316 Stainless Steel Given Treatment 6 With 4 x 10<sup>-5</sup>  
Atom Fraction Helium Tested at 760°C

Helium bubbles were found in samples given either treatment after testing at 760°C (bubbles were not detected after tests at 540 and 650°C) and were generally located on grain boundaries, dislocations, and precipitates. Figure 8 shows He bubbles in samples given Treatment 6. The average bubble size is less than 100 Å although some bubbles 1000 Å and greater are present on grain boundaries and attached to carbide particles (see Figure 8c).

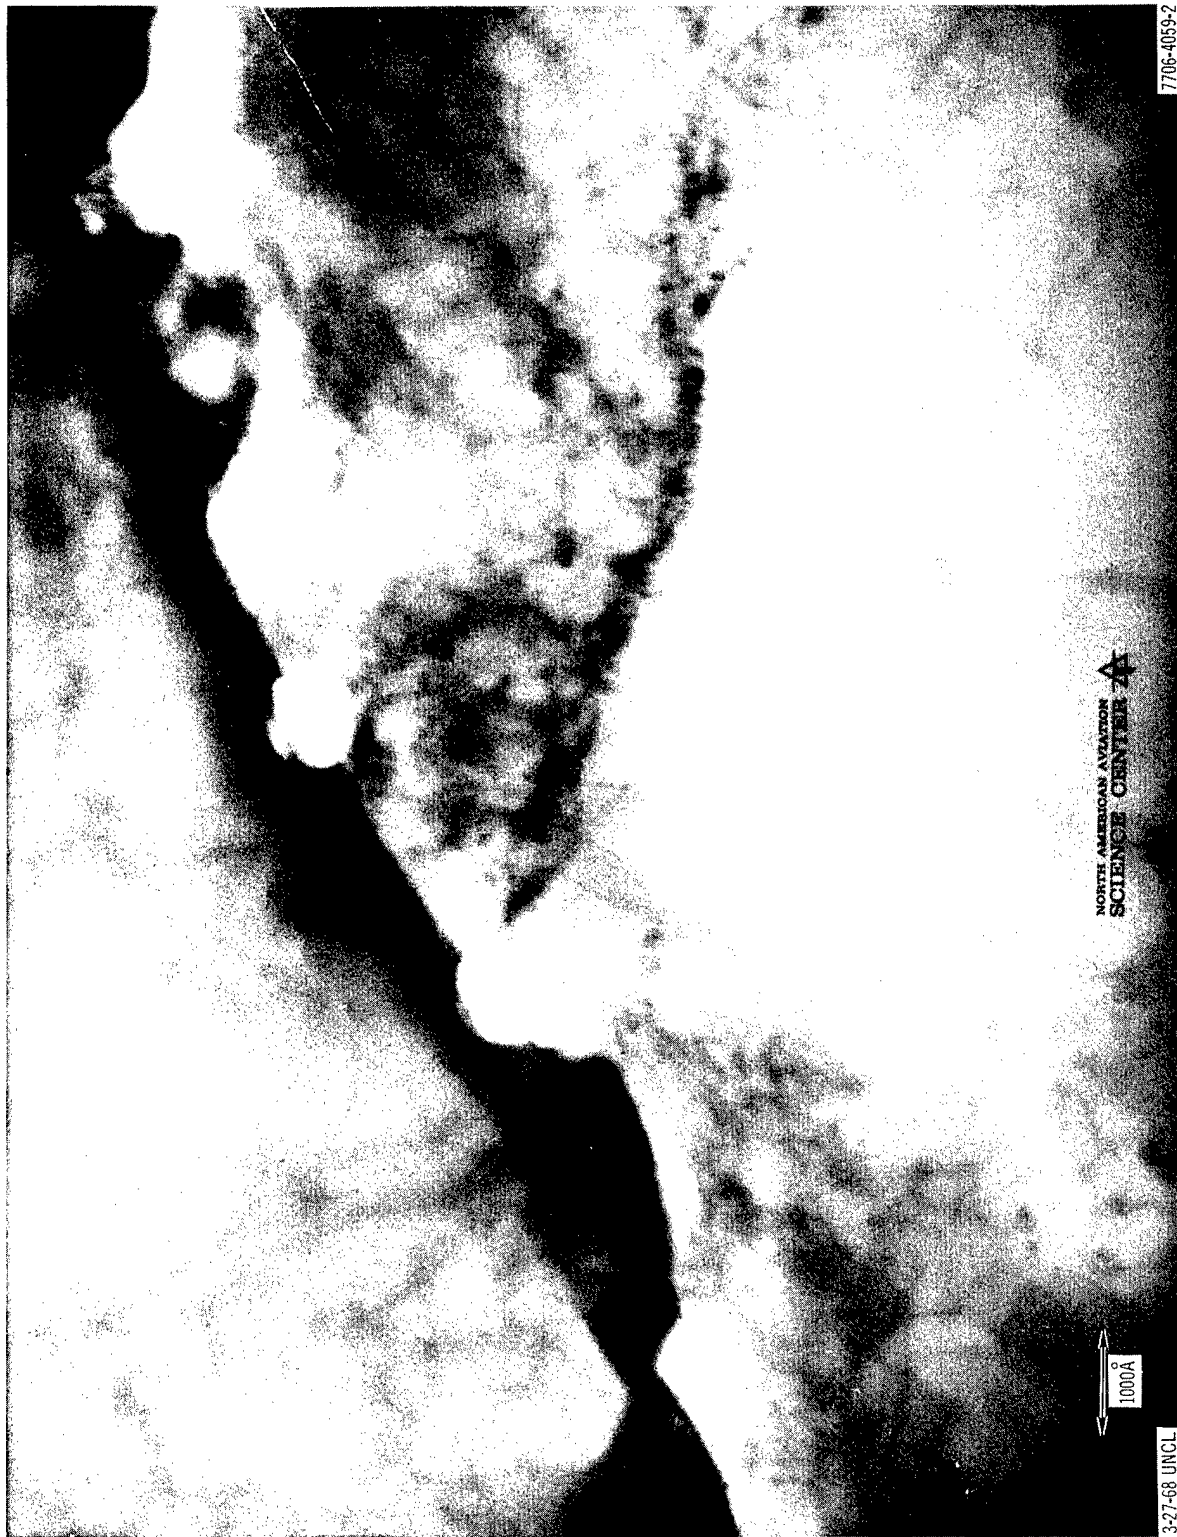
Figure 8b. Transmission Electron Micrograph Showing Helium Bubbles  
in Type 316 Stainless Steel Given Treatment 6 With  $4 \times 10^{-5}$   
Atom Fraction Helium Tested at  $760^{\circ}\text{C}$

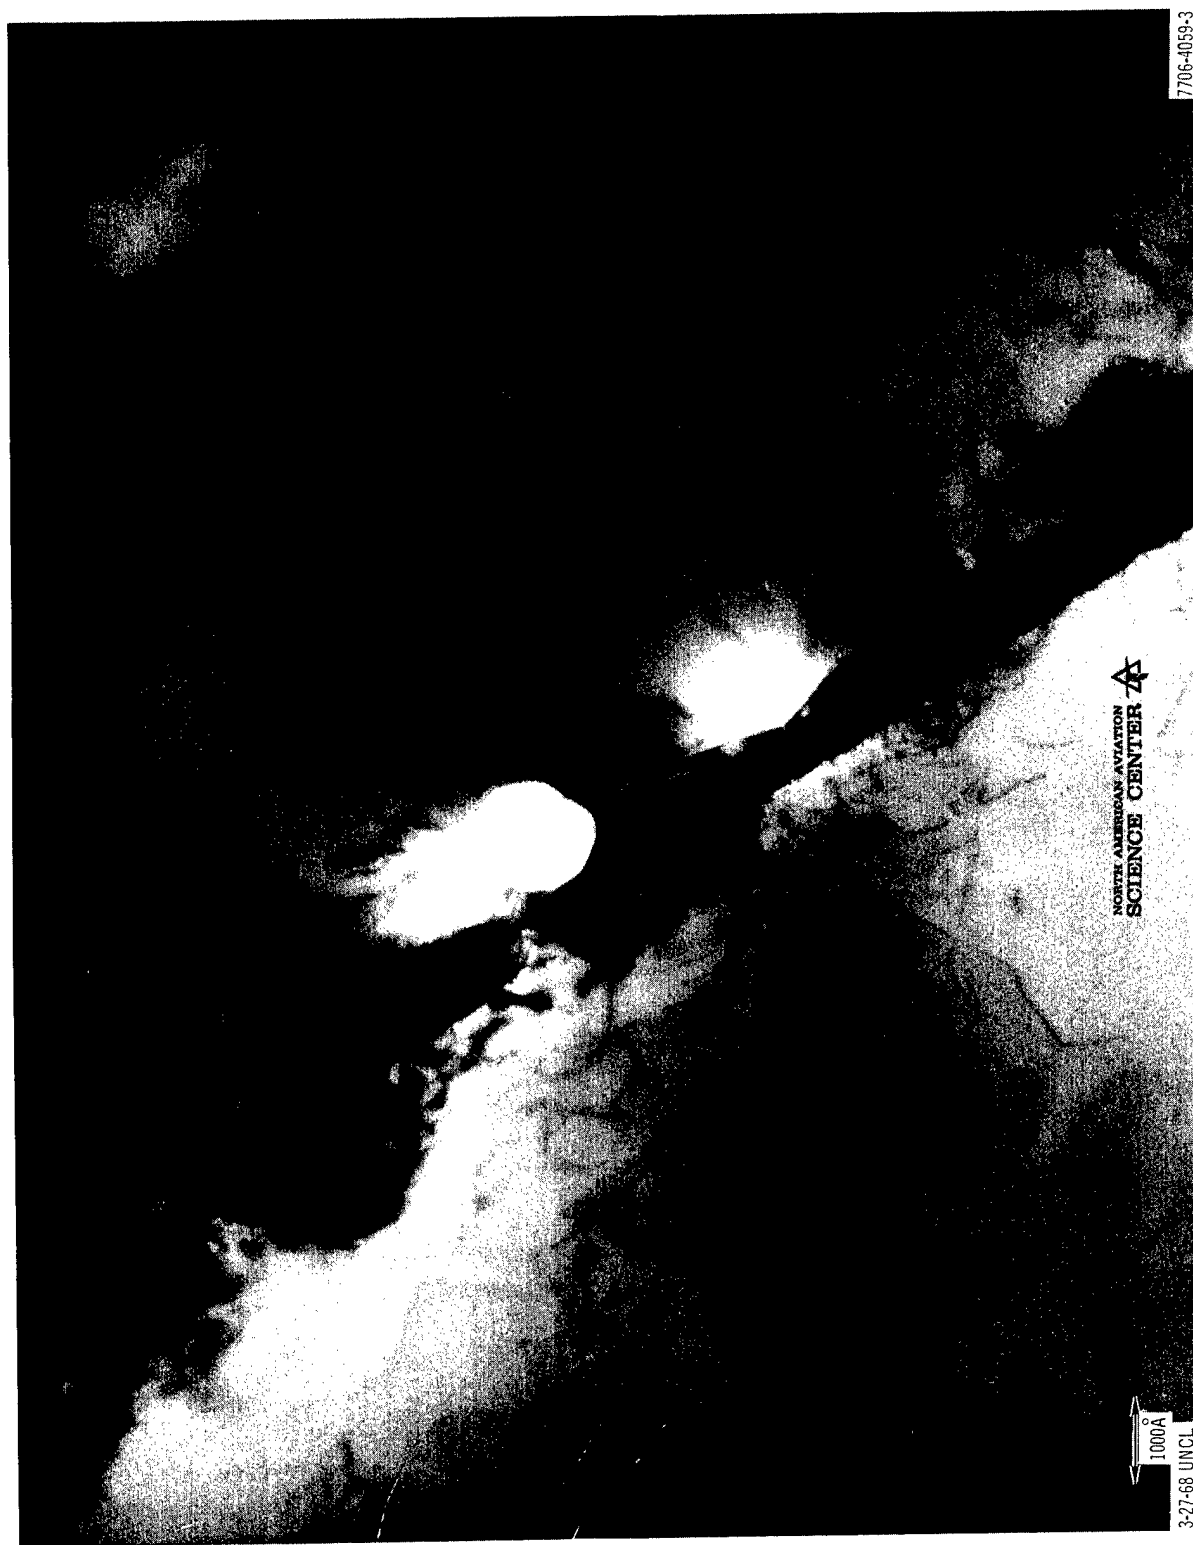
Figure 8c. Transmission Electron Micrograph Showing Helium Bubbles  
in Type 316 Stainless Steel Given Treatment 6 With 4 x 10<sup>-5</sup>  
Atom Fraction Helium Tested at 760°C

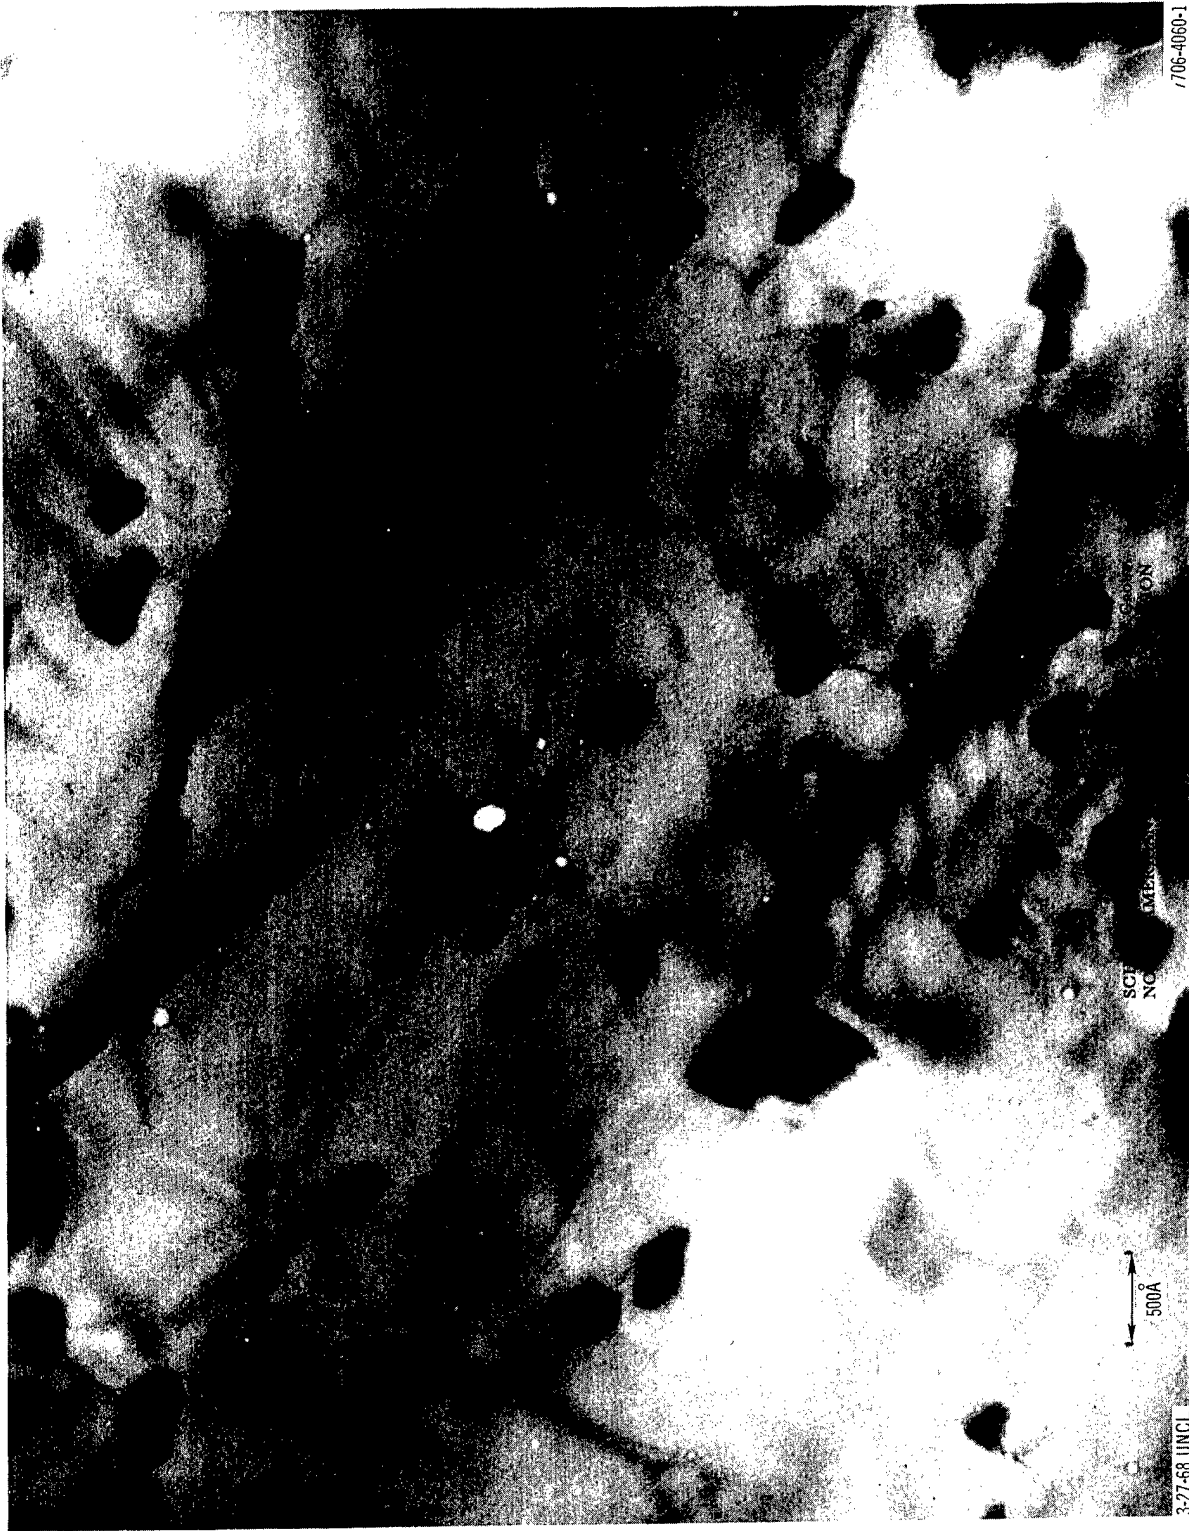
Figure 9a. Transmission Electron Micrograph Showing Helium Bubbles  
in Type 316 Stainless Steel Given Treatment 13 With  $4 \times 10^{-5}$   
Atom Fraction Helium Tested at  $760^{\circ}\text{C}$

Figure 9 shows He bubbles in samples given Treatment 13. Their average size is also less than  $100\text{\AA}$  but a very large bubble ( $>2000\text{\AA}$  in one dimension) has formed on a grain boundary (see Figure 9b). Most of the small bubbles are attached to  $\sigma$ -particles. Large bubbles were significantly less prevalent in samples of Treatment 13 than in 6.

Samples given Treatment 13 show loss of ductility beginning above 650°C, while at this temperature those given Treatment 6 have already lost more than half their ductility. This is due to the effectiveness of the high density of  $\sigma$ -particles ( $10^{13} \text{ cm}^{-3}$ ) in trapping He (seen in Figure 9a as bubbles attached to the particles), thereby delaying the accumulation of He at grain boundaries.

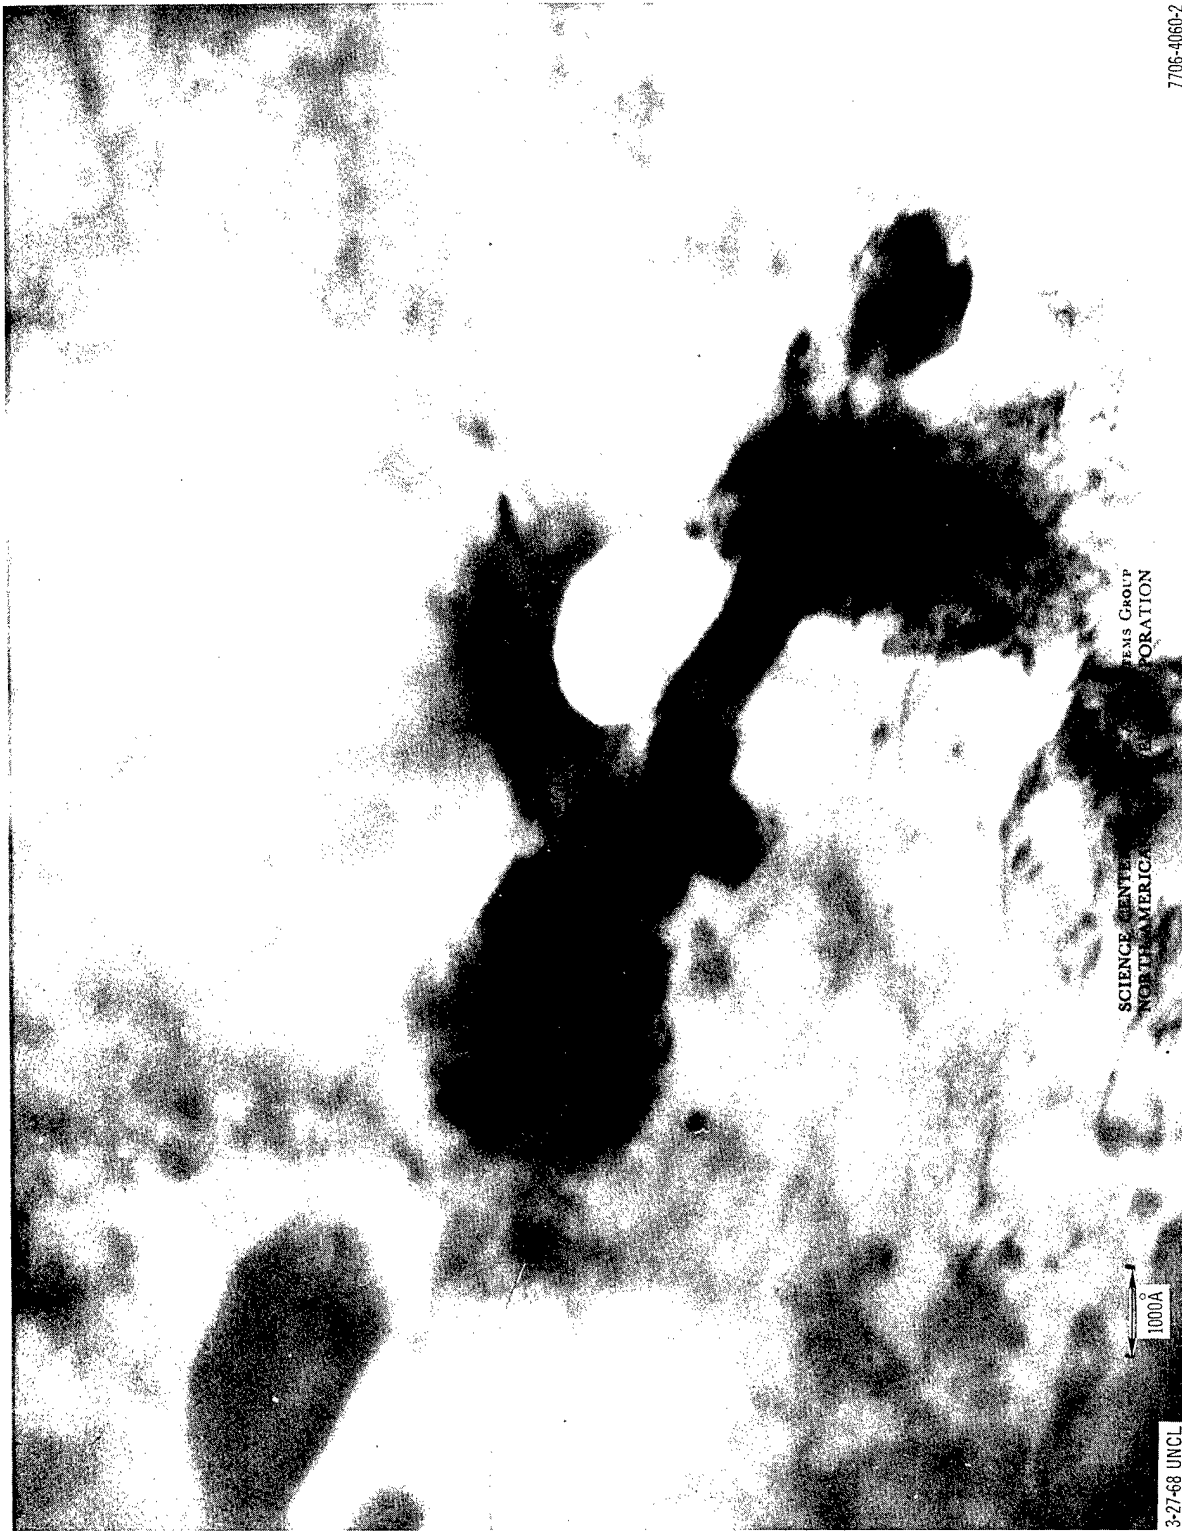
Figure 9b. Transmission Electron Micrograph Showing Helium Bubbles  
in Type 316 Stainless Steel Given Treatment 13 with  $4 \times 10^{-5}$   
Atom Fraction Helium Tested at  $760^{\circ}\text{C}$
