An Overview of the On-Orbit Results from the Electric Propulsion Space Experiment (ESEX)

D.R. Bromaghim, J. R. LeDuc, R.M. Salasovich, G.G. Spanjers, and J.M. Fife

Abstract

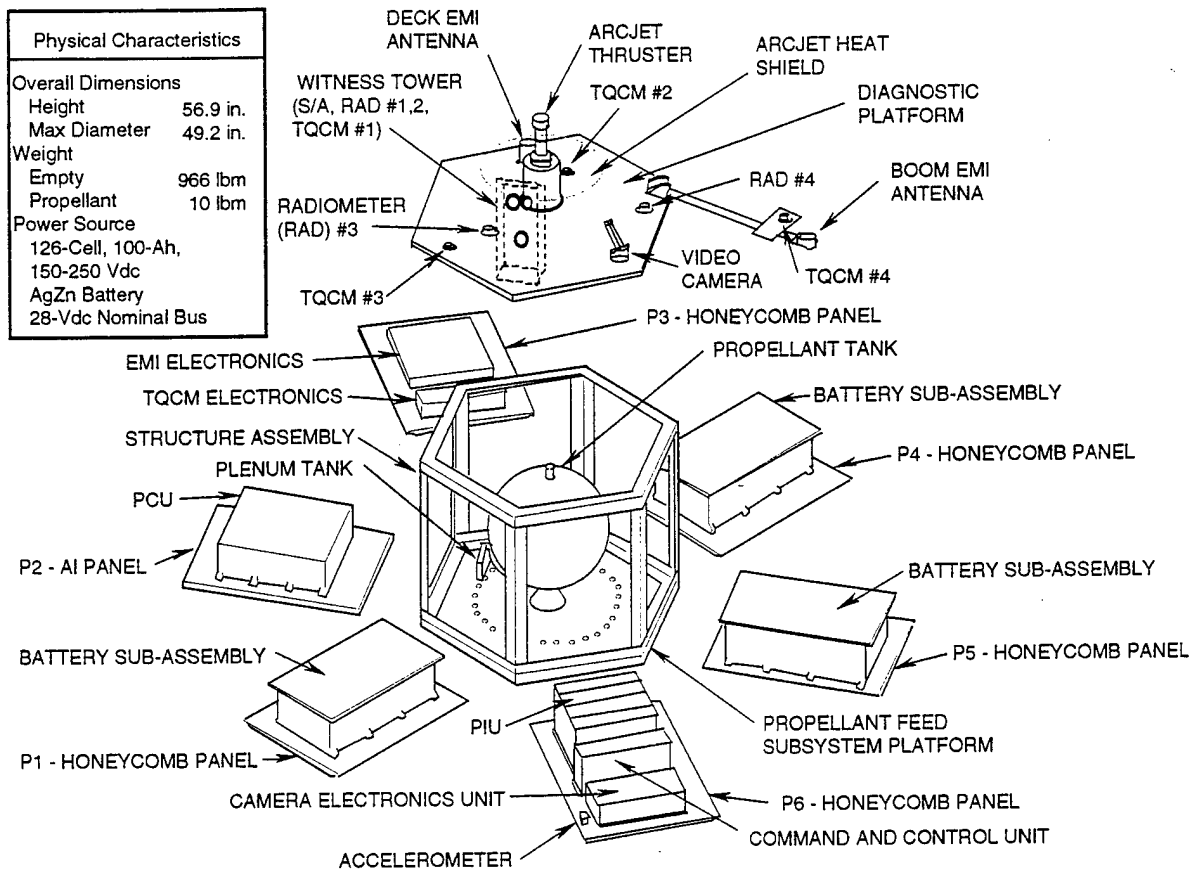
Figure 1

The ESEX flight system, Figure 1, includes a propellant feed system (PFS),⁶ power subsystem⁷ including the power conditioning unit (PCU)⁸ and the silver-zinc battery, commanding and telemetry modules, the on-board diagnostics,¹ and the arcjet assembly.⁸ ESEX was designed and built as a self-contained experiment to minimize the impact of any effects from the arcjet firings on ARGOS. This design allowed ESEX to function semi-autonomously, requiring ARGOS support only for attitude control, communications, radiation-hardened data storage, and housekeeping power for functions such as battery charging and thermal control.

Contamination Measurements - An array of sensors were positioned at strategic locations around the ESEX diagnostic deck (reference Figure 1) in order to assess the contamination effects of the arcjet firings.¹⁴ Mass deposition, which can impact satellite optical and thermal control surfaces, is measured using four TQCMs. Thermal flux from the arcjet firing is measured using four radiometers coated with S13-GLO, a common thermal surface material with low solar absorptivity and high emissivity. Measurement of heat transfer through the coating identifies the degradation of the S13-GLO when subjected to the spectral emission of the high-power arcjet. Any such degradation would affect the thermal design of spacecraft using high-power arcjets for propulsion. A sample Ga-As solar array segment was placed near the arcjet nozzle and used to determine the potential for plasma/solar array interactions or obscuration of the solar flux, which can have a deleterious impact on satellite power generation capability.

approximately 24 hours until, as subsequent analysis revealed, the battery sub-assembly on panel #1 (reference Figure 1) had a catastrophic failure. This failure was most likely a result of electrolyte leakage from one of the cells, causing a short circuit to the battery case. As the energy in the cell was discharging through the short circuit, there was a corresponding, dramatic increase in battery temperature, coupled with an increase in pressure as hydrogen gas was generated from decomposition of the electrolyte. This process continued until there was a breach of the battery case and a release of this super-heated gas internal to the ESEX flight unit. This gas was eventually vented into space, causing a dramatic attitude disturbance on the vehicle, resulting in a sunsafe event. A discussion on the contamination effects from the battery venting is described elsewhere.¹⁴

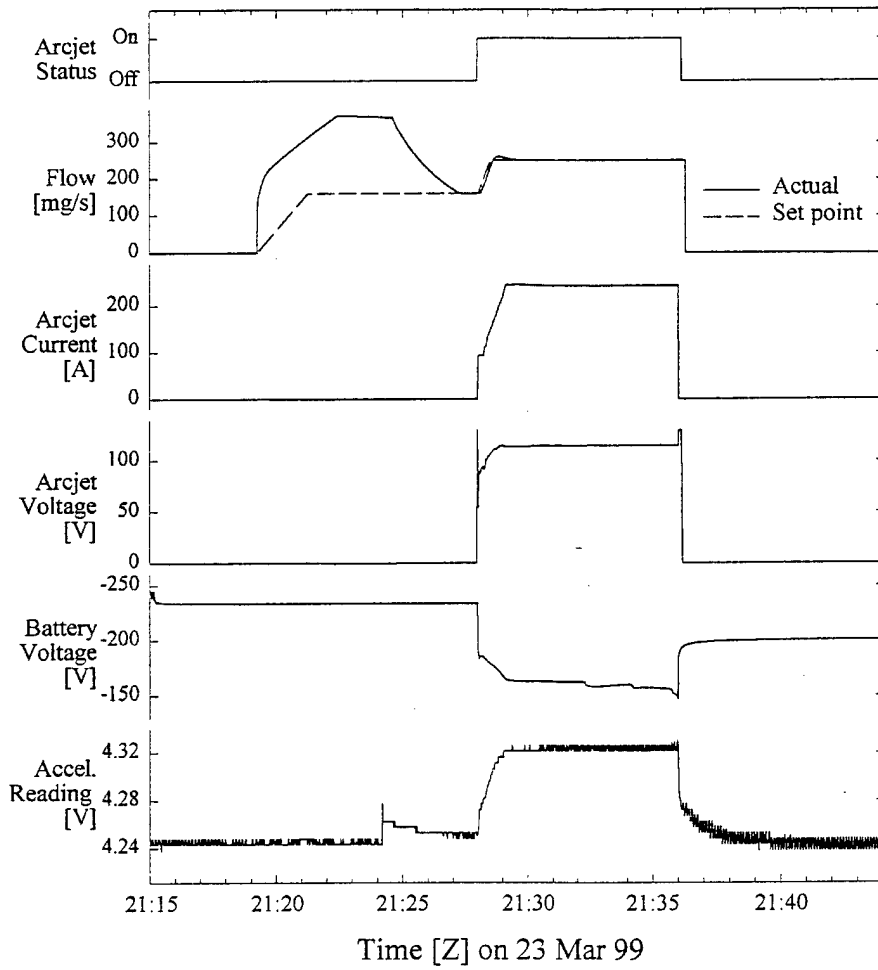
Figure 2

The ingestion of liquid NH_3 at the initialization of the PFS algorithm was unexpected since it was not observed in any ground tests (subsequent analyses indicated that it could have occurred, but may not have been observed). While the liquid ingestion was brief and confined to the initial valve pulse, it occurred for every outflow except the last firing (F-8). This minor problem was overcome by implementing an operational delay after opening the arcjet valve, which allowed the plenum tank to "dry out" and the flow to stabilize before starting the arcjet. The duty cycle of the flow control valve - the dual pressure control (DPC) valve (reference Figure 10 for the PFS schematic) - showed a large control margin. In fact, the measured flow rate was often within ± 0.3 mg/sec of the setpoint (reference Figure 2), well within the specified requirement of ± 5 mg/sec.

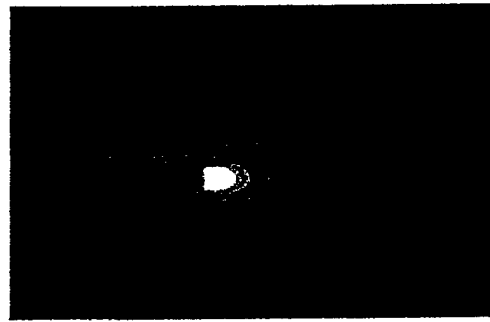
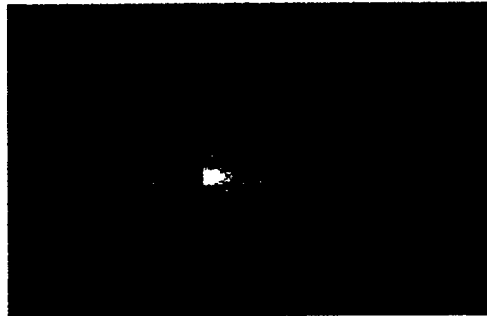
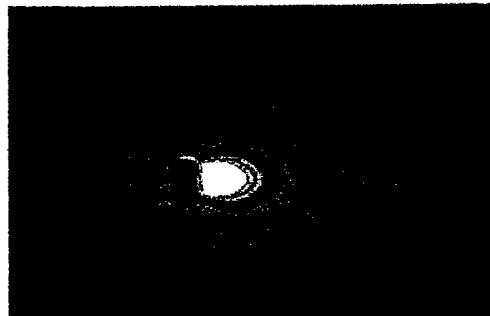
Figure 3

Image #1 - Acquired at $t + 15$ sec

Image #3 - Acquired at $t + 45$ sec

Image #2 - Acquired at $t + 30$ sec

Image #4 - Acquired at $t + 60$ sec

The on-board camera acquired images during each of the eight firings with several different shutter speed settings. The limited number of arcjet firings precluded testing over the full dynamic range of the camera, leading to the majority of the full-power images exceeding the maximum intensity range of the CCD detector. A survey of images of the arcjet during the first 90 seconds of operation illustrates the rapid heating of the anode and extent of the plume. Part of this series is shown in Figure 3, which shows the startup and most of the 70-second ramp to full power. The lack of steady-state images precluded quantitative correlation of arcjet thermal models to the on-orbit data, but the results did qualitatively confirm the expectation of the smaller plume extent.

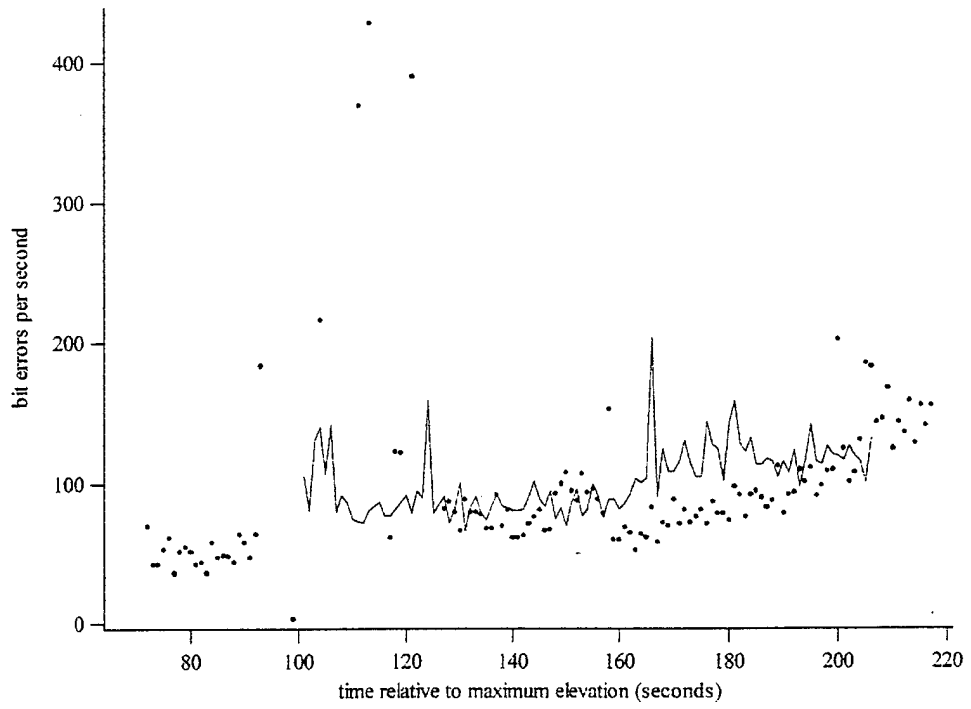
Figure 4 - Representative bit error rate data for firing #2 (dots) with baseline pass taken under similar conditions (line)

The BER test enabled a quantified assessment of the effect of the arcjet on the satellite ranging channel. This test is performed by replacing the normal ranging pattern with a test pattern from CPCA and determining the number of bit errors on the return signal using a BER counter.^{3,12,20} A series of baseline measurements were made while the arcjet was off, and with the vehicle in several transmit configurations for comparison with firing data. Figure 4 shows a representative data set from the BER tests with an arcjet firing vs. a baseline measurement. These data were recorded at transmit rates of 1.024×10^6 bits/sec, with typical error rates less than 2 bits in 10,000. It should be noted that the CPCA system was significantly de-tuned in order to increase the sensitivity of the measurement. During routine satellite operations, the BER is typically less than 1 in 1×10^6 bits.

In total, three arcjet firings and over thirty baseline BER curves were recorded during the ESEX flight. Analyses did not reveal a clear correlation between features observed in the arcjet firing curves and the operation of the arcjet, since similar features are identifiable in both baseline and arcjet firing curves.

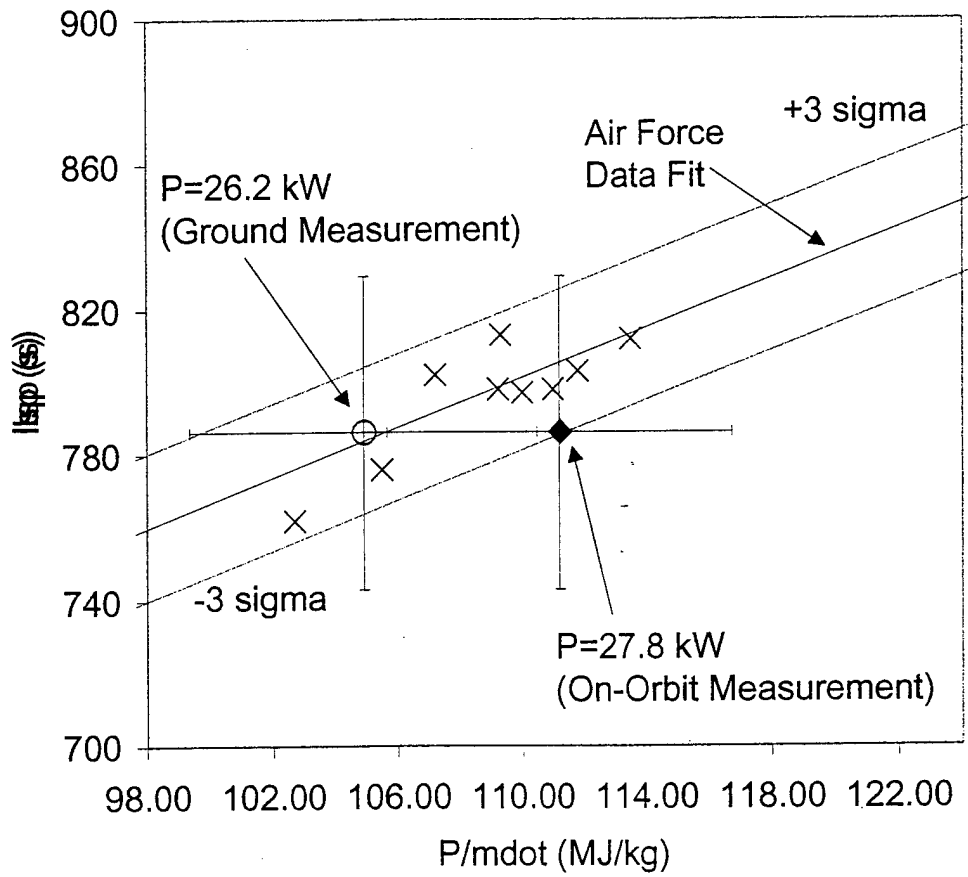
Figure 5 - Summary of the arcjet on-orbit mean performance showing the corrected and uncorrected results

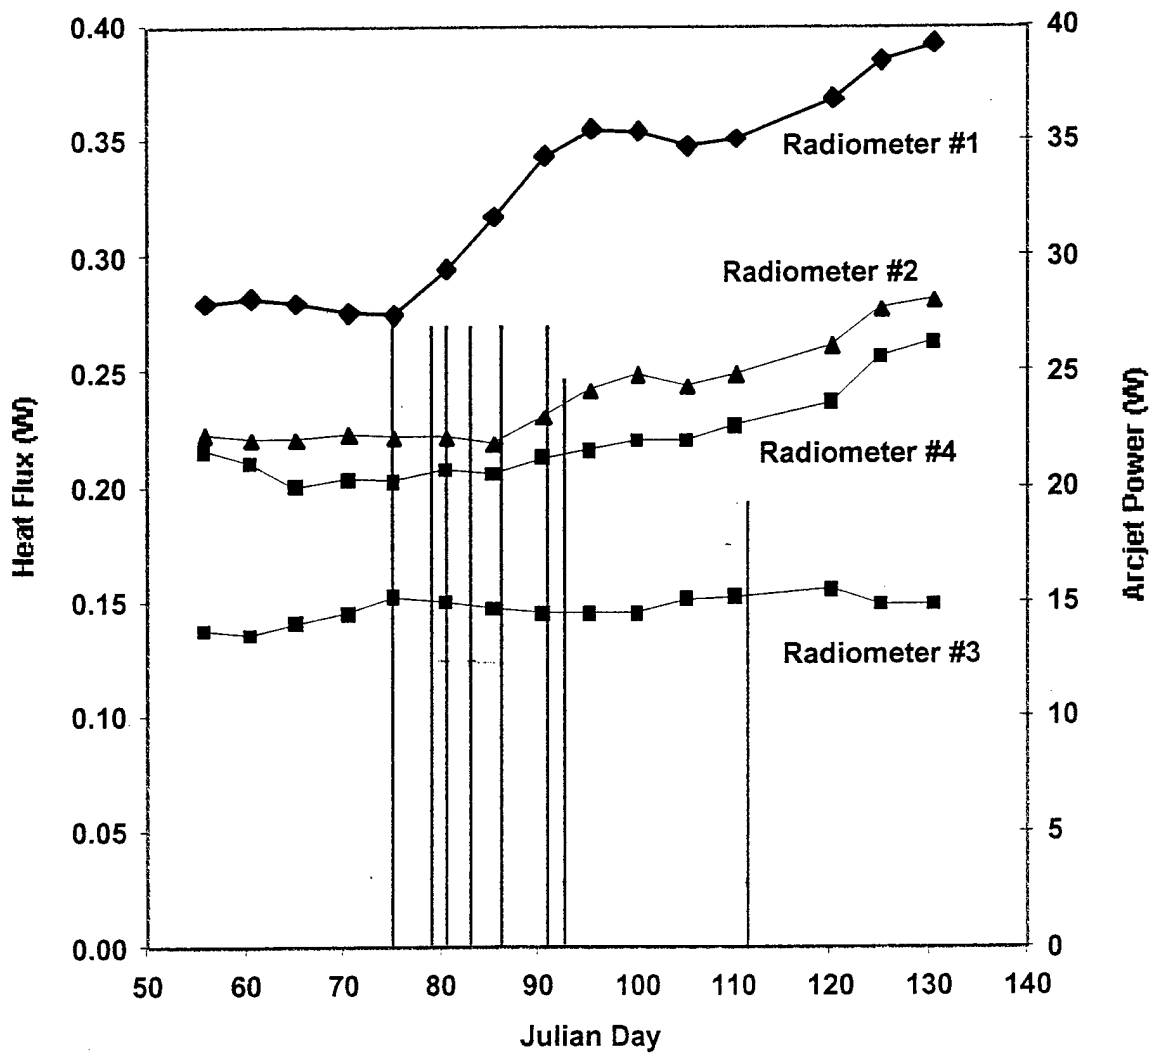
Figure 6 shows a summary of the maximum heat flux measured by the radiometers during the arcjet firing portion of the mission. Radiometer #1, placed near the thruster exit with a view of both the arcjet plume and body, shows an increase in the heat flux during this period, indicating a degradation of the sensor material from the arcjet firings. The other radiometers, which have no view of the arcjet, or a view of only the plume, show less degradation as a result of the arcjet firings.

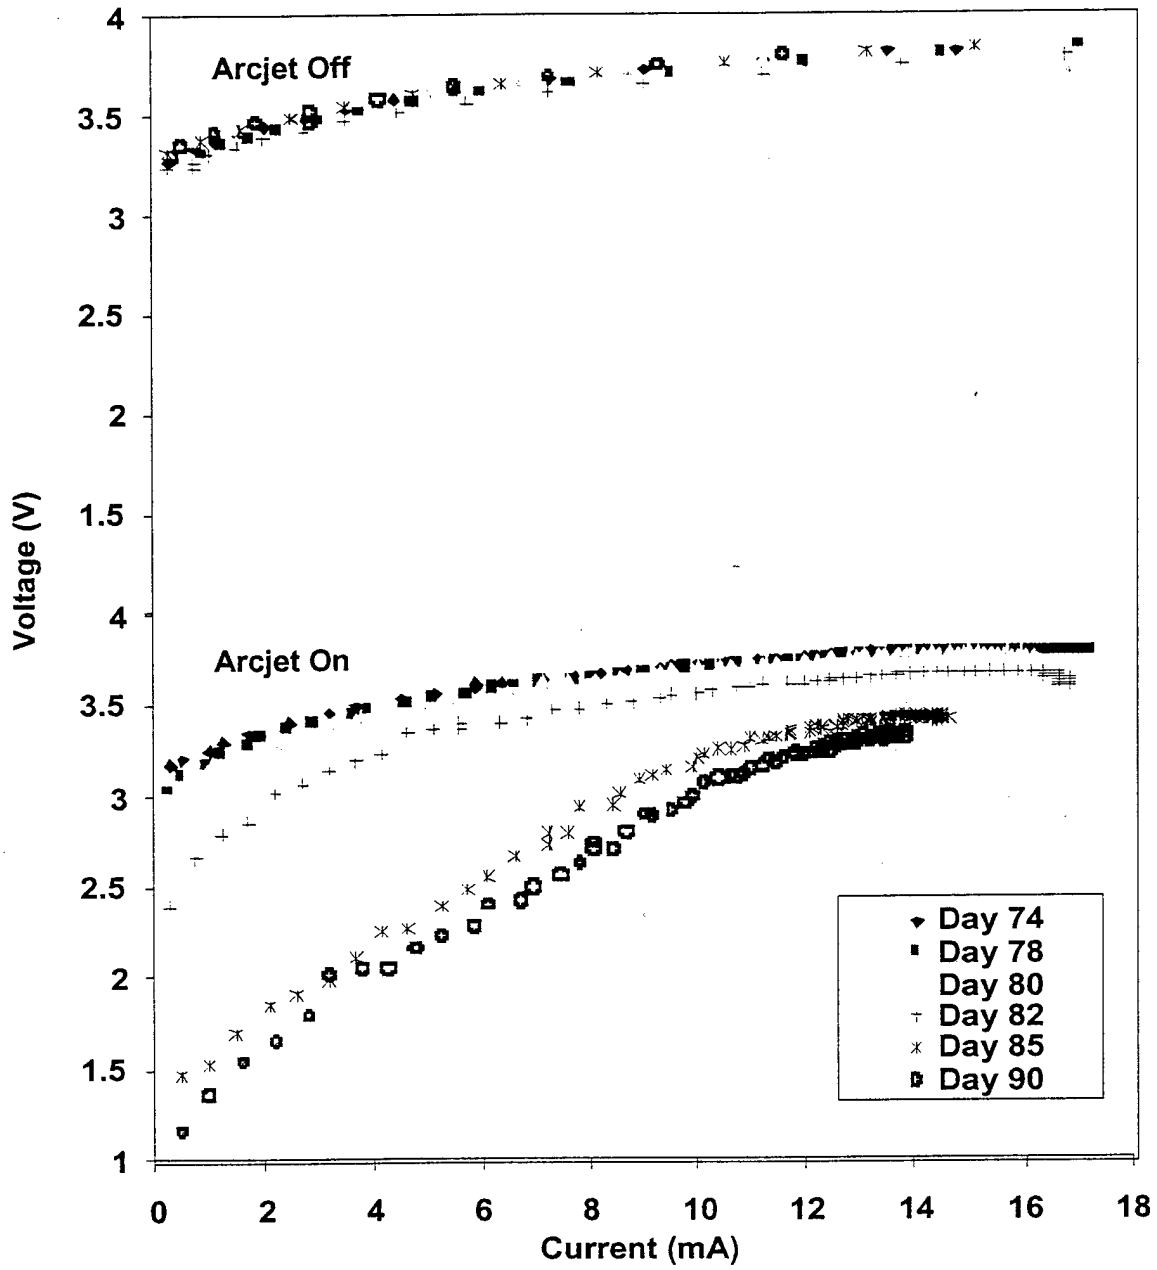
Figure 7 - Summary of the solar cell V-I performance during the arcjet firings

Solar cell segments placed near the thruster exhaust show a degraded performance, seen as a temporary drop in open circuit voltage, during the initial portion of the ramp-up phase of each firing, which worsened as the mission progressed. This degradation is attributable to the arcjet exhaust plasma partially shorting the solar cell load. A plot of the solar cell V-I curve is shown in Figure 7, further illustrating this effect and showing the decrease in performance as the mission progressed - each firing causing further degradation from the non-firing baseline illustrated in the top half of the figure. The solar array measurements also show a 3% decrease in power generation over the 60-day period in which the arcjet was fired, attributable to degradation in the solar transmissivity of the cover glass material. No deleterious effects associated with the arcjet firings were observed on the main ARGOS solar arrays.

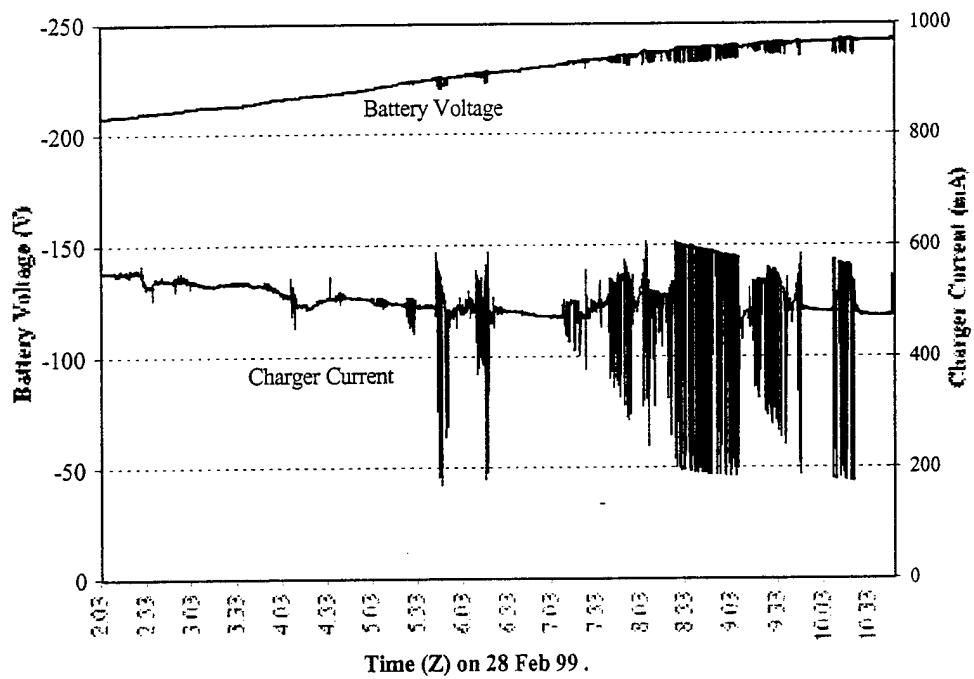
Figure 8 - Typical battery charging circuit instability

Battery Anomaly - The first signs of anomalous behavior in the battery were observed during the first charging cycle, shortly following the first ARGOS sunsafe event. The charging circuit operated nominally (except for a lower output current than expected) until the battery voltage approached -225 Vdc. At this point, as shown in Figure 8, the output current from the charging circuit began cycling on and off, resulting in oscillations of the open circuit battery voltage. These oscillations are believed to be a result of higher-than-expected internal battery impedance, perhaps exacerbated by a low charging-circuit output current. In an attempt to lower the charging-circuit impedance, high-capacitance filters were switched into the circuit via high voltage relays connecting the battery with the PCU.^{7,8} Although this procedure decreased the

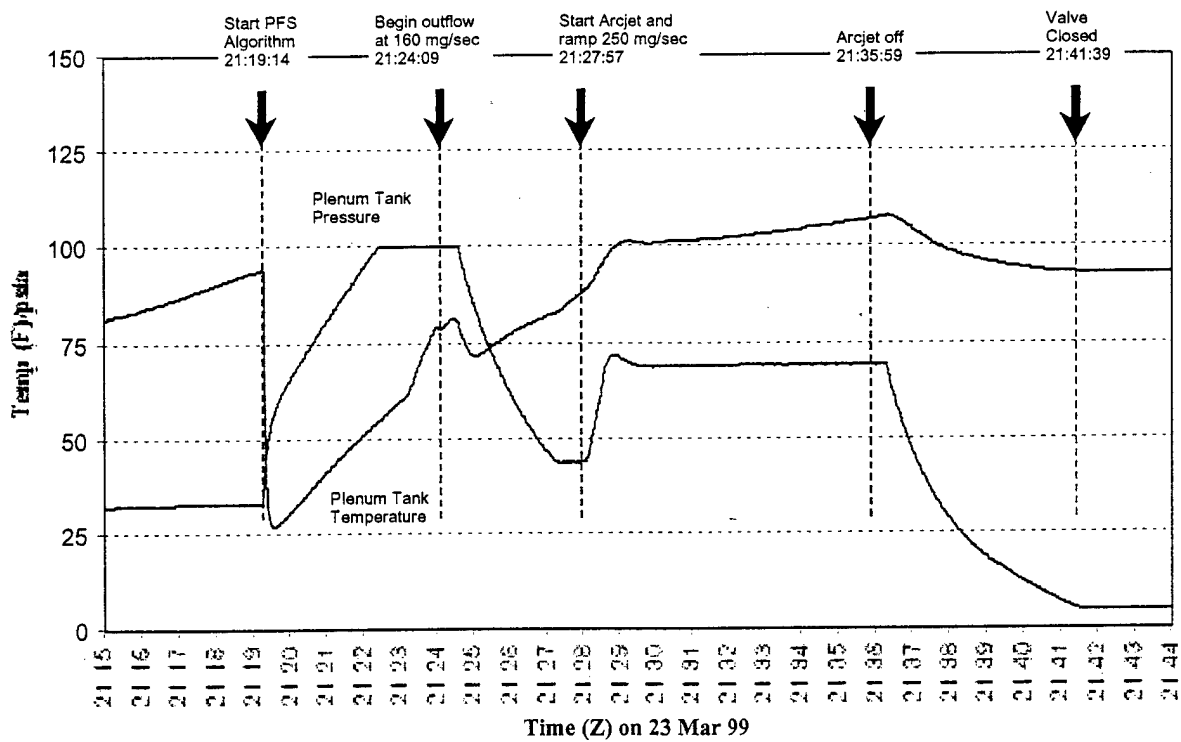
Figure 9 - Typical PFS performance showing liquid ingestion into the plenum tank

PFS Liquid Ingestion - The liquid ingestion was initially observed on the first successful NH_3 outflow (R-3, Reference Table 1). Upon initiation of the PFS algorithm, evidence of a single slug of liquid NH_3 ingested into the plenum tank was observed on the initial DPC valve cycle. Figure 9 illustrates the issue for a typical outflow (note that the plenum tank pressure output saturates at 100 psia). As can be seen, the plenum tank temperature decreases by greater than 60 °F within 15 seconds of initiating the PFS algorithm, indicating that liquid NH_3 is expanding into the plenum tank. Approximately five minutes later, the plenum tank pressure and temperature indicate a super-heated condition and drying out of the liquid in the plenum tank as some of the NH_3 vapor is vented through the open arcjet valve (indicated in Figure 9 by the label "Begin outflow at 160 mg/sec"). A flow meter immersion thermistor located just upstream of the arcjet shows no corresponding drop in temperature, indicating that the liquid is confined to

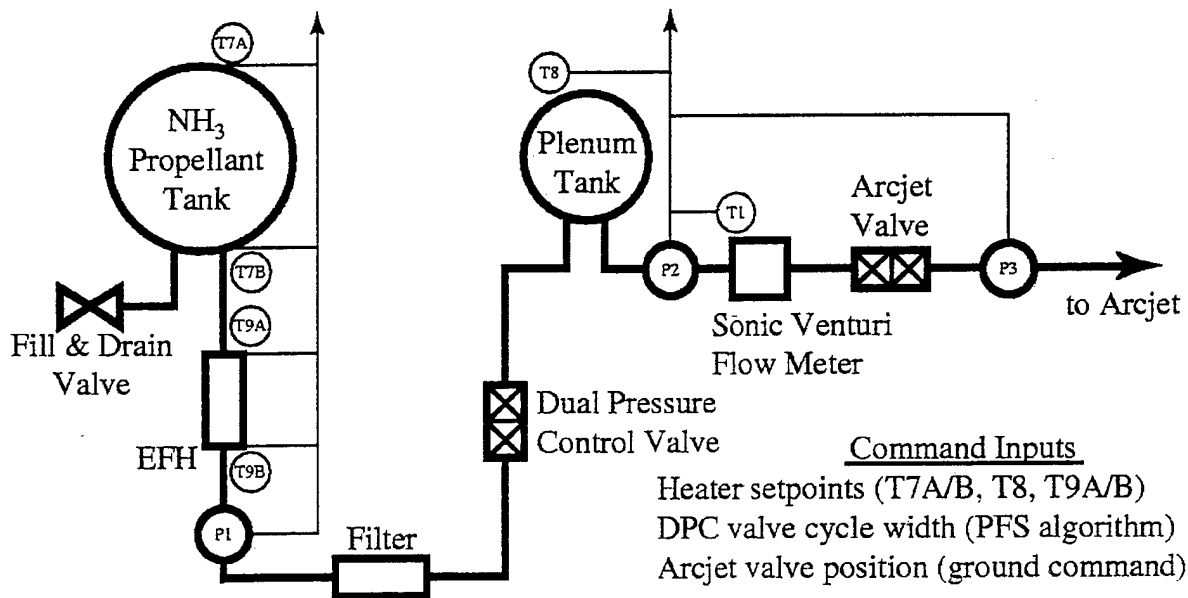
Figure 10

A schematic representation of the PFS is shown in Figure 10. The operational profile is presented in detail elsewhere^{6,16} but basically consists of two heating periods prior to the outflow - one at t-17 hours, and one within minutes of the firing. This first heating period is to ensure sufficient pressure in the propellant tank to support flow, and the second is to heat the system to ensure the impending outflow to the arcjet is vaporized. The PFS algorithm is started just before the firing and controls the NH₃ flow rate by cycling the DPC valve to maintain pressure in the plenum tank corresponding to the specified flow rate. As a result of the software encoding, however, the DPC valve is cycled once at the start of the PFS algorithm regardless of the plenum tank pressure.
