# Ice Engineering

## Ice Jams in New Hampshire

This *Ice Engineering Information Exchange Bulletin* provides a brief summary of ice event data within New Hampshire that is contained in the CRREL Ice Jam Database. This is the third in a series that will characterize every state affected by ice jams using the CRREL Ice Jam Database.

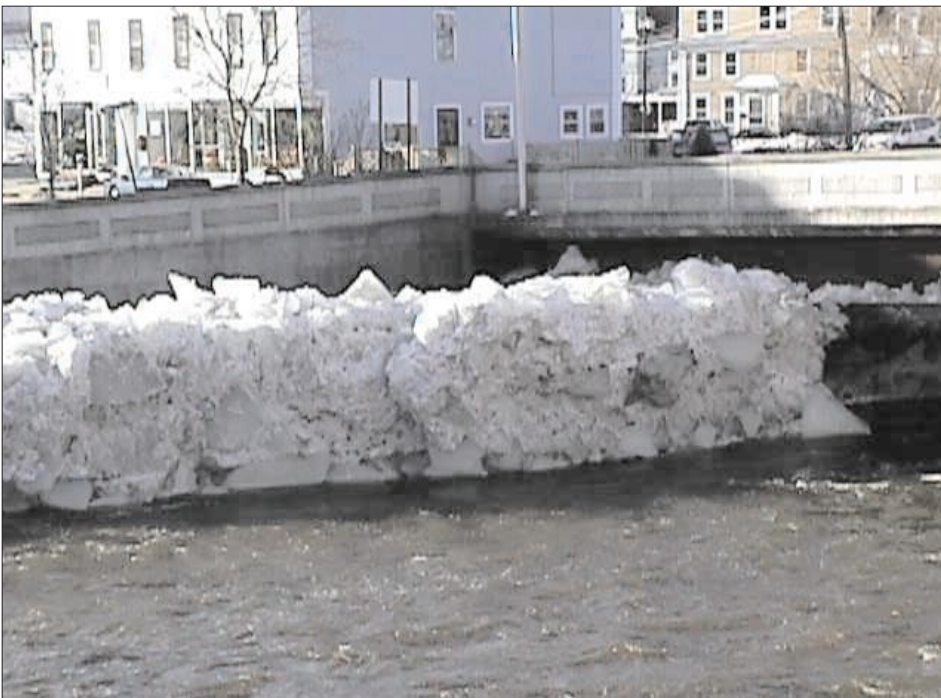
*Figure 1. Shear wall left behind following failure of the January 1999 ice jam on the Israel River in Lancaster, New Hampshire. Note ice on low steel of bridge. (Photograph courtesy of [www.greatnorthwoods.org](http://www.greatnorthwoods.org).)*

An ice jam is an accumulation of ice in a river that restricts water flow and may cause backwater that floods low-lying areas upstream from the jam. Areas below the ice jam can also be affected when the jam releases, sending water and ice downstream. Damages resulting from ice jams can affect homes, buildings, roads, and riverine structures; block hydropower and water supply intakes; and decrease downstream discharge (Fig. 1).

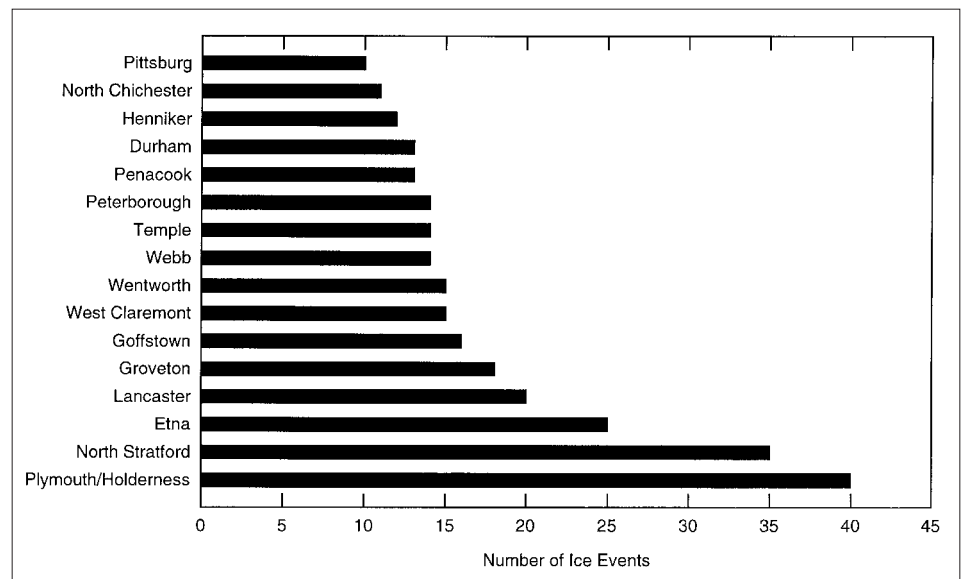
Figure 3. New Hampshire towns with the most reported ice jams.

The database contains information on ice jam events at 96 locations on 72 rivers in New Hampshire (Fig. 2). The localities with the most recorded ice jam events are Plymouth/Holderness (40) on the Pemigewasset River, and North Stratford (35) on the Connecticut River. The towns of Goffstown, Groveton, Lancaster, and Etna each have more than 15 recorded events in the Ice Jam Database (Fig. 3). The most ice jams reported for one river occur on the Connecticut River, with 58 events, followed by the Contoocook River with 39, and the Pemigewasset River with 38 events (Fig. 4)

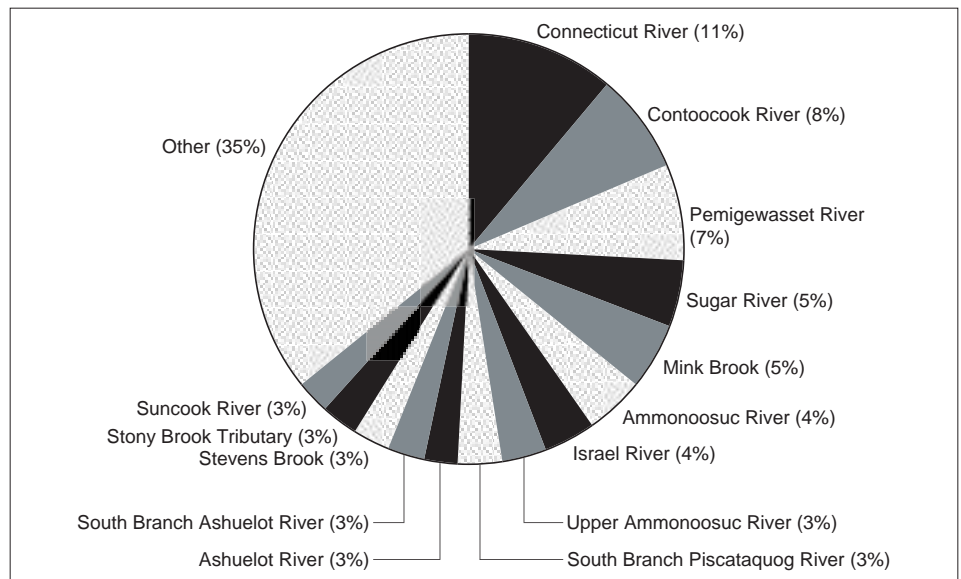
Figure 4. Percentage of known New Hampshire ice jams on specific rivers.

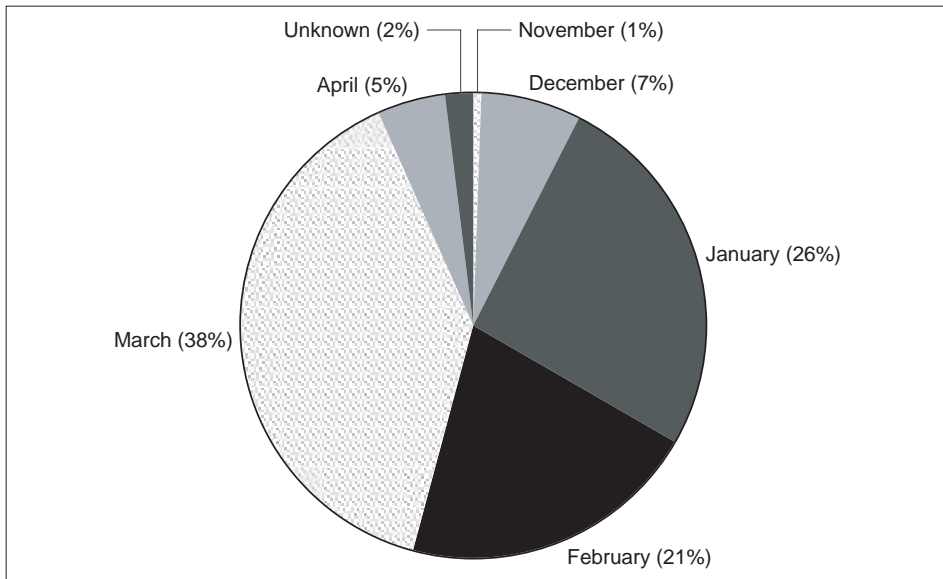
Figure 6. Months for which ice events are reported in New Hampshire.

Ice jam occurrence also depends on the time of year; 43% of New Hampshire ice jams have occurred in March and April, when the rivers begin to break up, an indication that these ice jams are largely breakup ice events (Fig. 6). The 47% of jams that occur in January and February could be either freezeup or breakup ice jams.

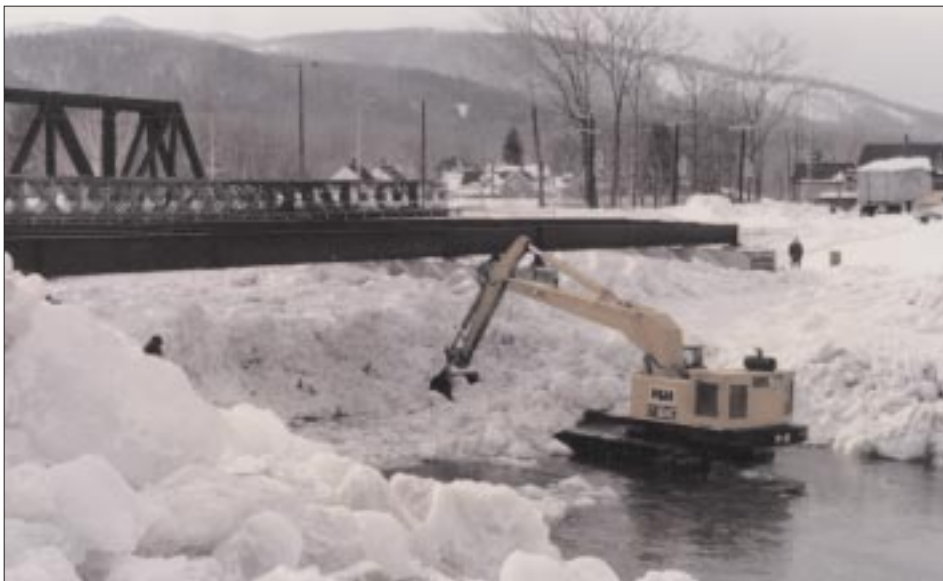
Figure 7. Backhoe clearing channel in Peabody River, Gorham, New Hampshire, February 1982. (Photograph by Dan Ayer.)

It took a bulldozer, backhoe, loader, and wood skidder 15 days to cut a 2,500-foot-long channel approximately 50 to 100 feet wide and 10 to 15 feet deep to alleviate the flooding. The bulldozer and backhoe did the majority of work from their own ice roads, which were constructed as they went along (Fig. 7). Total project cost was \$17.8K (1982 USD).

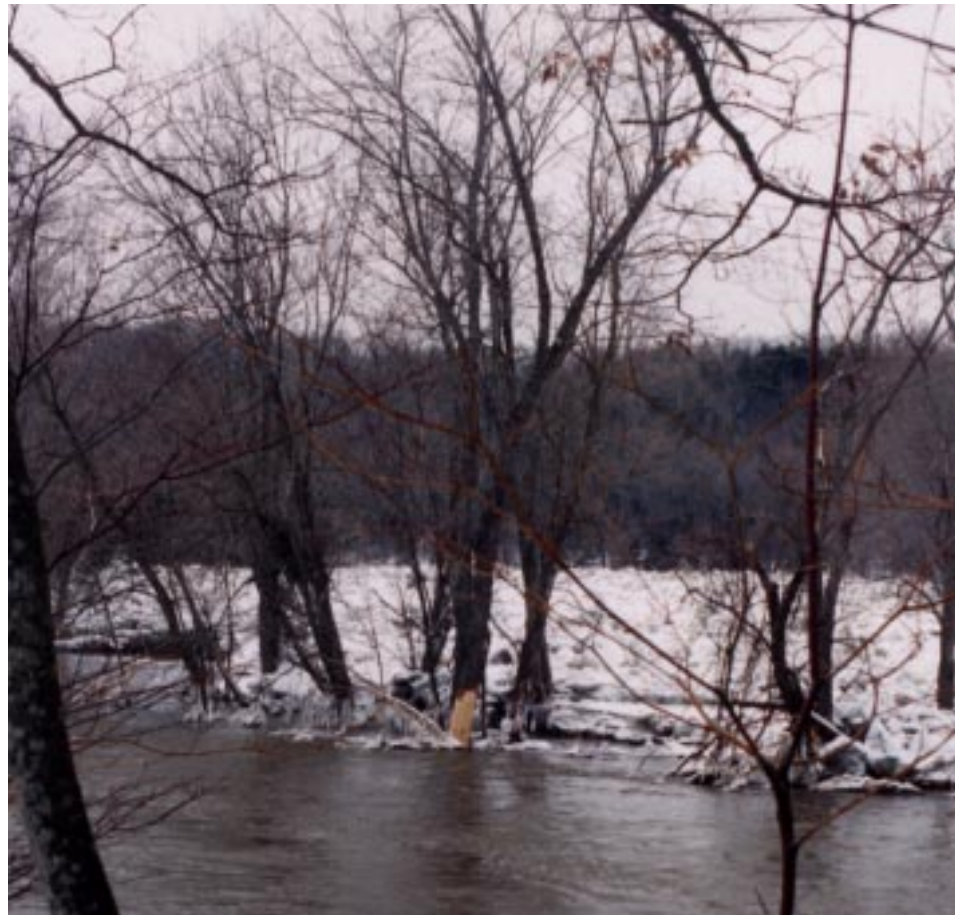
Figure 8. Wild Ammonoosuc River between Lisbon and Bath. Note ice in the floodplain and tree scar caused by ice. (Photograph by Kate White.)

As is true for the database as a whole, many of the sources relied upon for information on ice jams in New Hampshire lack quantitative data on damages. However, 82 (16%) of the New Hampshire ice jam events in the database have known damages, a much higher percentage than for the whole database (about 2%). The most common damages include bridge, commercial, and residential damage, road and railroad flooding, evacuations, and agricultural damages. Figure 8 shows an ice-covered floodplain and an ice-damaged tree.
