The Northwest Tropical Atlantic Station (NTAS): NTAS-2 Mooring Turnaround Cruise Report

Technical Report

WHOI-2002-07
UOP-2002-04

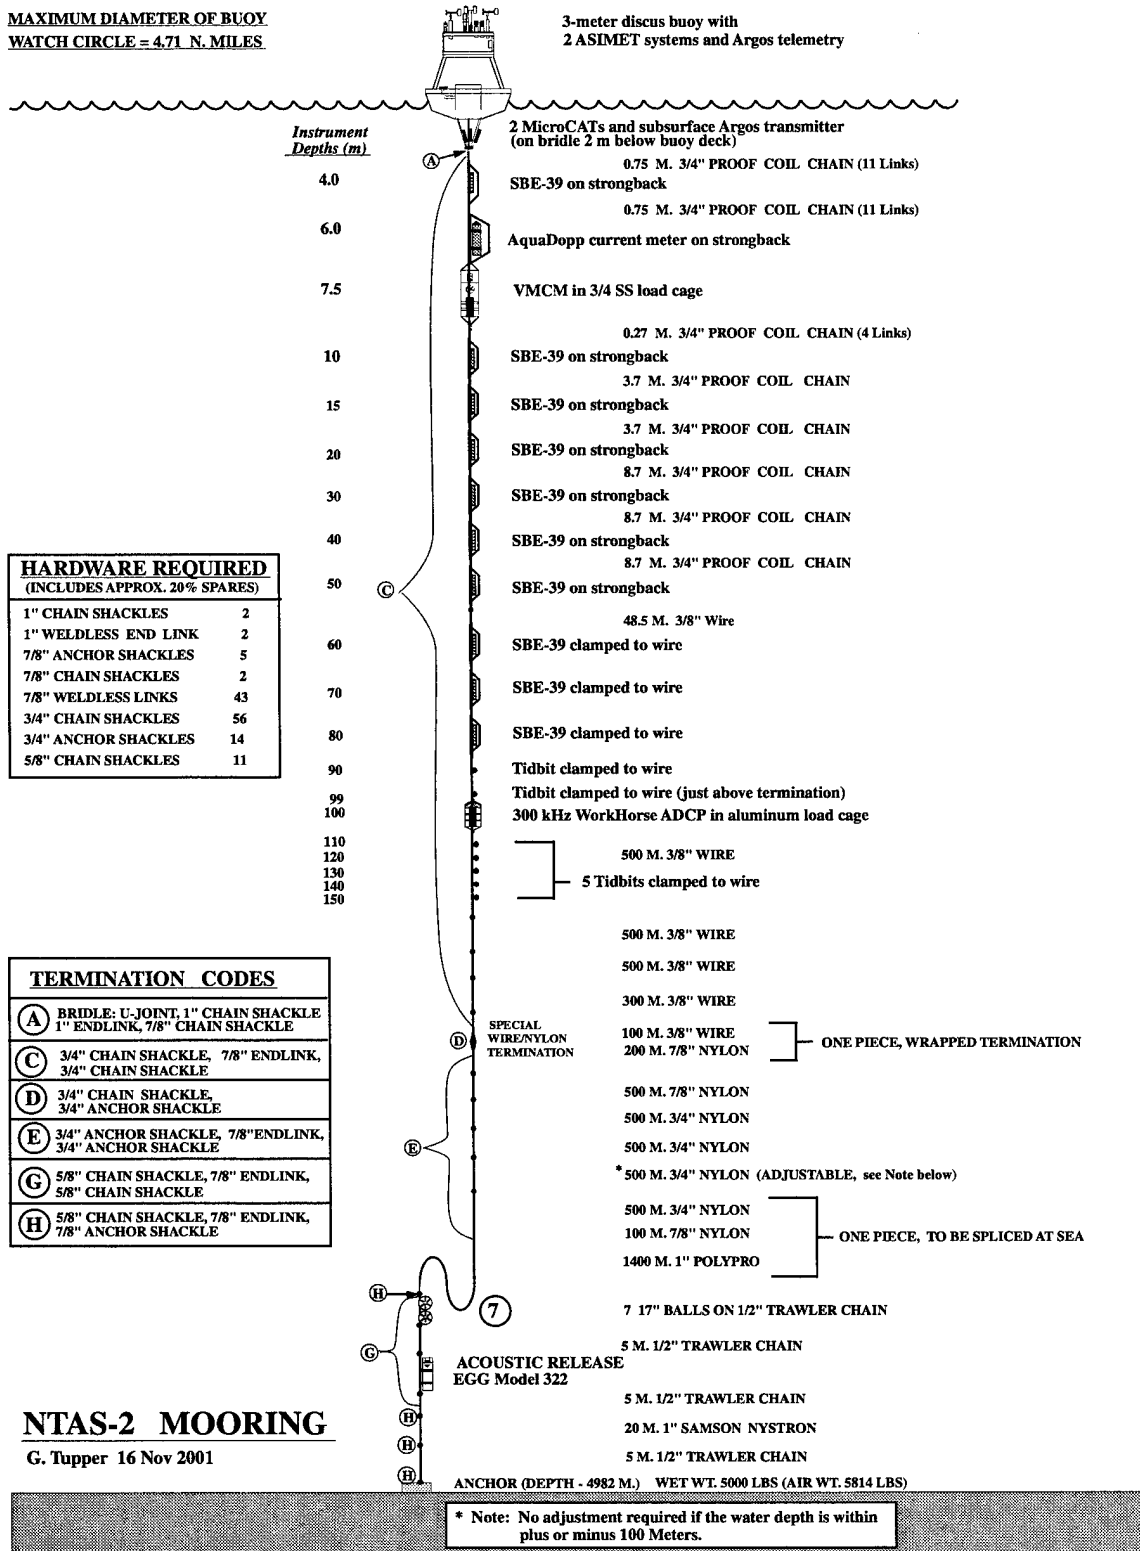
Figure 2. NTAS-2 mooring diagram.

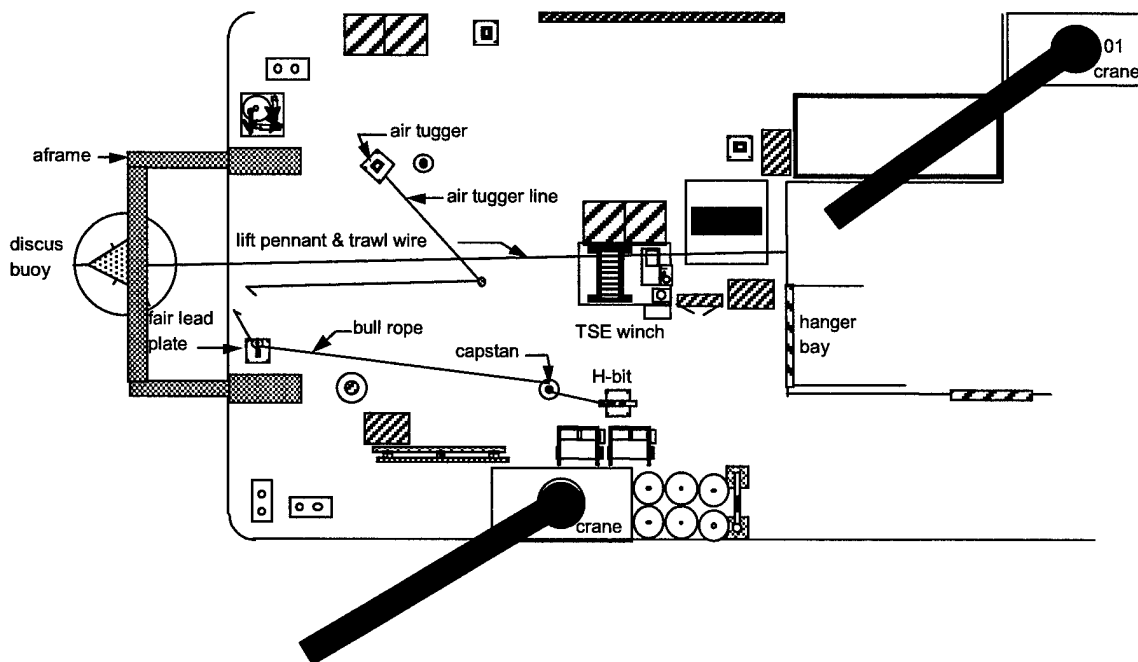
Figure 29. Deck layout and fair lead details for NTAS-1 mooring recovery operations.

The TSE winch, ship's trawl winch, starboard-side fantail capstan, and assorted WHOI deck lines and hooks were utilized during the recovery (Fig. 29). Two mooring blocks were hung on the A-frame. A Skookum Rope Master 508 trawl block was positioned on the center A-frame bail, and a WHOI Gifford block hung from the adjacent port-side bail. The trawl wire, with a WHOI-designed lifting pennant attached, was fair led through the center trawl block. The components used to build the lifting pennant were a 45 ft. long length of 3/4" single-braid Spectra line with a WHOI-designed titanium pickup hook and 3/4" wire rope thimble sliced to either end of the line. This pennant was used to improve handling of the 1/2" trawl wire during the hook up of the buoy from the small boat. An Ingersal Rand air tugger was positioned on the fantail so that its line could be fair led to the center of the ship's transom, as shown in Figure 29.

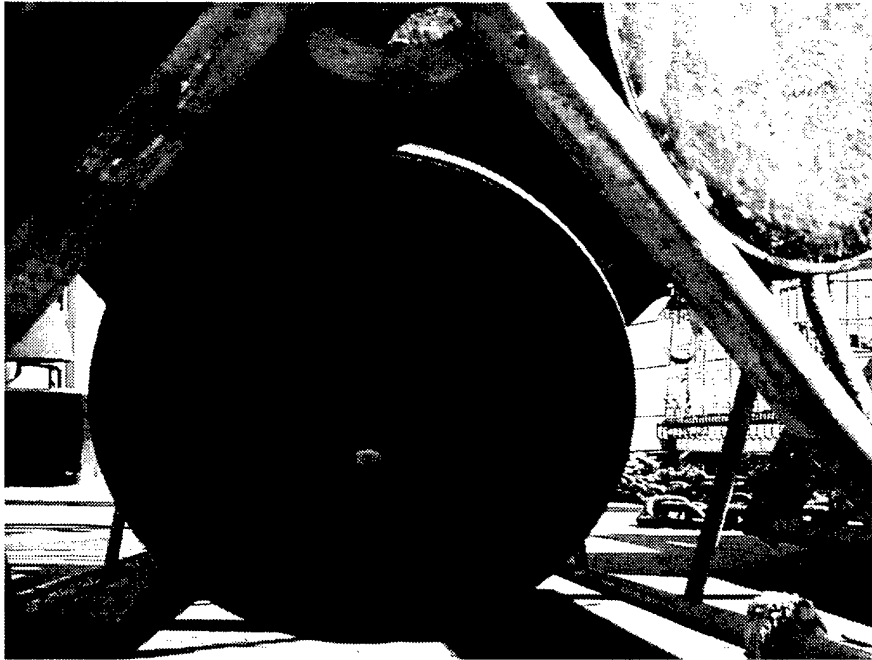
Figure 36. The base from a gooseneck barnacle on 300 kHz ADCP transducer.

Instrumentation. Fouling to recovered instrumentation was minimal, and like the discus buoy hull, concentrated in regions protected from fish predation. A thin brown bacterial slime coated all instrumentation from the surface to 100m. The temperature recording Onset Computer "Tidbit" at 120m was not visibly fouled. The bases (30-40) of gooseneck barnacle stalks were observed on the 300 kHz ADCP (100m). This species of barnacle is known to colonize surfaces >60m beneath the surface. The remnant of a gooseneck barnacle on one of the four 300 kHz ADCP transducers is visible in Figure 36. The four transducers were coated with a TBTO grease prior to deployment.

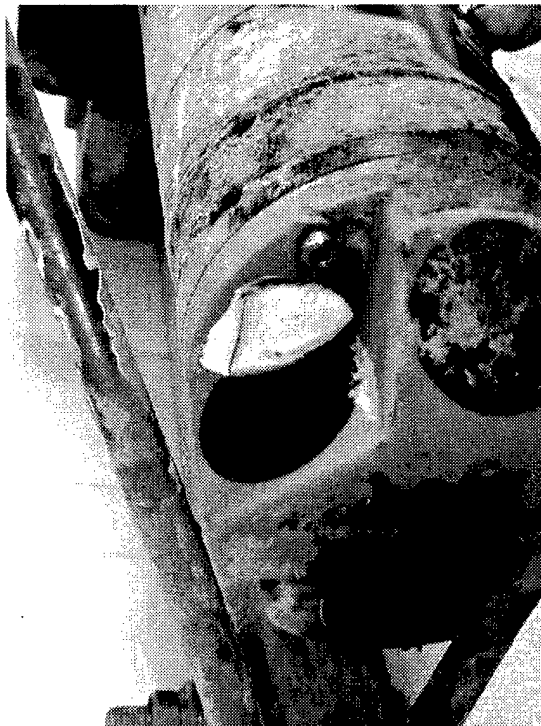
Figure 38. Fouling on the Aquadopp current meter.

Figure 38 shows fouling on the Aquadopp current meter positioned 7.8 m from the surface. A thin film of green algae encrusts the entire assembly. Though not visible in the picture, many (30-40) gooseneck barnacles colonized this instrument.
