**Intensive Cultural Resources Survey of the Proposed  
Geneva Levee Rehabilitation Project  
Geneva, Alabama**

**Final Report**

**Contract No. DACA01-97-D-0002  
Delivery Order 0049**

**Brockington and Associates, Inc.  
Atlanta Charleston Raleigh  
2002**

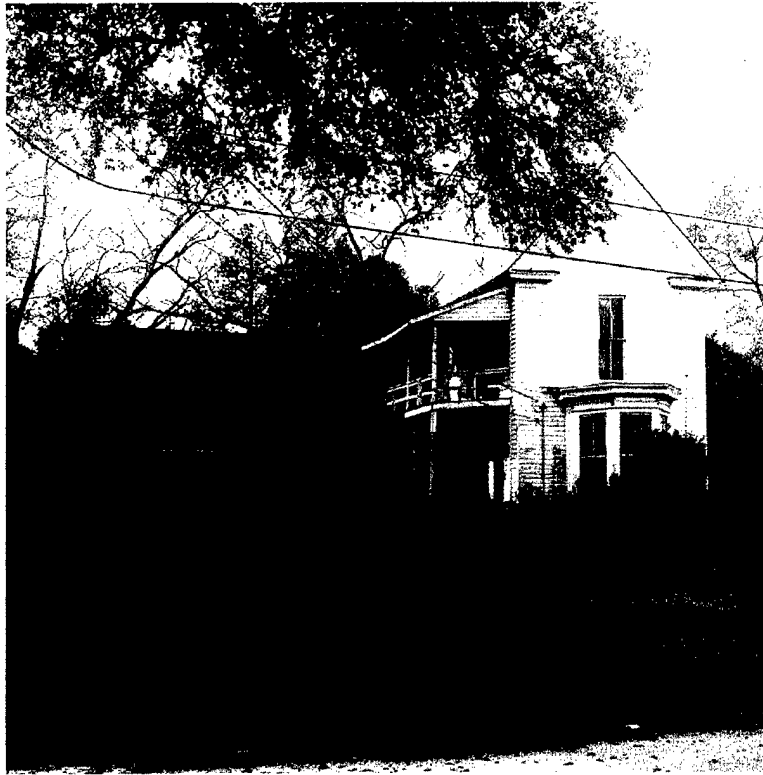
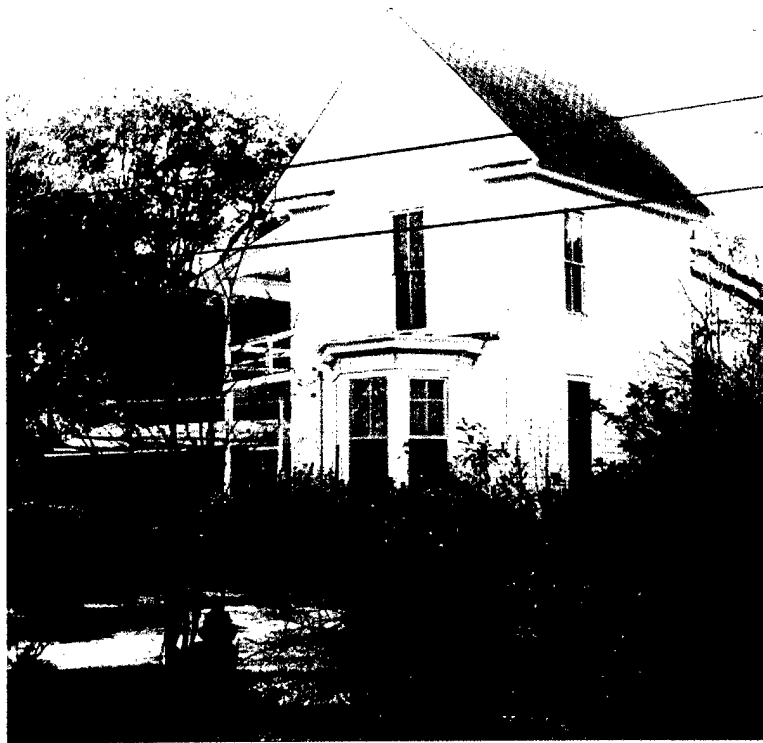
Figure 5. Laird House (site 061 195). Top: looking southwest (R11F8); Bottom: looking southeast.

Site 061 195 has been altered with the addition of synthetic siding. Despite this alteration, the building continues to convey its historical association with Captain H. W. Laird and his family, who were significant in the history of the City of Geneva. The house is one of the earliest remaining buildings from the City of Geneva after its relocation from the junction of the Pea and Choctawhatchee Rivers. We recommend site 061 195 eligible for the NRHP under Criterion A (Exploration/Settlement).

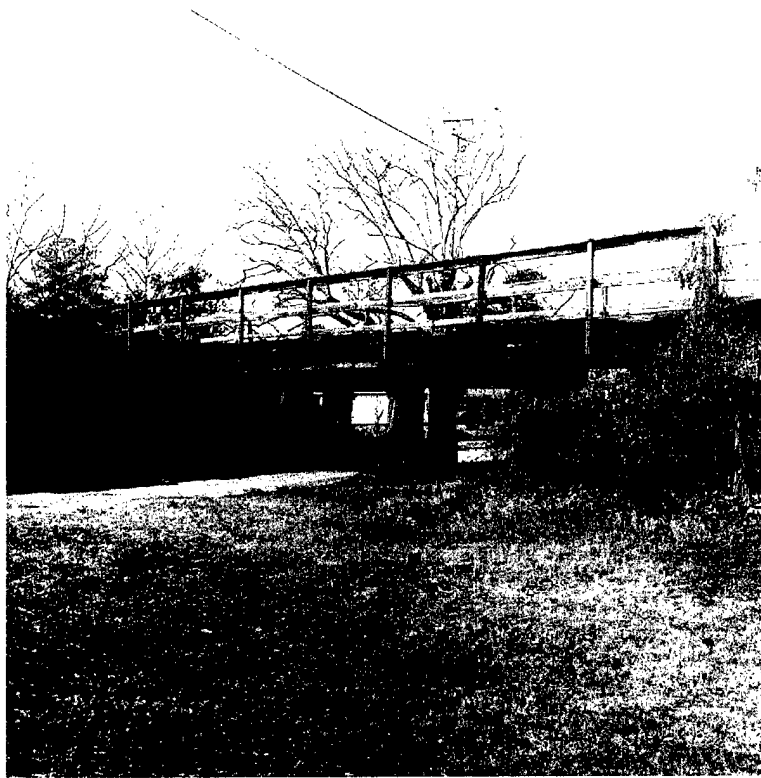
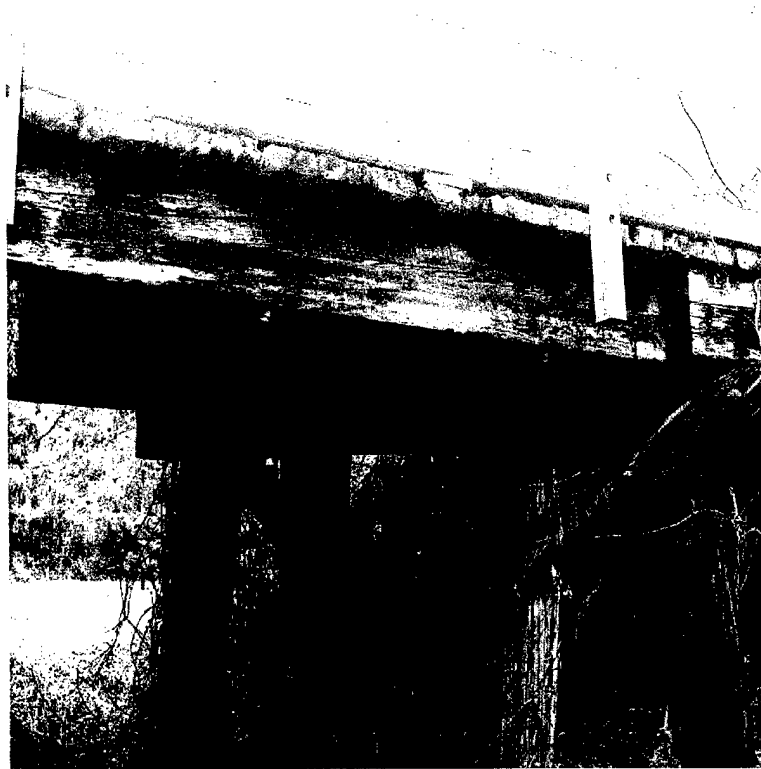
Figure 8. The L&N Railroad Bridge, site 061 245. Top: looking northwest;  
Bottom: detail looking northeast.

Site 061 245 has retained good integrity. While the rails were removed in approximately 1985 and the path of the railroad converted for use as a walking trail, the structure of the bridge remains intact. A new approach to the bridge from the east was created in 1938 when the levee was constructed, but the bridge apparently was not altered, as the original timber supports and frame remain. Moreover, site 061 245 is the only remaining artifact from the L&N Railroad in the City of Geneva, and it is also a good example of timber bridge construction. We recommend site 061 245 eligible for the NRHP under Criteria A (Transportation) and C (Engineering).

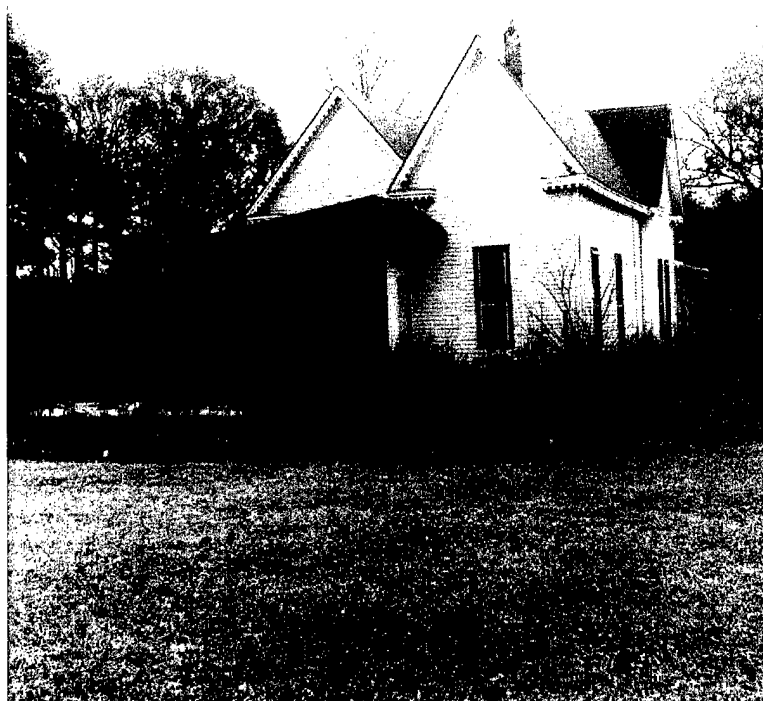
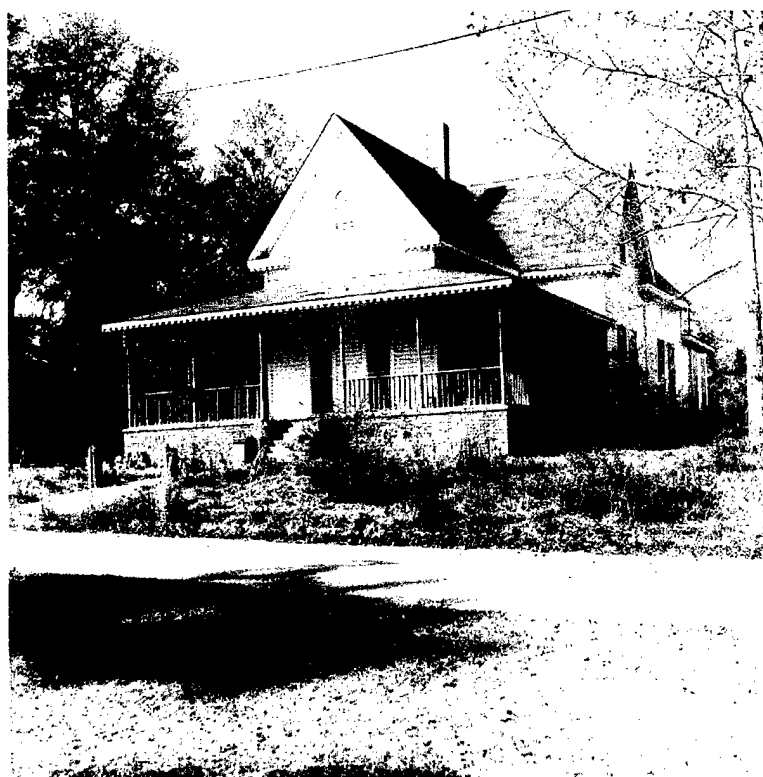
Figure 11. The Wallace House, site 061 037. Top: looking northwest; Bottom: looking southeast (rear).

The house was built by the Wallace family, who were Jewish merchants in Geneva. Site 061 037 has been altered with the replacement of the original porch foundation with brick, and new porch supports, windows, and doors. It is possible that the entire porch is new. While the house has an interesting history and has distinctive architectural features, its integrity has been compromised. We recommend site 061 037 not eligible for the NRHP.

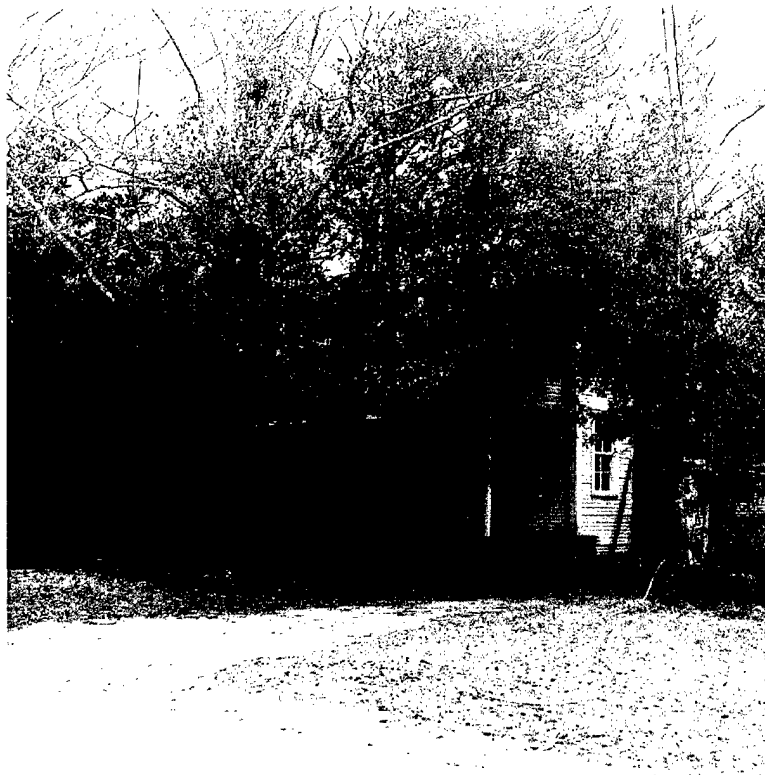
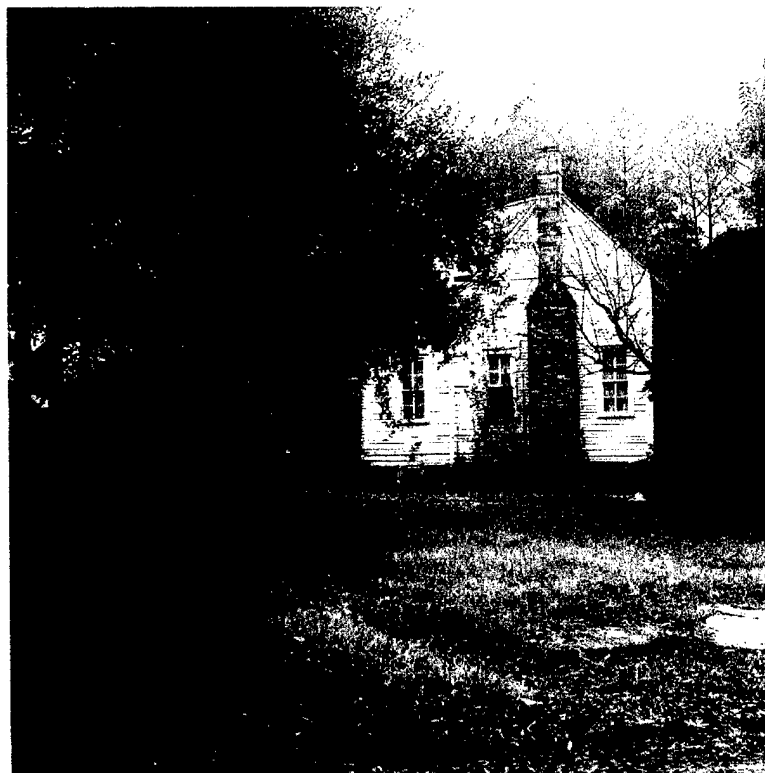
Figure 12. Site 061 187. Top: looking northwest; Bottom: looking east.

Site 061 187 is a one story frame house located on West Water Avenue (see Figure 1). Built in approximately 1900, the house features a side gable roof with a cross gable extension on the rear. The facade is symmetrical, with a central single door with side lights flanked on each side by a single door and a single four-over-four window. A shed roof porch

projects from beneath the main roof eave, supported by simple wood posts. There is an exterior brick chimney at each gable end. Figure 12 presents views of site 061 187.

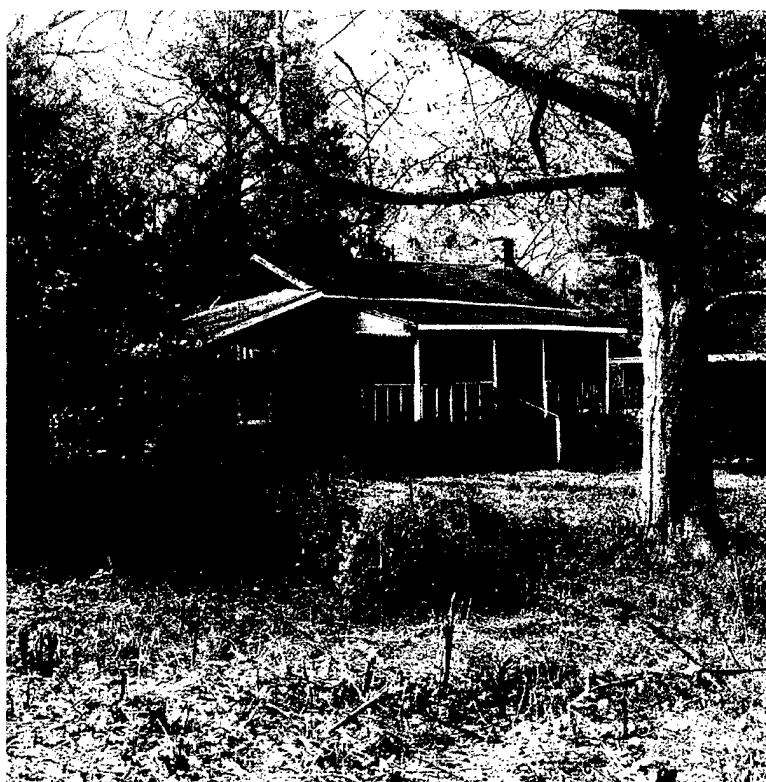
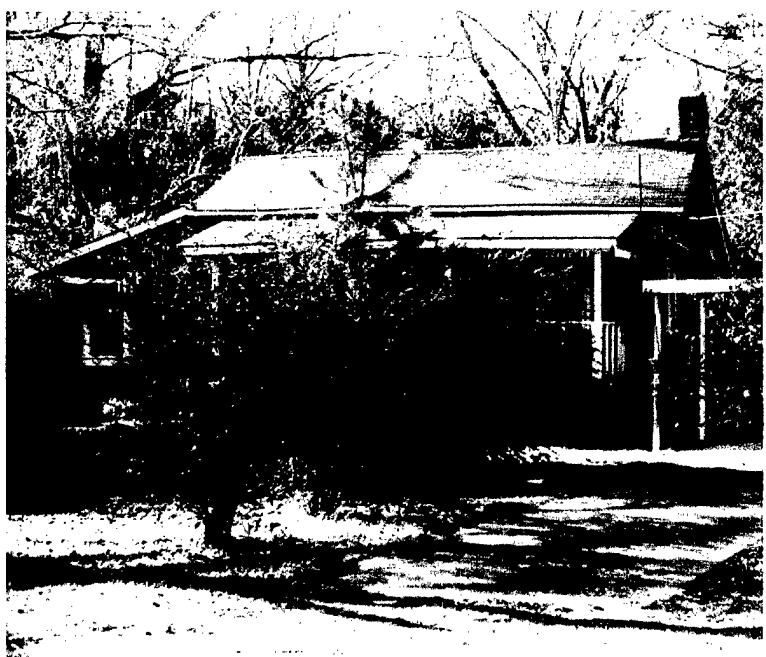
Figure 13. Site 061 197. Top: looking southwest; Bottom: looking southwest.

Site 061 197 is a small one story frame house located on Westville Avenue at the corner of South Commerce Street (see Figure 1). Built in approximately 1910, the house features a four bay facade with two off-center single doors flanked on each side by single four-over-four windows, surmounted by a side gable roof. A shed roof porch projects from beneath the main roof eave, supported by simple wood posts and a simple wood balustrade. There is a shed roof addition on the left side, and an exterior brick chimney on the right side. The house is clad in faux brick asphalt shingle siding. Figure 13 presents views of site 061 197.

Site 061 197 has been altered with the addition of synthetic siding, the replacement of the original porch, and a one room addition on the left side. Site 061 197 lacks historical or architectural distinction and is recommended not eligible for the NRHP.

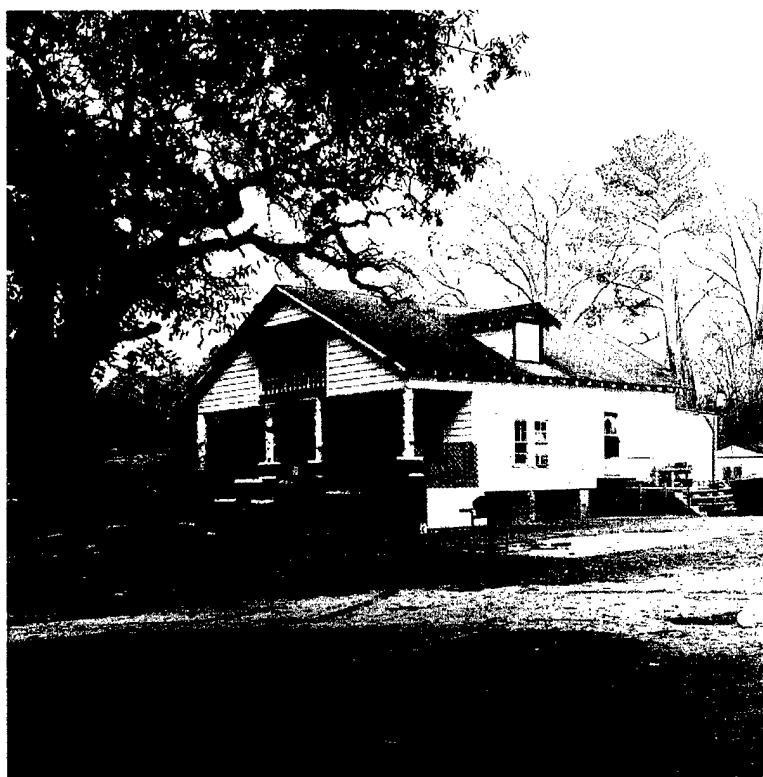
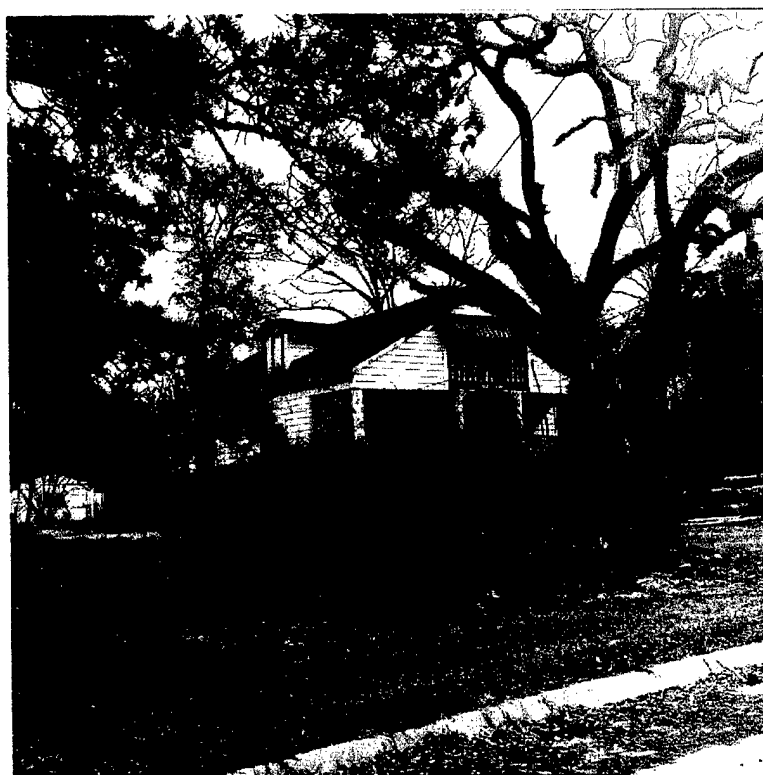
Figure 14. Site 061 198. Top: looking northeast; Bottom: looking southeast.

Site 061 198 has been altered with the addition of synthetic siding on the main house and faux brick asphalt shingle siding surrounding the door, and the creation of a window in the main roof gable. Despite the interest of its architectural details, site 061 198 lacks additional historical or architectural distinction and is recommended not eligible for the NRHP.

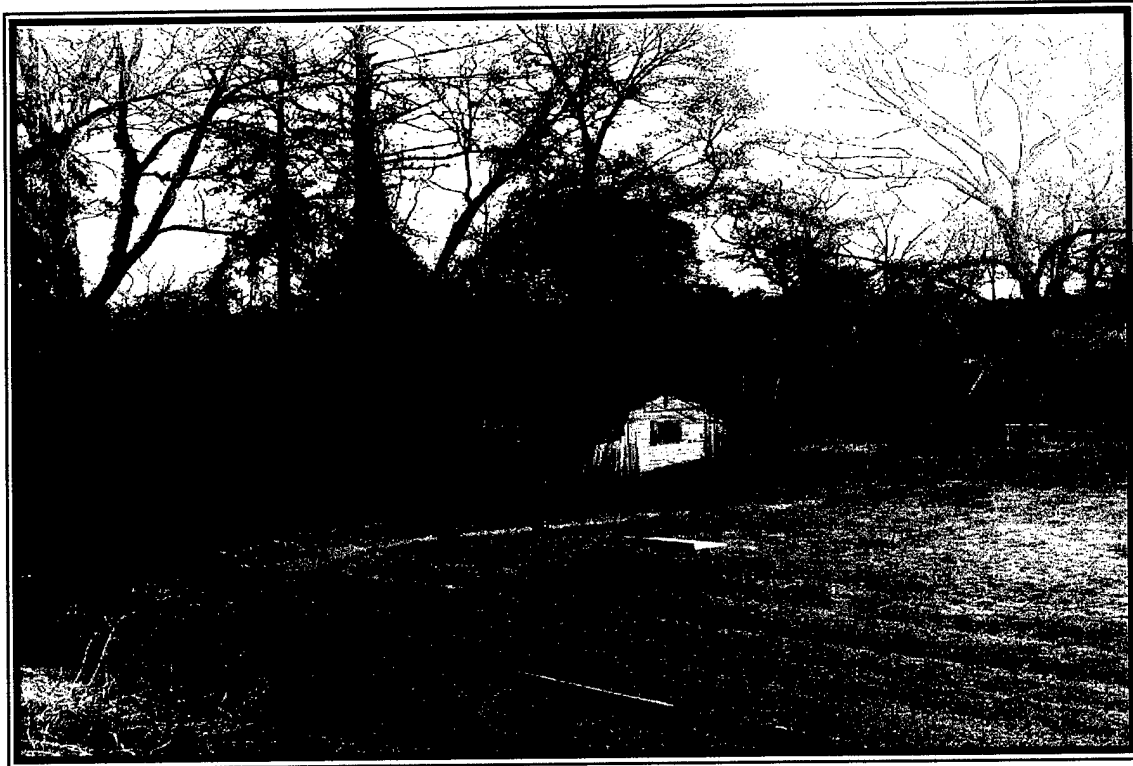
Figure 15. Shed behind Site 061 198, looking southeast.

Site 061 198 is associated with a small shed that lies adjacent to the current levee. Figure 15 presents a view of this shed. Current plans for the Geneva levee rehabilitation project call for the shed to be removed. The shed lacks historical or architectural distinction on its own, and is recommended not eligible for the NRHP.

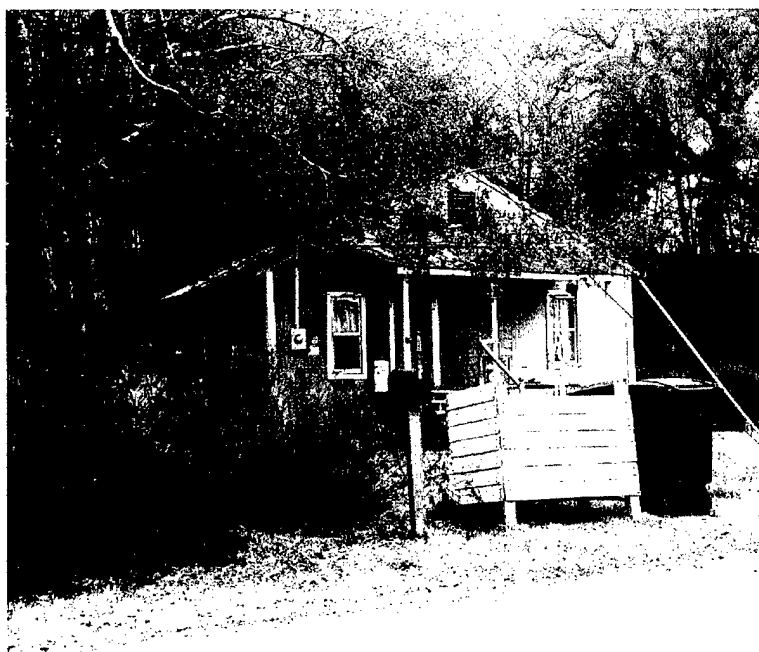
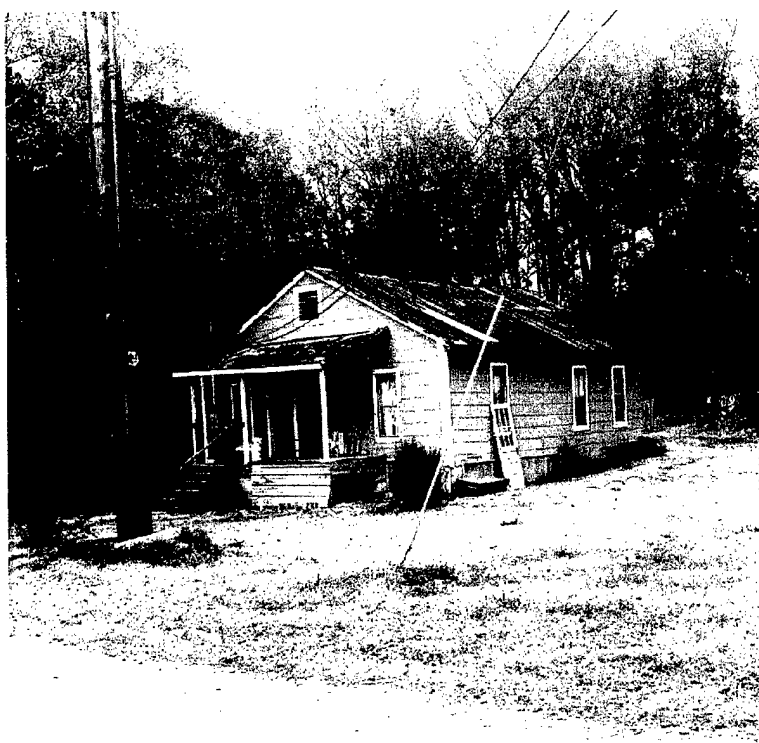
Figure 16. Site 061 243. Top: looking northeast; Bottom: looking southeast.

1940. Originally, the house had a four bay facade, with two single doors flanked on each side by a single window. One of the original doors has since been covered. A shed roof porch projects from beneath the front gable, supported by simple wood posts. Figure 16 presents views of site 061 243.

Site 061 243 has been modified with the addition of synthetic siding, the removal of one of the original doors, and the replacement of the original windows and door. Site 061 243 lacks historical or architectural distinction and is recommended not eligible for the NRHP.

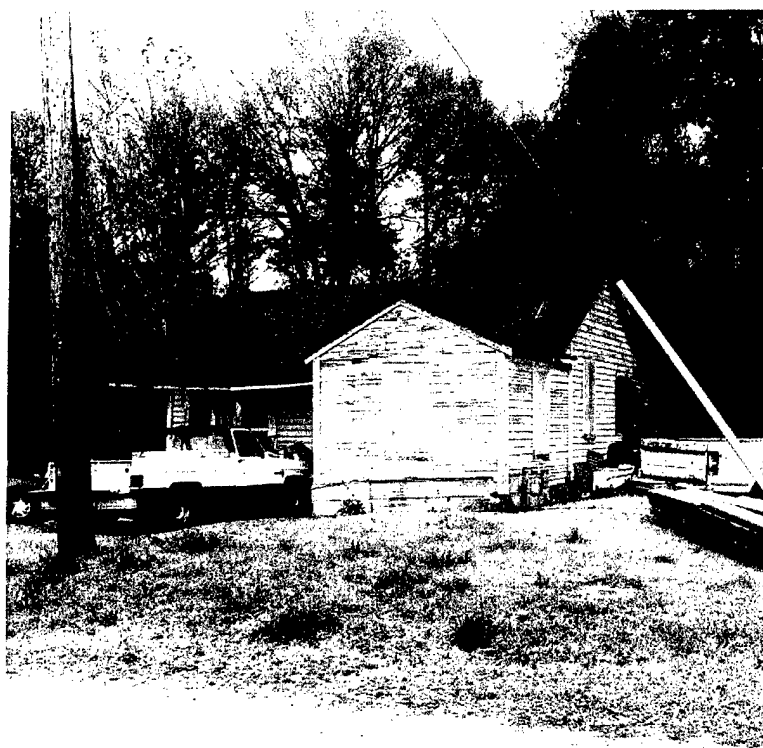
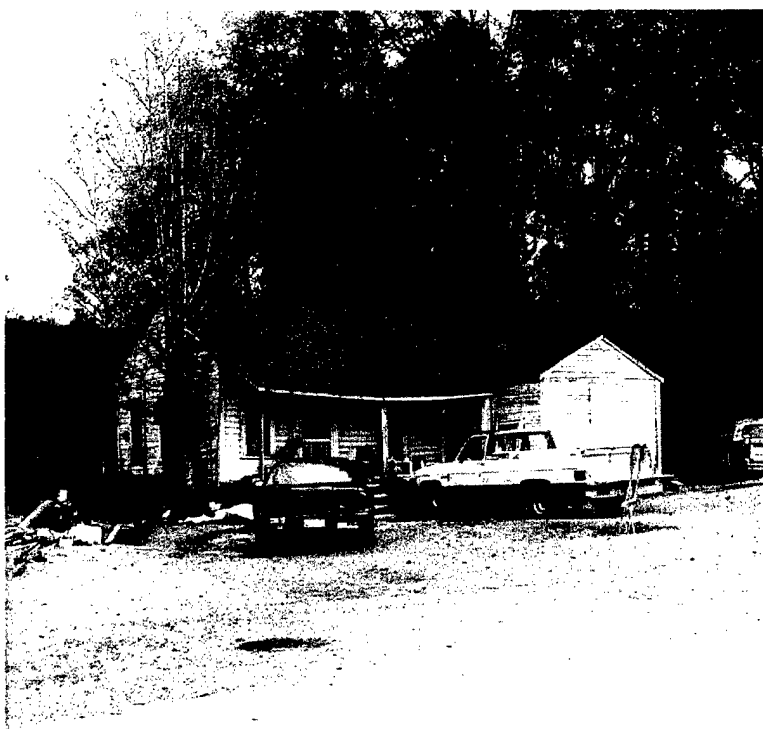
Figure 17. Site 061 244. Top: looking southeast; Bottom: looking northeast.

Site 061 244 has been altered with the reconfiguration of the original facade. The house is in fair condition. Site 061 244 lacks architectural or historical distinction and is recommended not eligible for the NRHP.

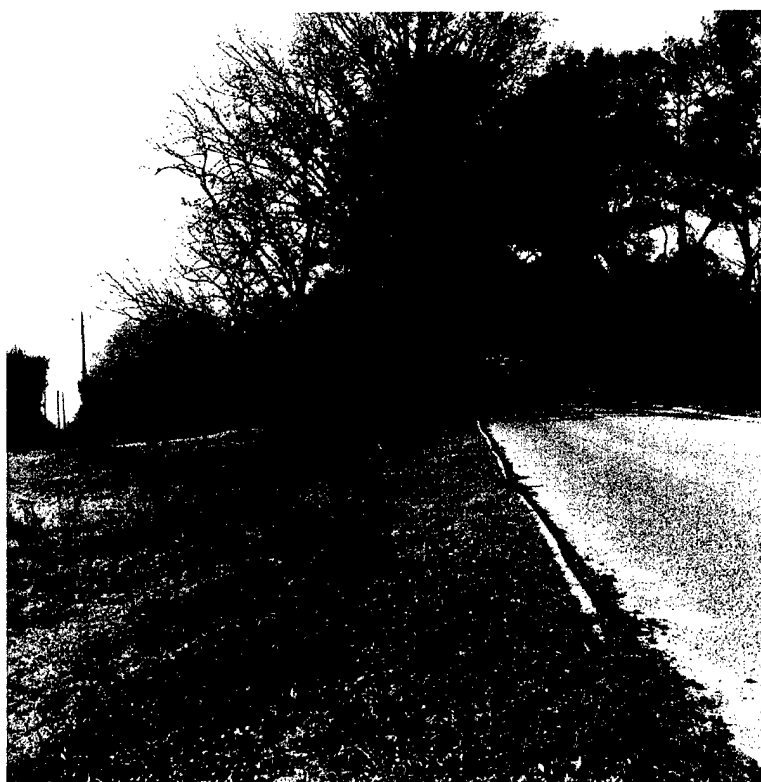
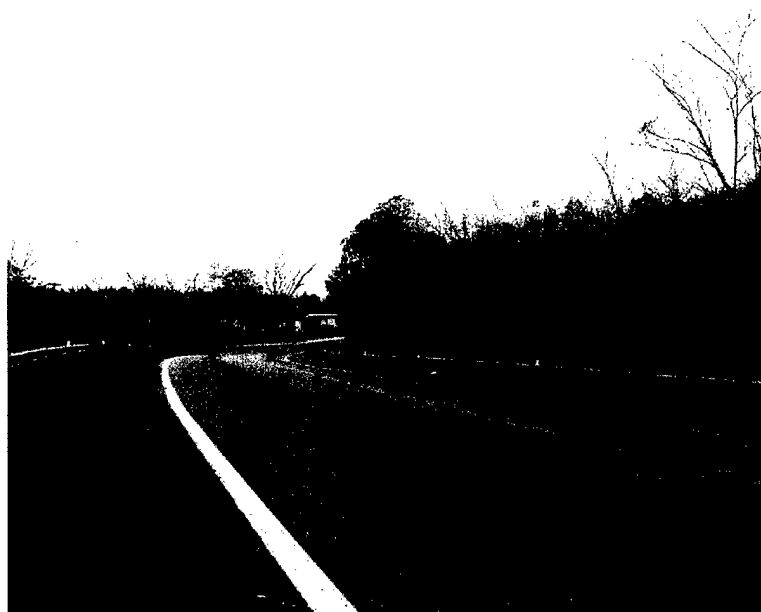
Figure 19. Geneva Levee, site 061 247. Top: Westville Ave crossing, looking west;  
Bottom: AL Route 27 crossing, looking northeast.

Site 061 247 is the Geneva Levee. As noted in Chapter II, the levee was constructed during the mid-1930s and completed in 1938. Construction of the levee was prompted by a devastating flood in 1929, and resulted from a combination of federal WPA funds and local efforts. The levee is roughly U-shaped, and stretches for approximately 5.0 kilometers (3.1) miles (see Figures 1 and 3). With the exception of AL Route 52, which crosses through the levee at grade in the northeastern part of Geneva, all roads which carry traffic across the levee rise over the top. Current road crossings include AL Route 52 in the northeast, Promenade Ave in the east, Westville Ave in the southeast and southwest, AL Route 27 in the southwest, and South Trinity Street in the west (Figure 19). As noted above, the L&N Railroad crosses the levee in the southeast, while there are two abandoned road crossings: Watson Street and Stevens Ferry Road, both in the southwest (Figure 20).

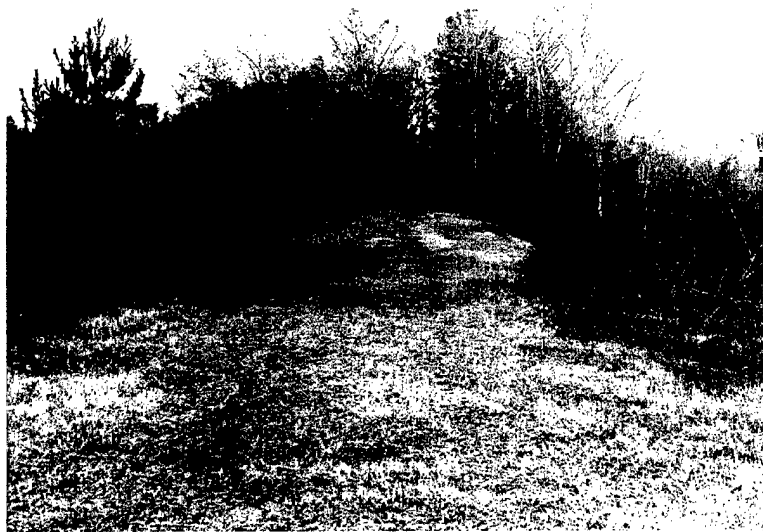
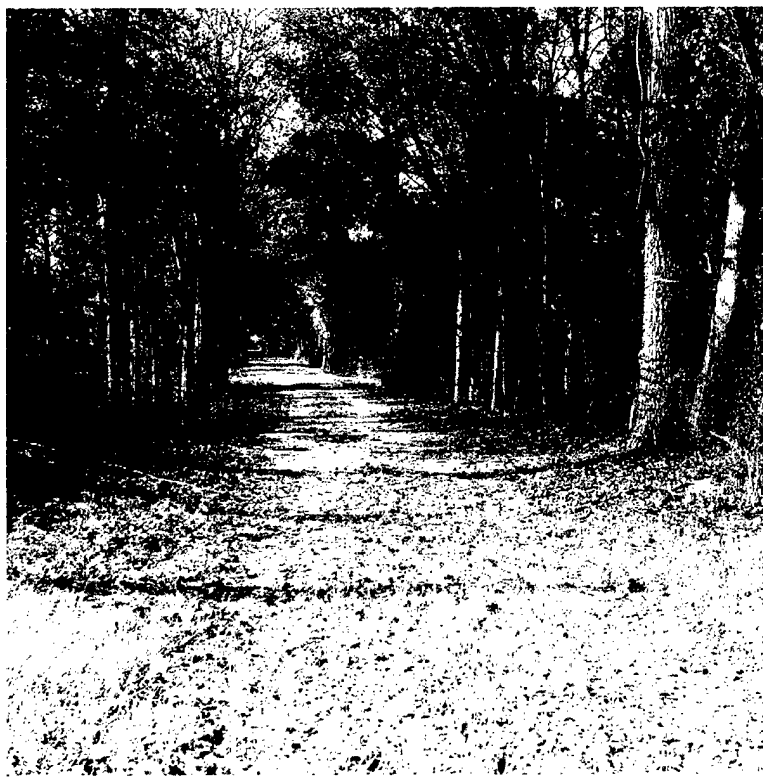
Figure 21. Geneva Levee, site 061 247. Top: top of levee, looking north from the L&N Railroad crossing; Bottom: top of levee, looking west from Westville Ave.

The levee varies in height, rising from grade to a maximum height of approximately 7.5 meters (25 feet), and in width, with a maximum width of approximately 20 meters (65 feet). Since it was constructed, the levee has become densely overgrown with trees (Figure 21).

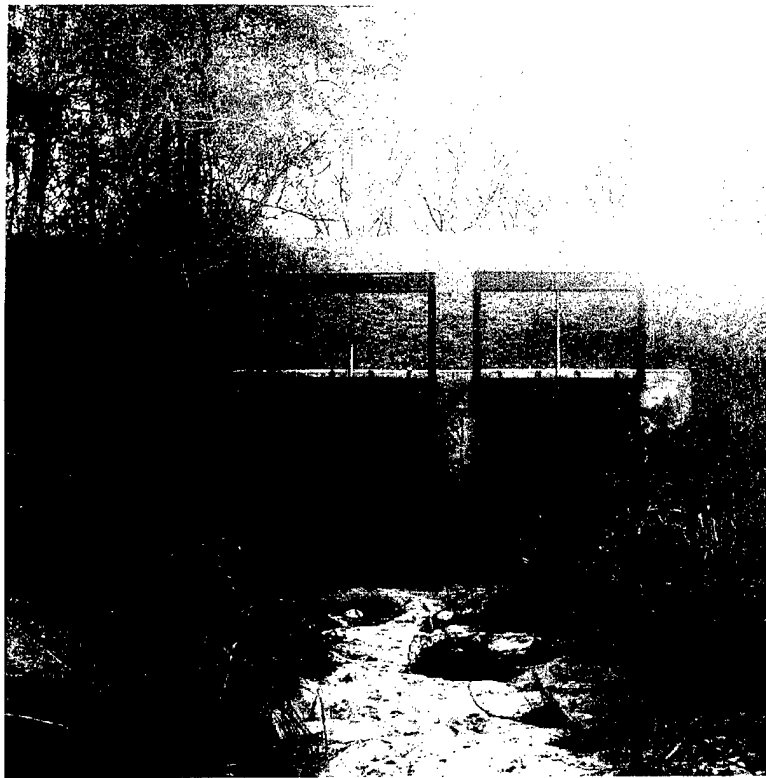
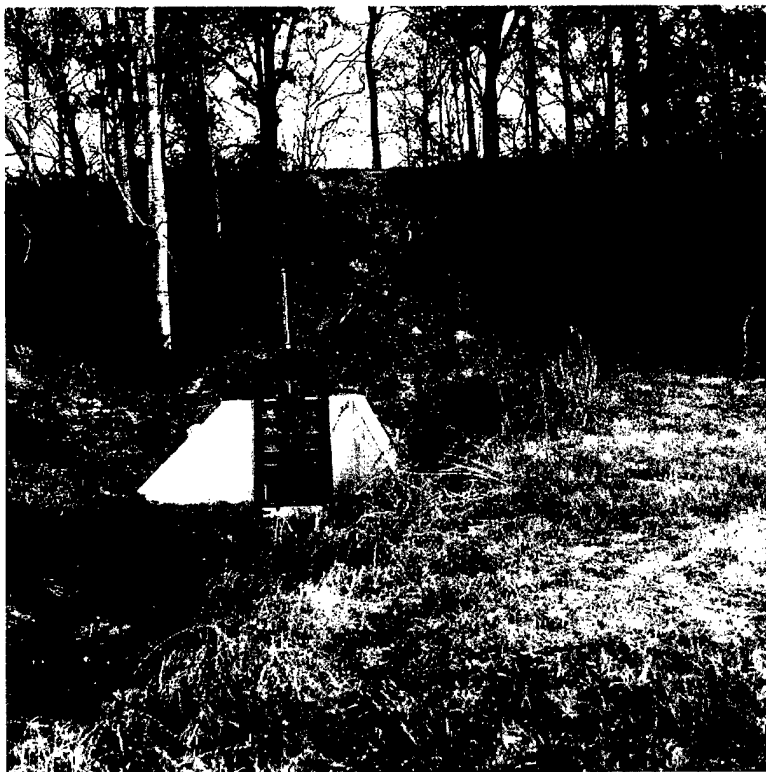
Figure 22. Geneva Levee, site 061 247, modern screw gates. Top: drainage structure 6, looking southwest; Bottom: drainage structure 3, looking east.

As noted above, the levee has retained fair to good integrity. The most significant alteration has been the replacement of the original flap gates with manually operated screw

gates (Figure 22). In addition, the levee is now largely overgrown with trees. Despite having retained fair to good integrity, the Geneva Levee has only modest historical significance. The levee presents few distinctive technical features such as gates or pumps, and has been tested only minimally in the prevention of floods. Therefore we recommend site 061 247 not eligible for the NRHP.
