AFFDL-TM-79-9

**TEST REPORT ON VIBRATION
MEASUREMENTS ON THE C-141
LASER TEST**

REPORT NO: AFFDL/FBG/79-9

TYPE OF TEST: Measurement of Vibratory Environment

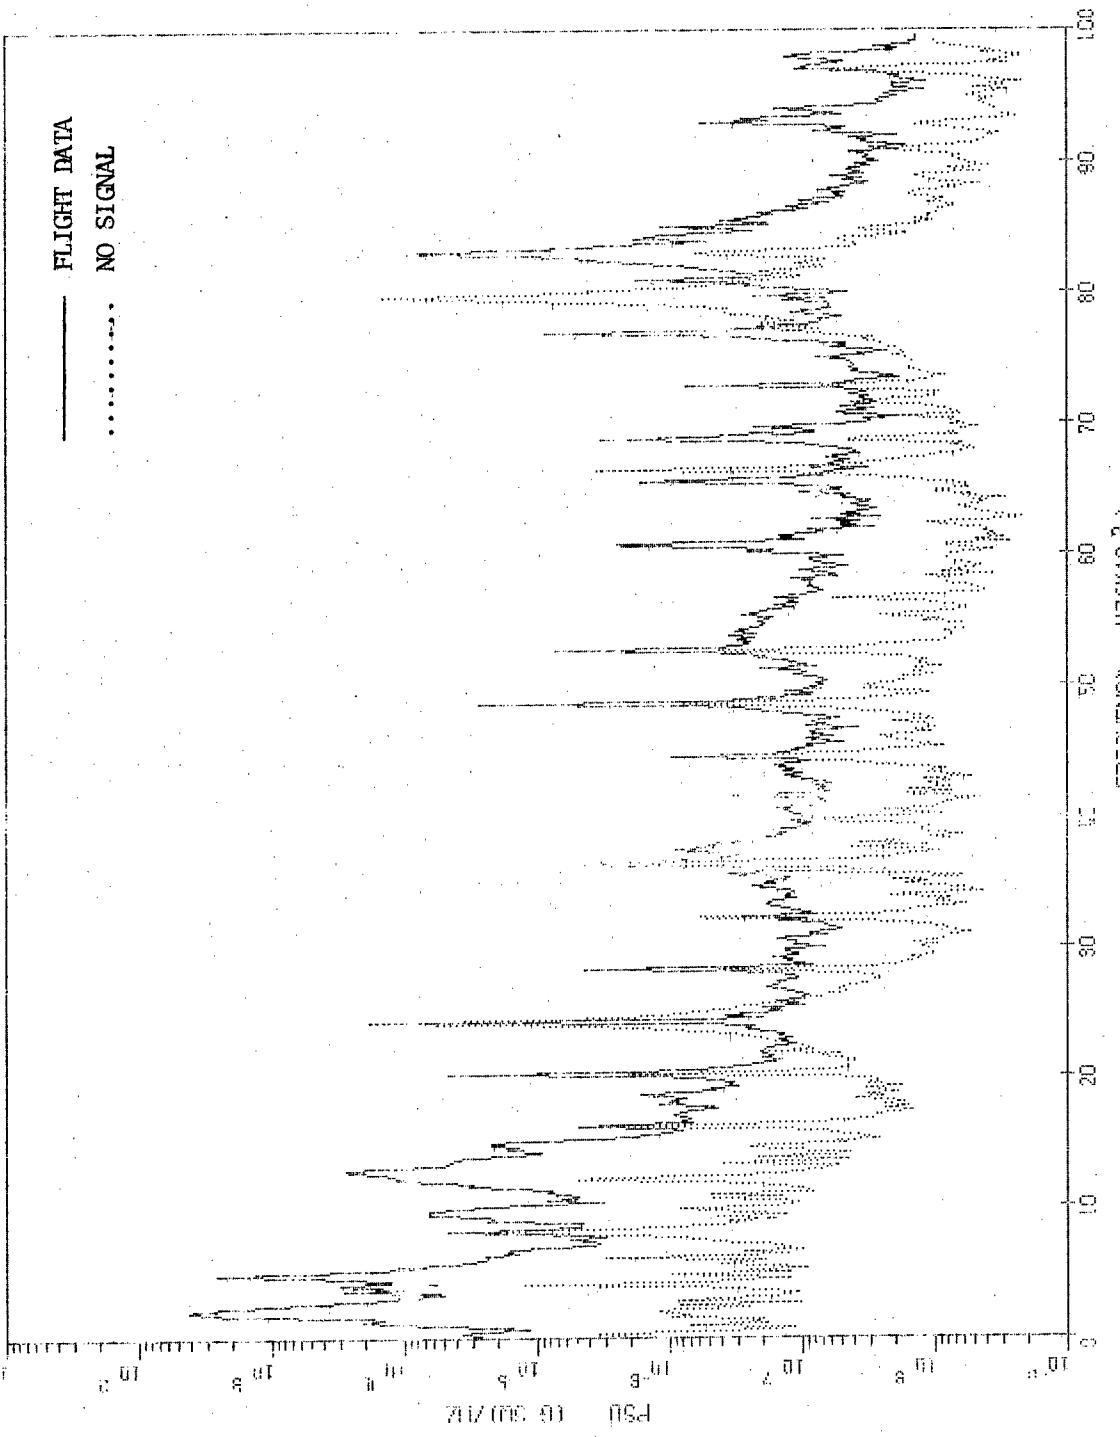
Figure 9. Typical 10kHz PSDs of Flight Data and No Signal Data

C-141 LRSEER TEST
18K ALT/360 KTS
ACCELEROMETER 2

Preliminary analysis: Figure 9 is a typical result of the 10kHz preliminary analysis. The frequency components in the "No-Signal" data

but not in the flight data are from the ground power unit which was on during "No-Signal" recording. The signal-to-noise ratio was generally higher in the 0-2kHz range. Consequently, the final analyses were restricted to that range, permitting a much finer frequency resolution. Though the signal-to-noise ratio is acceptable in this analysis range, it is probably the limiting factor in the overall accuracy.

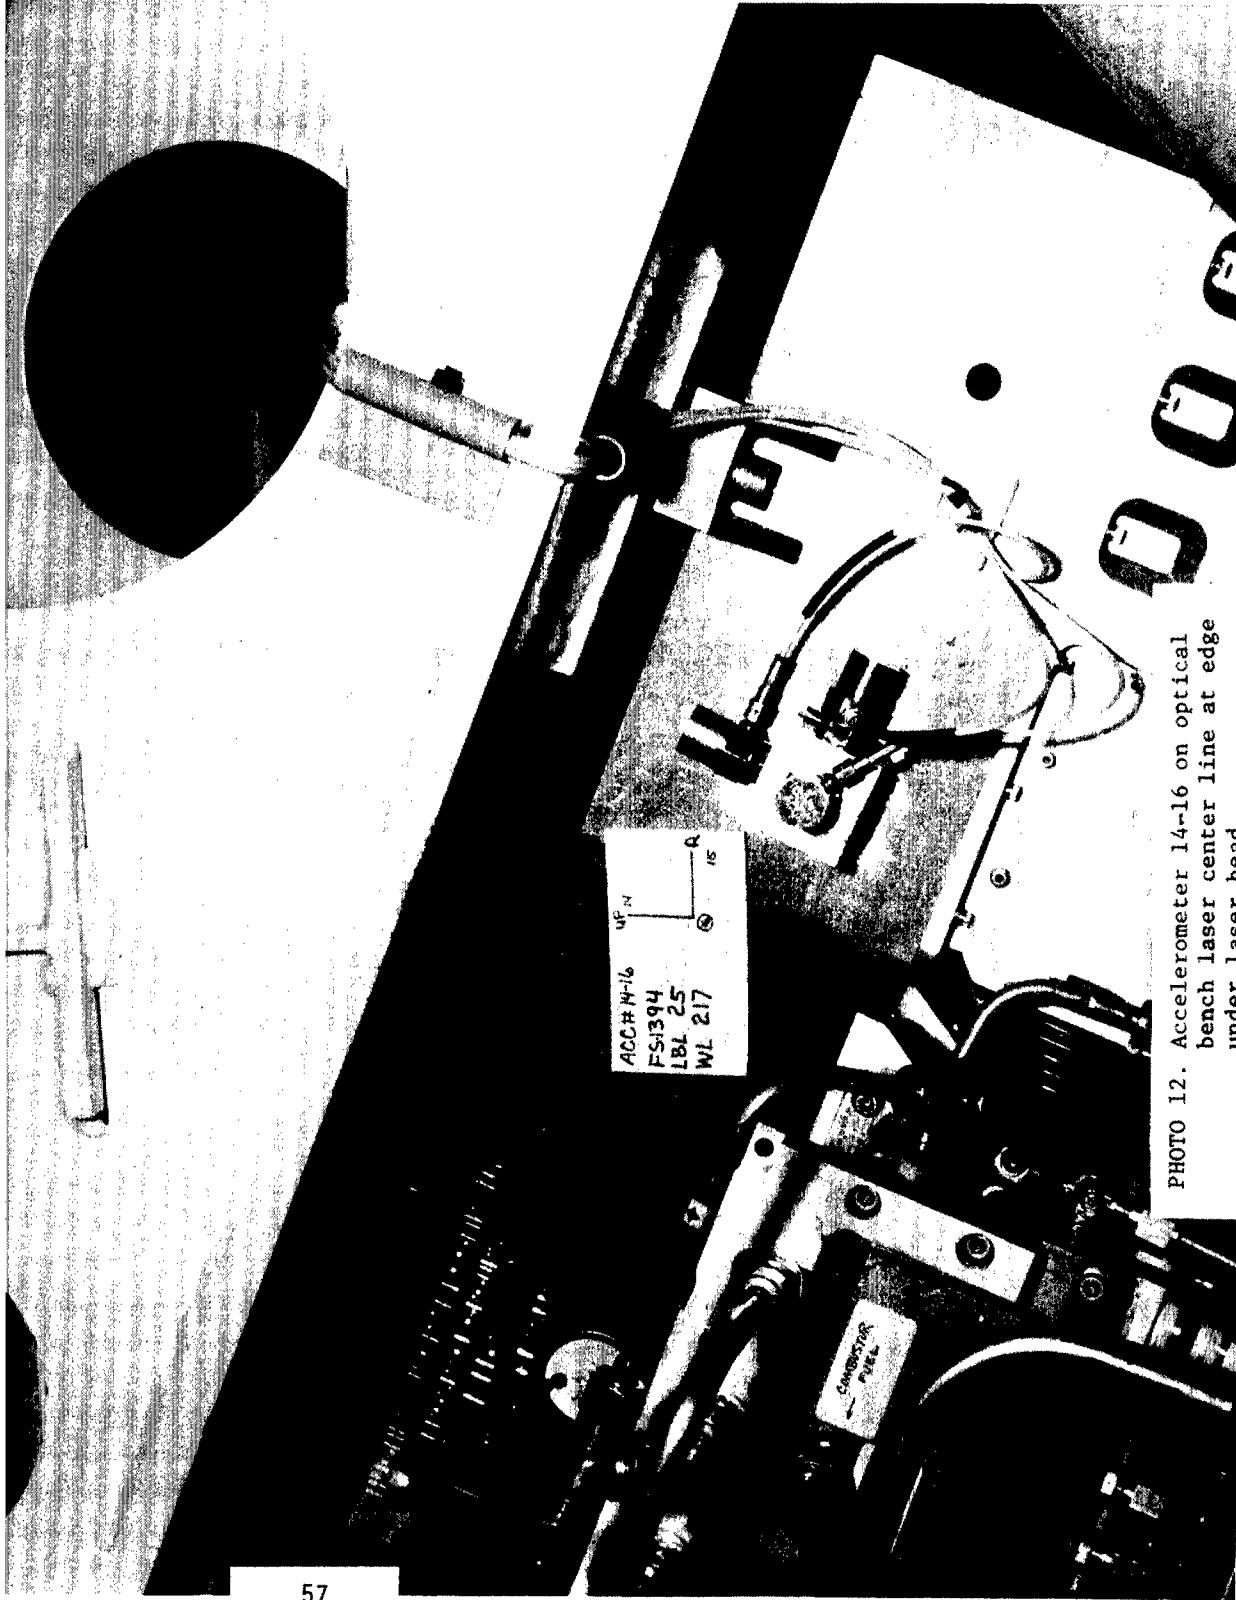
PHOTO 12. Accelerometer 14-16 on optical bench laser center line at edge under laser head

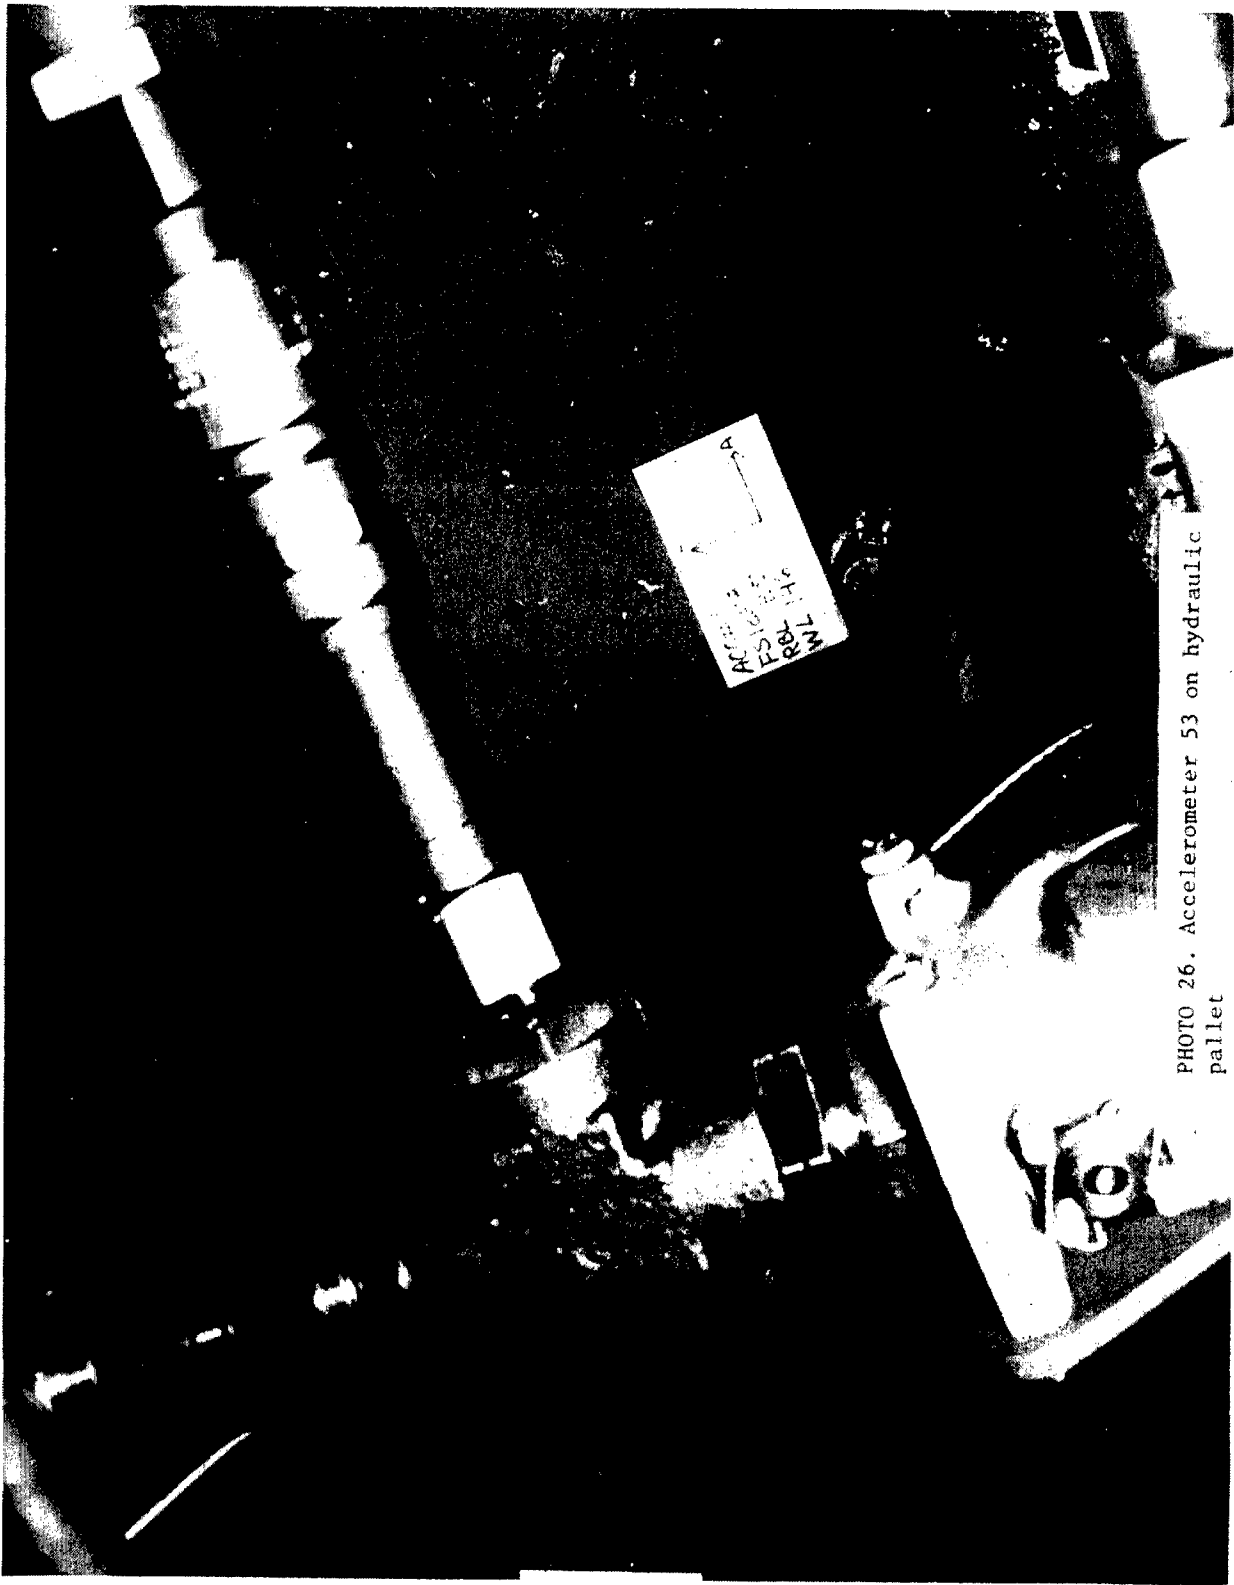
PHOTO 26. Accelerometer 53 on hydraulic
pallet

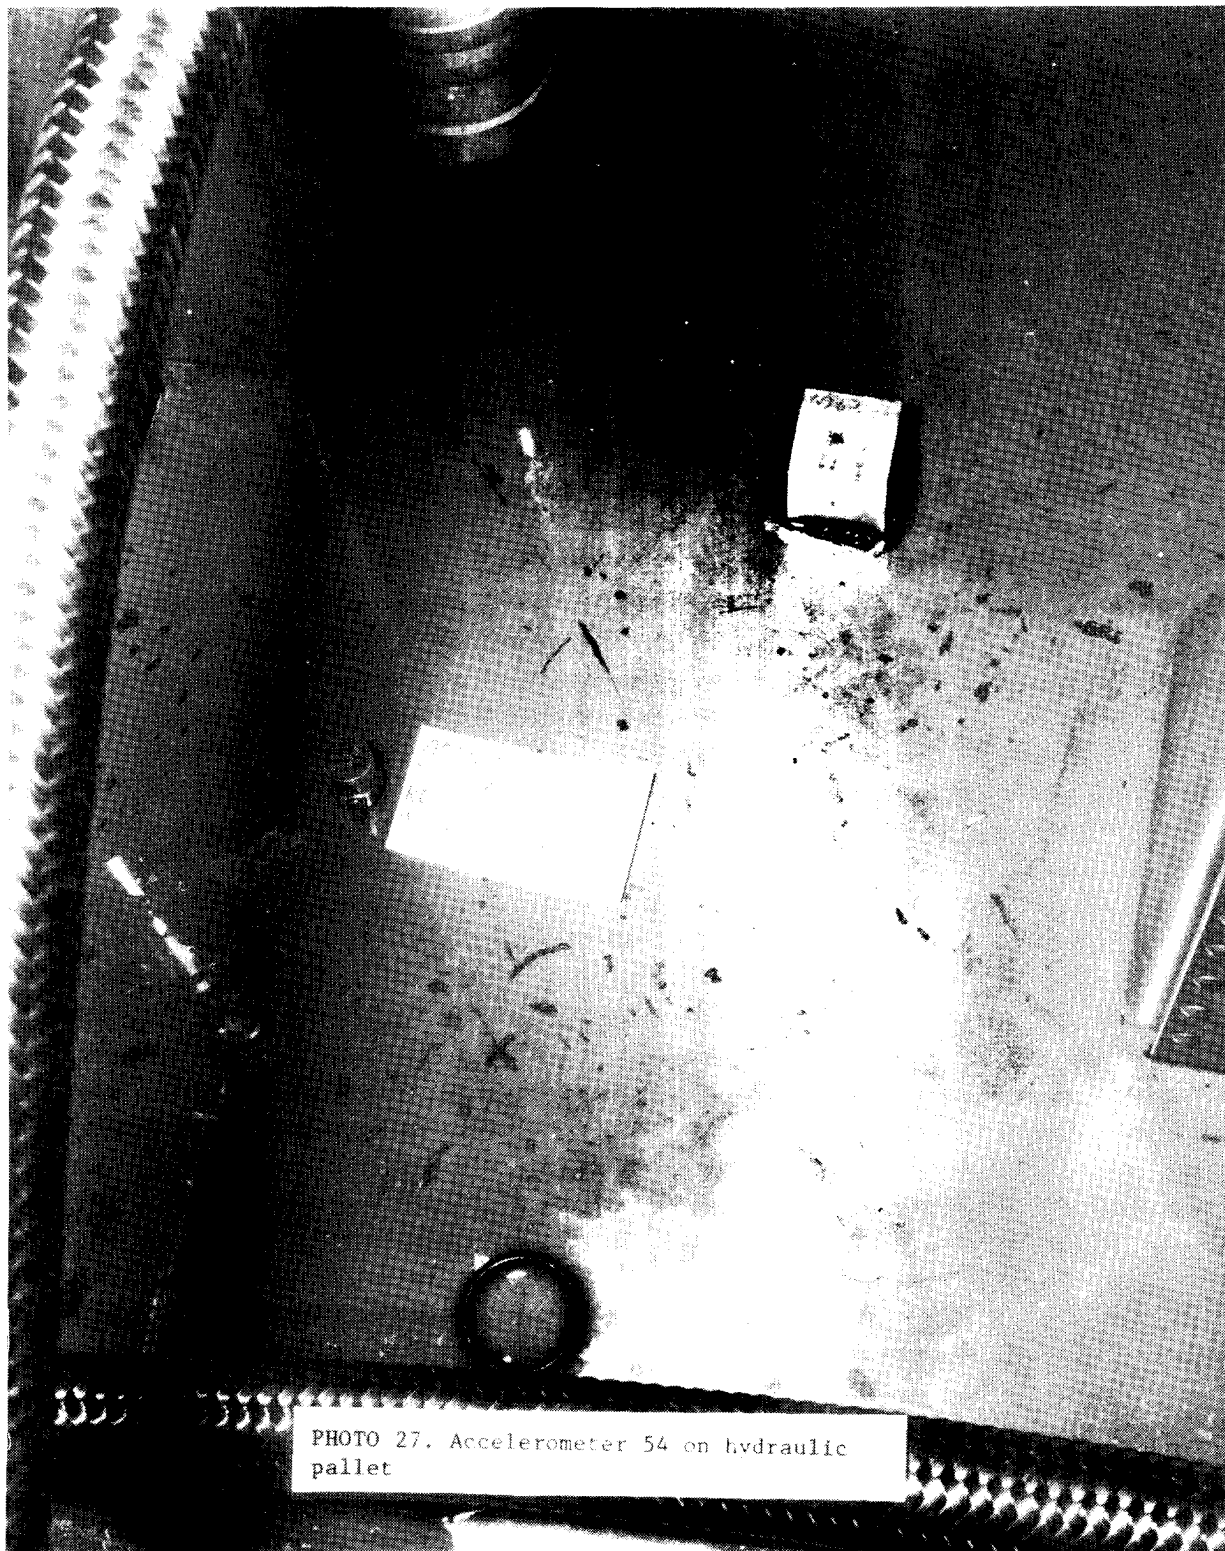
PHOTO 27. Accelerometer 54 on hydraulic pallet
