*Monitoring Completed Navigation Projects Program*

## **Periodic Inspection of Ofu Harbor Breakwater, American Samoa**

**Armor Unit Monitoring for Period 1996-2002**

January 2003

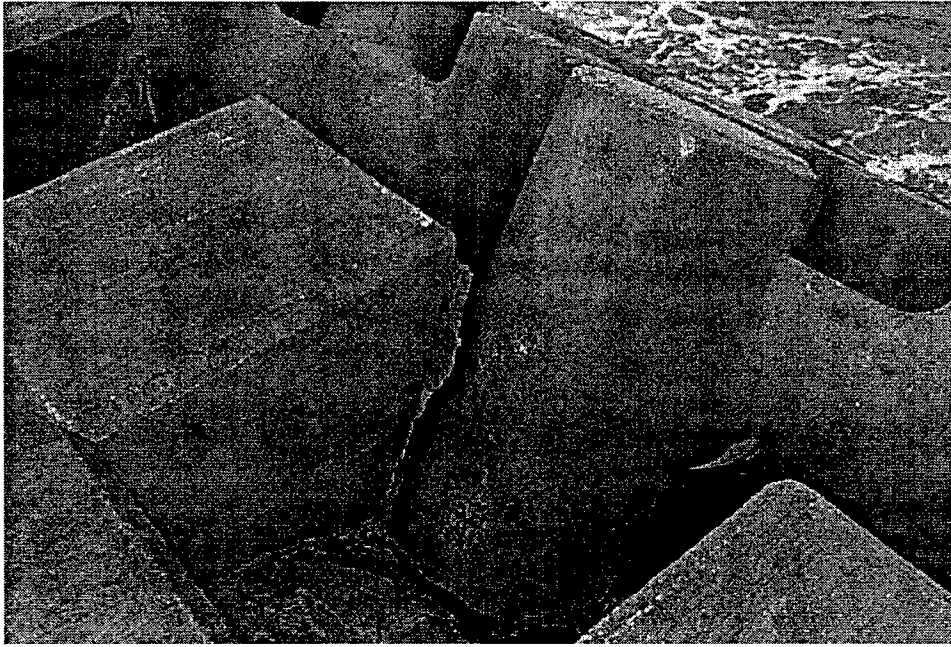
On 22 May 2002, a walking survey of above-water armor units was conducted on the outer 132.6-m (435-ft) portion of the Ofu Harbor breakwater. The survey of the structure revealed no broken tribars. Fifteen sea-side tribars were slightly separated from the rib cap (Figure 11). These separations ranged from 0.64 to 7.62 cm (0.25 to 3 in) and occurred on ribs 2, 12, 13, 14, 16, 20, 22, 25, 26, 32, 39, 42, 66, 67, and 71 (beginning with ribs at the shoreward end). Only one separation was noted during the previous survey at rib 22 (sta 3+07). On the entire sea-side of the structure it also was noted that some of the "Swiss cheese block" underlayer units had separated along the slope between the third and fourth rows (down from the crest). Typical separations ranged from 2.54 to 10.16 cm (1 to 4 in.), and the maximum was about 20.32 cm (8 in.). Some separations were predominantly vertical (Figure 12) while others were predominantly horizontal (Figure 13). Separations of about 2.54 to 10.16 cm (1 to 4 in.), both horizontally and vertically were also noted on "cheese blocks" on the harbor side of the structure. Separations between the "cheese block" underlayer units appeared to be more widespread during this inspection as opposed to the previous one. The geotextile bags had deteriorated and some spalling along the edges of the 510-kg (1,125-lb) high-strength concrete underlayer units was also noted around the head of the structure (Figure 14). These conditions were also noted during the previous inspection. Some slight movement in the breakwater's underlayer armor units has occurred, but in general, the breakwater appeared to be in excellent condition.

Figure 11. Separation between tribar and rib cap

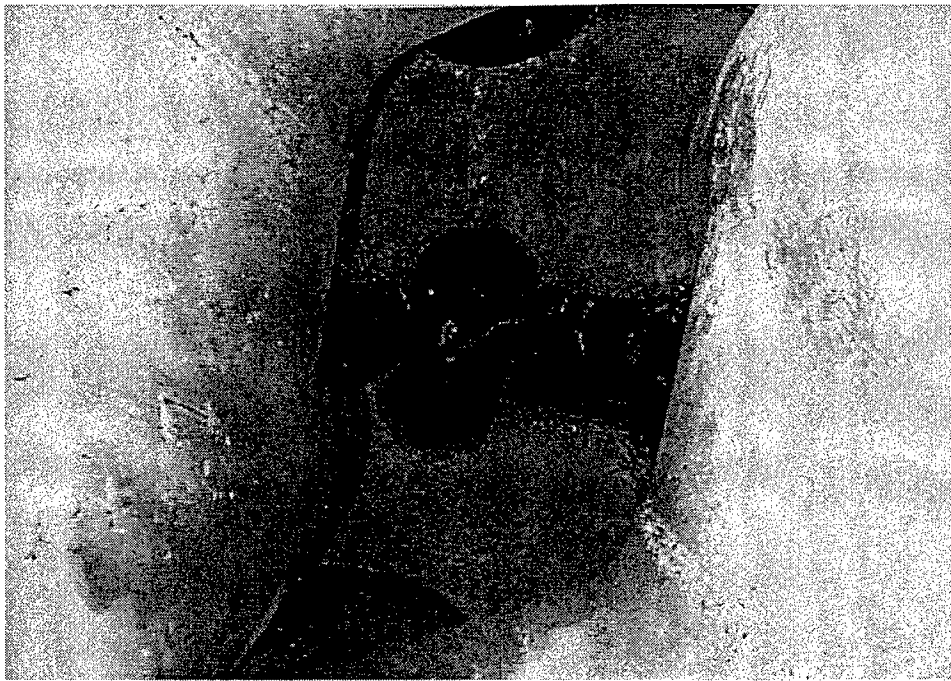
Figure 12. Vertical separation between "Swiss cheese block" underlayer units

0.012 m (0.04 ft) and 0.024 m (0.08 ft) in the horizontal and vertical directions. The current (2002) walking inspection revealed more widespread separations between the "cheese block" concrete underlayer units relative to the 1996 inspection; however, most of the separations were less than 0.09 m (0.3 ft). No armor unit breakage was noted. Overall, the structure appeared to be in excellent condition.
