Lateral Migration Radiography Image Signatures for the Detection And Identification of Buried Land Mines

**Grant Extension
Technical Report
ARO Grant Number
DAAG-55-98-1-0400**

**NUCLEAR AND RADIOLOGICAL ENGINEERING DEPARTMENT
UNIVERSITY OF FLORIDA
Gainesville, FL 32611
January, 2002**

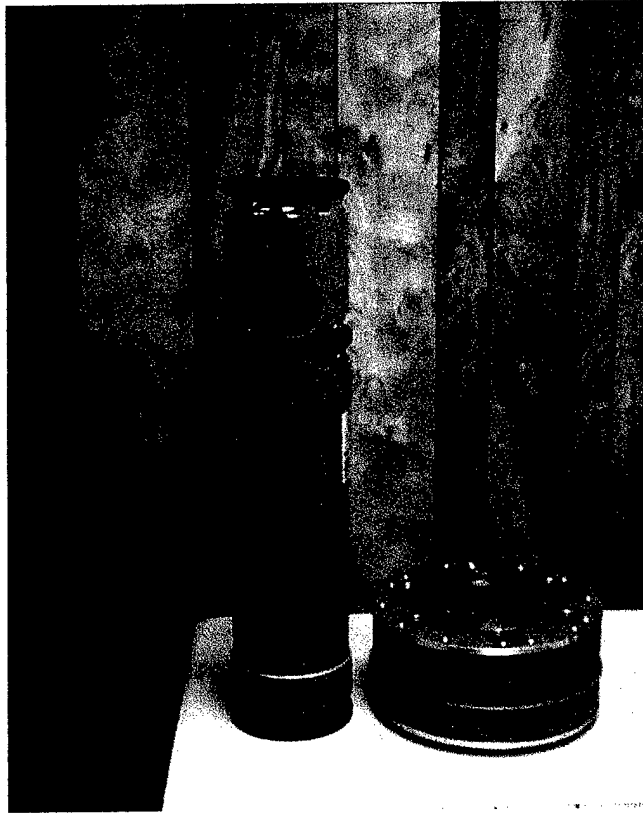
Figure 1. The LORAD LPX-160 and the rotating x-ray source collimator.

A significant accomplishment in this research effort was the development of an x-ray source collimator design that uses a continuously rotating cylinder to synthesize a moving aperture from side-to-side with negligible retrace time. Coupled with the x-ray generator forward motion, this provides a raster scan of the ground. This collimator design is a key element in reducing the required x-ray head movement and in obtaining a simple, compact LMR detector system. Although this collimator efficiently achieves raster direction side-to-side motion while delivering the same photon intensity to each pixel, it results in the x-ray source beam having an incident angle that is perpendicular to

the ground only at the central location in the scan. This source beam tilting causes a raster direction distortion in the acquired images but this slight distortion is readily removed by using simple geometric projection. A photograph of the air-cooled LPX-160 and the fabricated x-ray generator collimator assembly is included as Figure 1 in which the size scale is apparent by noting that the diameter of the cylindrical collimator assembly is about 30 cm and the length of the generator is approximately 78 cm .

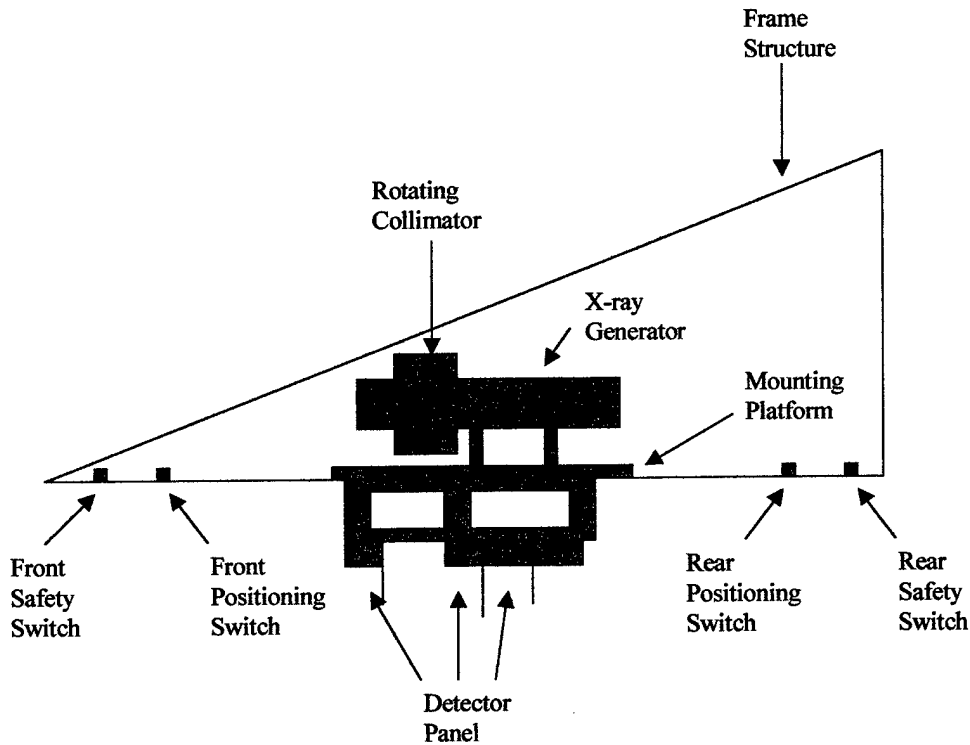
Figure 2. The LMR landmine detection system

Figure 2 illustrates the relative positioning of the LMR components of the XMIS. The x-ray generator with rotating collimator assembly is supported above, and fixed relative to, the mounting platform, which is a 1.9 cm thick aluminum plate. Attached, and fixed relative, to this platform are the detector panel array supports, the digital electric servo motors (not shown in the figure) which provide rotational motion to the x-ray collimator through a belt drive and translational motion to the platform through a lead screw (both not shown in figure), and linear ball bearing assemblies (not shown in figure) which support translational motion (left-to-right in the figure) of the platform. The linear bearings surround two cylindrical steel rails (length left-to-right, but not shown, in the figure). These rails are fixed to the rigid steel frame structure which also provides fixed relative positioning of the limit and safety switches for the platform linear motion. Figure 3 is a photograph of the LMR system as just described. The linear drive lead screw is visible in the lower right corner of the photograph.

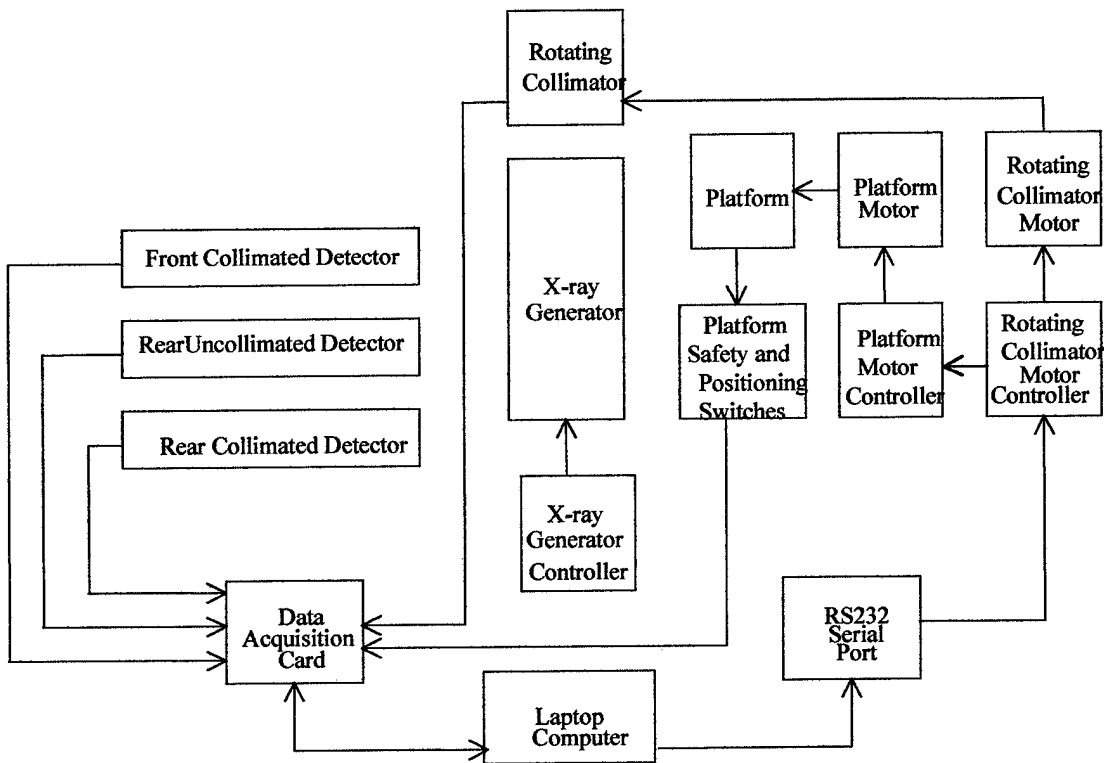
Figure 8. Block diagram of signal flows in the LMR land mine detection system.

In Figure 8 the flow of signals for the LMR system is shown as a block diagram. This diagram, along with the XMIS schematic configuration shown in Figure 4, shows the interrelation of the components discussed in this report section.

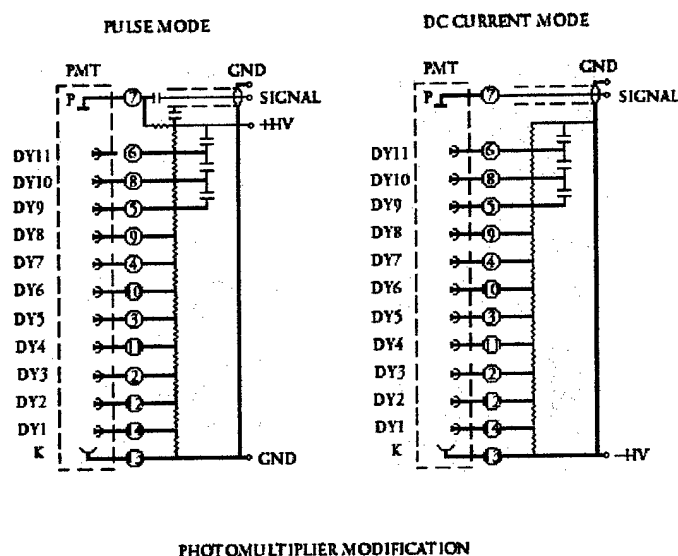
Figure 9. Photomultiplier structure modification.

Mounted on either end of each of the three plastic detectors are the photomultiplier tube assemblies, with preamps and bias high voltage supplies. The PM tubes and base assemblies as delivered from Bicon were set up for pulsed voltage mode, so it was necessary to modify the PM tubes to operate in continuous DC current mode for the integral transimpedance type preamplifiers. This modification to the PM tube structure is shown in Figure 9.
