**AFWAL-TM-79-10**

**TEST REPORT ON INFRARED  
WARNING RECEIVER (IRWR) FLIGHT  
VIBRATION MEASUREMENTS**

**APRIL 1980**

| <b>14. ABSTRACT</b><br><br>This test report presents data which define the vibration environments experienced by two infrared warning receiver (IRWR) units mounted on the HH-53 helicopter and the C-130E transport aircraft. | | | | | | |

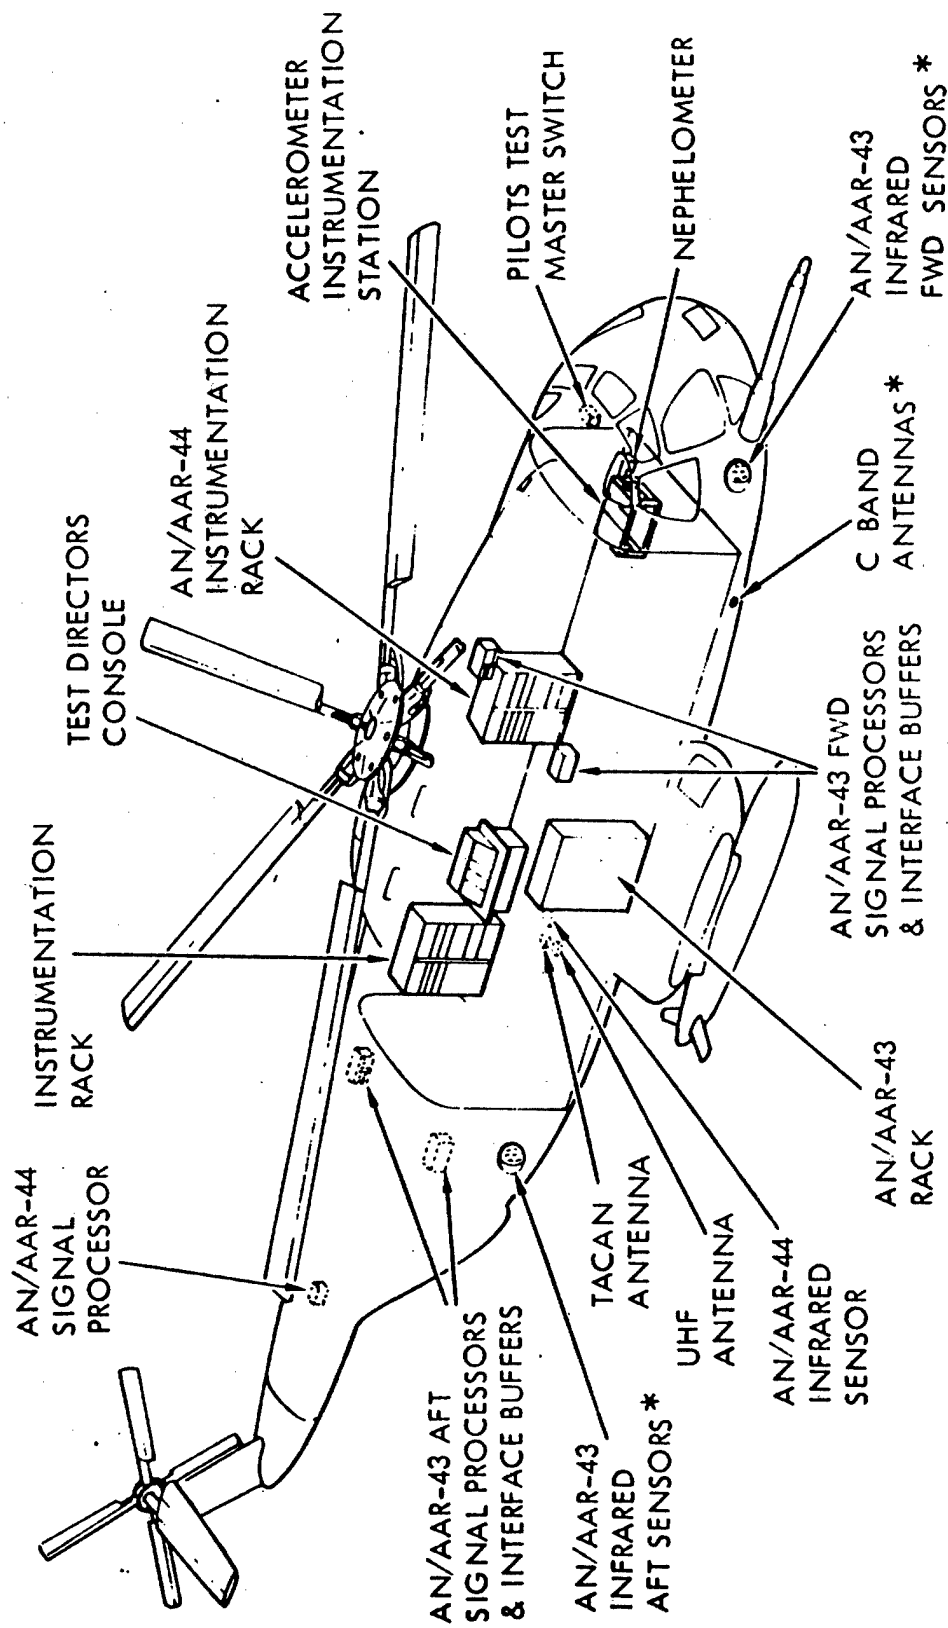
Figure 2. HH-53C Installation.

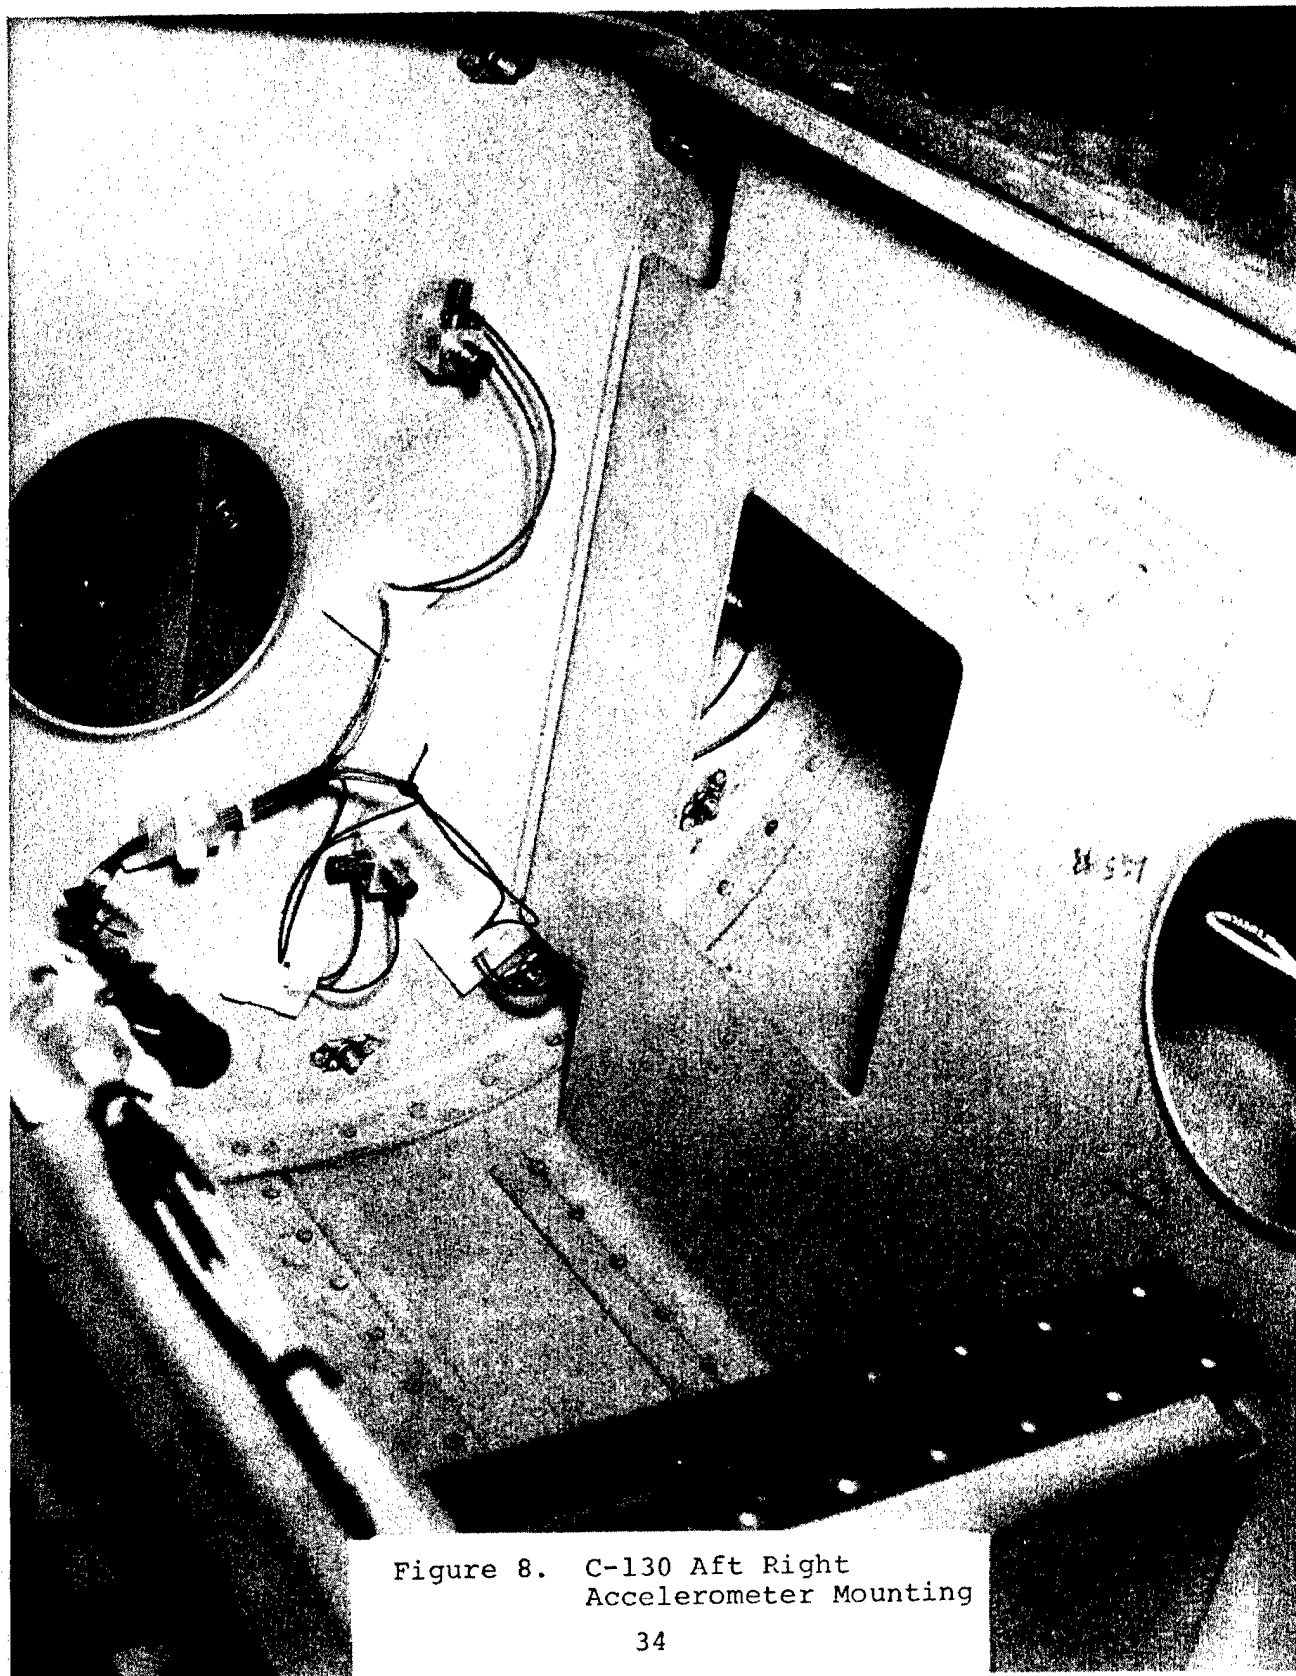
Figure 8. C-130 Aft Right  
Accelerometer Mounting

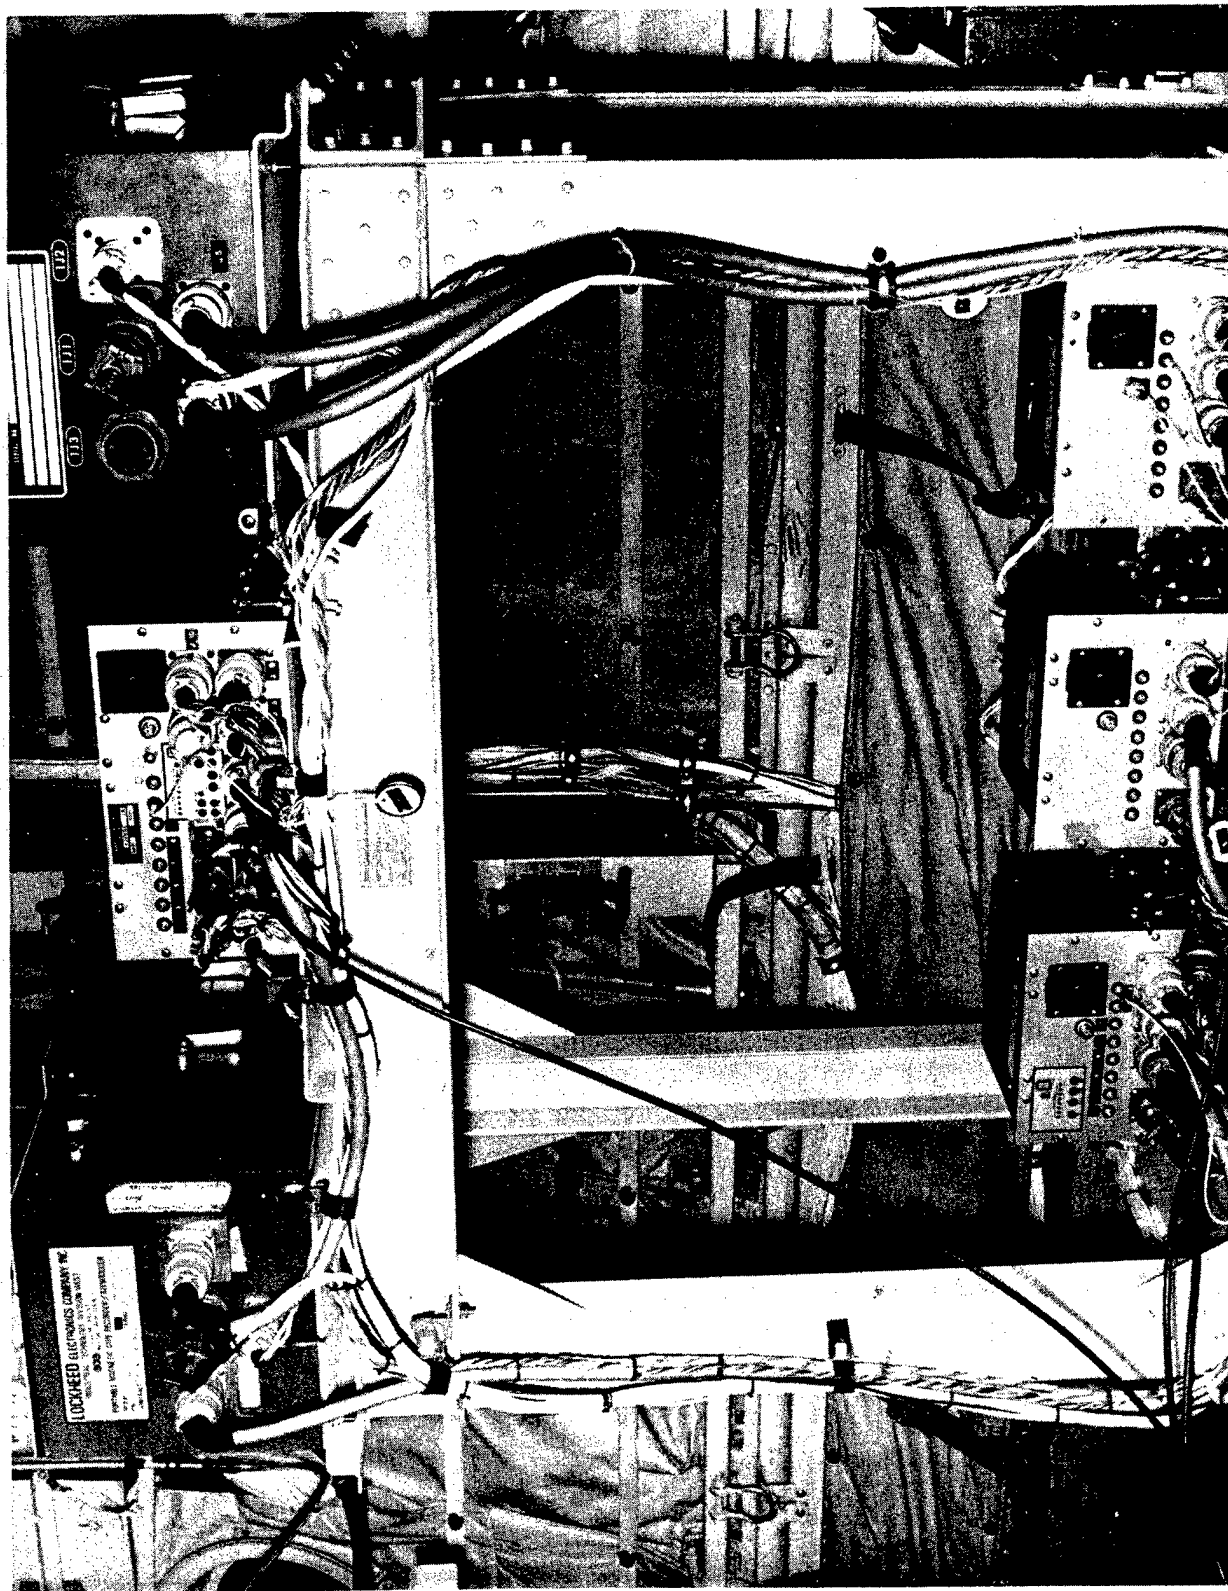
Figure 9. Wheaton Table and Electronics

The four amplifier systems, two tape recorders, power supplies, and power distribution box were mounted on a Wheaton table by 4950th TW personnel as shown in Figure 9. The table, including equipment and cables on it, was moved from one aircraft to the other as required by the test conditions. A separate remote control panel and its associated cables were installed in both aircraft, as shown in Figure 10. The four amplifier input signal cables and the aircraft power input cable were also installed in both aircraft. Thus, moving the instrumentation system on the Wheaton table required disconnecting and reconnecting the four amplifier input connectors, four remote control connectors, and the aircraft power input connector. The estimated weight of the Wheaton table plus equipment and cables was 196 pounds.

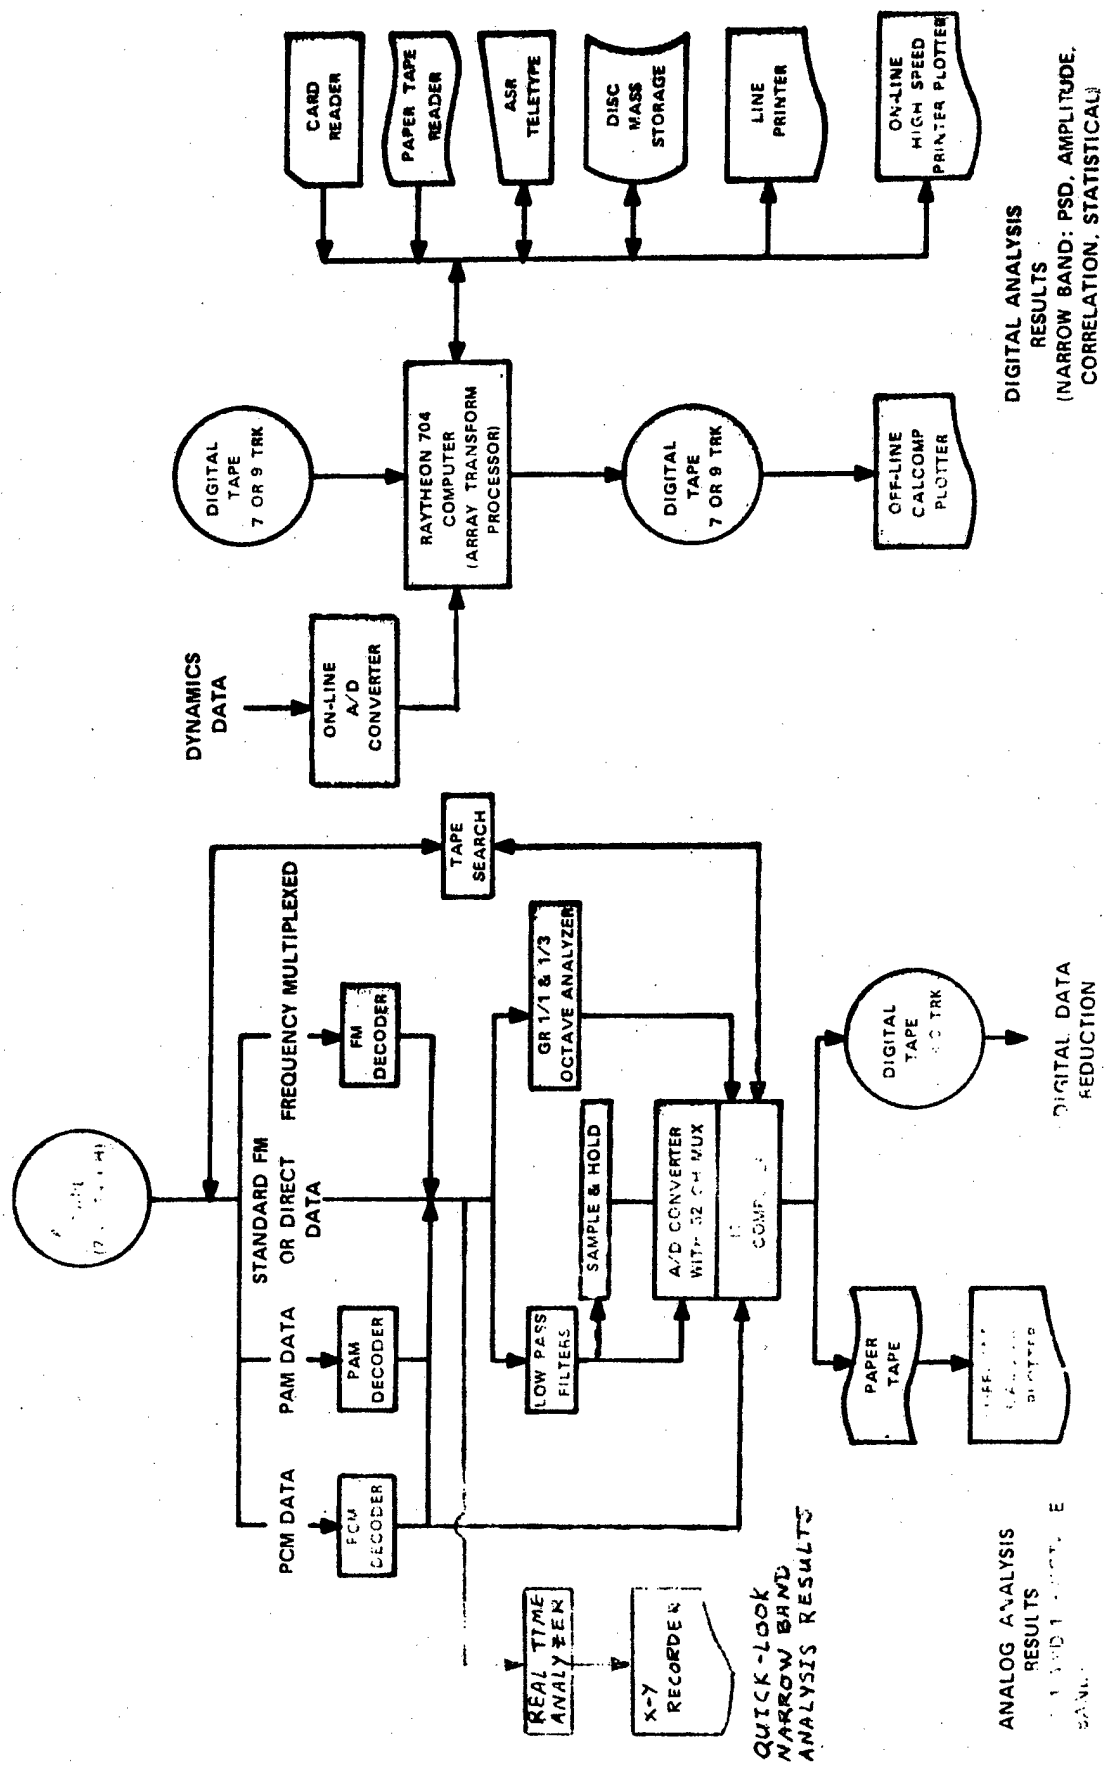
Figure 11. Flow Chart for Data Analysis

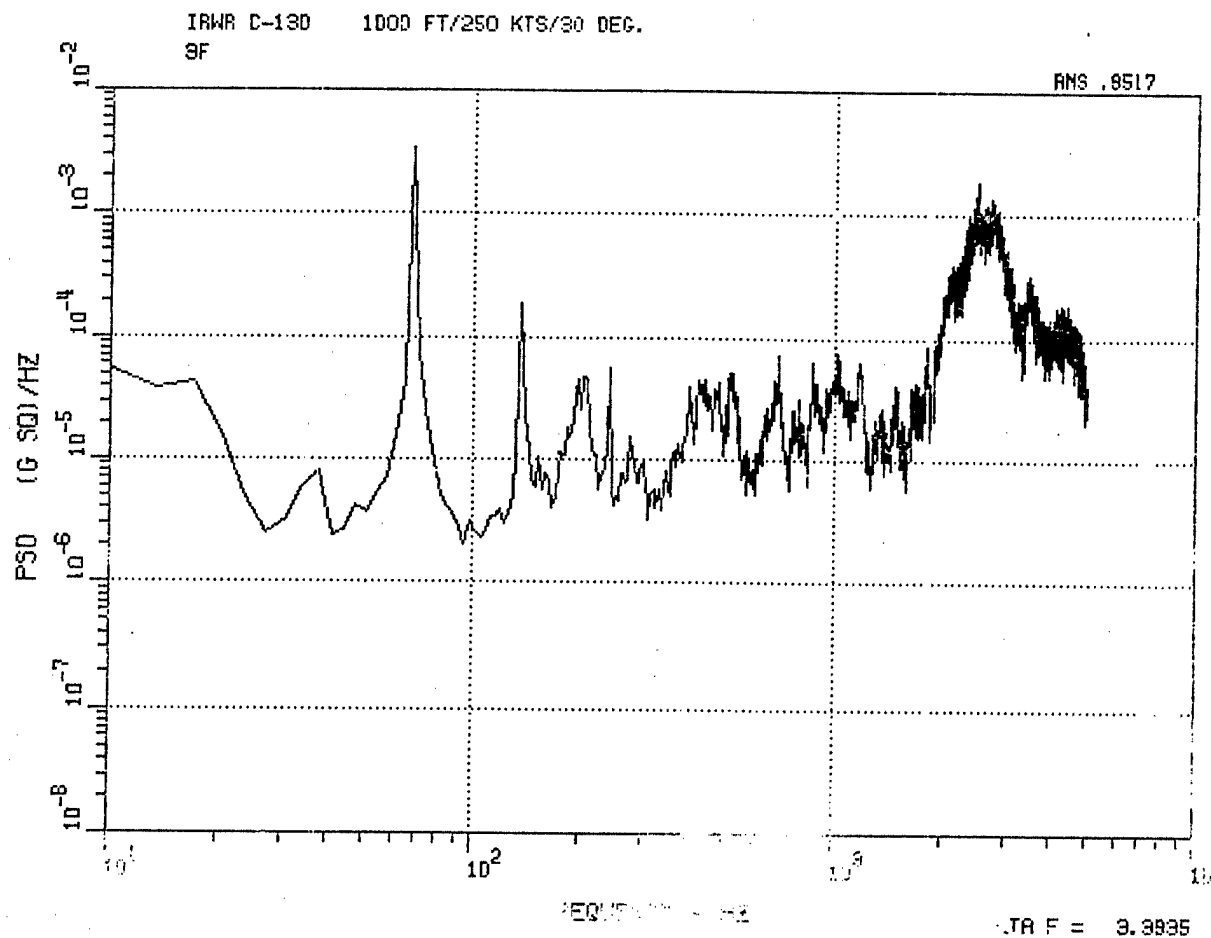
Figure 18. C-130 Fwd Vertical Accelerometer 3F, 1000 Ft, 250 Kt, 30 Deg, and 5000 Ft, 250 Kt, 30 Deg.

The vertical acceleration is much lower than the lateral, as shown for Sensor 3F in Figures 16-19. The longitudinal vibration, shown for Sensor 6F in Figures 20-23, is lower still, and is dominated at the higher frequencies by several discrete blade-passage frequencies and overtones. The forward microphone, MF, plotted in Figures 24-27, shows fairly low overall sound-pressure levels. The 400-Hz peak in the microphone data is probably instrument noise. The higher speed flight conditions add about 10 dB to the noise levels at the forward AAR-43 location.

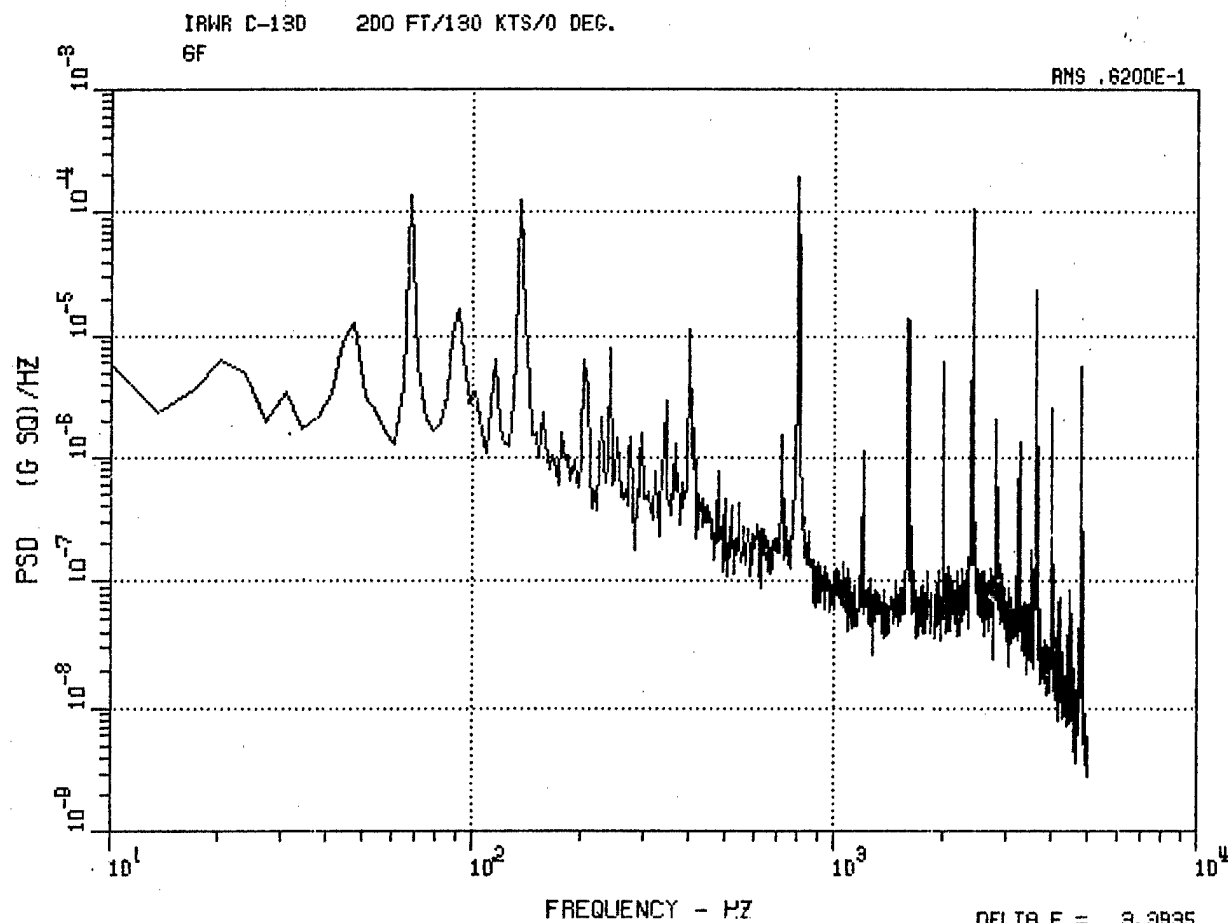
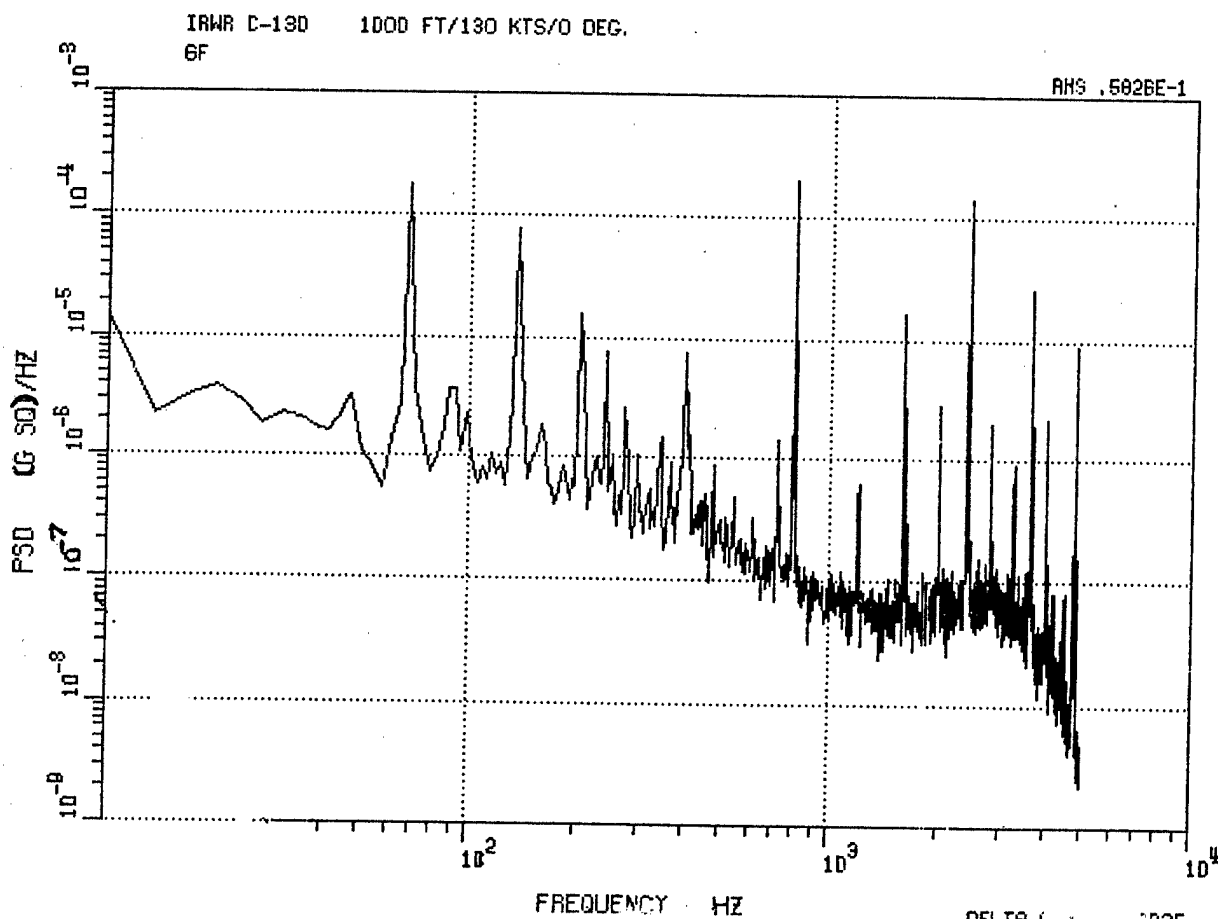
Figure 20. C-130 Fwd Longitudinal Accelerometer 6F, 200 Ft, 130 Kt, 0 Deg, and 1000 Ft, 130 Kt, 0 Deg.

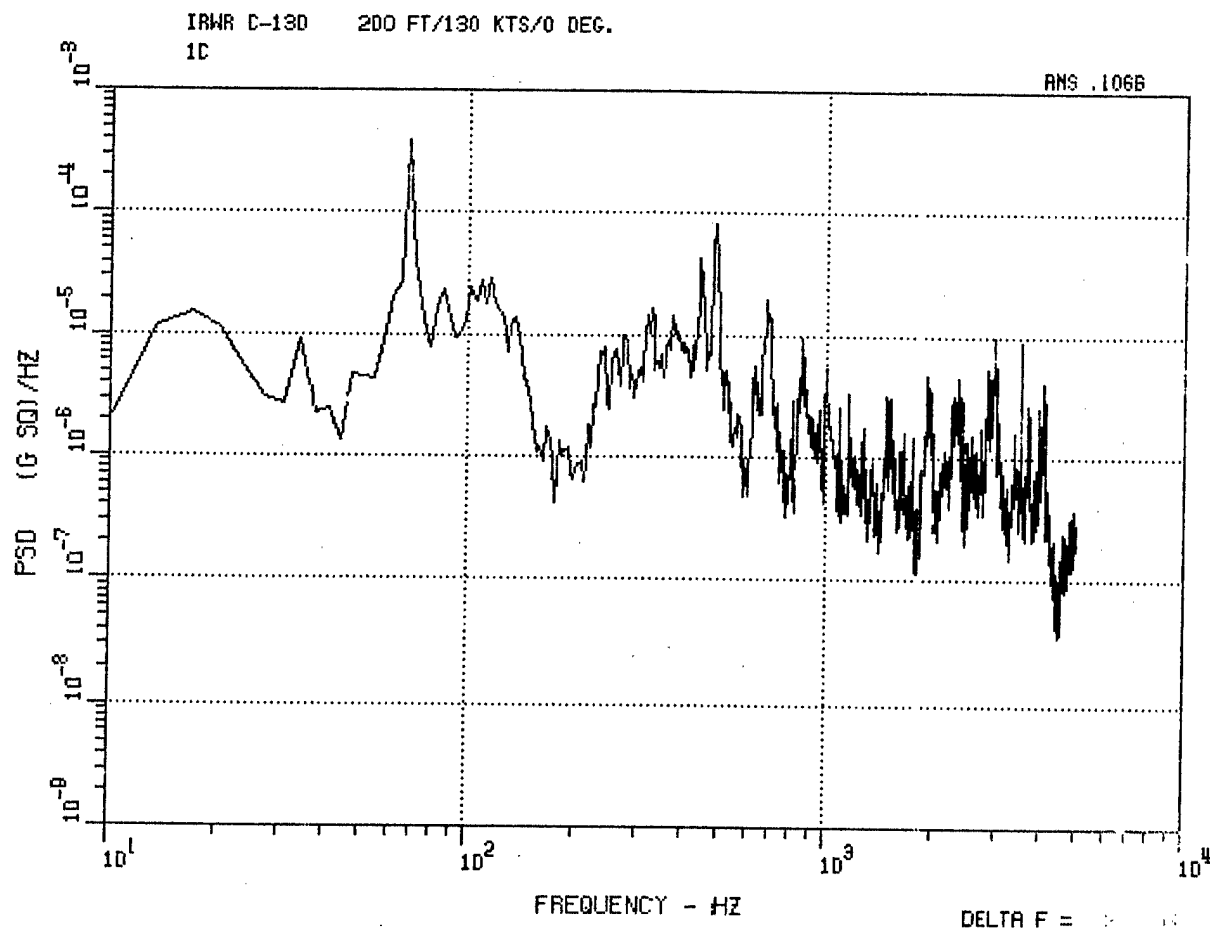
Figure 28. C-130 Center Vertical Accelerometer 1C, 200 Ft, 130 Kt, 0 Deg, and 1000 Ft, 130 Kt, 0 Deg.

The AAR-44 environments on the C-130 are shown in Figures 28-43. The vertical acceleration PSDs for Sensor 1C are shown in Figures 28-41, the lateral PSDs (Sensor 3C) in Figures 32-35, and the longitudinal PSDs (Sensor 6C) in Figures 36-39. The spectra are all distinctly lower in overall rms response than the forward AAR-43 location. The acoustic noise levels, shown in Figures 41-43, are about 16 dB higher than the forward location at 130 knots airspeed and are about 11 dB higher at 250 kts. At the higher flight speeds the noise levels are 139-140 dB, which may cause some difficulty for sensitive electronics.

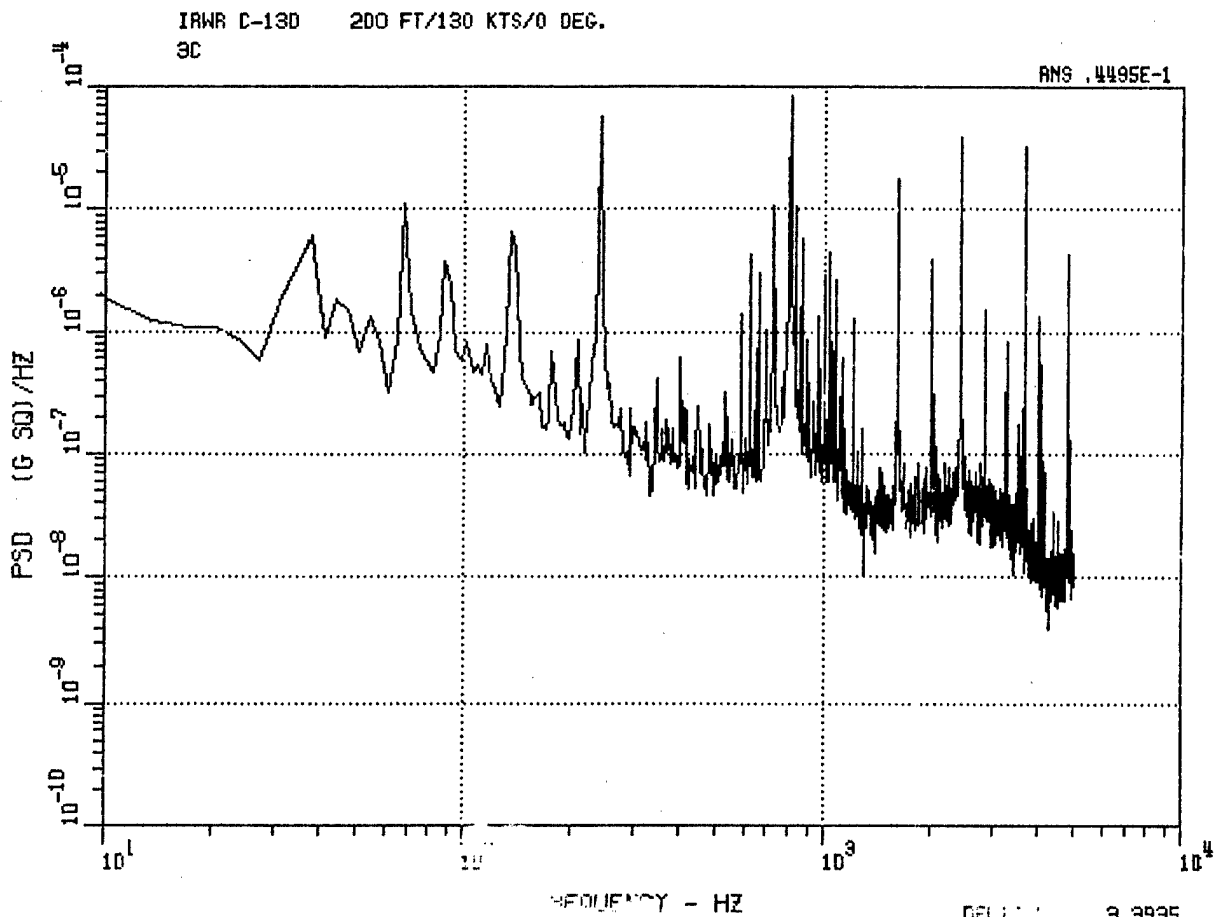
Figure 32. C-130 Center Lateral Accelerometer 3C, 200 Ft, 130 Kt, 0 Deg, and 1000 Ft, 130 Kt, 0 Deg.

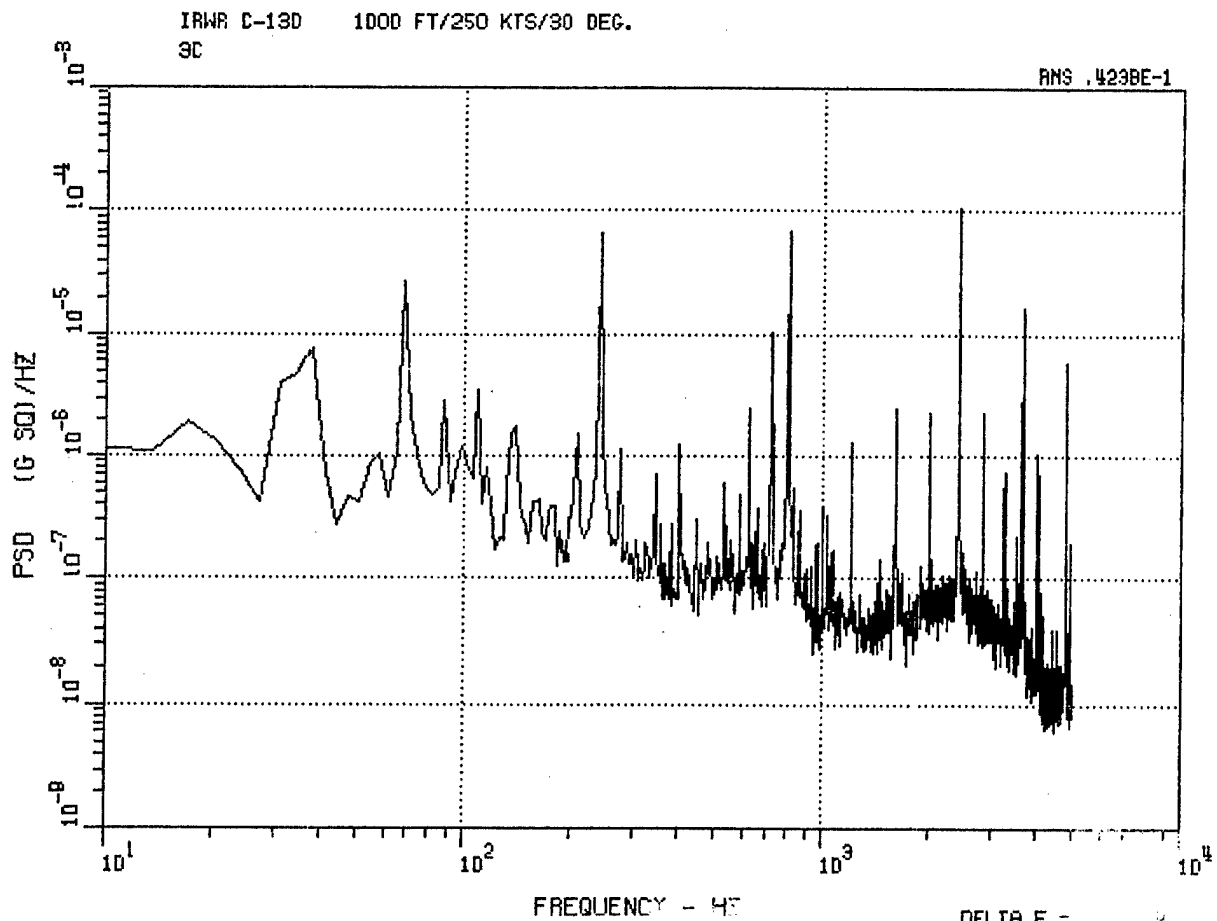
Figure 34. C-130 Center Lateral Accelerometer 3C, 1000 Ft, 250 Kt, 30 Deg, and 5000 Ft, 250 Kt, 30 Deg.

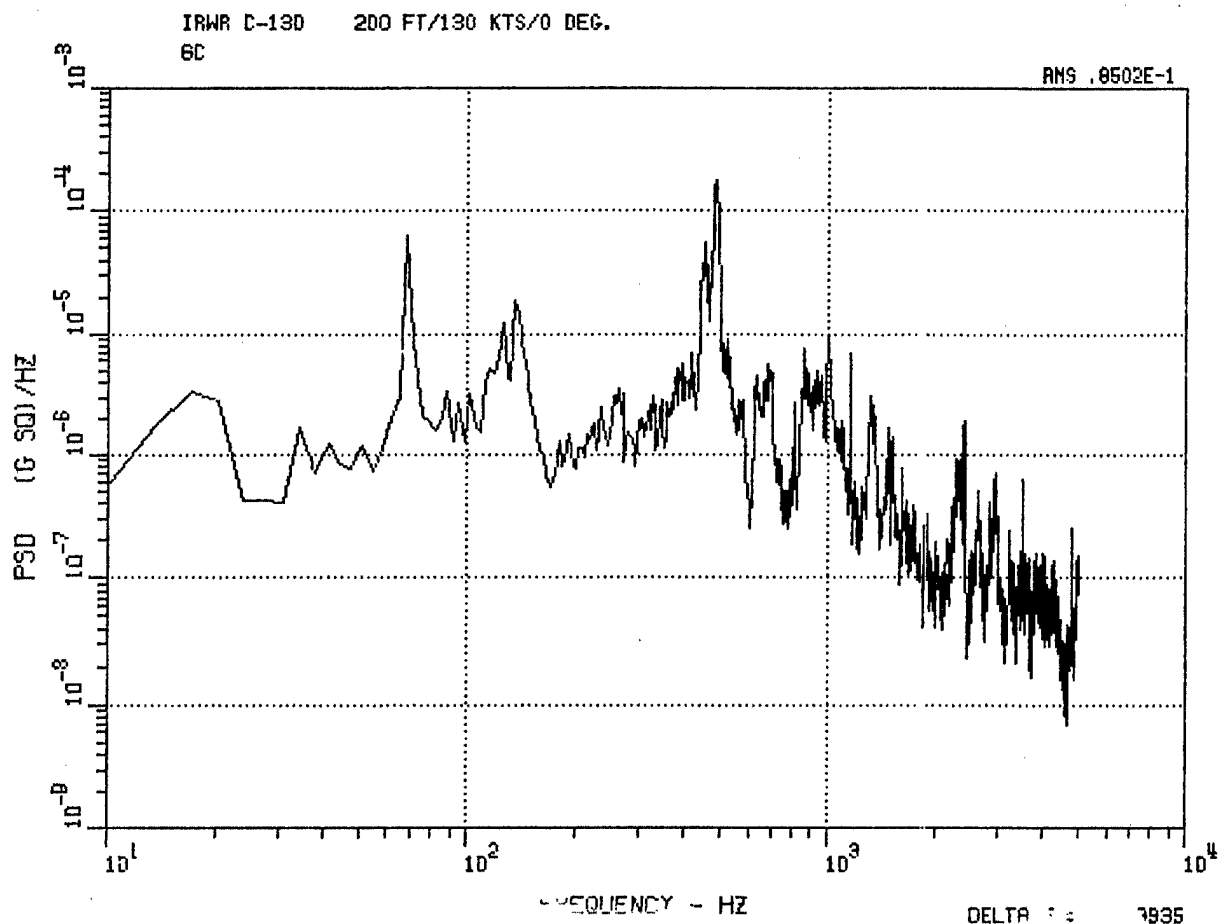
Figure 36. C-130 Center Longitudinal Accelerometer 6C,  
200 Ft, 130 Kt, 0 Deg, and 1000 Ft, 130 Kt,  
0 Deg.

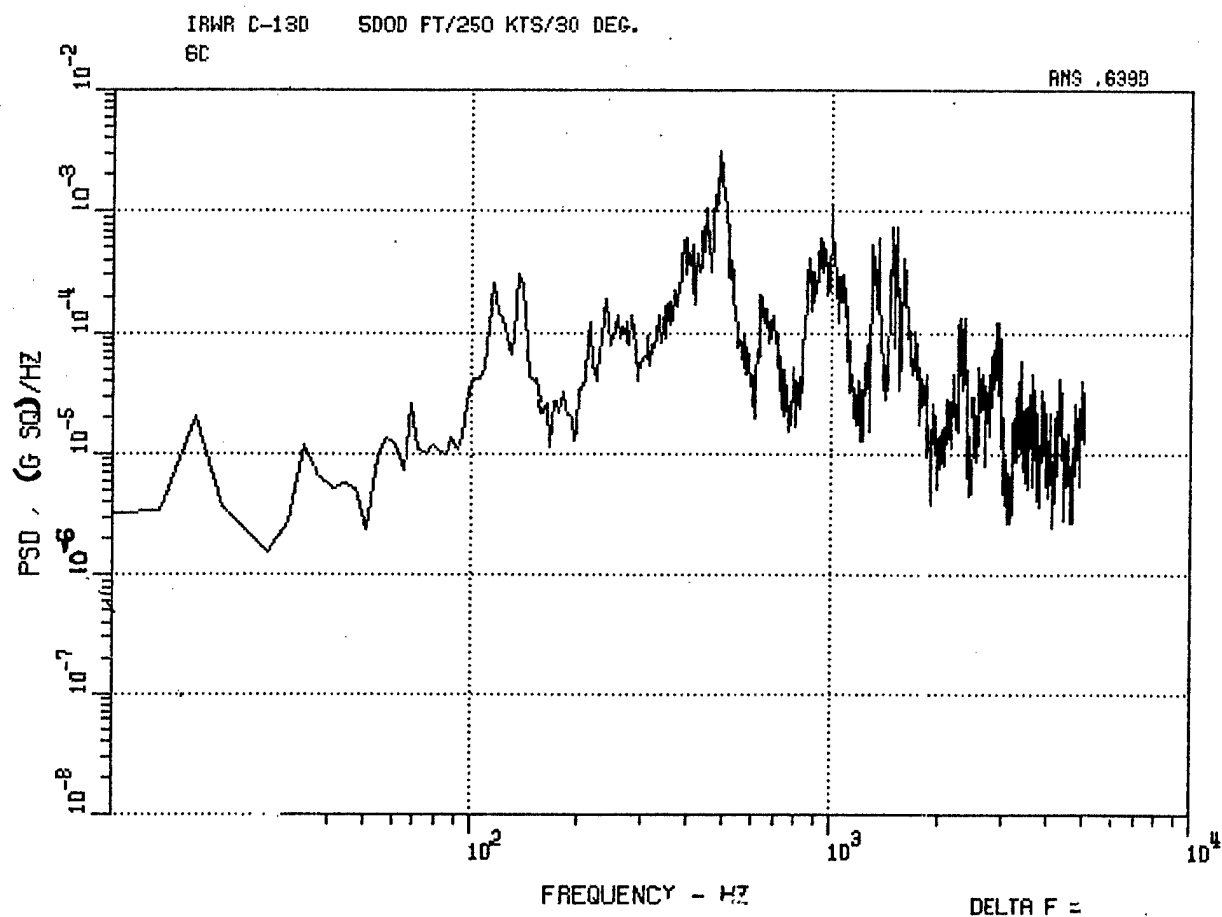
Figure 38. C-130 Center Longitudinal Accelerometer 6C,  
1000 Ft, 250 Kt, 30 Deg, and 5000 Ft, 250 Kt,  
30 Deg.

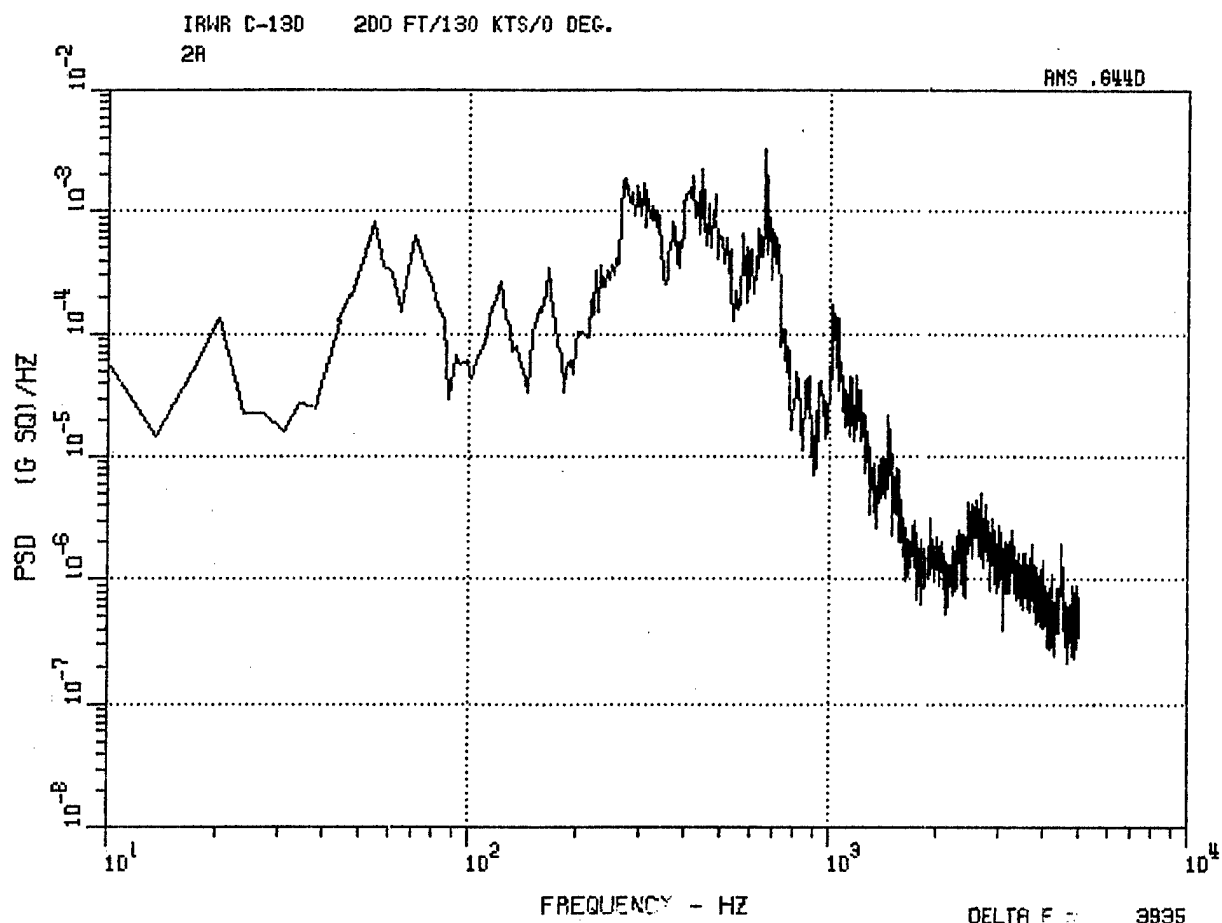
Figure 44. C-130 Aft Lateral Accelerometer 2A, 200 Ft, 130 Kt, 0 Deg, and 1000 Ft, 130 Kt, 0 Deg.

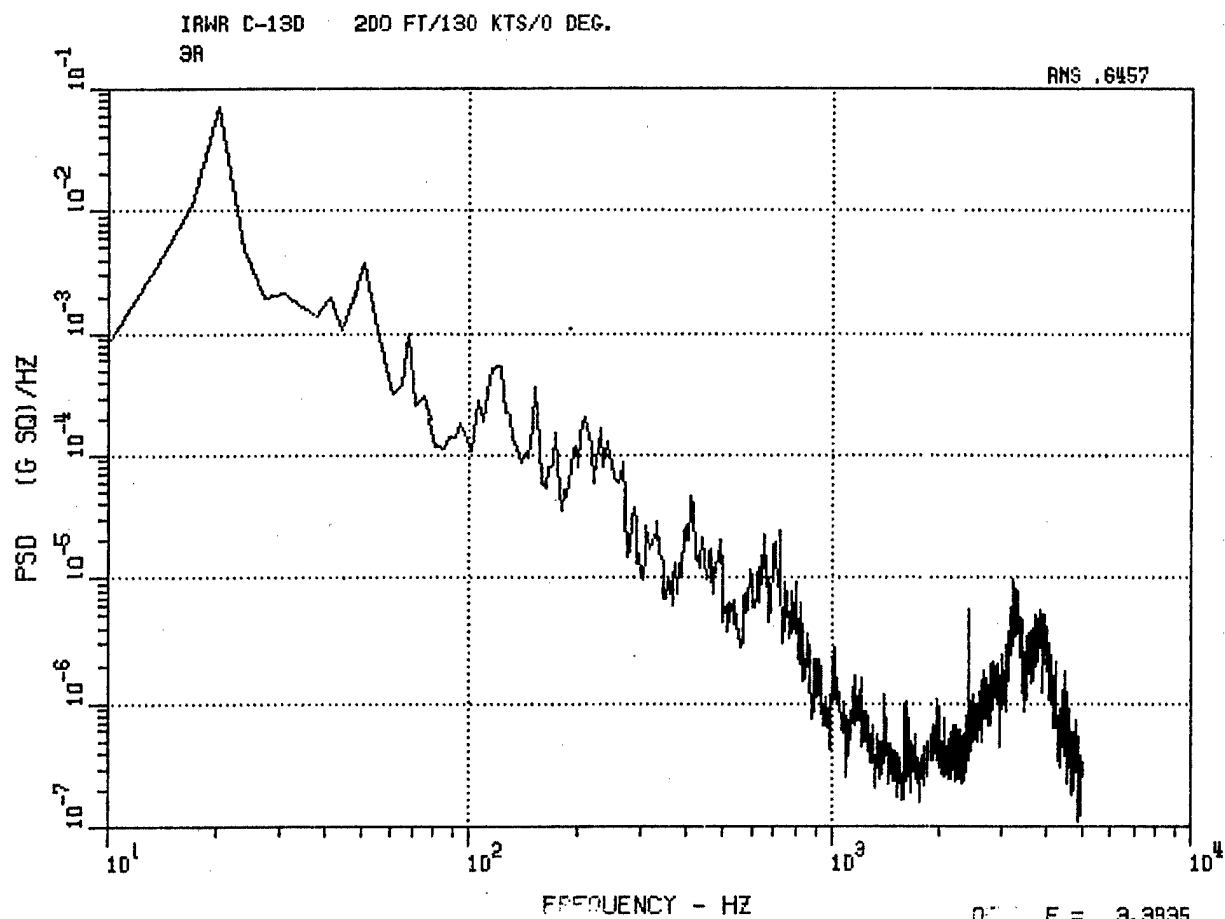
Figure 48. C-130 Aft Vertical Accelerometer 3A, 200 Ft, 130 Kt, 0 Deg, and 1000 Ft, 130 Kt, 0 Deg.

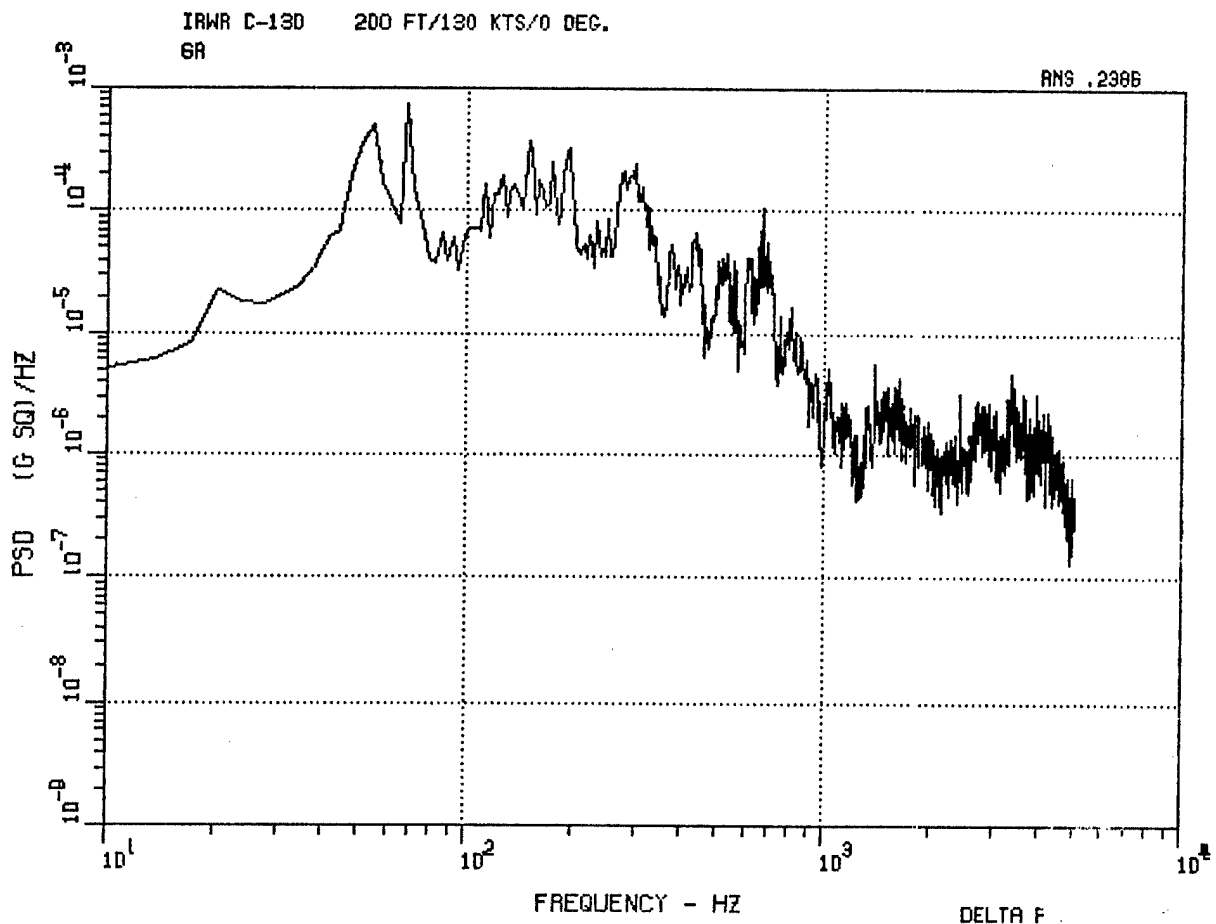
Figure 52. C-130 Aft Longitudinal Accelerometer 6A,  
200 Ft, 130 Kt, 0 Deg, and 1000 Ft, 130 Kt,  
0 Deg.

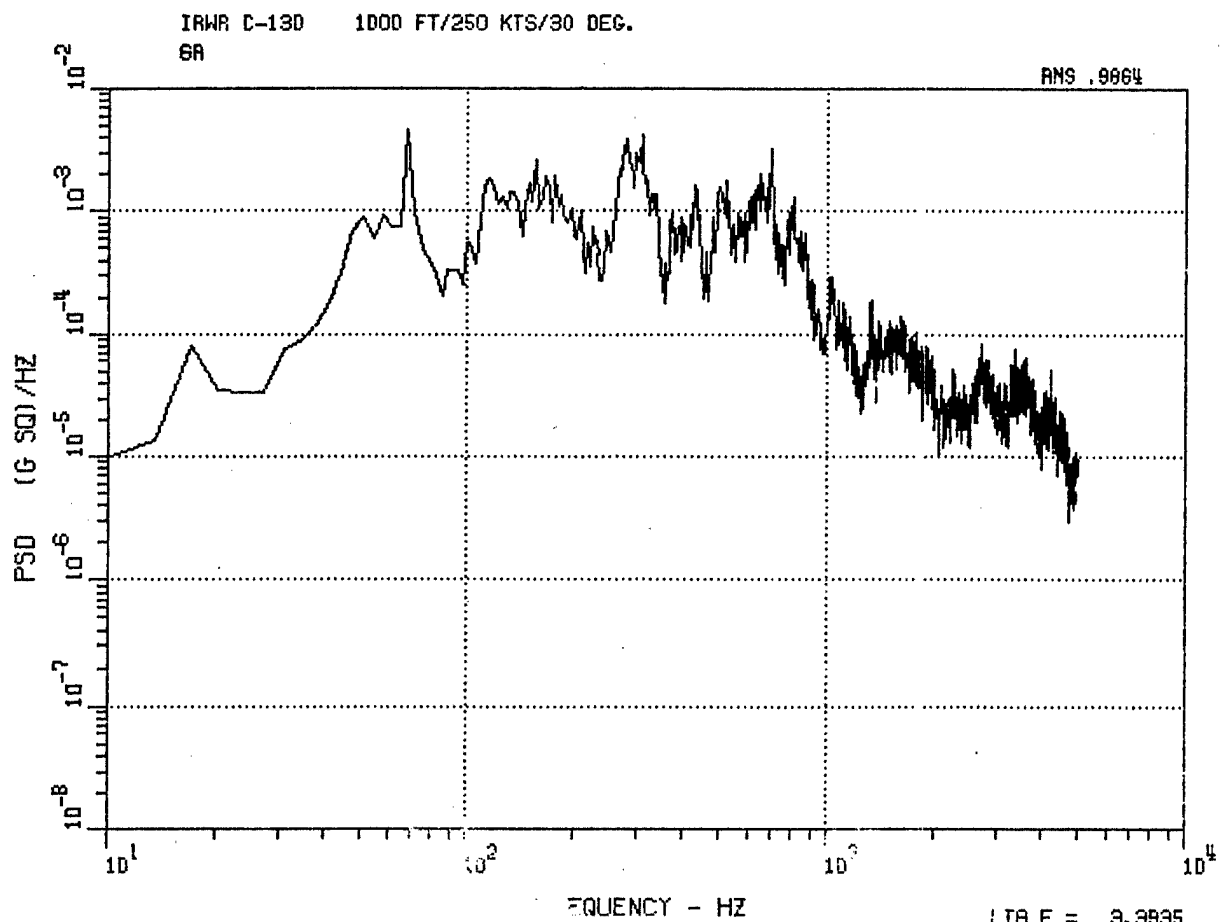
Figure 54. C-130 Aft Longitudinal Accelerometer 6A,  
1000 Ft, 250 Kt, 30 Deg, and 5000 Ft, 250 Kt,  
30 Deg.
