**AFWAL-TM-79-10**

**TEST REPORT ON INFRARED  
WARNING RECEIVER (IRWR) FLIGHT  
VIBRATION MEASUREMENTS**

**APRIL 1980**

| <b>14. ABSTRACT</b><br><br>This test report presents data which define the vibration environments experienced by two infrared warning receiver (IRWR) units mounted on the HH-53 helicopter and the C-130E transport aircraft. | | | | | | |

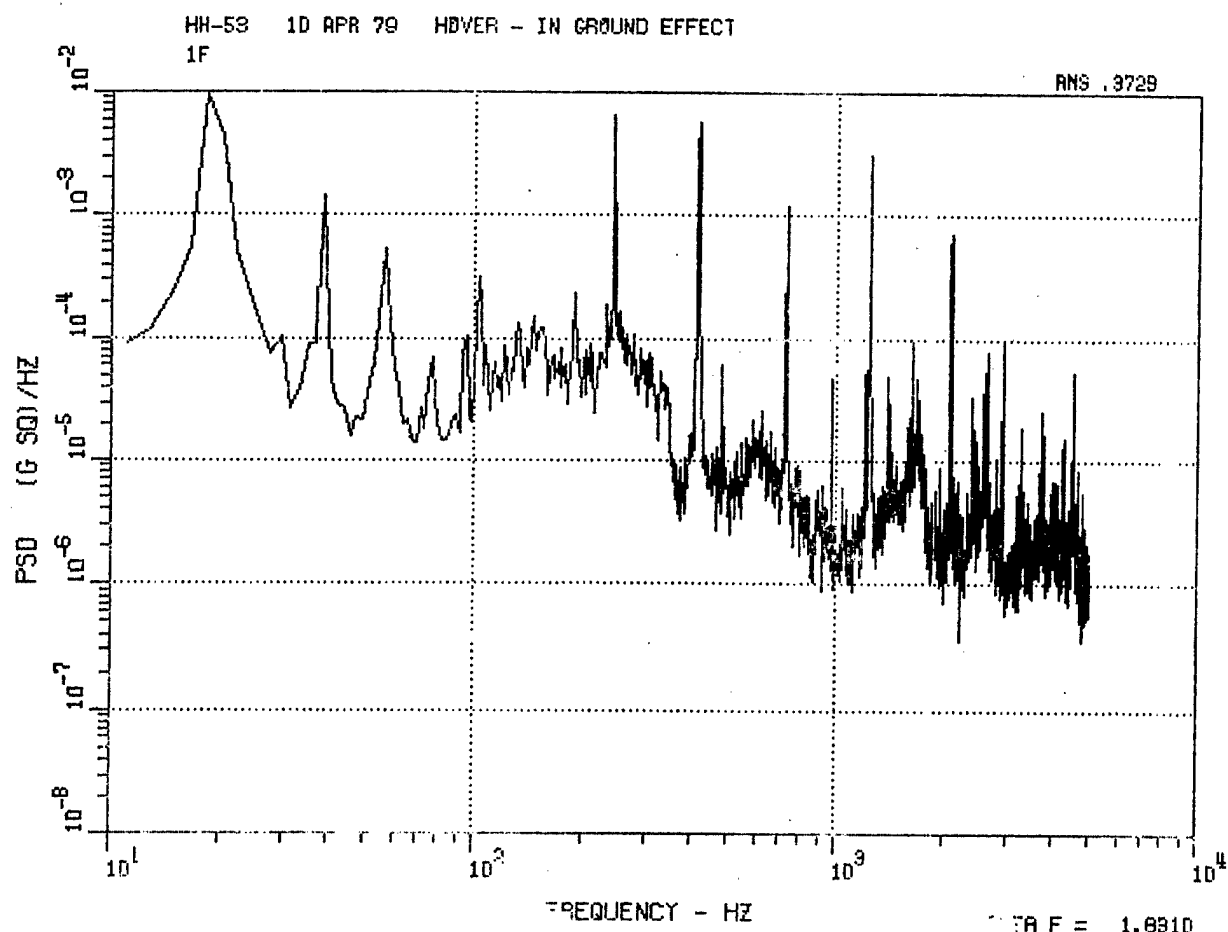
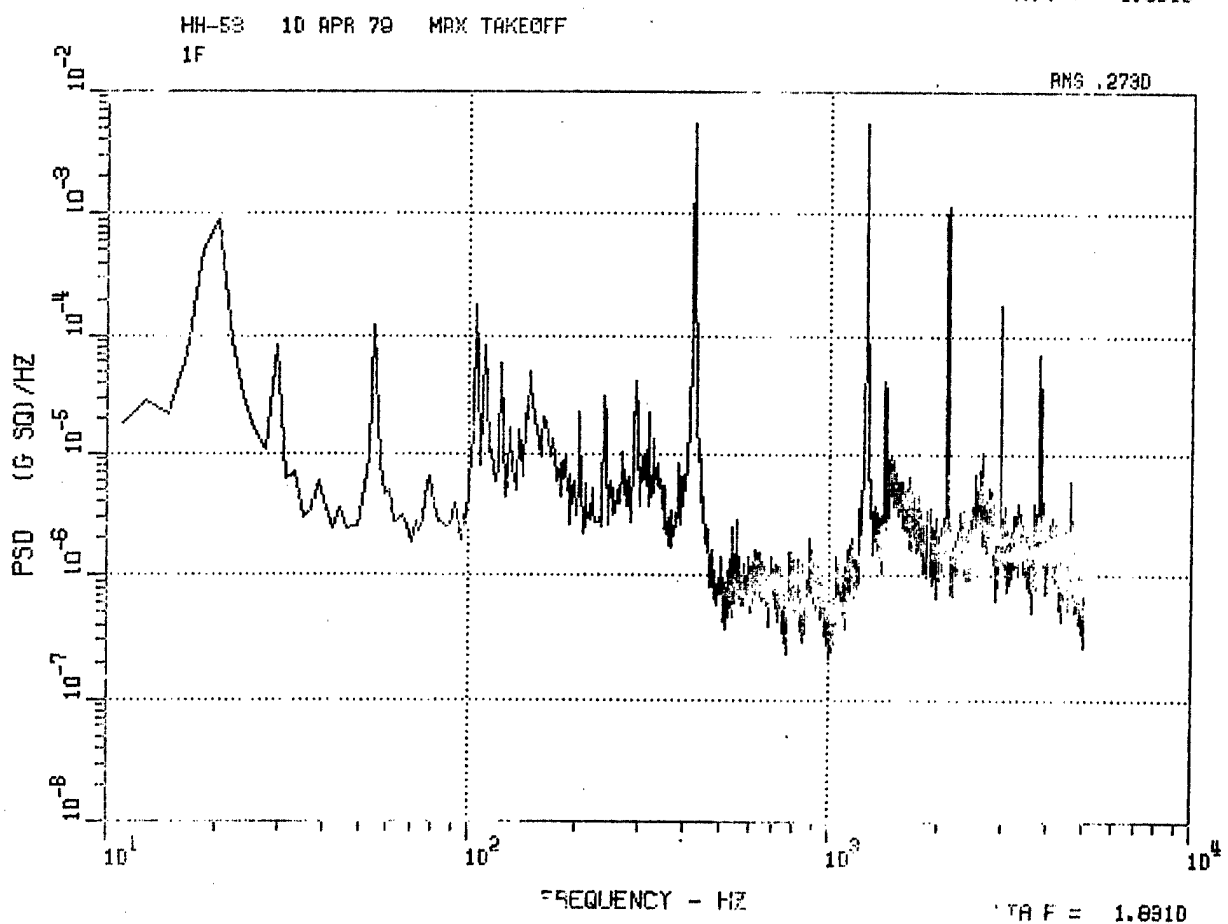
Figure 60. HH-53 Fwd Lateral Accelerometer 1F,  
Hover IGE and Max Takeoff.

The HH-53 spectra are shown in Figures 60-95 for five flight conditions and for the no-signal condition. The lateral vibration at the forward AAR-43 location is shown for Sensor 1F in Figures 60-62. The responses are less than 0.5g rms and are dominated by the rotor blade passage frequencies and by the narrowband engine frequencies. The vertical accelerations, shown for Sensor 4F in Figures 63-65, are no more than 0.25g rms and the spectra show a gradual decrease at frequencies from 100 Hz to 1000 Hz. The longitudinal accelerations, represented by Sensor 6F in Figures 66-68, are also very low, reaching less than 0.3g. The noise responses from microphone MF, shown in Figures 69-71, are a moderate 122-130 dB. The greatest response is at the 18-Hz rotor slapping frequency.

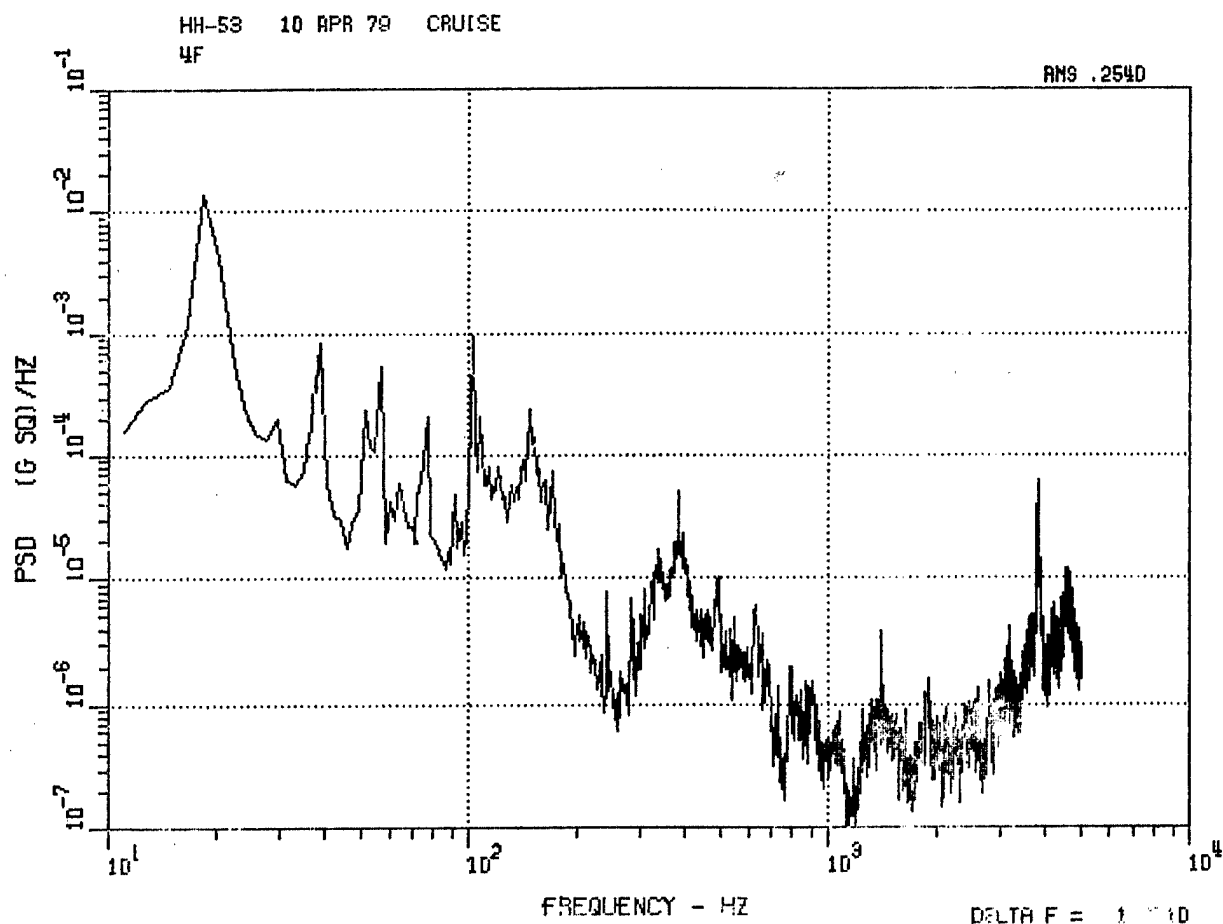
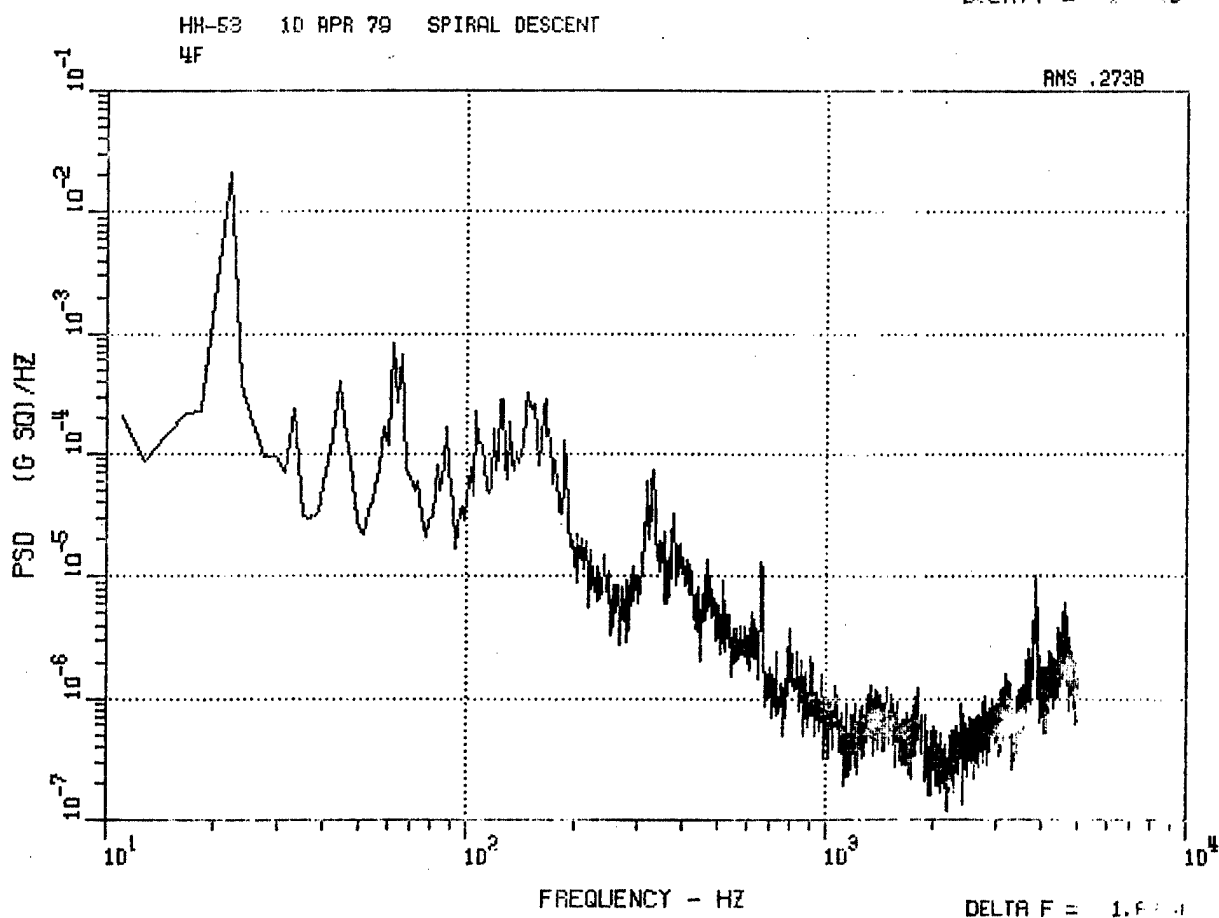
Figure 64. HH-53 Fwd Vertical Accelerometer 4F, Cruise and Spiral Descent.

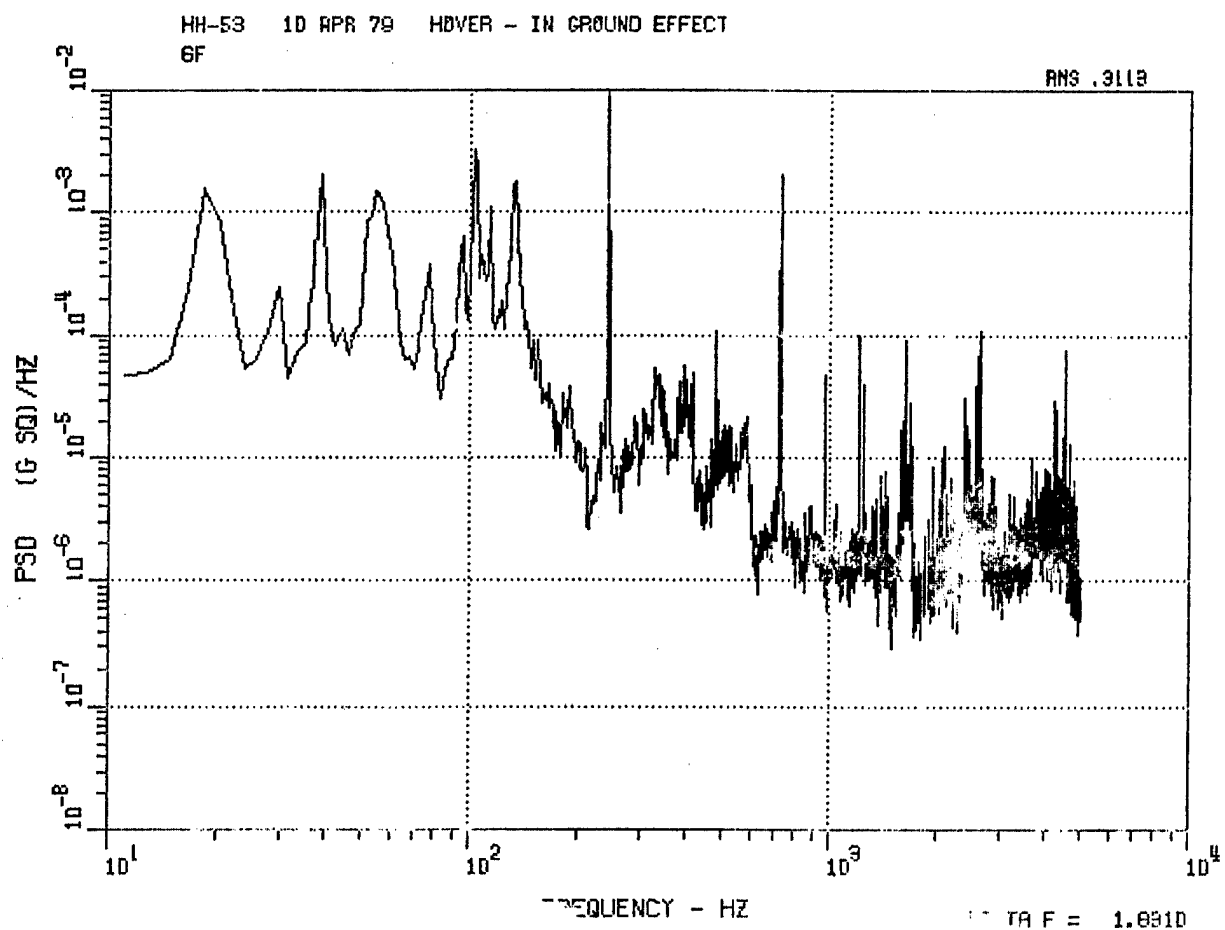
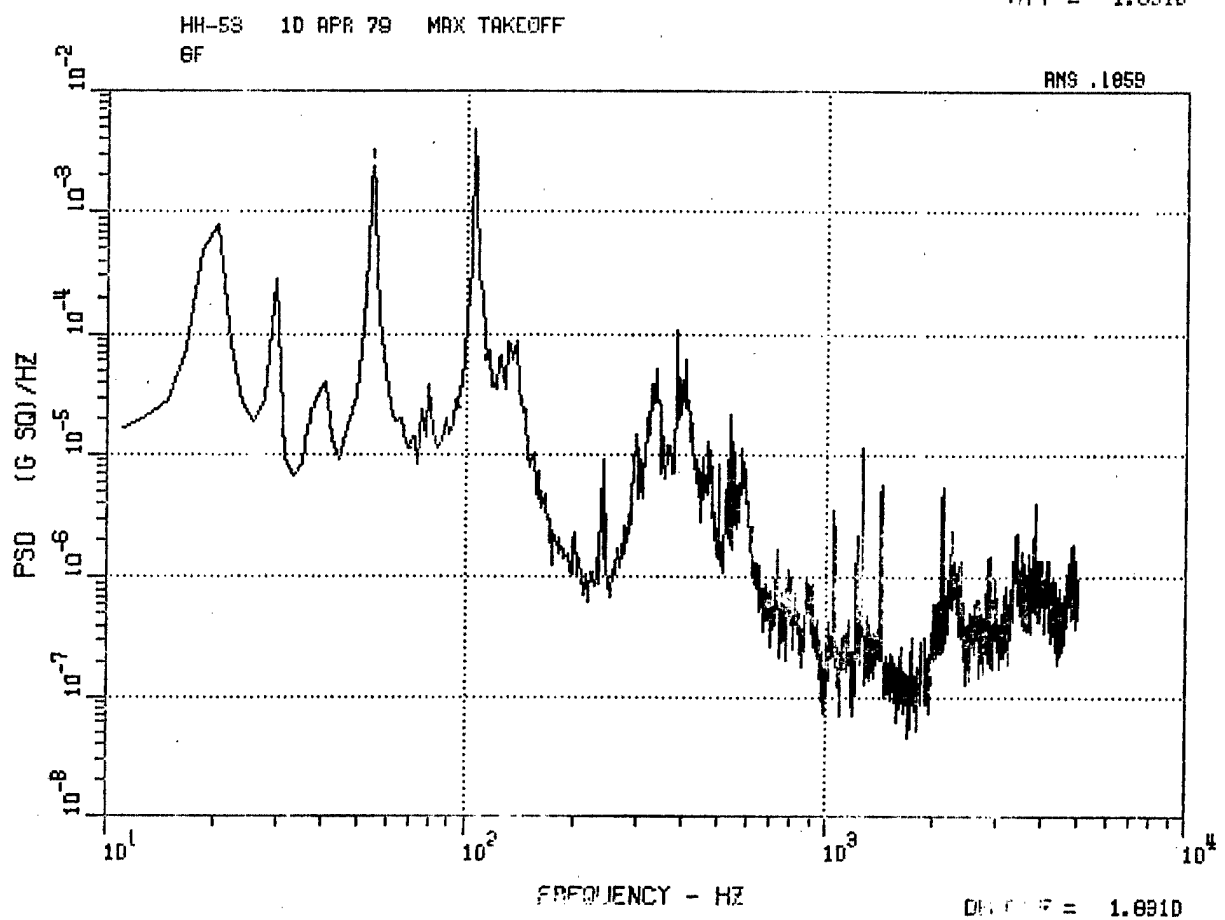
Figure 66. HH-53 Fwd Longitudinal Accelerometer 6F,  
Hover IGE and Max Takeoff.

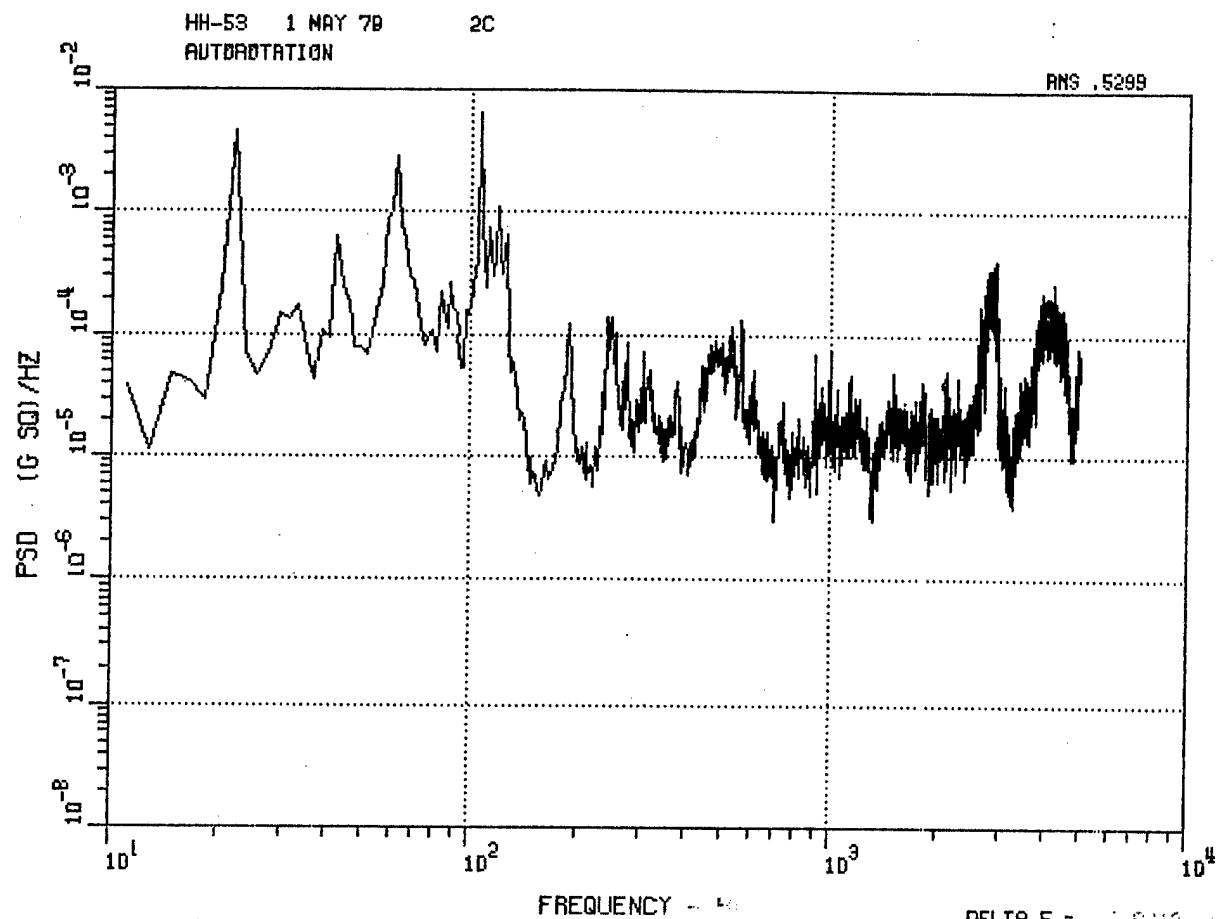
Figure 74. HH-53 Center Vertical Accelerometer 2C,  
Autorotation and No-Signal Record.

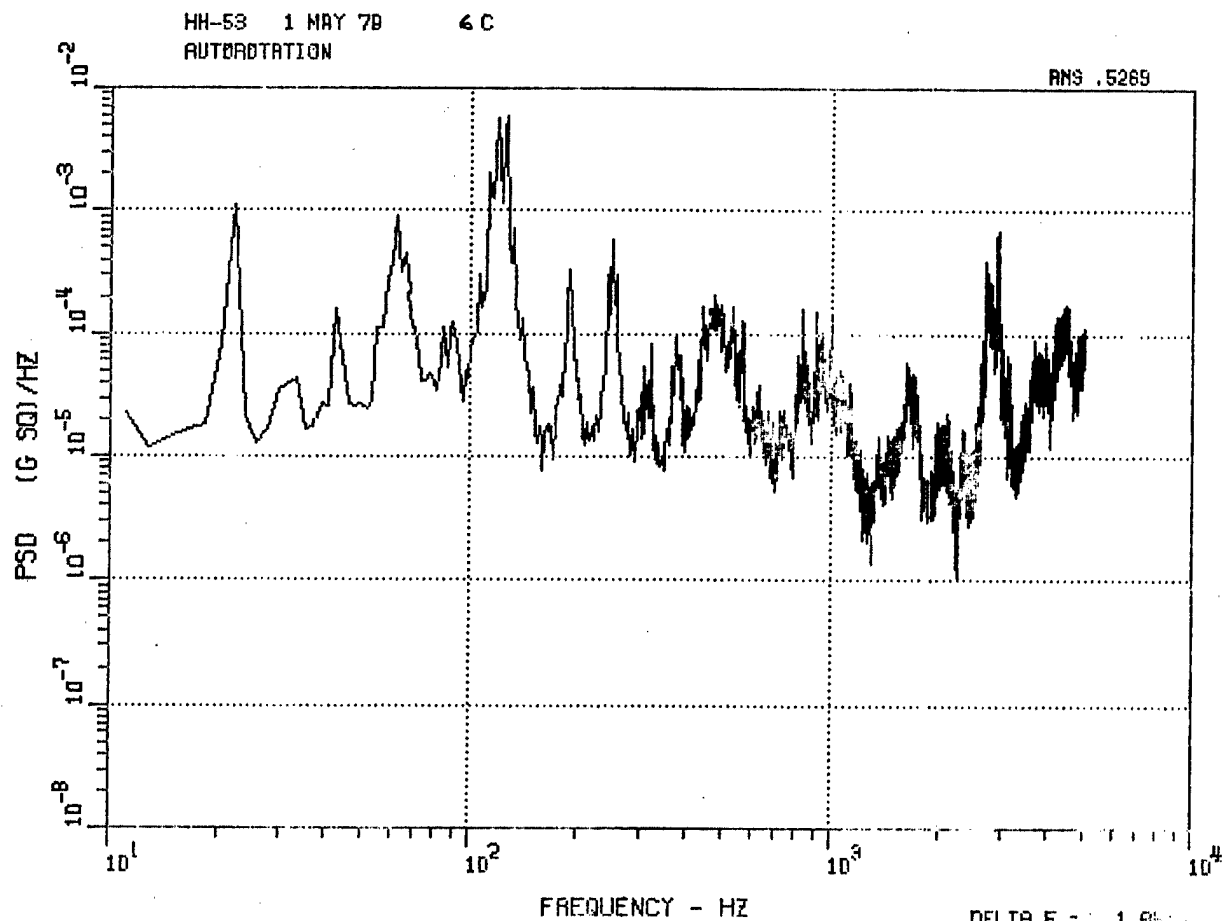
Figure 80. HH-53 Center Longitudinal Accelerometer 6C, Autorotation and No-Signal Record.

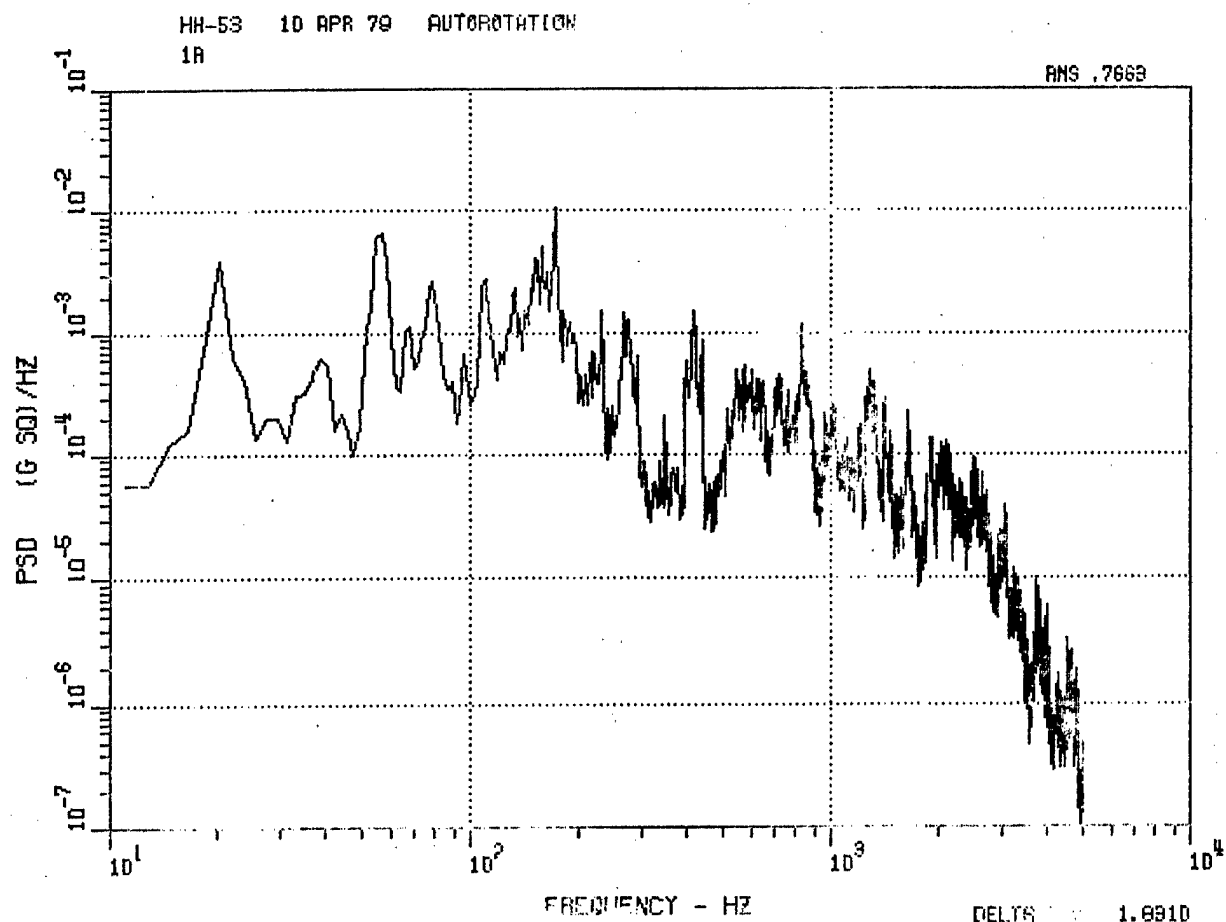
Figure 86. HH-53 Aft Lateral Accelerometer 1A,  
Autorotation and No-Signal Record.

The aft AAR-43 location showed the highest vibration levels on the helicopter. The lateral accelerations (Sensor 1A) are shown in Figures 84-86, the vertical accelerations (Sensor 3A) are shown in Figures 87-89, and the longitudinal accelerations (Sensor 6A) are shown in Figures 90-92. The microphone data (MA), shown in Figures 93-95, show sound pressure levels of 111-124 dB, lower than the forward or center locations. The HH-53 helicopter vibration levels are generally lower than the corresponding C-130 levels, and are not expected to cause any difficulty in sensor operation.

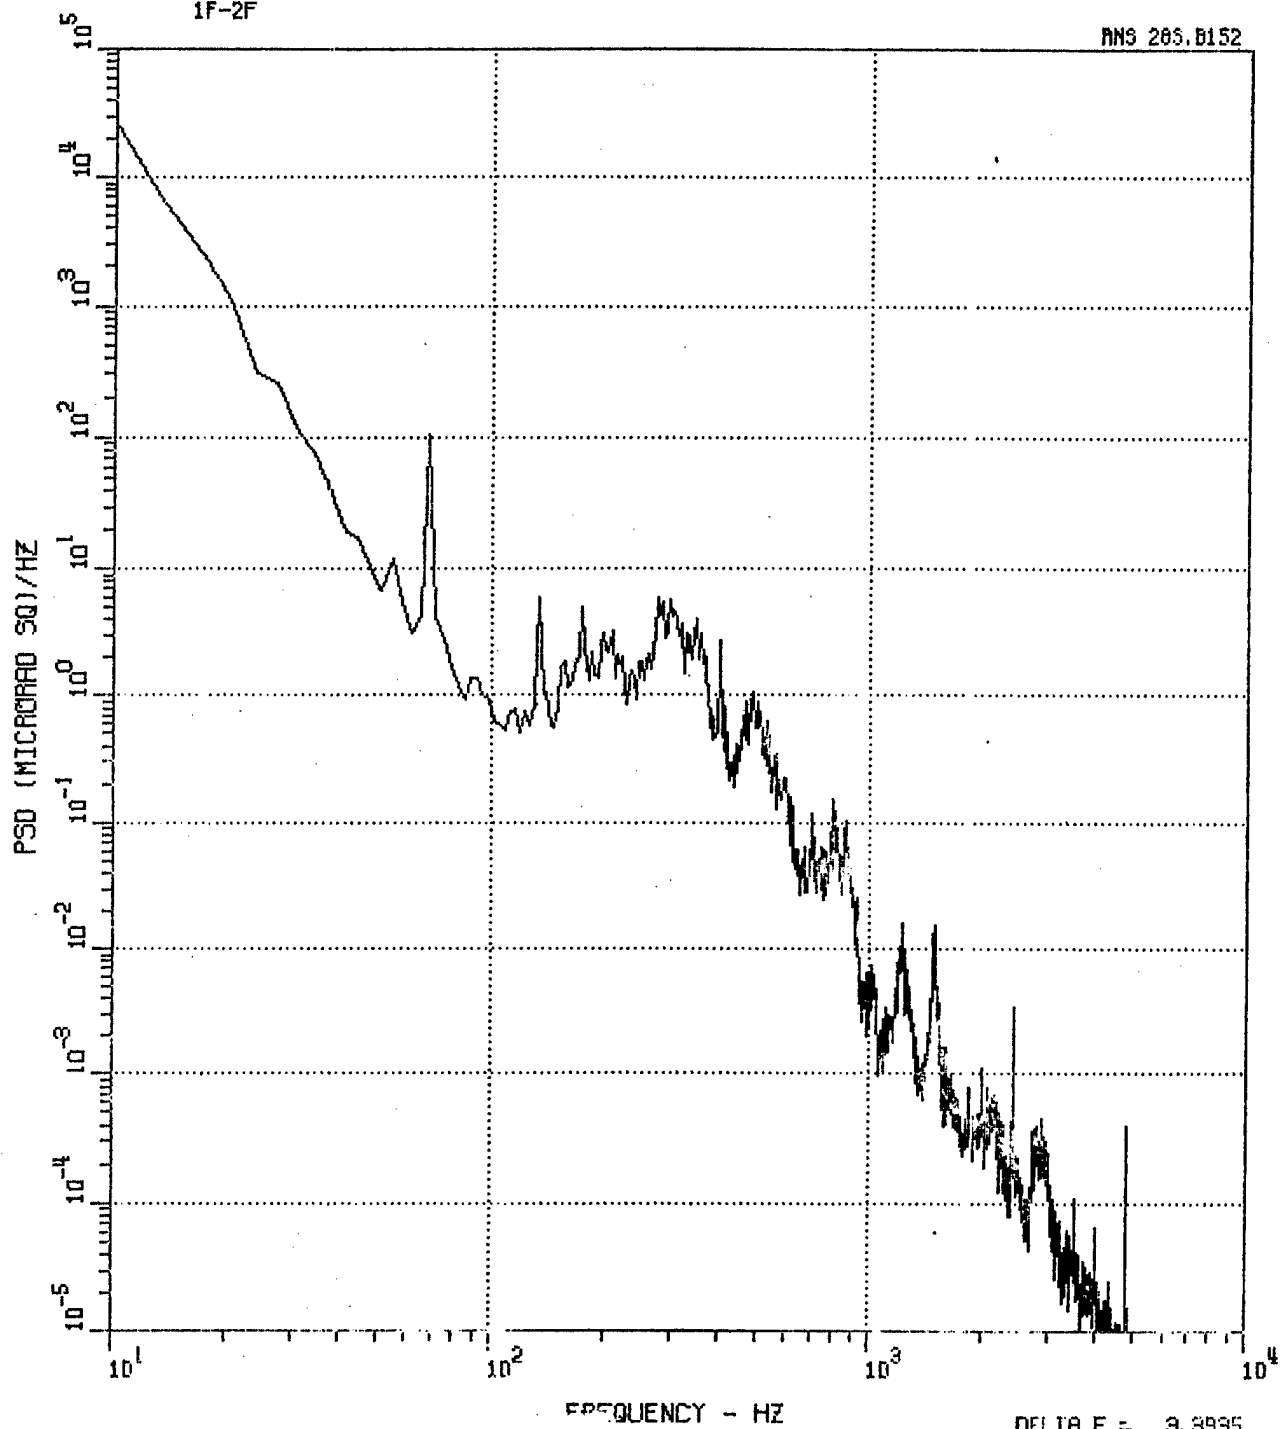
Figure 96. C-130 Fwd Roll PSD, 1F-2F, 1000 Ft, 250 Kt, 30 Deg.

Several pairs of linear accelerometer signals on the C-130 were combined to produce a measure of the angular accelerations experienced by the sensors. The sensors chosen are shown in Table 7 and the results are shown in Figures 96-100 for the selected flight condition of 250 knots, 30° bank, and 1000 feet altitude. The results, shown in PSDs of microradians squared per hertz, are for information only and were not used to evaluate the sensor vibration environments.

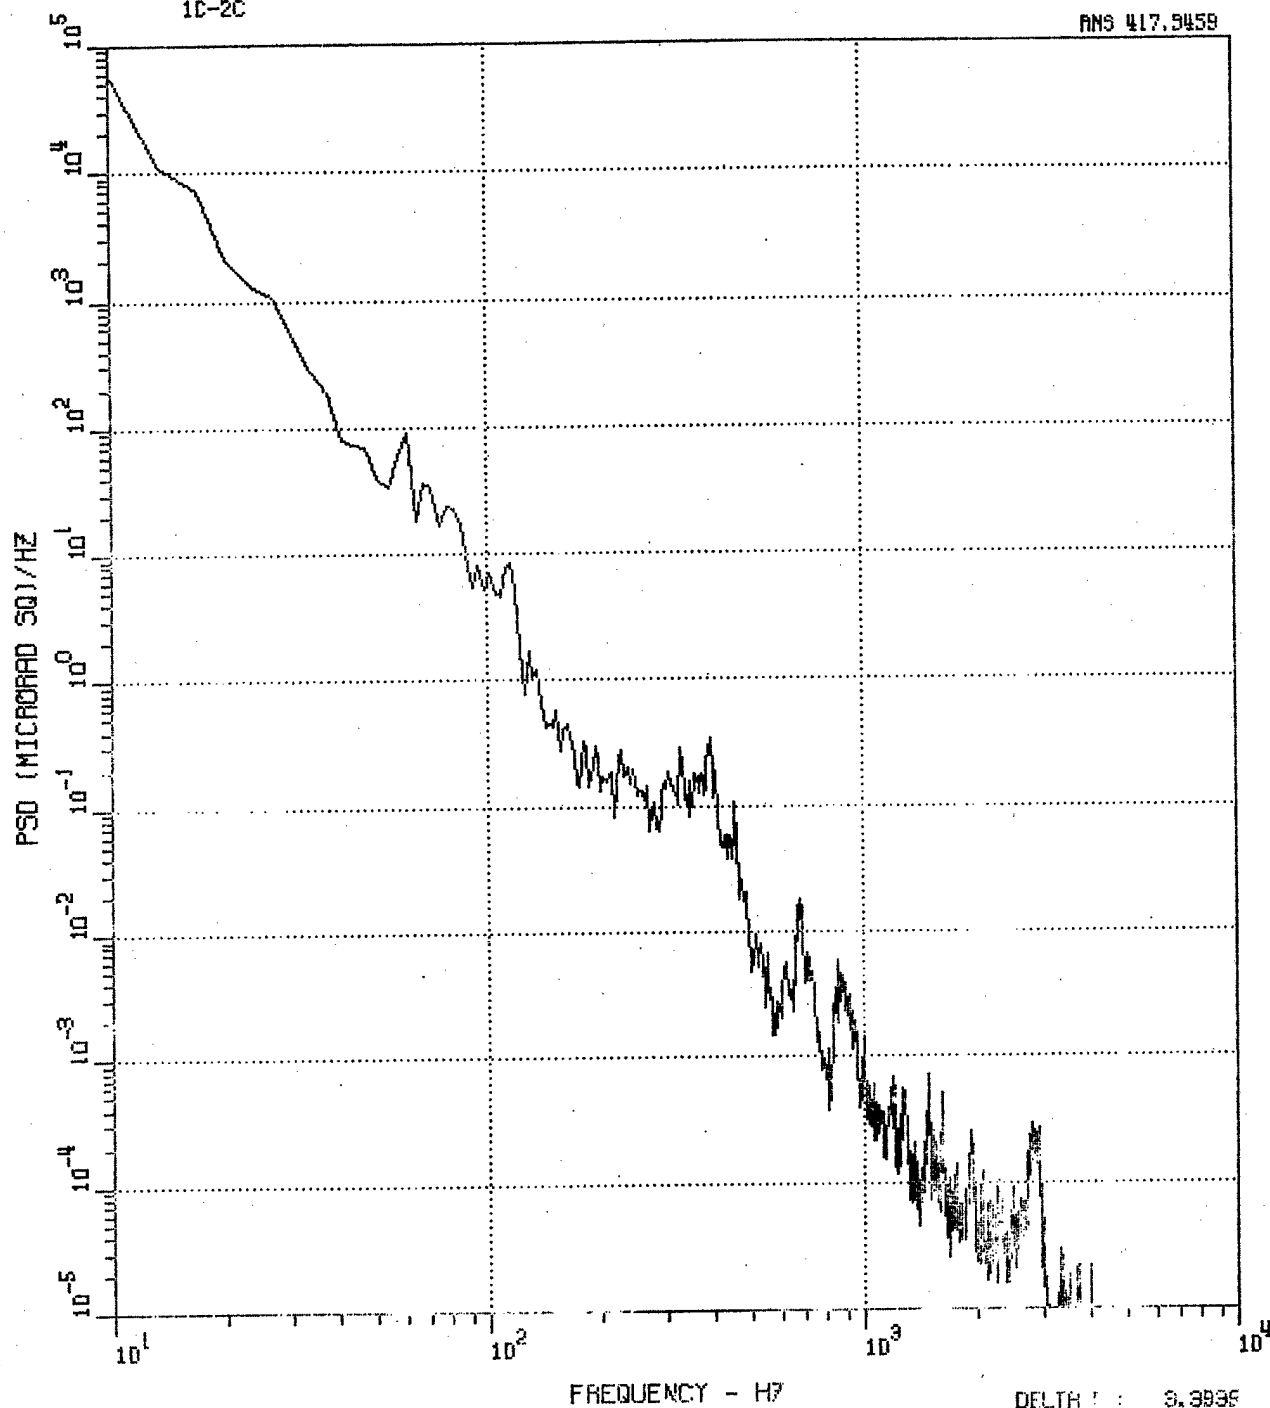
Figure 97. C-130 Center Roll PSD, 1C-2C, 1000 Ft, 250 Kt, 30 Deg.

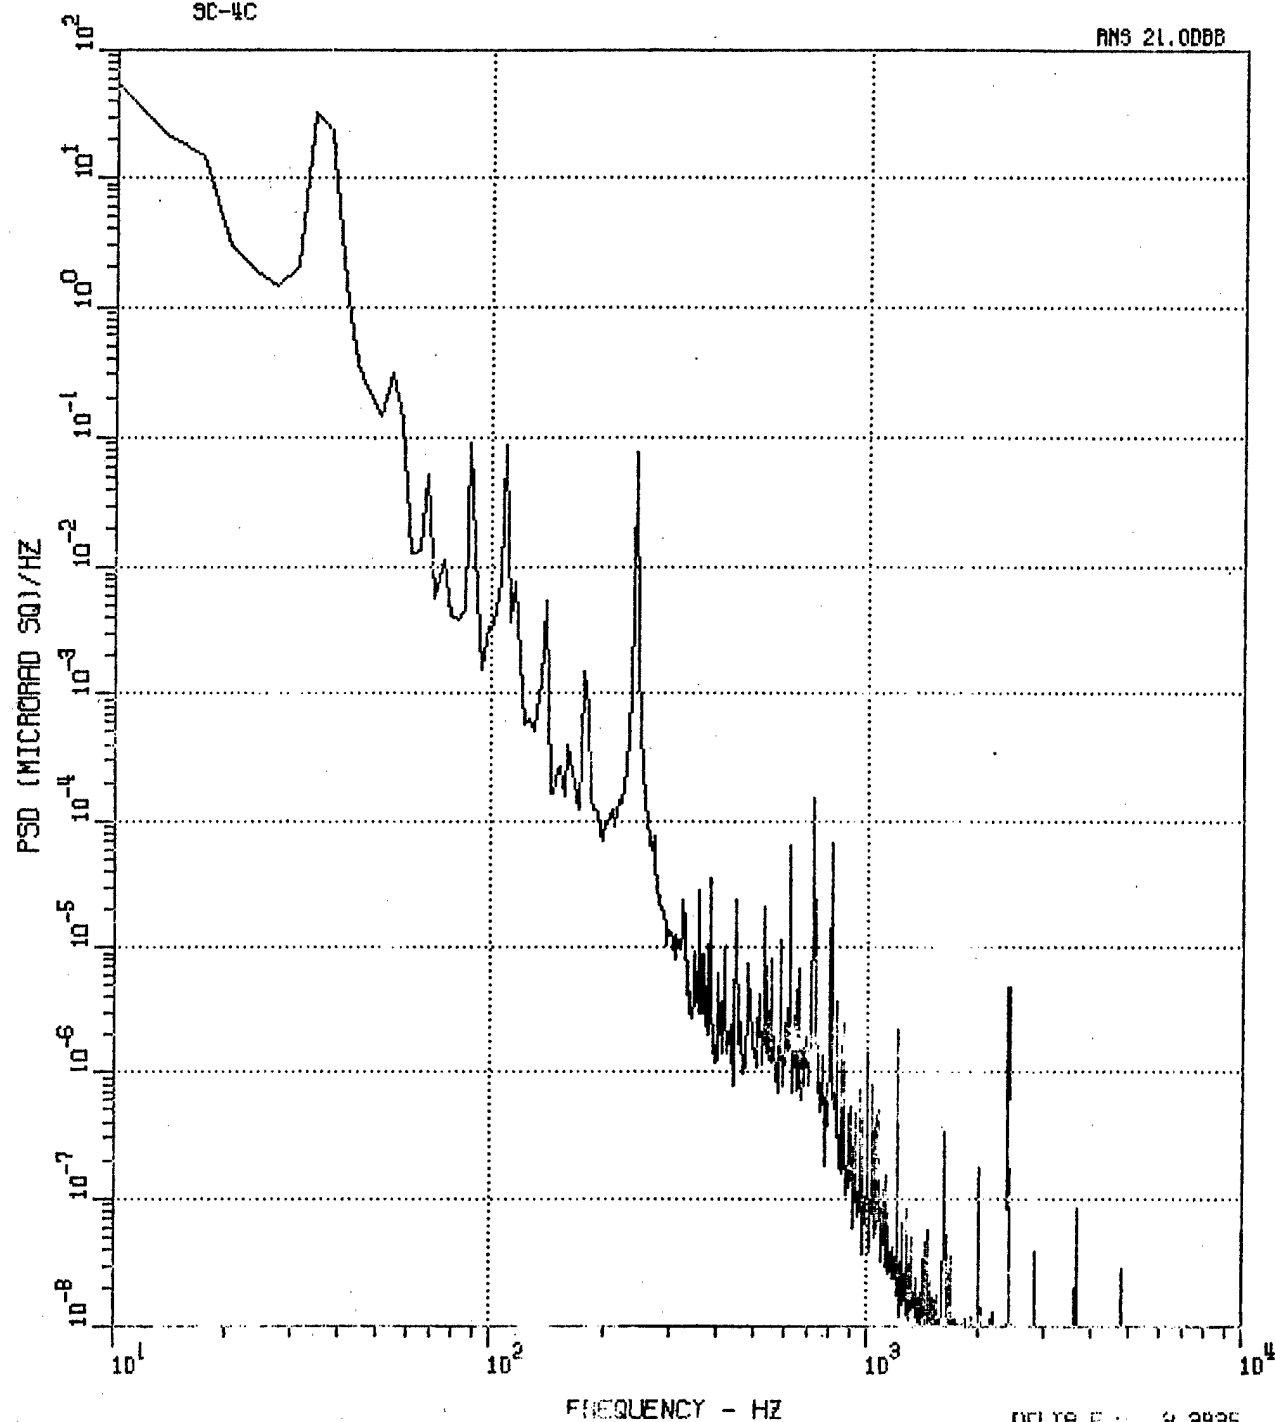
Figure 98. C-130 Center Yaw PSD; 3C-4C, 1000 Ft, 250 Kt, 30 Deg.

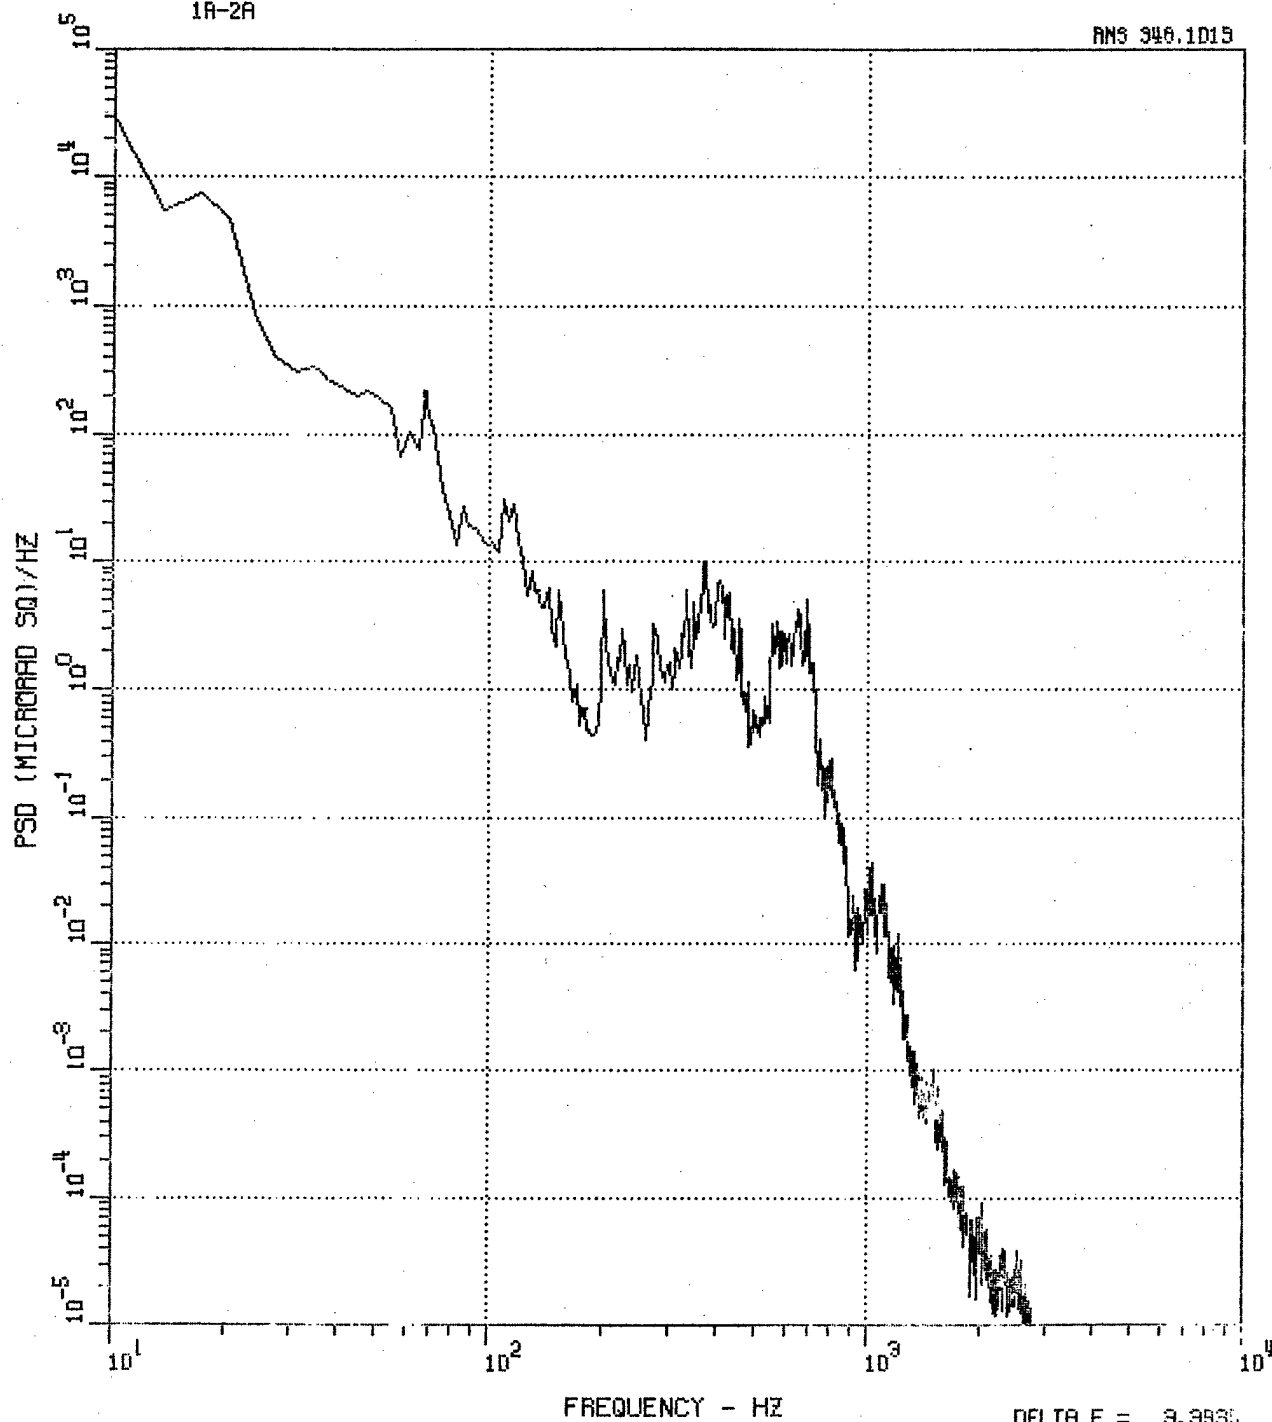
Figure 99. C-130 Aft Roll PSD, 1A-2A, 1000 Ft, 250 Kt, 30 Deg. DELTA F = 3.9835
