NRL/FR/5520--03-10,048

# **Dragon Warrior Communications Relay Testing Using the K-MAX Helicopter**

April 14, 2003

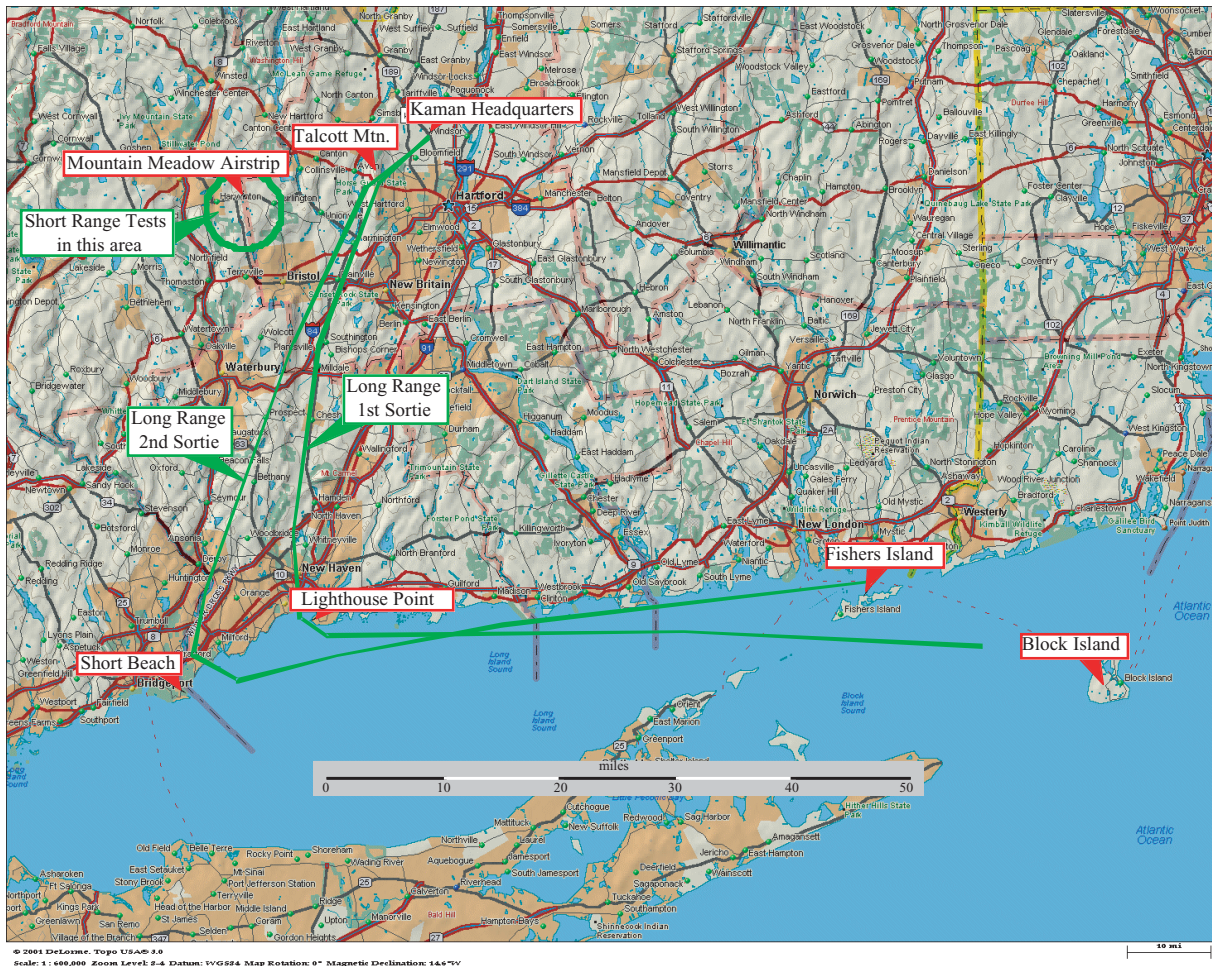
Fig. 1 — Test area for the Comm Relay tests supported both short-range and long-range tests that included overland and overwater flight paths

Ground-to-ground tests were performed near Kaman Headquarters in Bloomfield, CT; the low-altitude short-range tests were performed in the vicinity of Mountain Meadow Airstrip in Burlington, CT, and the long-range tests were performed in two sorties over central Connecticut and Long Island Sound. Sortie 1 covered the area from Bloomfield, CT, to Lighthouse Point, CT, to Block Island, RI. Sortie 2 was from Bloomfield, CT, to Short Beach, CT, to Fishers Island, CT. No ground station had clear line-of-sight to any other ground station. Table 1 lists distances from various test. Aircraft flight pattern and altitudes were based on FAA flight restrictions and weather conditions. Overwater altitude was typically 4500 to 5500 ft. Overland altitude varied from 1500 to 4500 ft.

For the first sortie, the flight path (shown in Fig. 1) began at Kaman headquarters, went past Talcott Mountain, past Lighthouse Point, to Block Island, and returned by retracing the same path. Talcott Mountain provided a good “high ground” vantage point for maintaining long LOS over much of the terrain. Lighthouse Point provided a good vantage point over water to the south. However, as we discovered during this test, the view to the east (which is the direction the flight path followed) was obscured by a nearby tree line. Figure 13 shows the connectivity between the K-MAX aircraft and the ground station at Talcott Mountain as a yellow line, and connectivity between the K-MAX and the ground station at Lighthouse Point is shown in purple. Areas where the yellow and purple lines are adjacent to each other is where the airborne node functions as a relay between the two ground stations.

For the second sortie, the flight path (see Fig. 1) began at Kaman headquarters, went past Talcott Mountain, to the vicinity of Short Beach, to Fishers Island, and returned by retracing the same path. Figure 14 shows the connectivity between the K-MAX aircraft and the ground stations for Sortie 2.

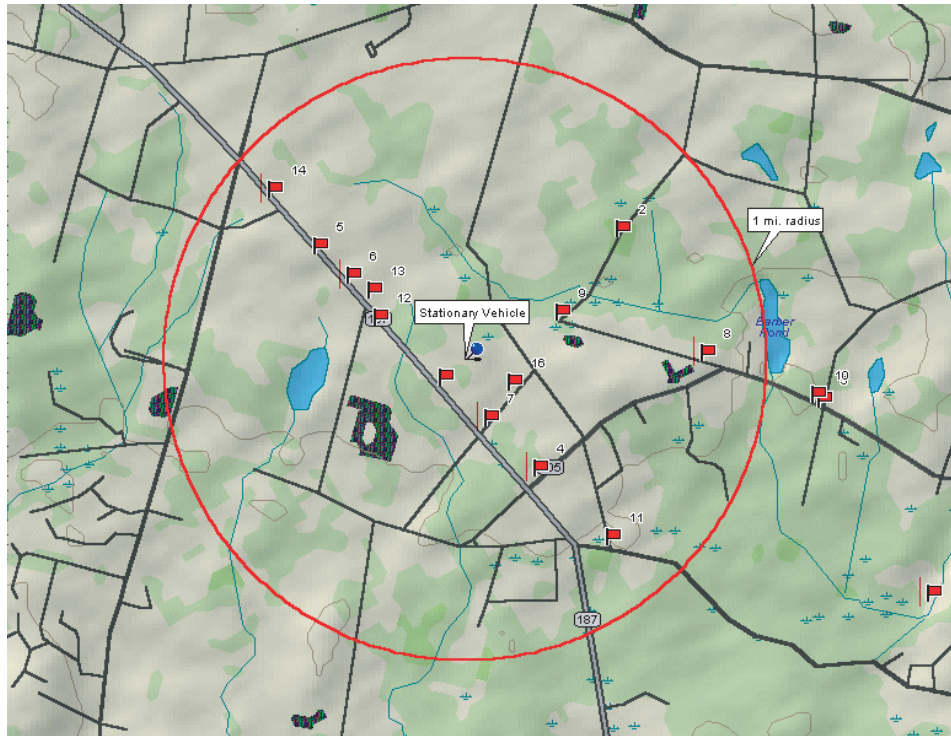
Fig. 11 — The ground-to-ground tests were performed around a central stationary vehicle within a 1-mi radius (shown as a red circle)

The test setup comprised one stationary vehicle with a second mobile vehicle following radial patterns emanating outward from the fixed node's position. Figure 11 shows the area of the tests, with the stationary vehicle positioned in the center, and flags positioned at locations where the signal was lost (when the mobile vehicle was moving away from the stationary vehicle), or where the signal was recovered (when moving toward the stationary vehicle). A circle with a 1-mi radius from the stationary node is drawn for reference.

The results of this test showed that the maximum achievable range was consistently less than 1-mi. Even though the radios were transmitting at 10 W, the foliage, terrain, and nearby buildings significantly blocked the VRC-99A's 1.4 GHz radio signals. Under these conditions, it is apparent that an airborne relay is necessary to provide connectivity between these radios, even at close range.
