AFRL-VA-WP-TR-2003-3010

**CORROSION PIT TO CRACK
TRANSITION**

Delivery Order 0051: Task 2

Final Report for 15 May 2002 – 20 December 2002

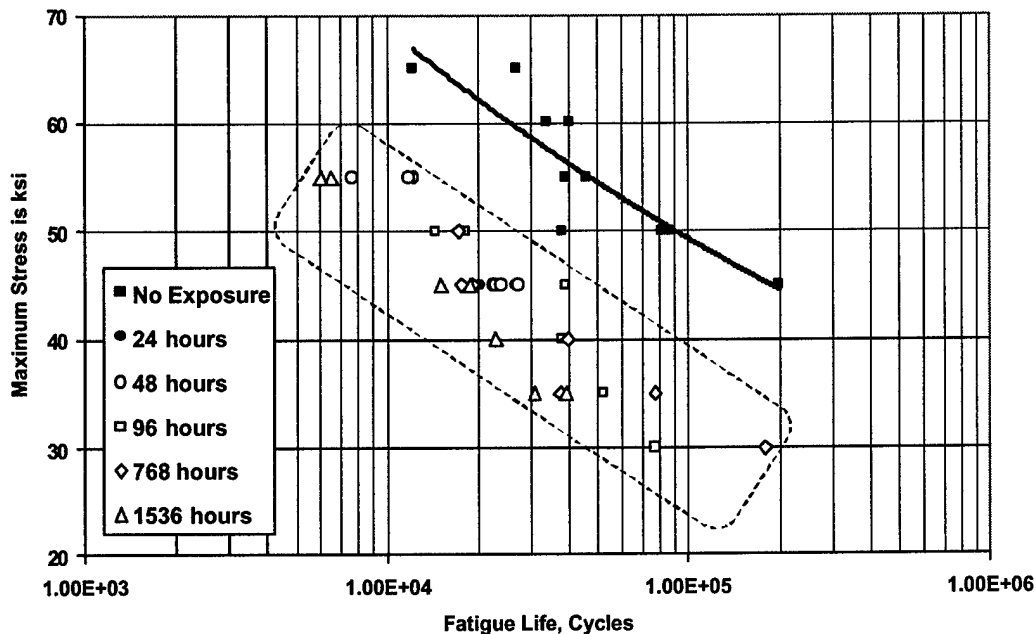
Figure 16. Fatigue Lives of Corroded and Baseline 7075-T6 Specimens

The measured fatigue lives of the 34 corroded specimens examined in this investigation are shown in Figure 16. The measured lives of bare, noncorroded baseline 7075-T6 specimens are also shown. The life of the noncorroded 7075-T6 specimen at a maximum stress level of 45 ksi, shown as 200,000 cycles, was obtained from Mil-HdBk-5. Consistent with the results of all earlier studies, fatigue life of 7075-T6 is reduced drastically once corrosion damage is present in the specimen surface, as evidenced by the large reduction in life following only 24 hours exposure. After this initial reduction, further corrosion exposure appears to reduce life only little.
