**A Review of Australian and
New Zealand Investigations
on Aeronautical Fatigue
During the Period April 2001
to March 2003**

DSTO-TN-0489

Air Vehicles Division
Platforms Sciences Laboratory

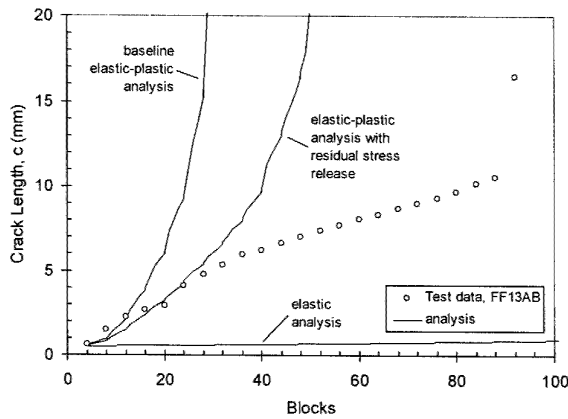
Figure 11: Comparison of Experimental and Analytical Crack Growth Results.

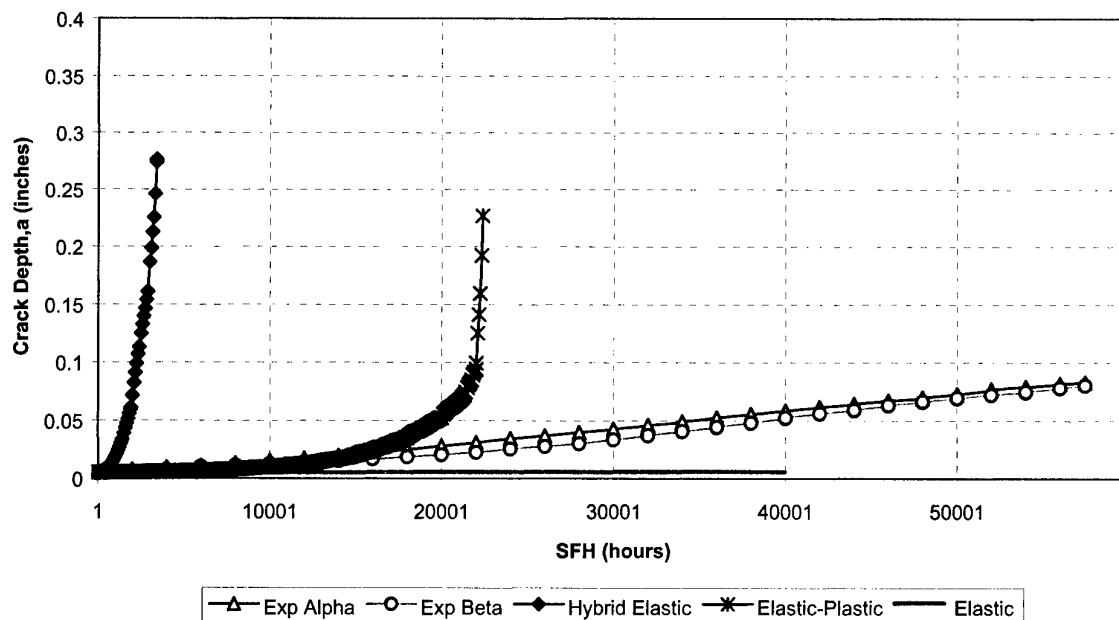
RS "I" Experimental and Computational Results

Figure 13: Experimental and Analytical Results for SRO # 2 Representative Specimen

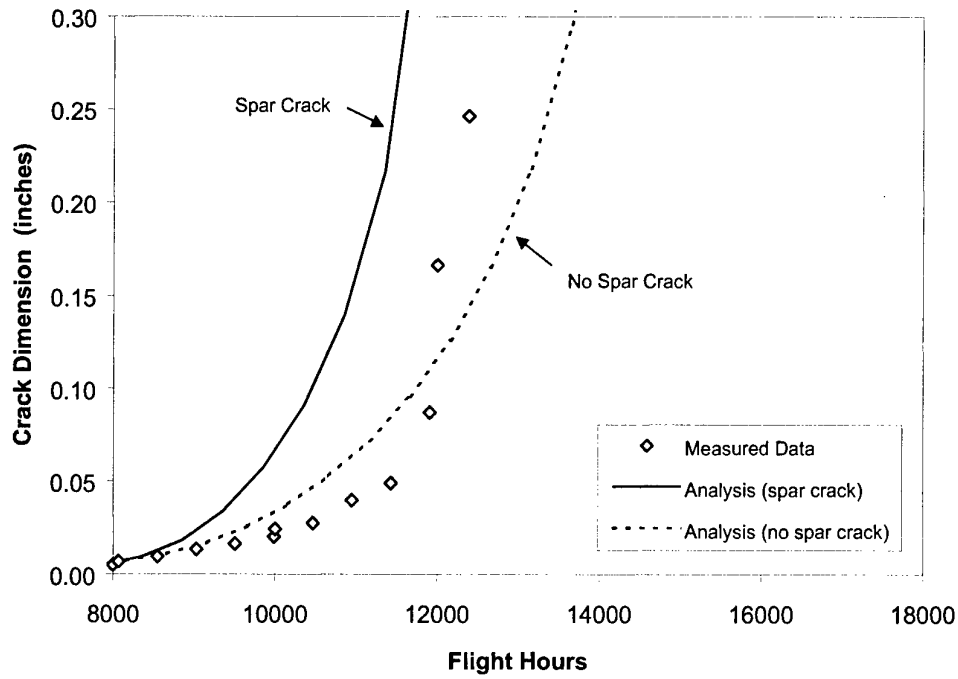
Figure 15: Crack Growth Correlation at Failure Location

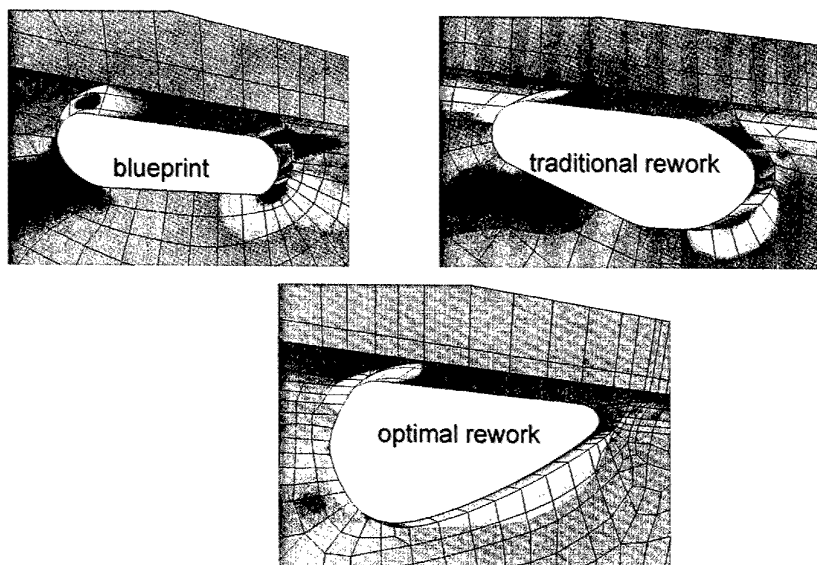
The F-111 wing optimisation modification (WOM) has been accepted by the RAAF, and fleet-wide implementation commenced in 2002. The modification is effected by electro discharge machining the free-form optimal shapes in the D6ac steel wing pivot fitting. A number of F-111 wing sets (including replacement wing sets) have been modified.

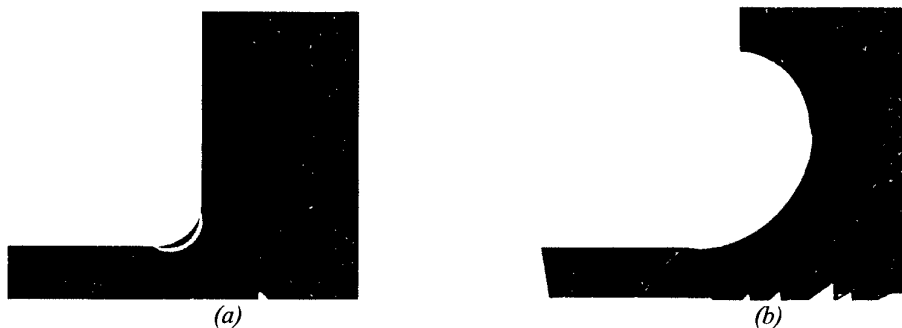
Figure 20: Local distribution of maximum principal stress for F-111 WPF bush: (a) nominal fillet, and (b) optimal non-circular shaped fillet (both rotated by 90 degrees clockwise, as compared to Figure 19).

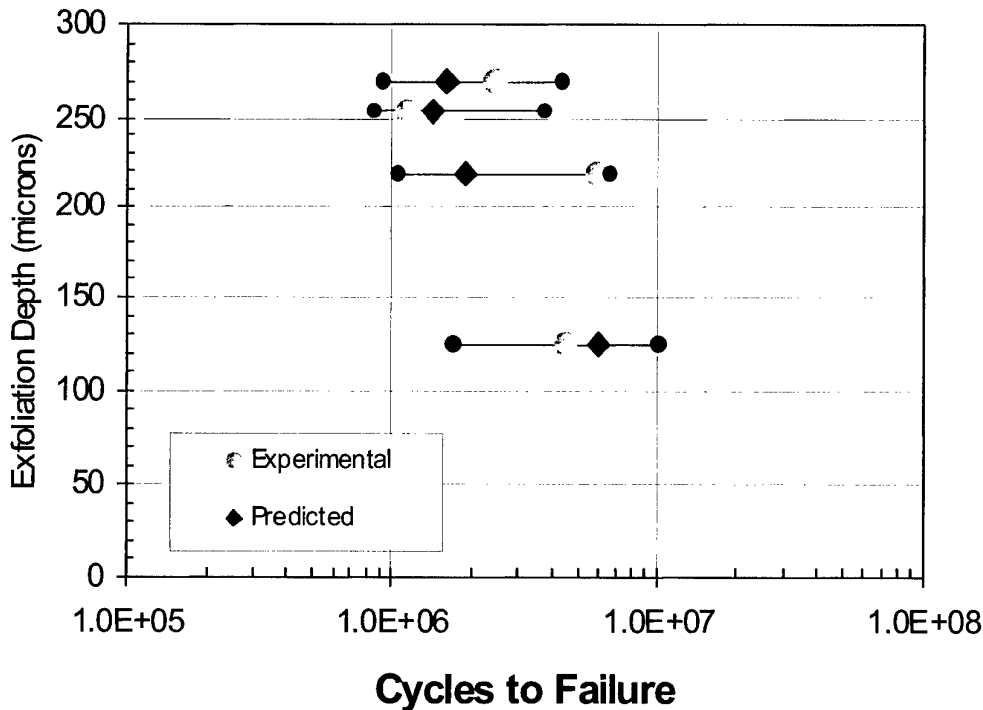
Figure 23: Prediction of remaining life for pitted steel specimens, and experimental results.

This model is now being used to assess the status of a number of durability parts on the F-111. By inputting the ECS data based on fleet pitting data a determination can be made as to the effect of corrosion pitting on inspection intervals.

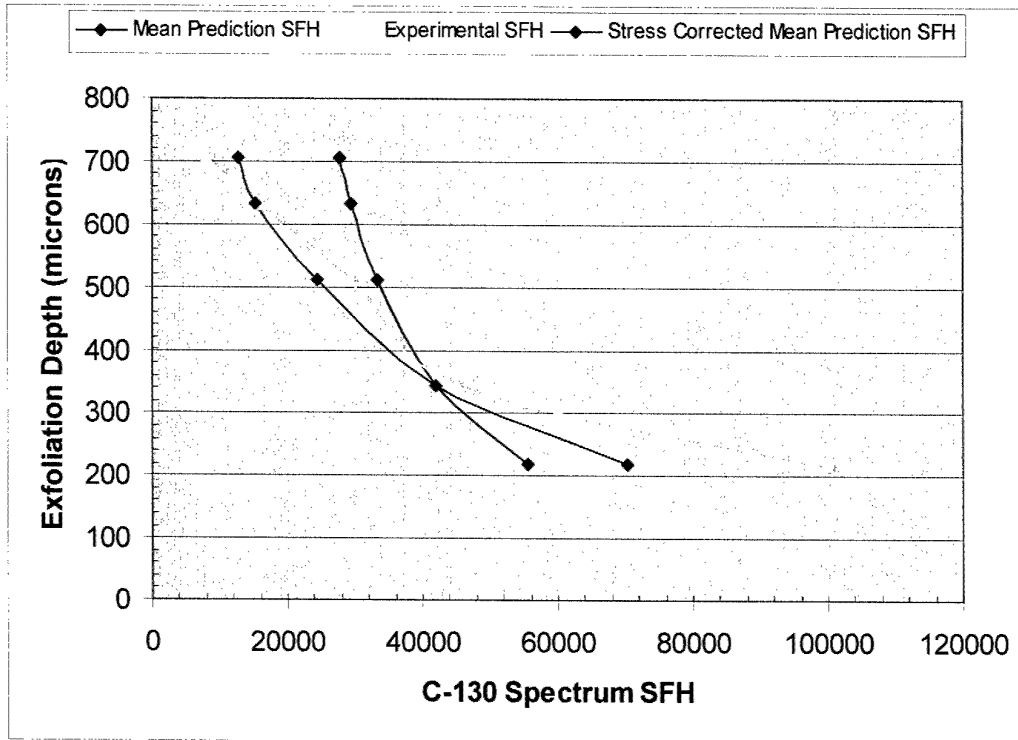
Figure 24: Exfoliation Corrosion modelling - a comparison of experimental fatigue life results vs mean prediction and mean prediction corrected for stress.

A very detailed but impractical model was initially developed for exfoliation. After the excellent results with pitting corrosion an ECS approach was tested. Some recent results are shown in Figure 24.

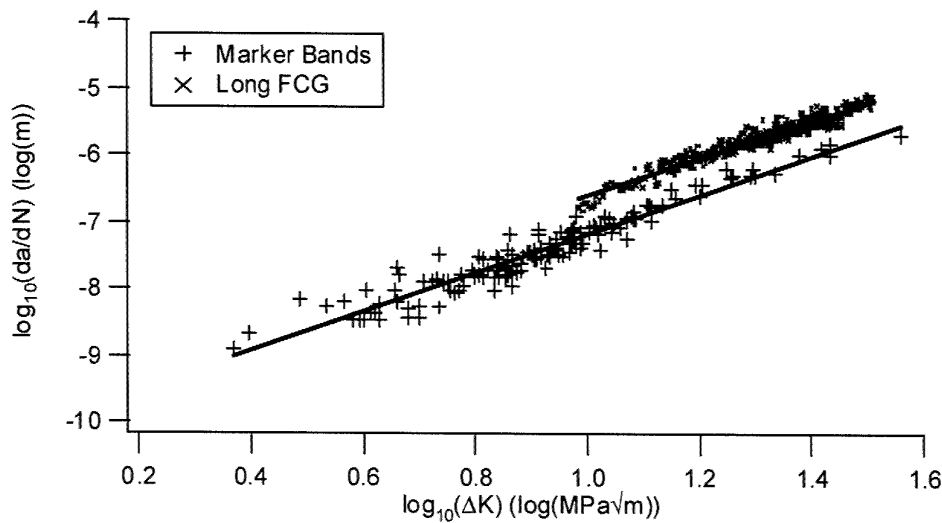
Figure 26: Comparison of long fatigue crack growth data with that obtained from marker band analysis

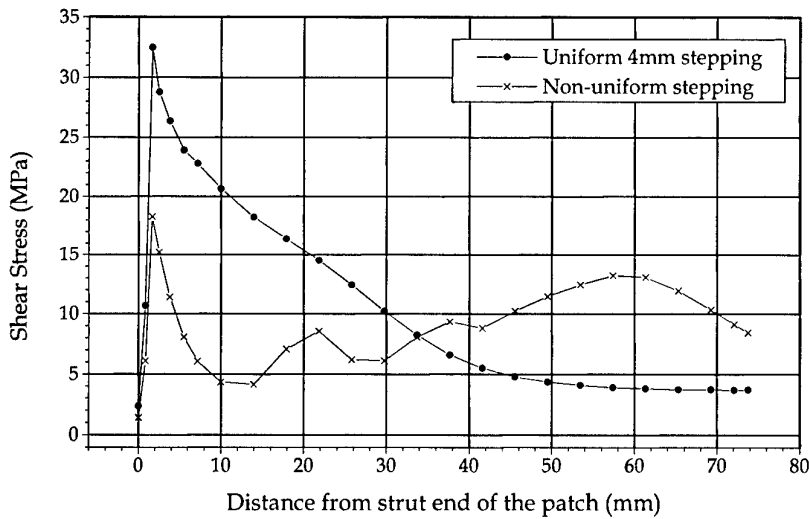
Figure 28: Results for taper stepping of bonded reinforcement to an F/A-18 aileron hinge, (a) stepping arrangements, and (b) adhesive shear stress distributions

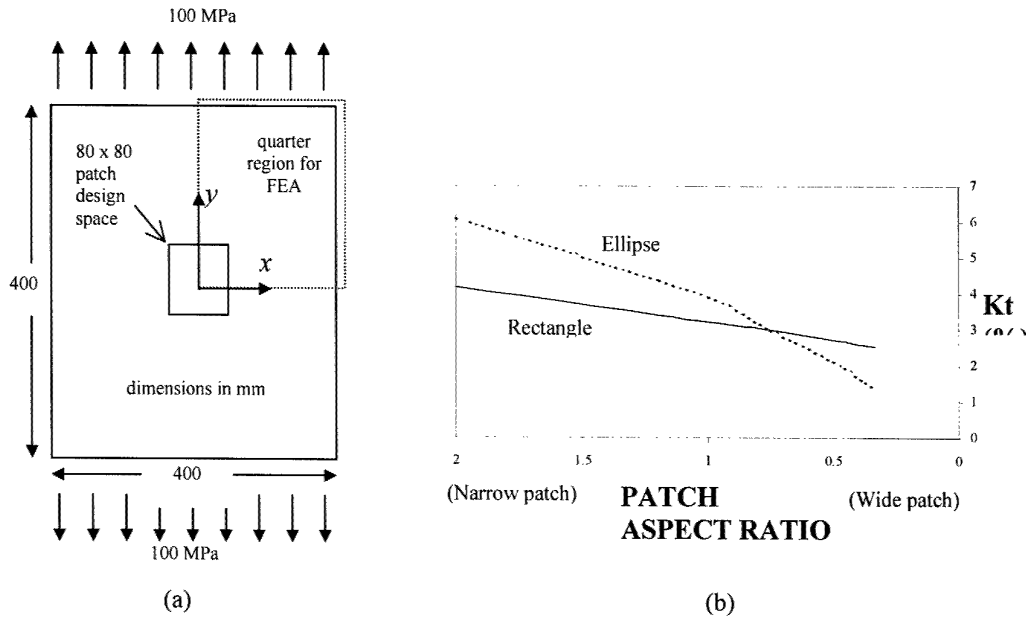
Figure 29: In-plane shape study of patch on plate, (a) geometry and loading arrangement for single layer of boron-epoxy patch on a 3 mm thick aluminium plate, and (b) percentage increase in plate peak stress concentration, as a function of patch aspect ratio.

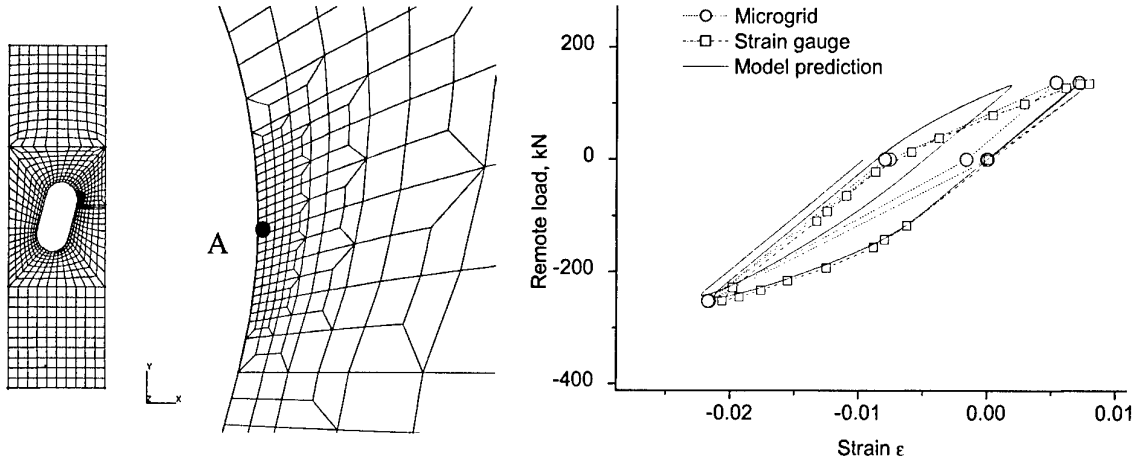
Finite element model for a coupon representing a wing pivot fitting on a military aircraft, with an oval hole. (a) the whole model, (b) enlarged view of the critical location.
