TECHNICAL REPORT ARCCB-TR-03004

**THERMAL DAMAGE, CRACKING, AND RAPID  
EROSION OF CANNON BORE COATINGS**

**JOHN H. UNDERWOOD  
ANTHONY P. PARKER  
GREGORY N. VIGILANTE  
PAUL J. COTE**

**MARCH 2003**

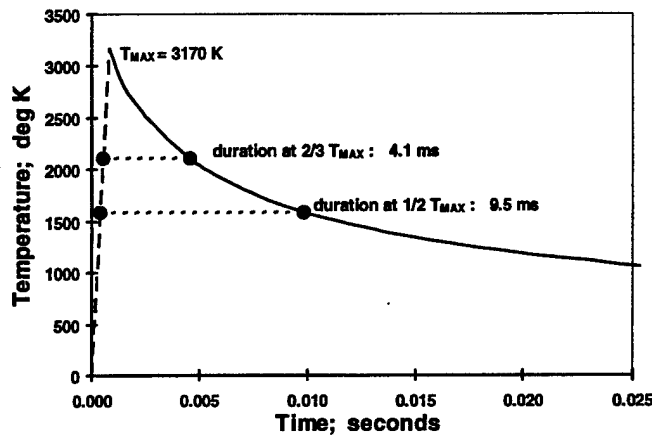
Figure 2. Interior ballistics model calculation of gas temperature for 120-mm cannon at 0.7-m location

The cause and driving force of thermal damage in cannons is the temperature and duration of the combustion gases produced during firing. In prior analysis, a representative constant time duration was chosen and gas temperature was varied until the near-bore temperatures matched those of the observed transformations. In the work here, different values of time duration will be considered, based on the information in Figure 2. Results are shown of an interior ballistics model (ref 6) of gas temperature for 120-mm cannon firing at the 0.7-m location. After rising quickly to a maximum of 3170°K, the gas temperature reduces so that the time durations at two-thirds and one-half of the maximum temperature,  $\Delta t_{2/3}$  and  $\Delta t_{1/2}$ , are 4.1- and 9.5-ms, respectively. These time durations will be used in the upcoming model of near-bore temperatures and stresses for the 120-mm tube. The duration  $\Delta t_{2/3}$  is expected to be more appropriate for modeling very near-bore behavior, such as the bore temperature,  $T_{ID}$ , whereas  $\Delta t_{1/2}$  is expected to be more appropriate for modeling the behavior further removed from the bore, such as the applied and residual stresses in the steel substrate beneath the coating.

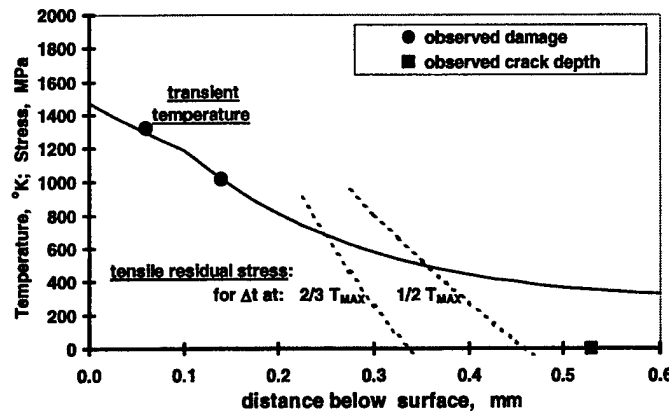
Figure 3. Thermomechanical model results for fired cannon #12 at 0.7-m location.

The model results for fired 120-mm cannon #12 at the 0.7-m location are shown in Figure 3. The temperature distribution for  $\Delta t_{1/2} = 4.1$ -ms drops from  $1470^{\circ}\text{K}$  at the bore surface, passes

near the approximate 1320°K chromium recrystallization temperature (ref 1) at the 0.06-mm observed depth, changes slope as expected at the chromium-steel interface at 1190°K, and passes through the chosen validation point, the 1020°K steel transformation temperature (ref 1) at the 0.14-mm observed depth. Referring again to Table 1, the gas temperature that matches model results with the observed steel transformation is 2490°K for the 4.1-ms duration results in Figure 1 and 1740°K for 9.5-ms duration. Note that these gas temperatures are quite consistent with the results in Figure 2 for the respective time durations. This consistency check, along with the validation by steel transformation results, gives confidence in the use of model temperatures for calculating stresses, discussed next.

Near-bore temperatures were used to calculate the significant compressive transient stresses for tube #12, and from these stresses, the tensile residual stresses, as outlined by equations (1) and (2). Tensile residual stress results for each of the time durations, 4.1- and 9.5-ms, and their respective gas temperatures, 2490 and 1740°K, are shown in Figure 3. Even though the longer duration had a significantly lower gas temperature, the result was a deeper penetration of tensile residual stress, which also was in better agreement with the observed crack depth. Similar calculations were performed for tube #26, with somewhat higher temperatures and deeper penetration of tensile residual stress. Note the corresponding higher heat input for #26 compared with #12, 1.51 and 1.28 J/mm<sup>2</sup>, respectively. These values will have use in comparing the intensity of thermal loading for cannon firing considered thus far with the laser-heating simulation of cannon firing considered in upcoming sections.

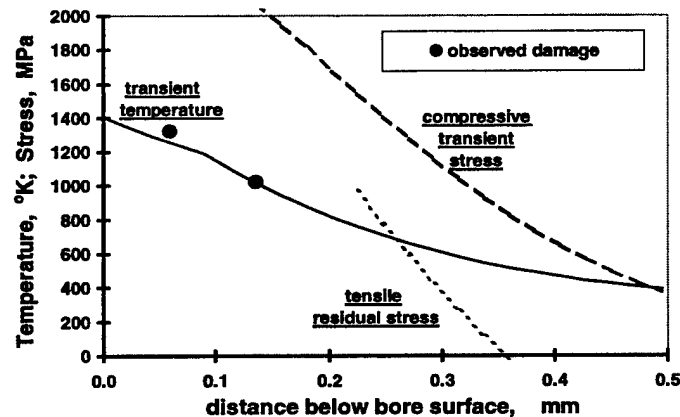
Figure 6. Thermomechanical model results for laser-heated chromium on A723 steel.

Model temperature and stress distributions for the laser-heated samples are shown in Figures 6 and 7. Gas temperatures of 2240 and 3020°K, respectively, were input to the model to provide heat input equivalent to laser heating. Equivalency was verified by matching the observed steel transformation depths shown in Table 3. Other inputs were:

Note that the temperature distribution in both Figures 6 and 7 passes close to the observed depth and known temperature of the transformation damage in the respective coating, thus verifying the model temperature results. The finite-difference calculations also give the heat input that corresponds to the model temperatures. See Table 3. The temperatures are used to calculate the compressive transient and tensile residual stresses using equations (1) and (2). In the cannon firing results of Figure 3, the depth of tensile residual stress was seen to approximately match the observed depth of the hydrogen cracking. In the laser-heating results of Figures 6 and 7, tensile residual stresses are 0.35- to 0.40-mm deep, but there was no hydrogen present and thus no cracks observed, as has been discussed.
