ERDC/CRREL TR-03-8

Remote Determination of Bridging/Fording Sites

Barry Coutermarsh and Sgt. Benjamin Dwinal

April 2003

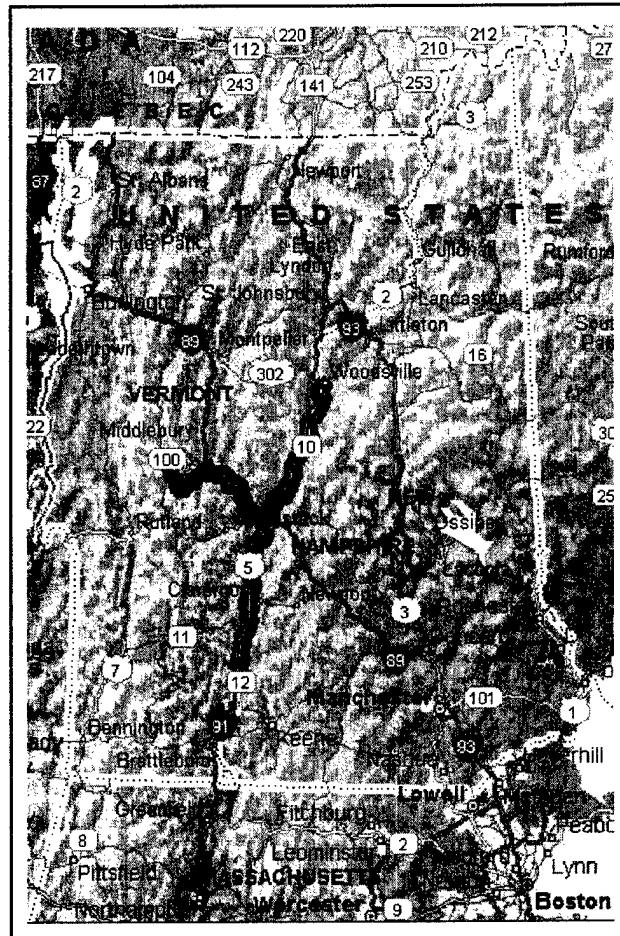
Figure 1. Study area in Vermont and New Hampshire with rivers emphasized in blue.

The areas assigned as the crossing zones comprised two rivers in northern New England, in Vermont and New Hampshire. Approximately 85 miles of the Connecticut River between Wells River, Vt., south to Bellows Falls, Vt., and approximately 36 miles of the White River from White River Junction, Vt., north to Rochester, Vt., for an approximate total of 121 miles of river (Figure 1) were studied. The White River joins the Connecticut in White River Junction, Vt.

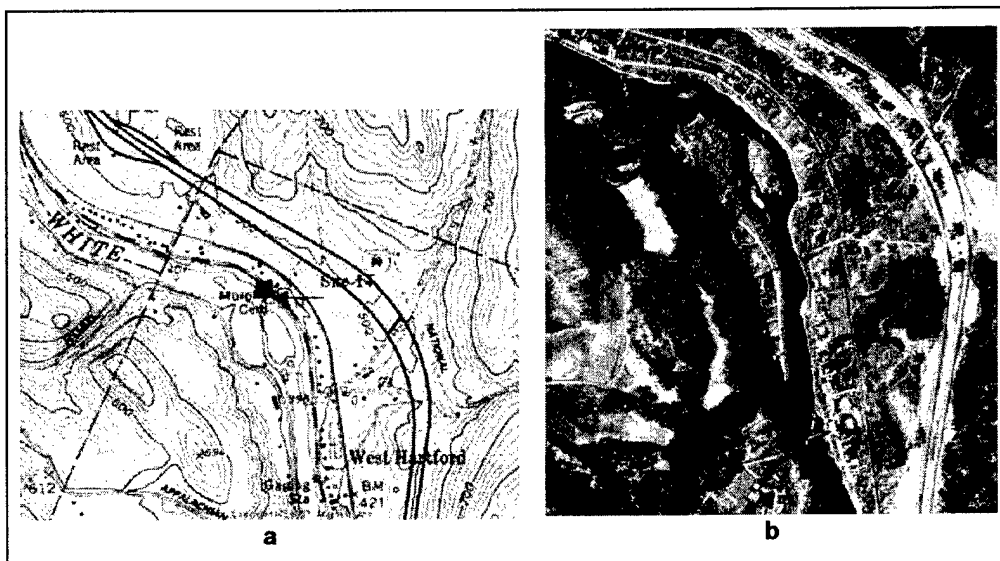
Figure 8. Site 14: Contour map (a) and aerial imagery (b) of possible AVLB site.

At site 14, it was thought the AVLB could be deployed between the river-banks and the smaller island just north of the larger island shown on the map (Figure 8). It can be seen in the aerial imagery that the river has widened the gap between the west bank and the large island. In addition, the smaller island off the northern tip of the large island is now practically nonexistent, essentially just ledge protruding above the water, which shows up as rapids in the imagery.

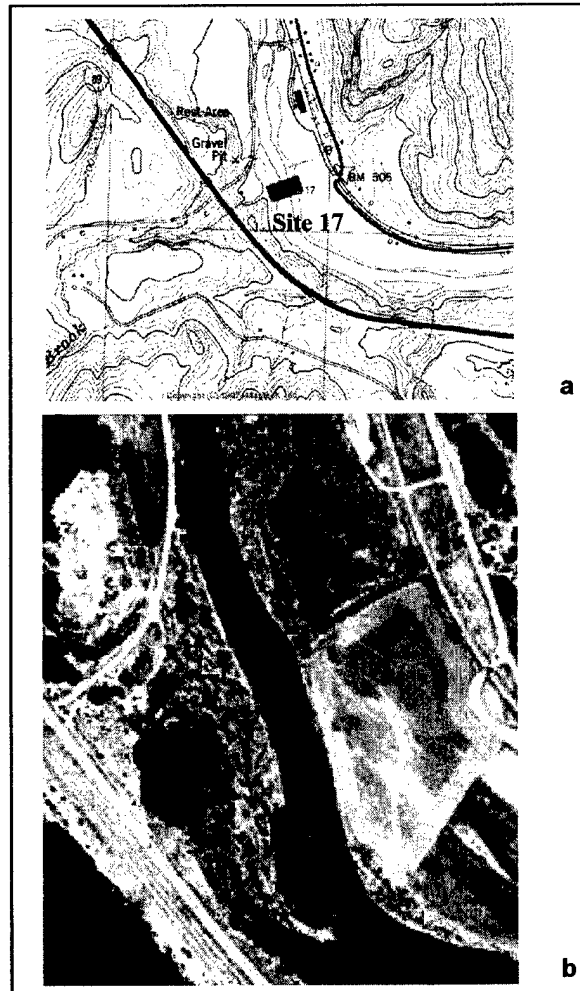
Figure 12. Site 17: Contour map (a) and aerial imagery (b).

The map for site 17 (Figure 12) indicates a relatively large flat area on the east side of the river and narrower but still flat west bank at the river. The aerial imagery shows the flat area on the east side of the river to be open fields with little indication of a bank at the river. The west side has vegetation in the area shown on the contour map as an access strip to the river, but roads are visible throughout so the vegetation was not thought to be a major obstacle.

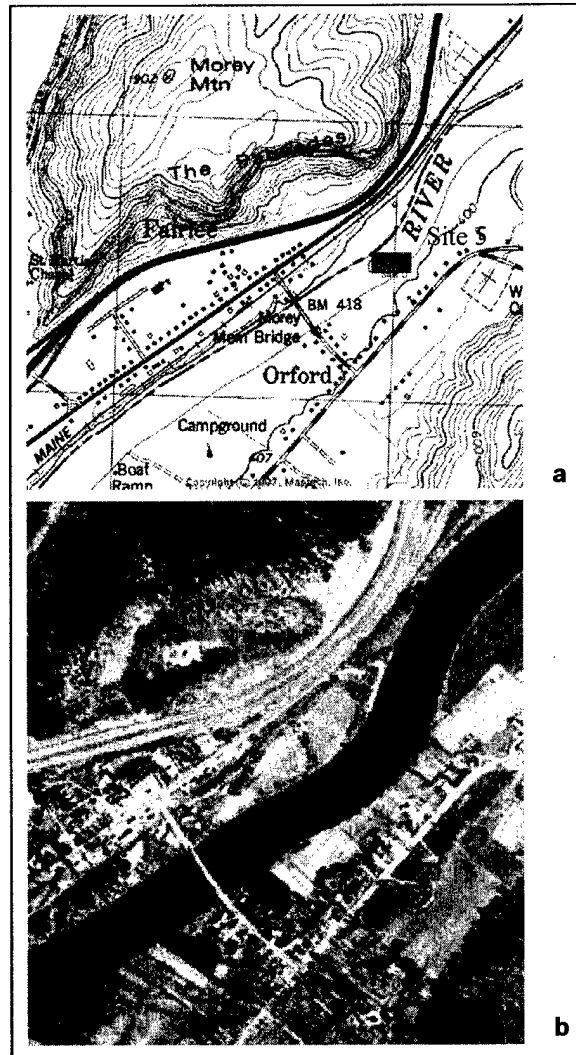
Figure 14. Site 5: Contour map (a) and aerial imagery (b).

For comparison, the successfully identified sites are discussed below. In area 1, on the Connecticut River, site 5 (Figure 14) was considered a successful crossing site. The aerial imagery shows, just to the south of a large building, what appears to be a private road on the east bank leading down to the river. This was thought to be a good access point on the east side of the river, and the contour maps and imagery show the east side to be open fields with little slope.

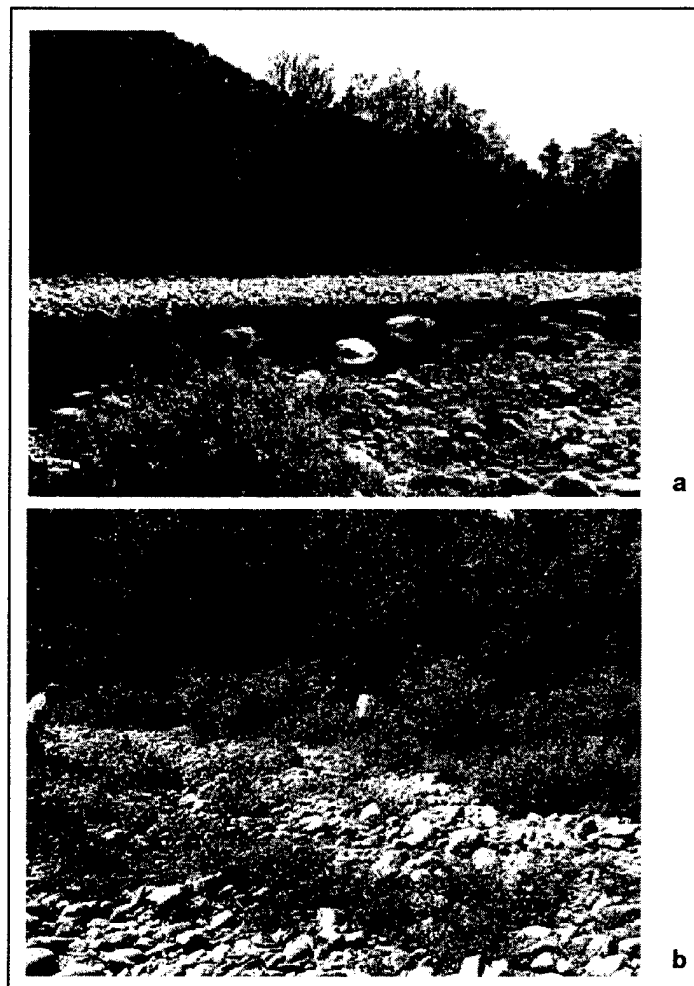
The site offers good access to the river on both sides (Figure 19) with low banks but with dense vegetation, mostly small-diameter (2- to 4-in.) trees with some larger trees at intervals that would allow vehicles to pass. The east bank also provides easy access immediately at the river. The bank has less than a 10% slope and is approximately 3 to 4 ft high. As on the east bank, however, the terrain beyond the river is very steep and would be impossible to traffic. Although this was considered a successful site for the purposes of this study, it is doubtful it would be used in actuality because of the difficulty of reaching the roadways beyond the river.

Figure 19. Site 19: (a) East bank (a cliff about 200 m from riverbank adjacent to road would be impossible to traffic) and (b) west bank.

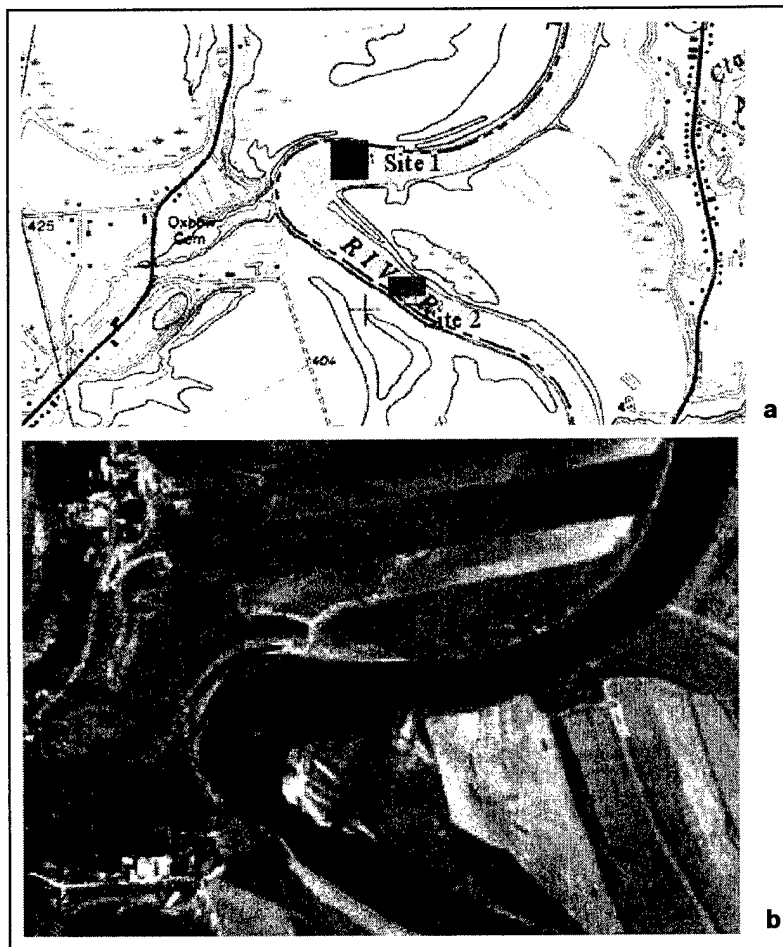
Figure 20. Sites 1 and 2: Contour map (a) (note marsh areas northwest of site 1 and east of site 2) and aerial imagery (b).

It is difficult to see indications of these marsh areas in the aerial imagery. The field inspections showed the land around both sites 1 and 2 was dry enough to support vehicles. If infrared (IR) imagery of the area had been available, it might have shown differences in the ground cover that would have indicated wet or dry conditions.

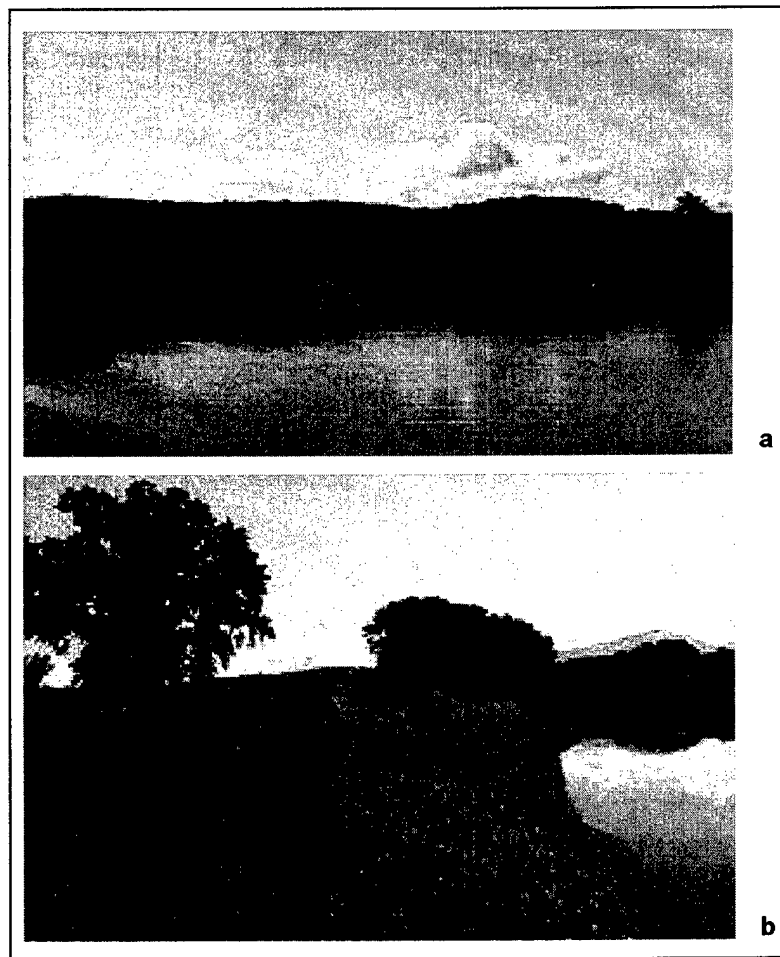
Figure 21. Site 1: (a) East bank looking back at oxbow turn in river and (b) west bank.

Figure 21 shows the east and west banks, at site 1, respectively. The east bank offers excellent access to the river with little bank and good soil for trafficking at the water's edge on the inside of the oxbow corner. The west bank has about a 12° slope over a total height of about 5 to 10 ft.

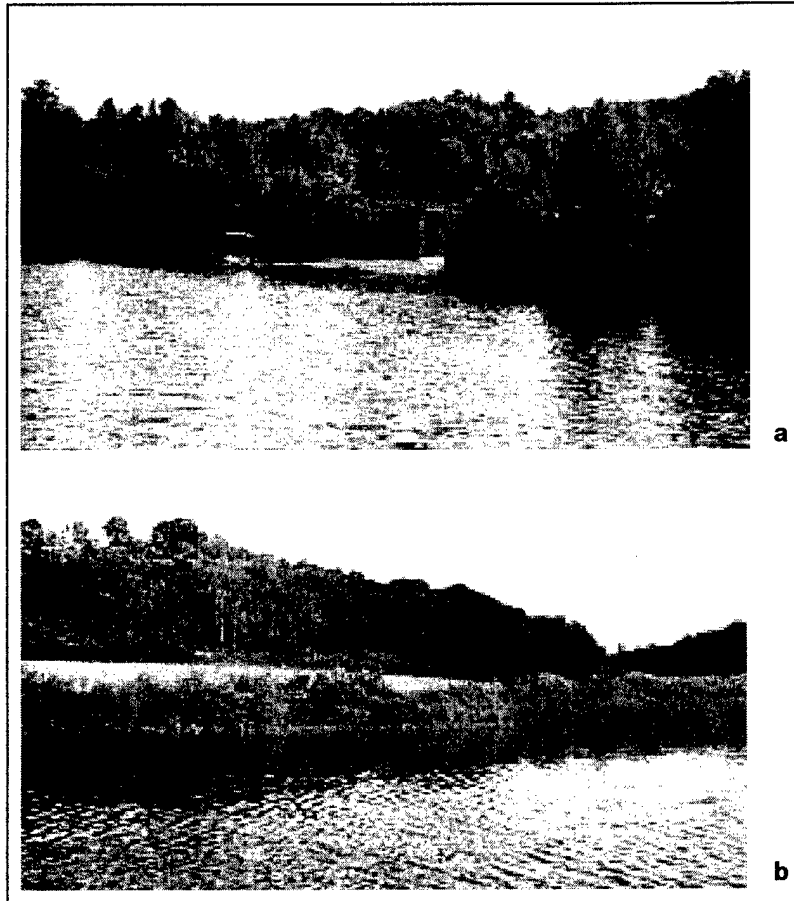
The next crossing site found during the field verifications was site 9, also in area 1 on the Connecticut River. It is about 0.6 miles north of remotely selected site 10 (Figure 23). There is no aerial imagery of this site. Site 9 was not chosen because it was thought wet ground might be present on the east bank, as indicated by the stream and small bay just to the north of the site. As it turned out, site 10 had to be rejected because the west bank was too high and steep, and the site 9 location was nearly ideal, with about a 2-ft-high west bank and an east bank with three ramps leading down into the water (Figure 24).

Figure 24. Site 9: (a) East bank, showing one of three ramps leading into river, and (b) west bank, where brush obscures approximately 2-ft-high bank.

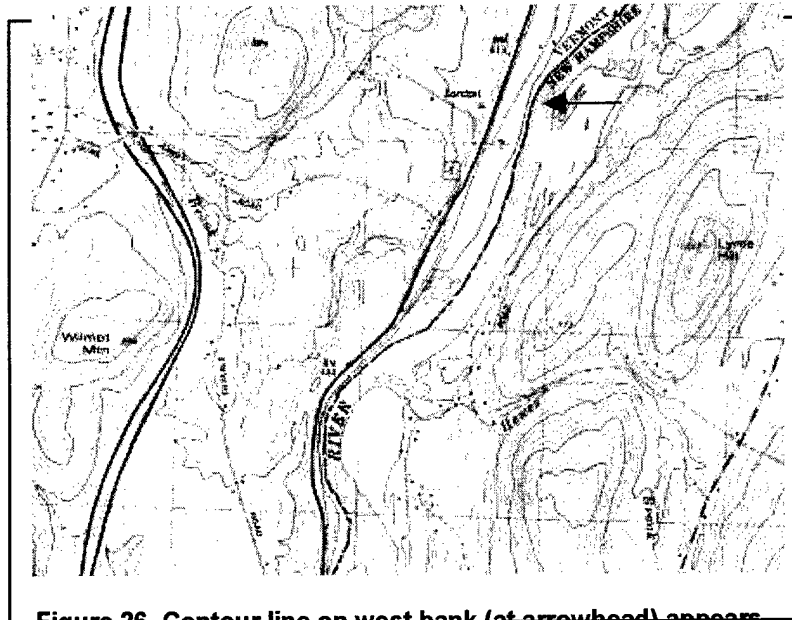
Figure 26. Contour line on west bank (at arrowhead) appears to indicate a bank that gradually disappears from north to south.

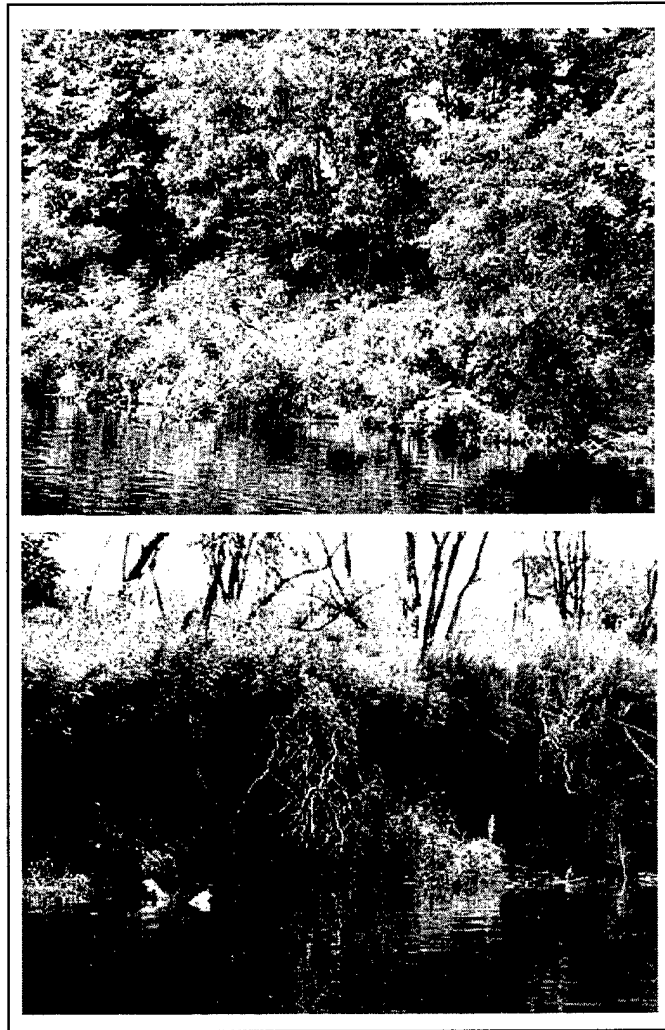
In actuality, there are steep banks at both locations (Figure 27).

Figure 27. Steep banks at locations indicated in Figure 26.

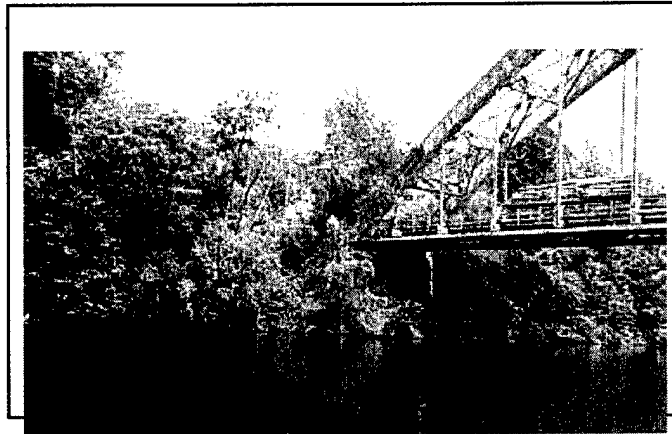
prone to ice formation, so bridges tend to be built at high points to keep them above ice jams or flood waters. At these locations, the banks tend to be steep and would be difficult, if not impossible, to traffic in most tactical bridging situations. As an example, Figure 28 is the USGS map of the Morey Bridge and surrounding terrain in area 1 of our study. Figure 29 shows the bridge at the west bank of the river. It is 30 to 40 ft above the water, and the bank angle here is too steep to traffic by the criteria used in this report. This condition is representative of the bridge locations on both of the study rivers.

Figure 29. West end of Morey Bridge and bank.

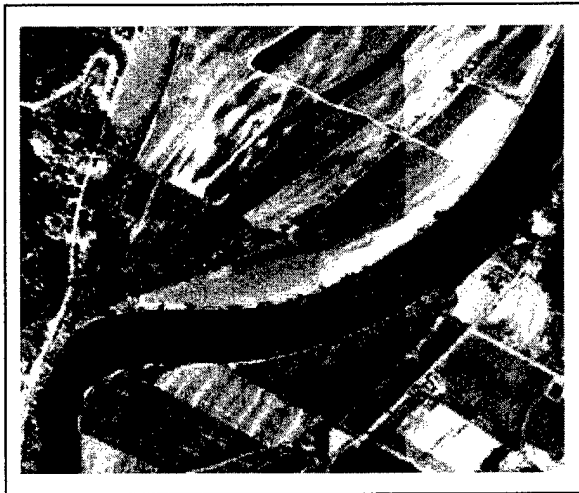
Aerial photo of site 4.

The banks were too steep and high for crossing.

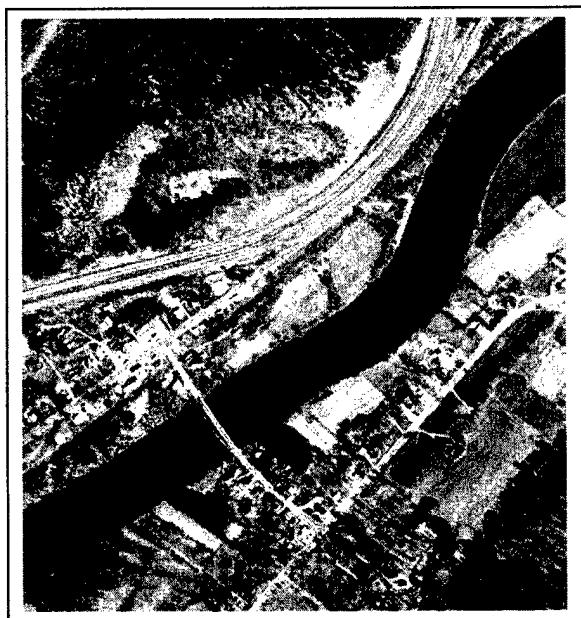
Aerial photo of site 5.

The road leading to the water made this site attractive.

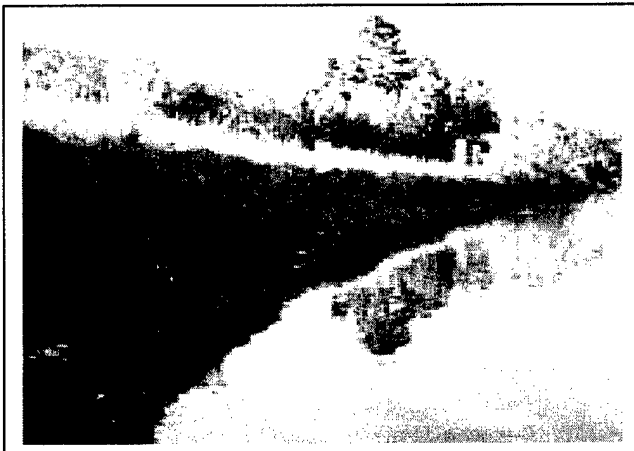
West bank of site 6.
The bank is 7 to 8 ft
high, nearly straight up
and down.

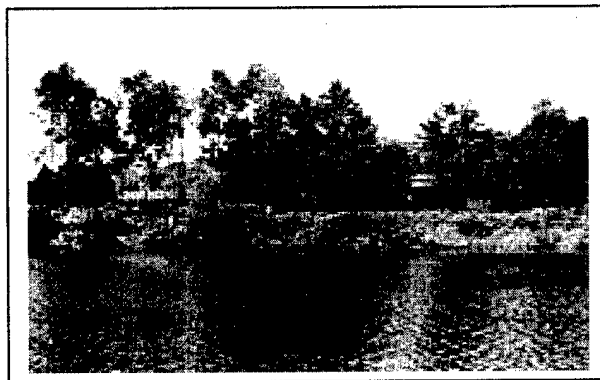
West bank of site 7. The bank is too steep to traffic.

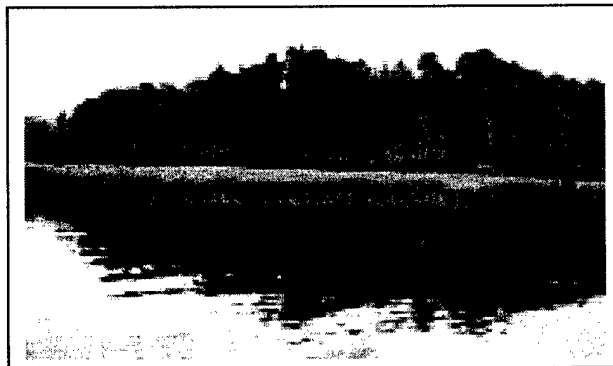
West bank of site 9. The west side is a field with about a 2-ft-high bank.

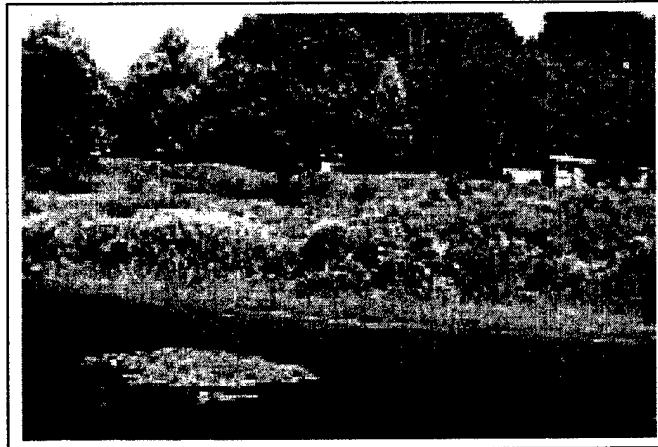
West bank south of site 10. It has an initial 24° slope, then it flattens slightly above.

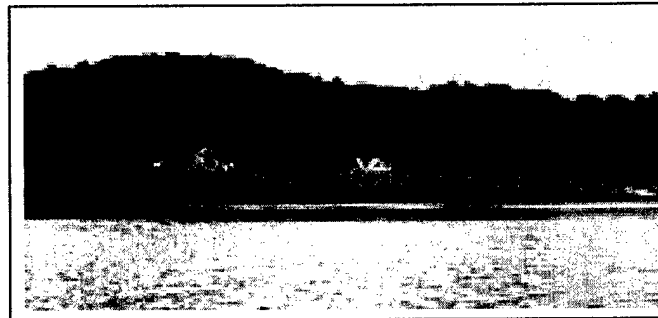
East bank of site 10 looking south.

Site 10 has a good approach and access with fields and lawns with low banks at the river.

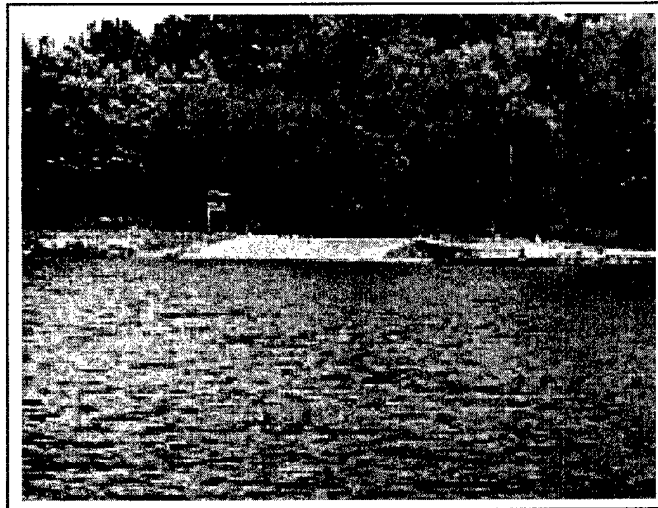
West bank of site 11. The boat ramp is excellent access.

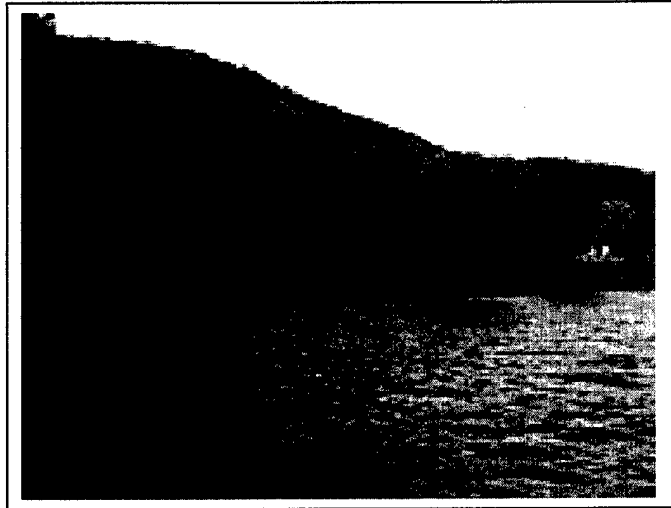
West bank of site 12. It is too steep to traffic.

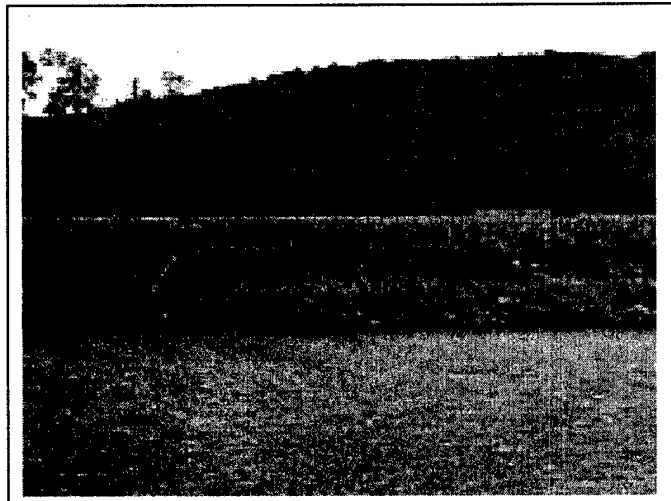
East bank of site 12. It is too steep to traffic - 90° in spots.

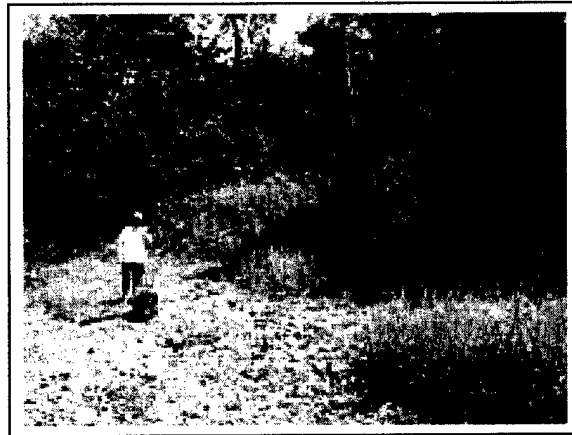
East bank of site 13. There is a low-slope initial bank, but a secondary bank hidden by trees is 8 to 10 ft high and near 90°.

In the imagery, site 13 looked flat near the river.

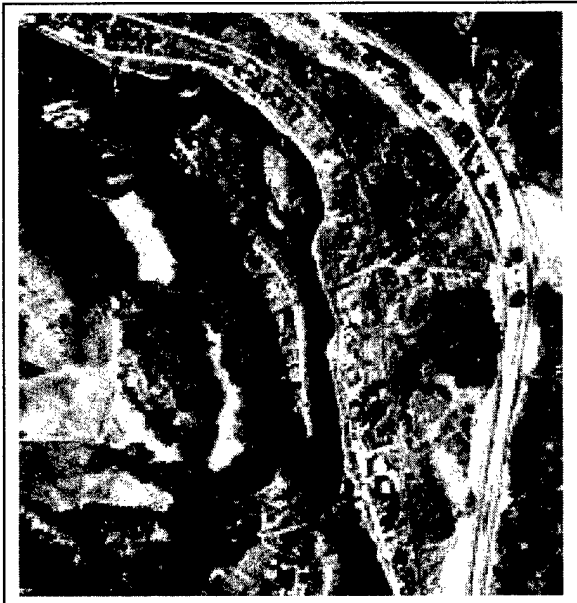
Aerial photo of site 14, which was chosen as a possible AVLB site but proved to be too wide. There is a large amount of ledge outcroppings in the water that are not evident in the aerial photo.

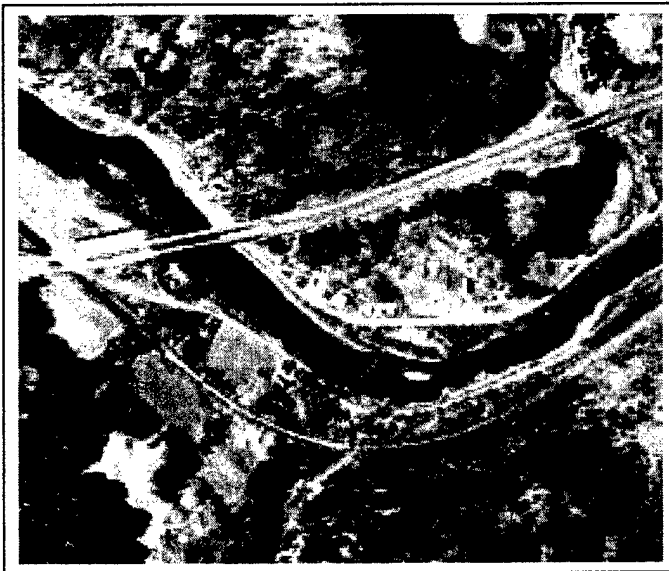
Aerial photo of site 15. The site was chosen as a possible AVL B site, but it is too wide.

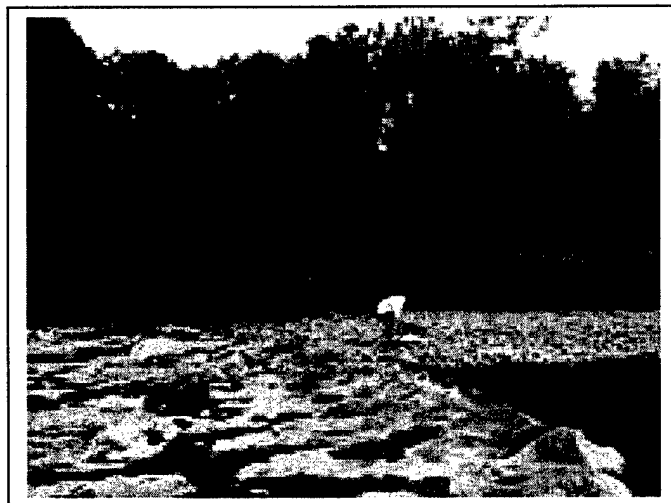
East bank of site 15. The bank is about a 20° slope and looks trafficable.

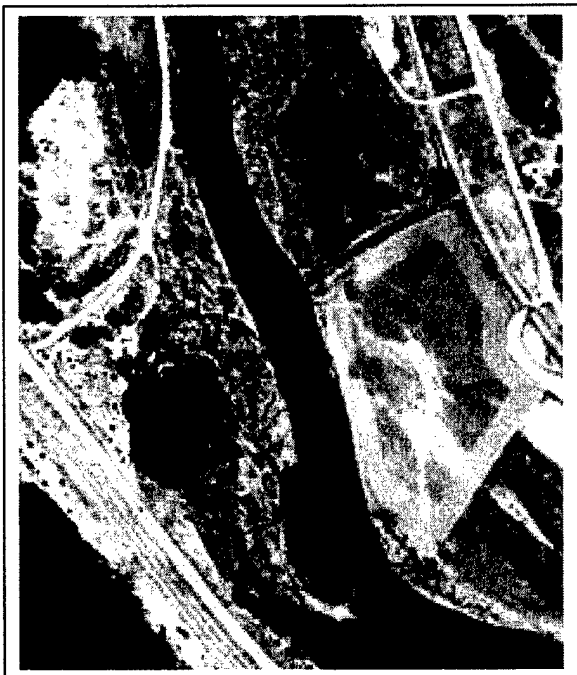
**Aerial photo of site 17.
The site was initially
chosed as a possible
AVLB site, but it was too
wide.**

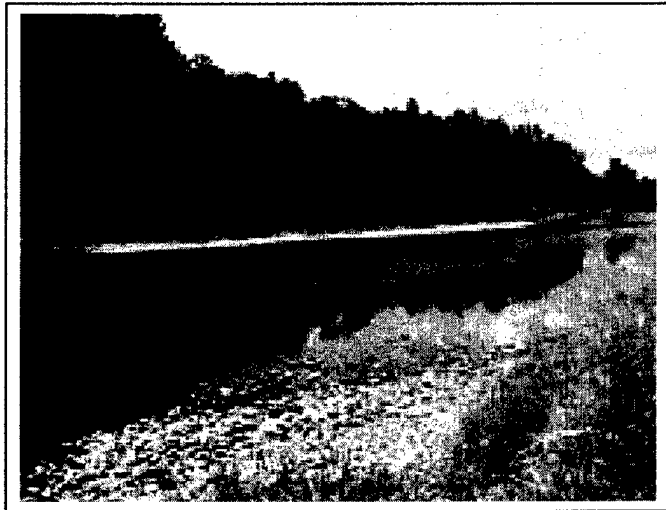
West bank of site 17. The bank starts nearly flat at the water, increases slope to about 19°, then flattens to about 10° with a total height of about 9 ft.

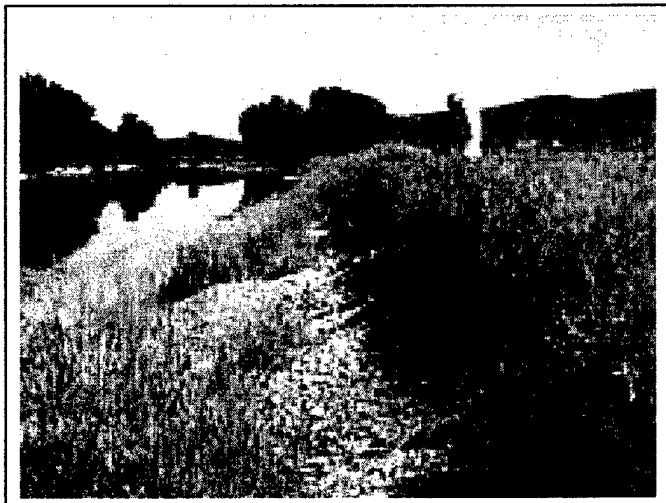
East banks of site 17. The bank is 8 to 10 ft high with some portions 90° at the top.

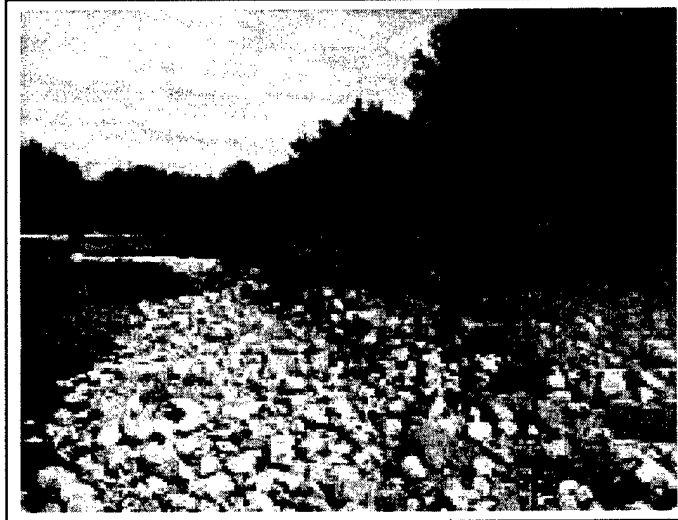
East bank of site 18. The land leads into the water with no abrupt bank. This bank is approximately 20°.

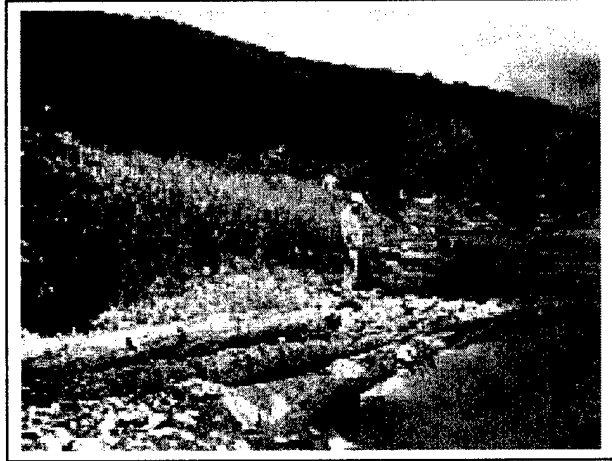
West bank of site 20 looking north. The initial slope out of the water is trafficable, but the bank has a secondary slope 5 to ft high near 90°.

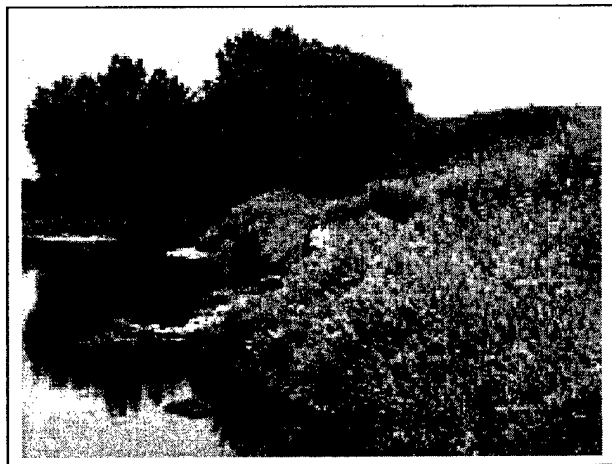
West bank of site 20 looking south. The initial slope out of the water is trafficable, but the bank has a secondary slope 5 to ft high near 90°.

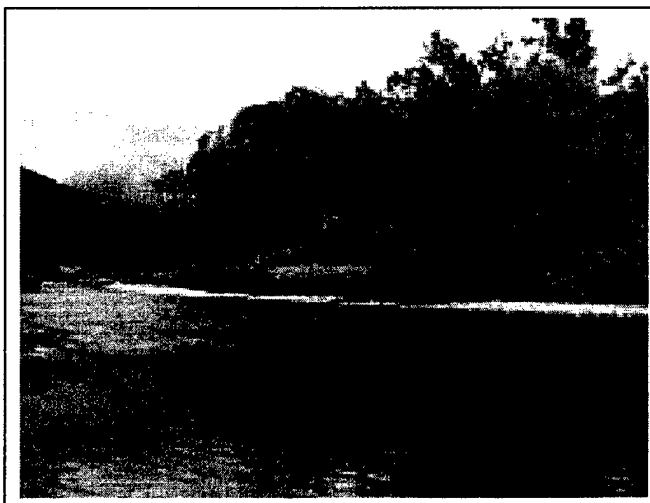
East bank of site 20 looking north. The bank is trafficable with an initial low slope out of the water, then a 1- to 2-ft-high secondary bank and level beyond.
