Assessment of Environmental and Economic Benefits Associated with Streambank Stabilization and Phosphorus Retention

by Lisa C. Hubbard, David S. Biedenbarn,
and Steven L. Ashby

PURPOSE: This technical note documents the assessment of potential water quality improvements and economic impacts associated with streambank stabilization and phosphorus retention. Phosphorus (P) comes from both point sources (e.g., sewage effluents and industrial discharge) and nonpoint sources (e.g., urban, agricultural, and forest runoff). Measures to control point source pollution (e.g., constraints on P-based inputs) were implemented with the 1972 U.S. Clean Water Act. Recent environmental management efforts have focused on the control of nonpoint sources of contaminants. Erosion and subsequent transport of sediment-bound phosphorus from streambanks can provide a major source of bioavailable phosphorus to aquatic systems. Reduction in the availability of phosphorus (and sediment, and nitrogen), associated with streambank stabilization provides potential economic benefits through reduced treatment costs and adverse environmental impacts. Recent studies in the Demonstration Erosion Control (DEC) Projec

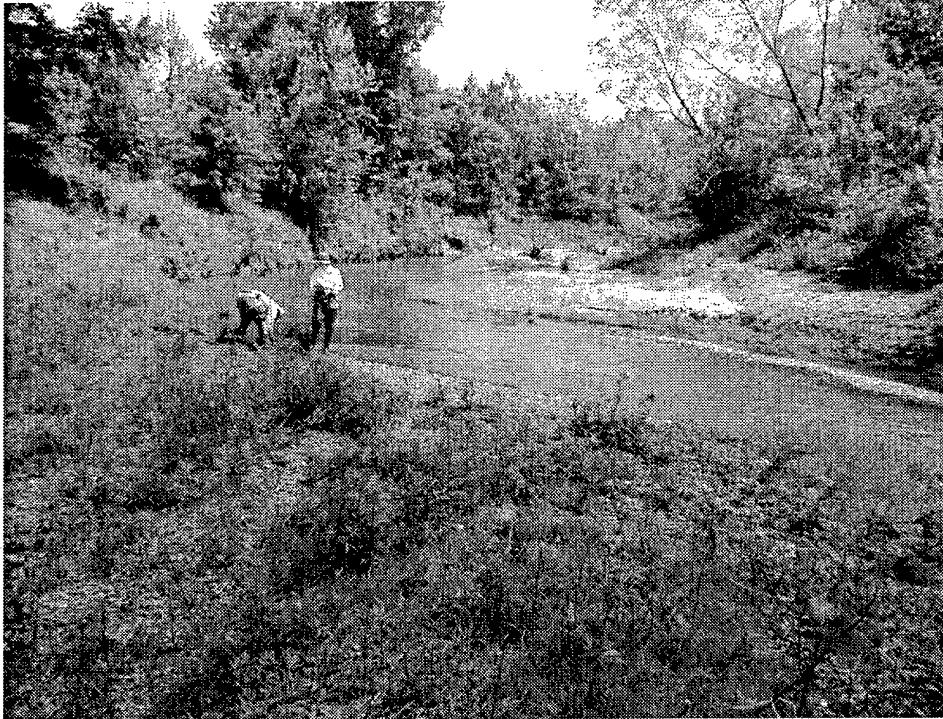
Figure 3. Reach 11, bendway weir site

Geomorphic Status of Harland Creek Post Stabilization. After nine years, the bendway weir and longitudinal peaked stone toe sites viewed during the field investigation seemed to be performing adequately with minimal bank erosion. Figure 3 shows an example of the stable banks with vegetation successfully colonizing and maturing. There are a few sites where raw banks were visible directly next to bendway weirs, as seen in Figure 4. However the majority of the raw banks appear to coincide with the willow post sites, an example of which is seen in Figure 5. The raw banks at the willow post sites may be due in part to the low survival rates of the willow posts. According to Pokrefke et al. (1996), survival at the willow post sites was at 80 percent in spring of 1994 but dropped to 42 percent by October. By 2002 there is almost 100-percent mortality of the willow posts. Although some of the banks are raw, they have not retreated much as remnants of the willow posts are still visible. Field observation at these sites revealed that there has been erosion at the toe (1 to 2 ft). This is supported by a numerical model study conducted in 1999 that found the added roughness of the willow posts increases stress on the toe (Watson et al. 2001). While it is possible that the willow post remnants may be contributing to the stability of the banks, it is more likely that the historical erosion rates in these bends were lower due to the presence of resistant bank material and the longer radius of curvature bends.

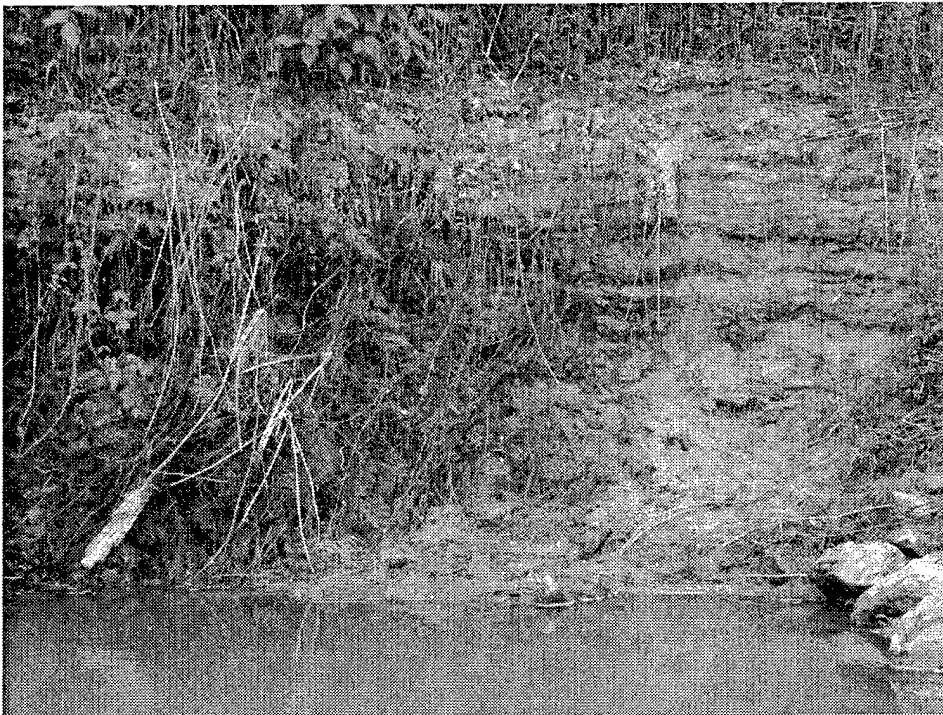
Figure 4. Reach 11, bank sample location next to bendway weir

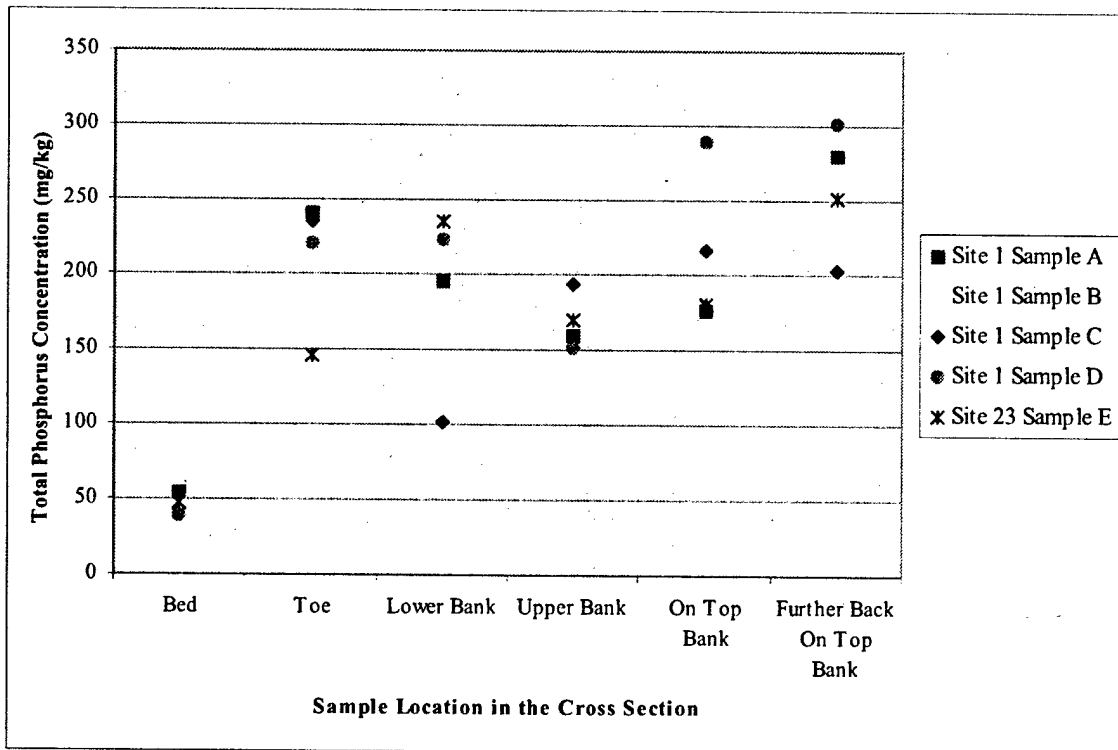
Figure 6. Total phosphorus concentrations for Harland Creek, Site 1 and Site 23

The bed total phosphorus values range from 39.20 to 62.92 mg/kg (0.08 to 0.13 lb/ton) and are significantly ($\alpha = 0.05$) lower than the toe and all bank site values that range from 91.32 to 301.65 mg/kg (0.18 to 0.60 lbs/ton). Figure 6 displays the total phosphorus concentrations graphically. A trend of greater concentrations of total phosphorus in bank sediments (417 mg/kg, 0.8 lbs/ton) compared to concentrations in bed sediments (281 mg/kg, 0.6 lbs/ton) has also been observed in an agricultural watershed in Pennsylvania (McDowell and Sharpley 2001). The same trend has also been reported on one of two Mississippi streams studied by Bledsoe et al. (2000). The concentrations reported from the two Mississippi streams are very similar to the Harland Creek values. A detailed assessment of the phosphorus release function of the two sediment sources led McDowell and
