# THE GREAT FLOOD OF 1993 POST-FLOOD REPORT

## UPPER MISSISSIPPI RIVER AND LOWER MISSOURI RIVER BASINS

## MAIN REPORT

US Army Corps  
of Engineers  
North Central Division

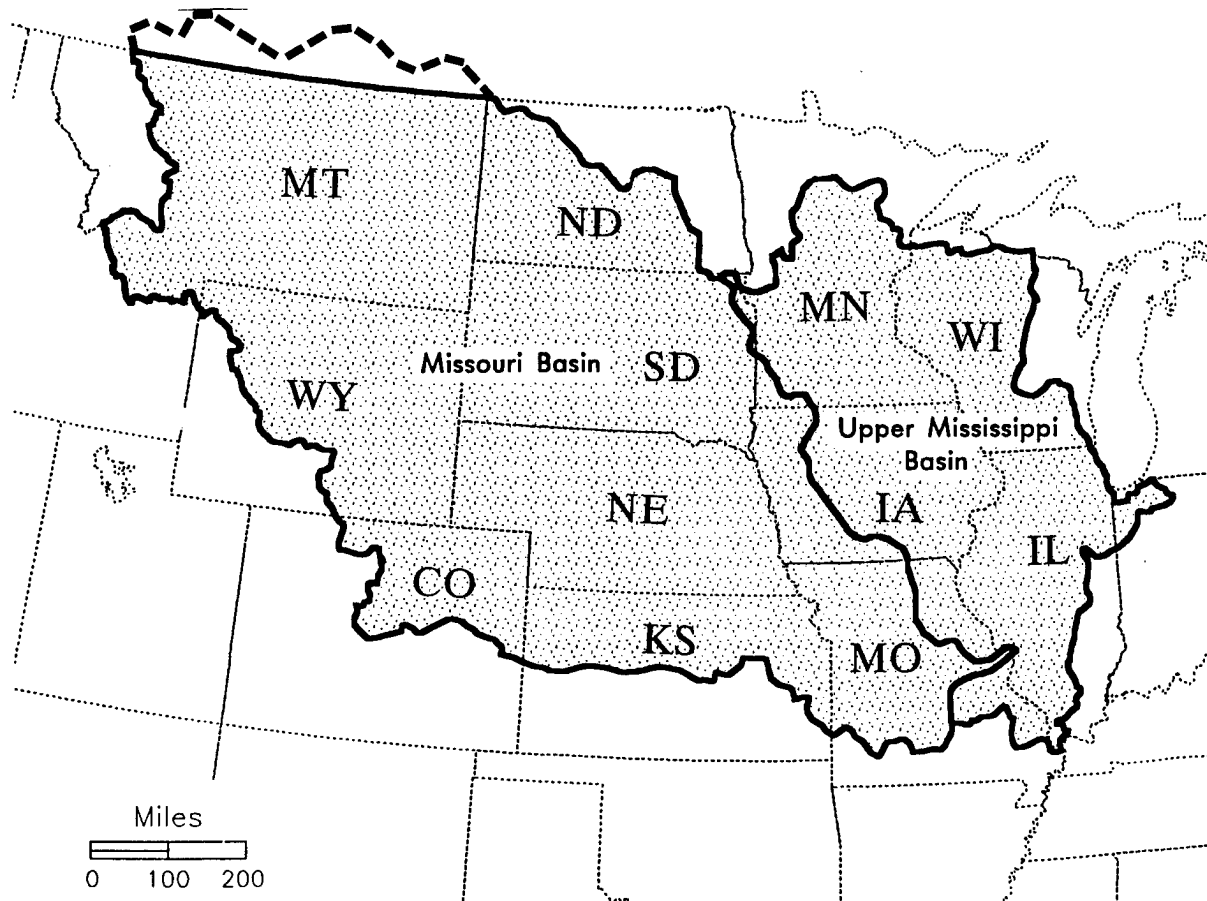
**Figure 1. Areal extent of the Missouri and upper Mississippi river basins.**

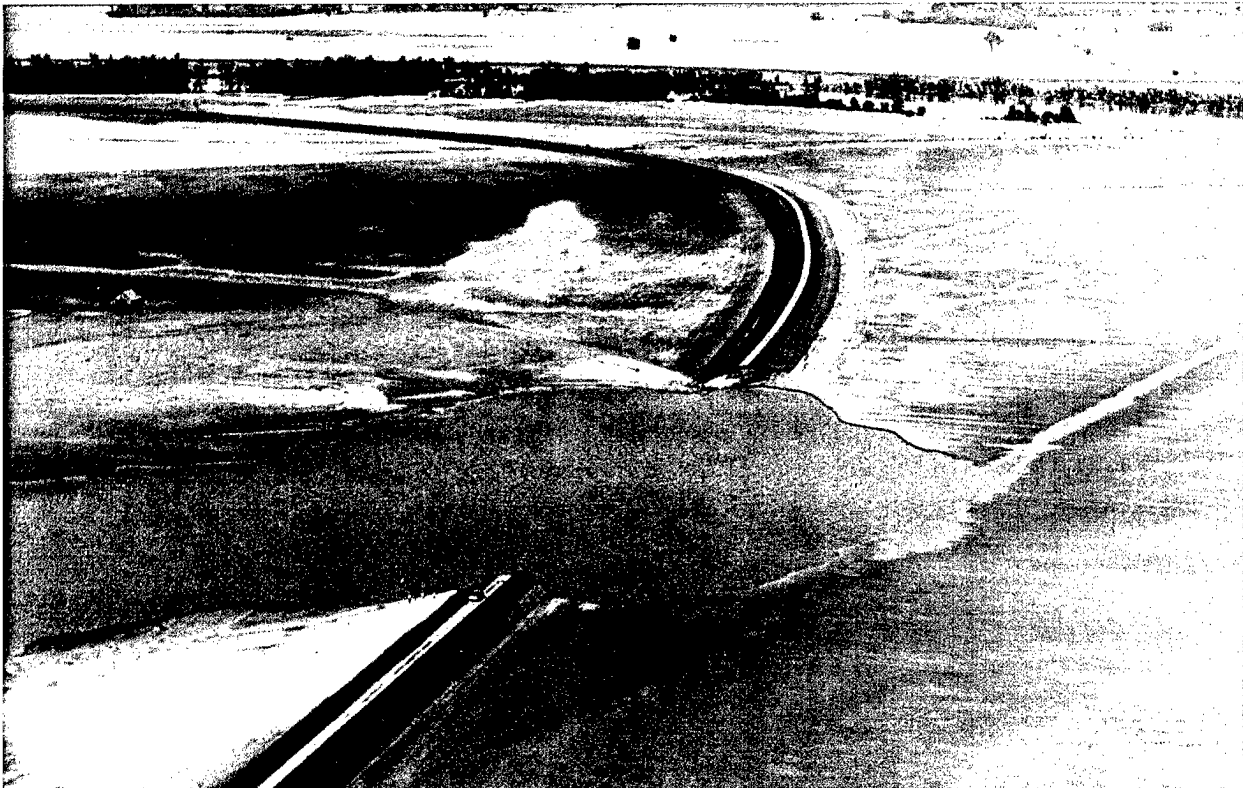
Levee breach at L470-460 near Elwood, Kan.

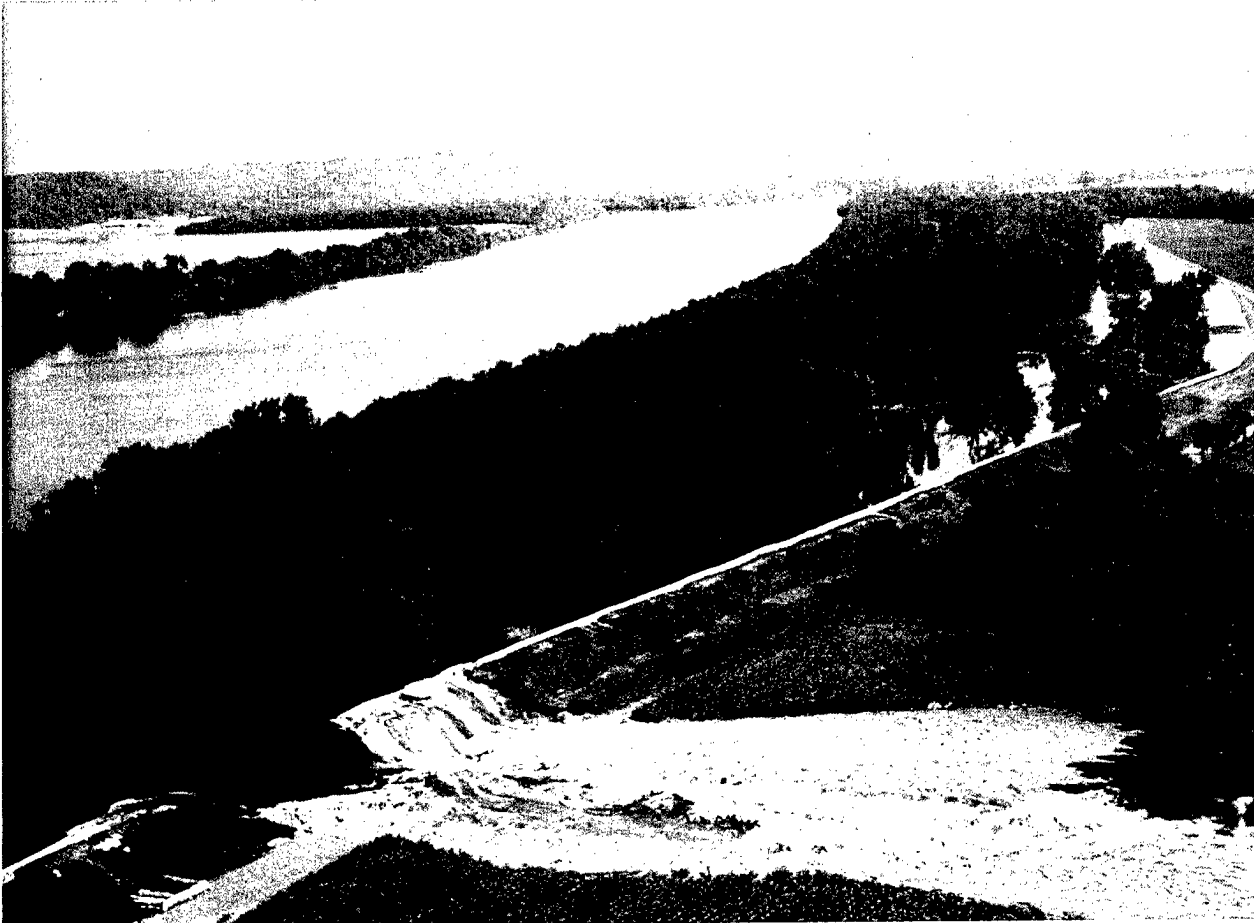
**Nutwood Levee break on the Illinois River.**

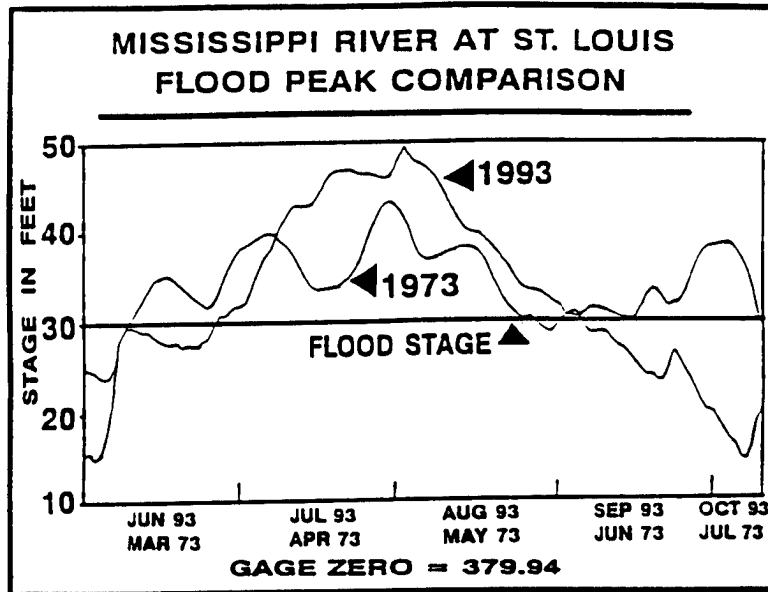
Figure 9. Mississippi River at St. Louis flood peak comparison.

A comparison of data concerning 1993 unregulated peak discharges with 1844 estimated peak discharges is presented in the fourth and fifth columns of Table 2. The 1844 peak discharge at Hermann is greater than the 1993 unregulated peak discharge and 1993 unregulated peak discharges at Kansas City and Boonville are greater than the 1844 peak discharges.

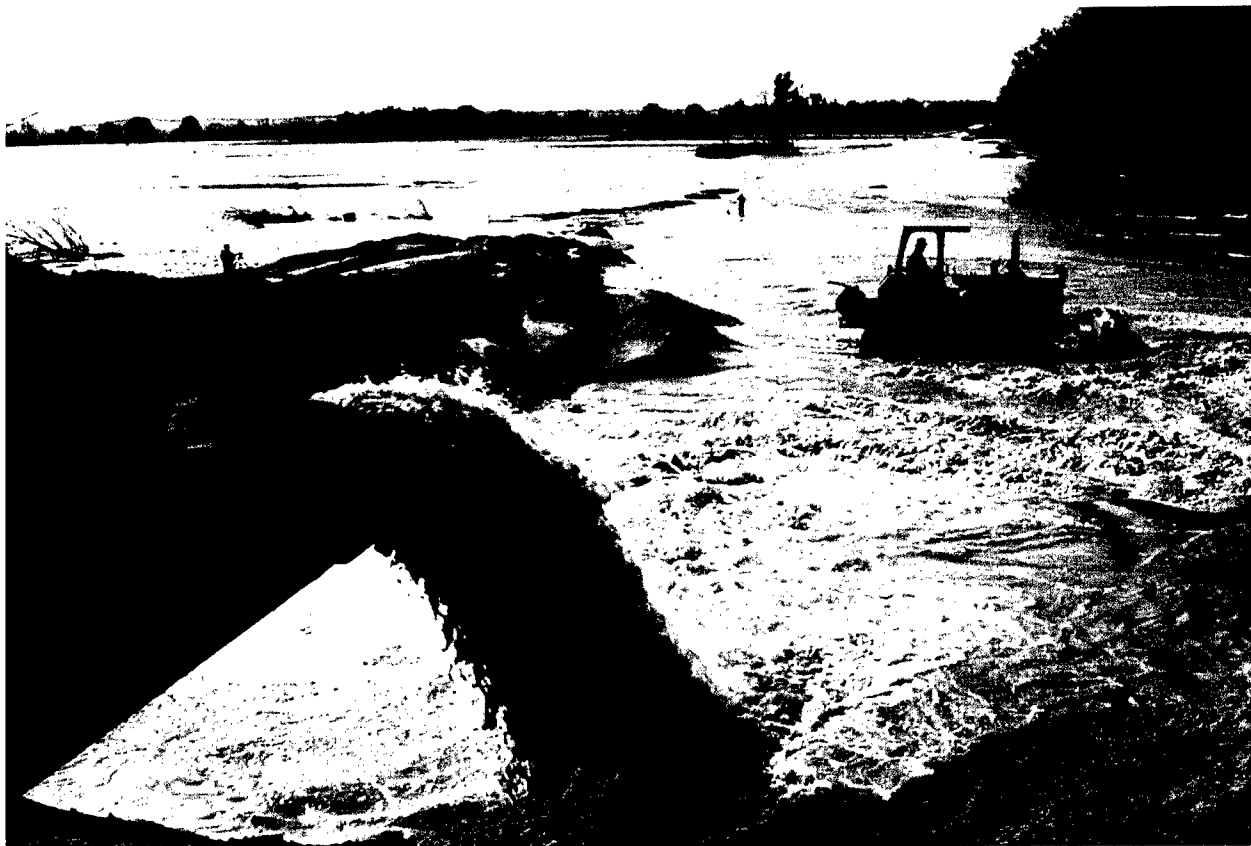
Hydraulic dredges repairing the damaged Sny levee.
