**TITLE: Laser Obstacle Detection System Flight Testing**

**AUTHOR:** Timothy Davis and Louis Centolanza

**COMPANY NAME:** Aviation Applied Technology Directorate (AATD)  
Platform Technology Division

**DATE (MONTH YEAR):** September 2003

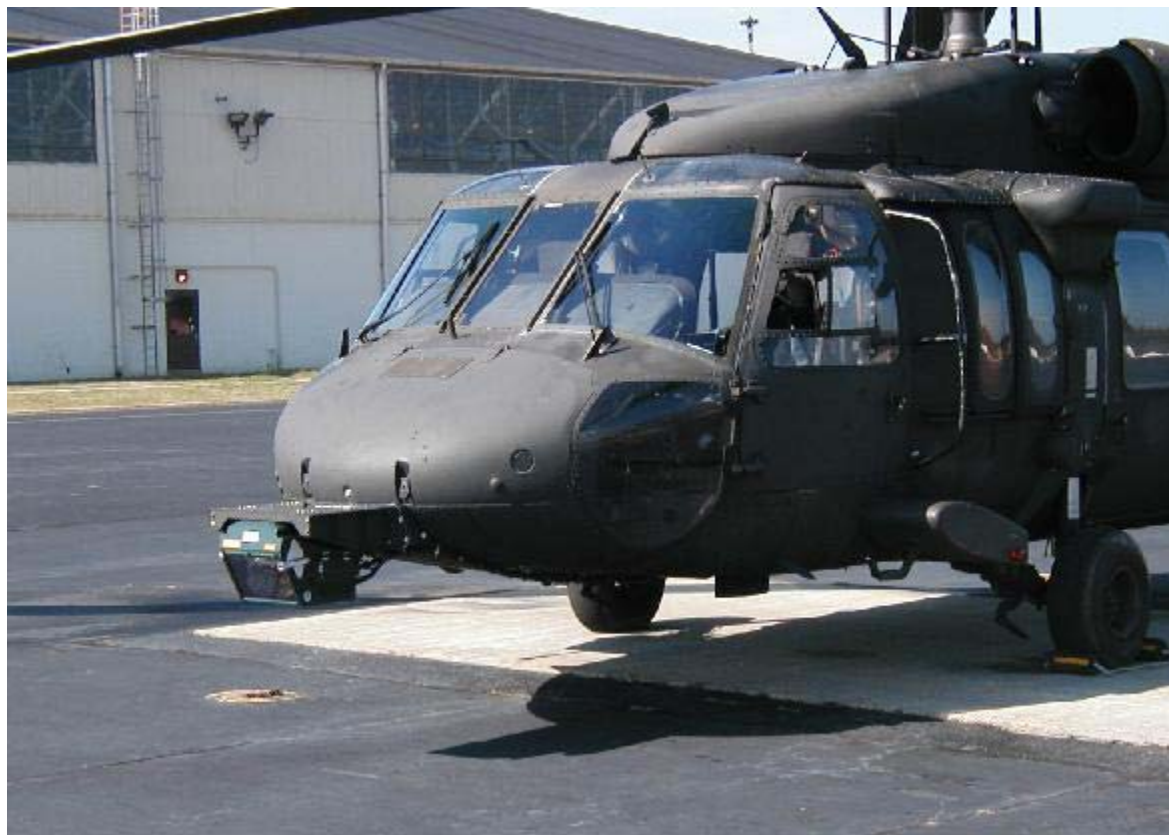
**FIGURE 1:** UH-60 BLACKHAWK WITH MOUNTED HELLAS OBSTACLE DETECTION SENSOR

The UH-60L is a two pilot (side by side seating) aircraft used for a host of utility, cargo, and medical missions. Tail number 468 was used for this flight test, shown in Figure 1. A complete description of the aircraft and related subsystems is presented in Reference 1c (Operator's Manual).

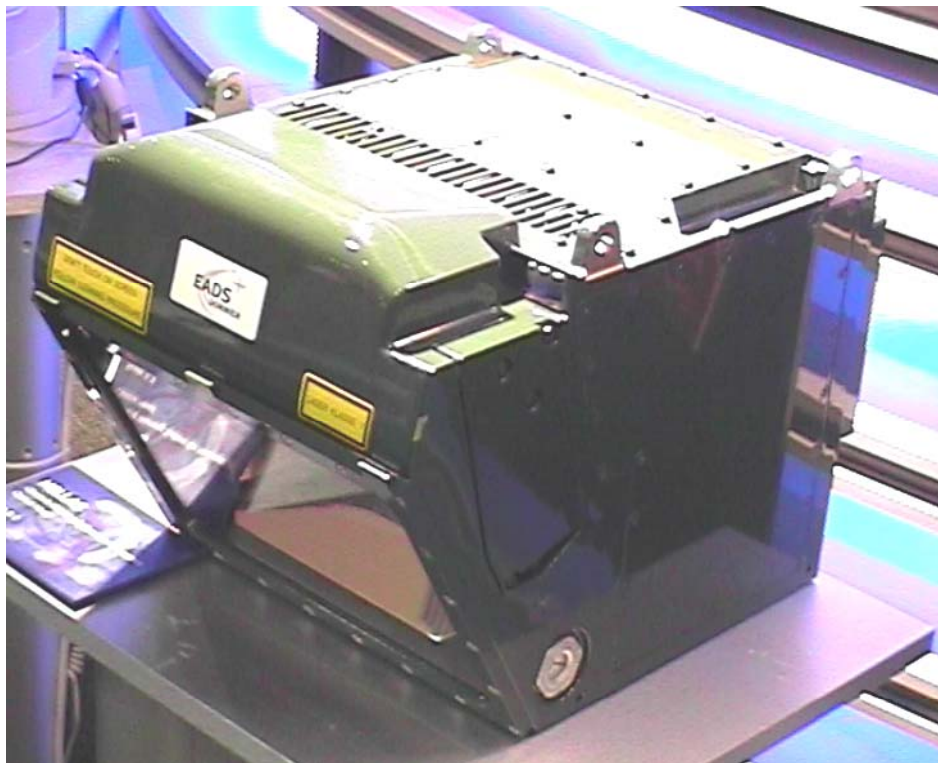
**FIGURE 2: HELLAS OBSTACLE DETECTION SENSOR**

The HELLAS obstacle detection sensor, shown in Figure 2, contains a 1.54  $\mu\text{m}$  wavelength Erbium-Fiber eye-safe laser system is manufactured by EADS Dornier and weighs approximately 62 lbs. The system generates a 3D LADAR image with a 32 degrees of elevation and 32 degrees of azimuth field of view. The sensor uses a two-axis scanning laser radar system to measure the 3-dimensional geometry of objects. The distances to targets are measured with a pulsed laser using time of flight measurements. A more detailed description of the HELLAS is presented in Reference 1d (HELLAS Interface Specification Document). Eye safety was tested by U.S. Army Center For Health Promotion and Preventive Medicine (CHPPM) and the report is included in enclosure 1.

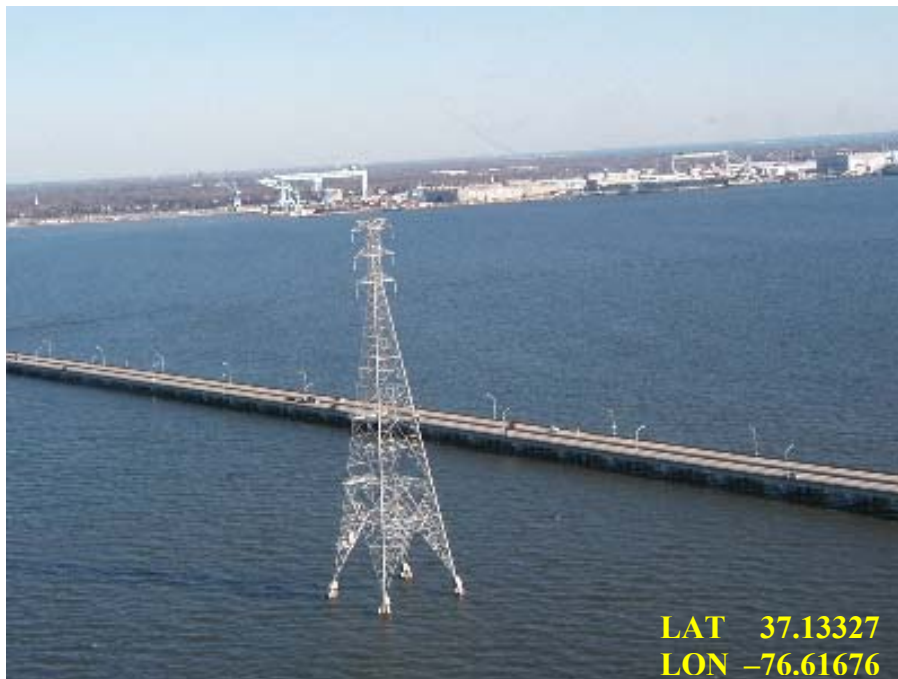
**FIGURE 4:** JAMES RIVER BRIDGE (WIRE SET #1)  
6 LARGE WIRES AND 2 SMALLER GUIDE WIRES  
EASILY DETECTED VISUALLY WITH NO BACKGROUND

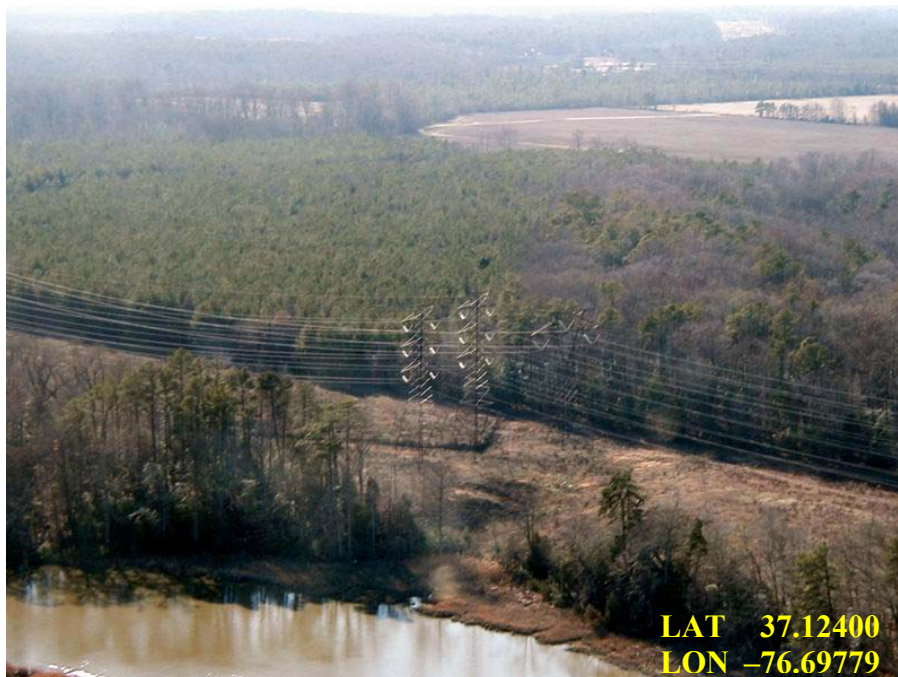
**FIGURE 5:** (WIRE SET #2)  
MANY LARGE WIRES AND SMALLER GUIDE WIRES  
HEAVILY WOODED BACKGROUND

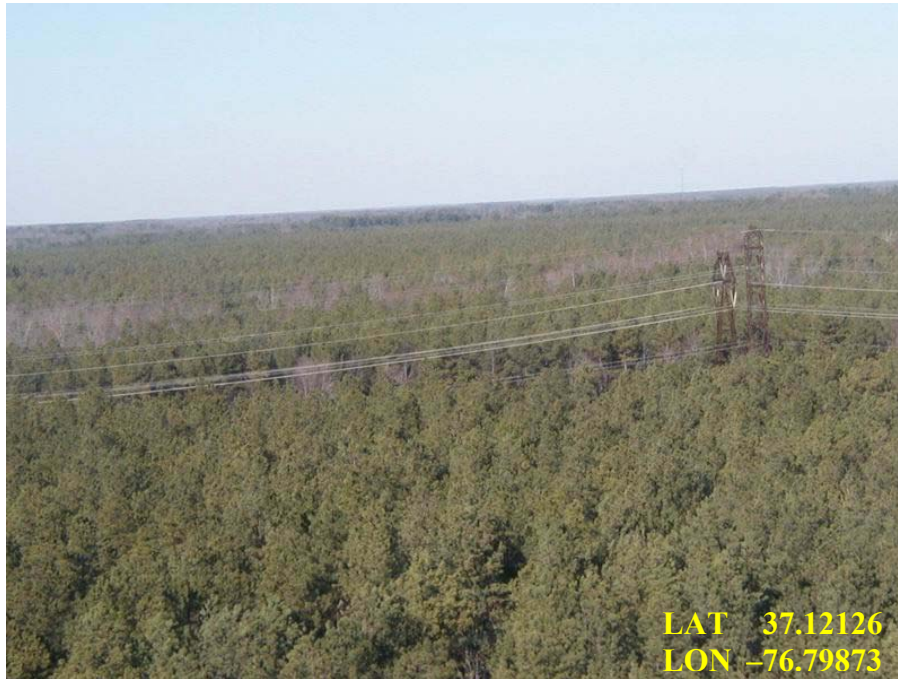
**FIGURE 6:** (WIRE SET #3)  
MANY LARGE WIRES AND SMALLER GUIDE WIRES  
HEAVILY WOODED BACKGROUND

Wire Set #3 was flown during the day and repeated after sunset. The evening flight was cut short due to weather. No additional night flights were flown prior to removal of the system and program completion. During the night flight, no cockpit displays were operational due to hardware and flight release limitations. From the operator's position, the LODS system functioned comparable to the earlier day flight. Additional flights would be required to determine if the range is increased or decreased under low light conditions.

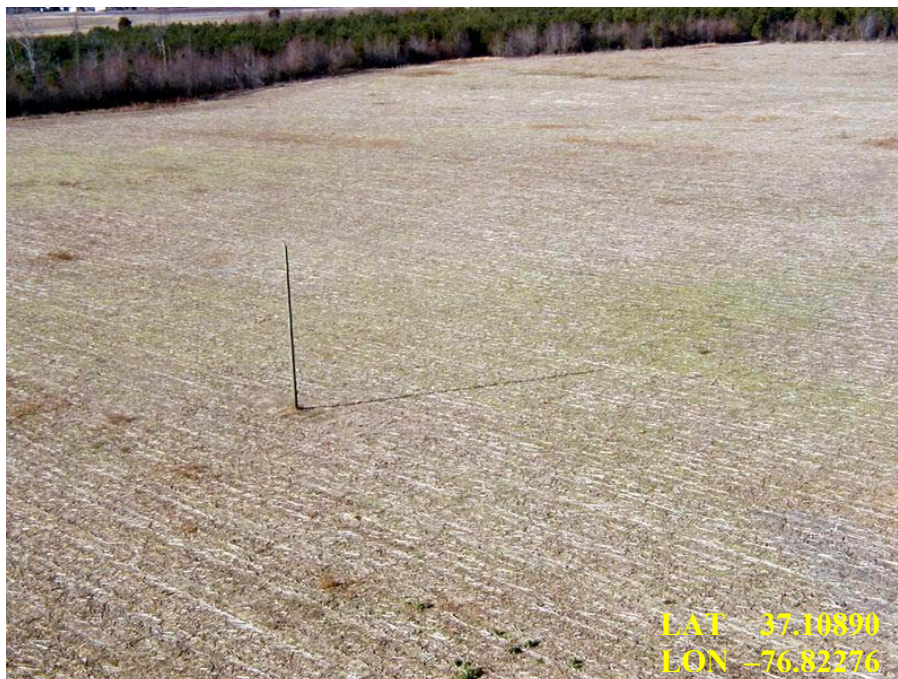
**FIGURE 7:** POLE IN OPEN FIELD (WIRE SET #4)  
2 VERY SMALL WIRES AND NO GUIDE WIRES  
NOT EASILY DETECTED VISUALLY

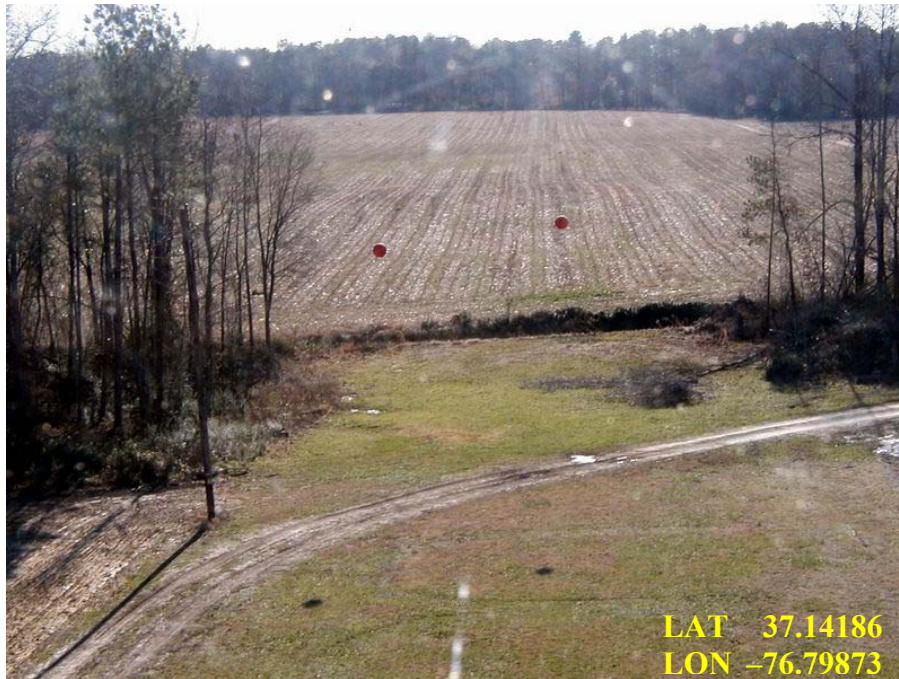
**FIGURE 8:** (WIRE SET #5)  
2 VERY SMALL WIRES AND NO GUIDE WIRES  
NOT EASILY DETECTED VISUALLY, POLES ARE IN OR NEAR TREE LINE

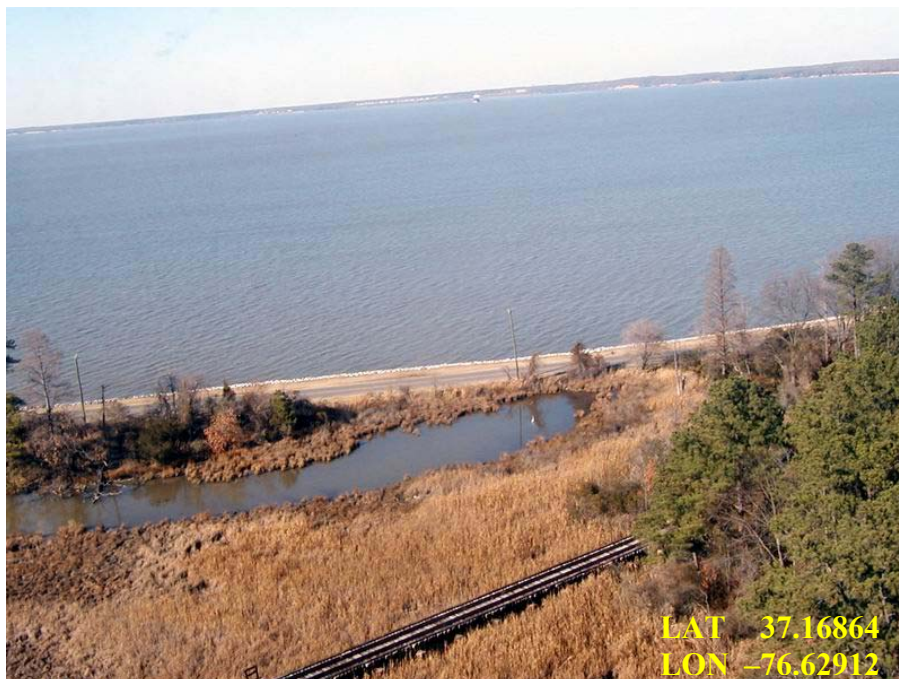
**FIGURE 9:** HARRISON ROAD FORT EUSTIS (WIRE SET #6)  
4 VERY SMALL WIRES AND NO GUIDE WIRES  
HEAVILY WOODED BACKGROUND FROM WATER SIDE

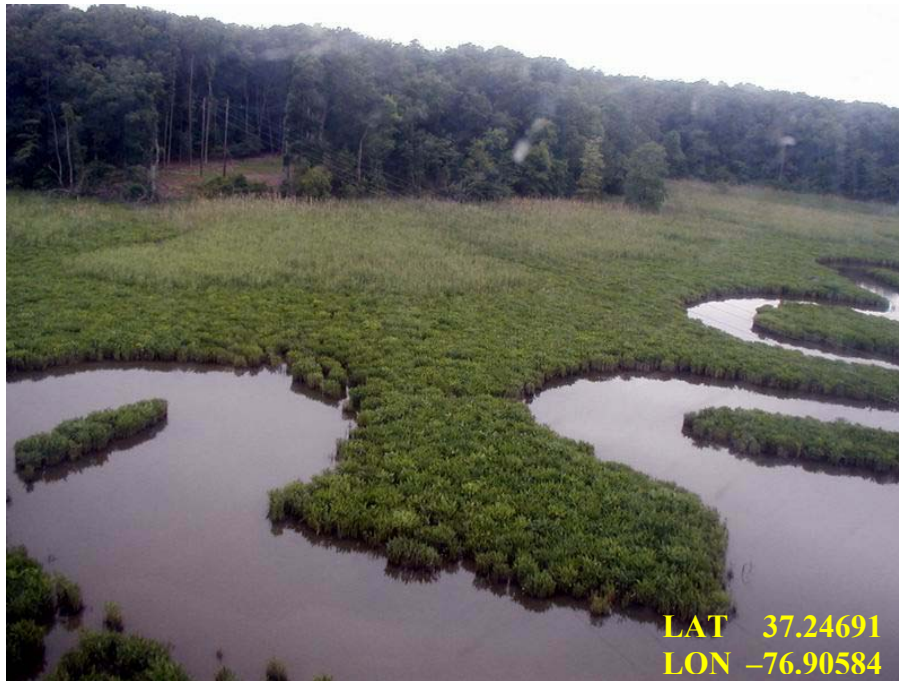
**FIGURE 10:** (WIRE SET #7)  
4 VERY SMALL WIRES AND NO GUIDE WIRES  
NOT EASILY DETECTED VISUALLY, TOWERS ARE IN TREE LINE

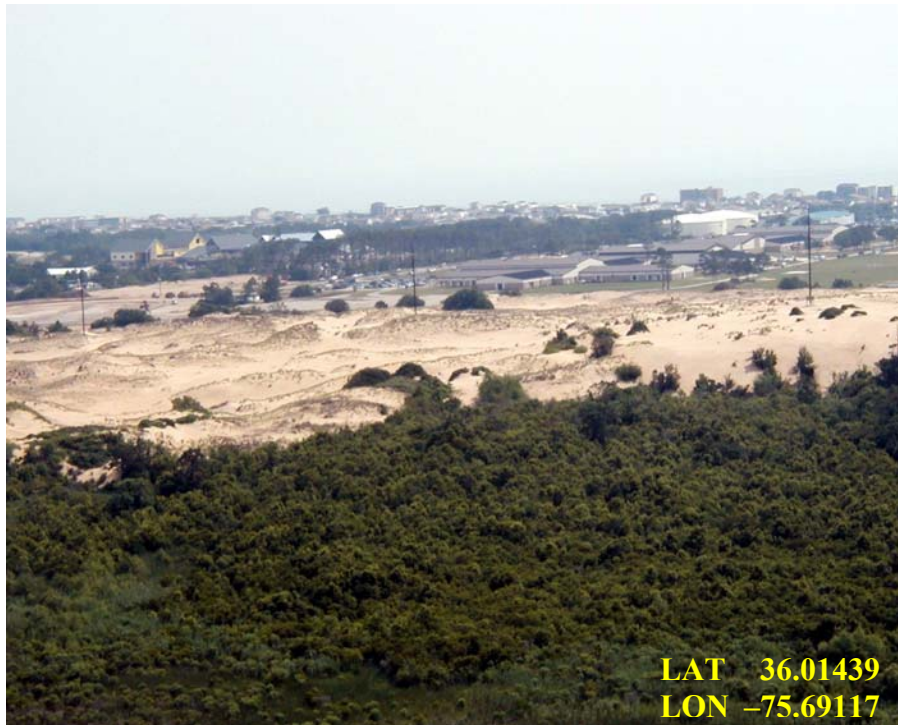
**FIGURE 12:** AREA AROUND FIRST FLIGHT AIRFIELD (WIRE SET #8)  
3 OR 4 SMALL WIRES AND SMALLER GUIDE WIRES  
LARGE SAND CONCENTRATION AND TERRAIN CONTOUR

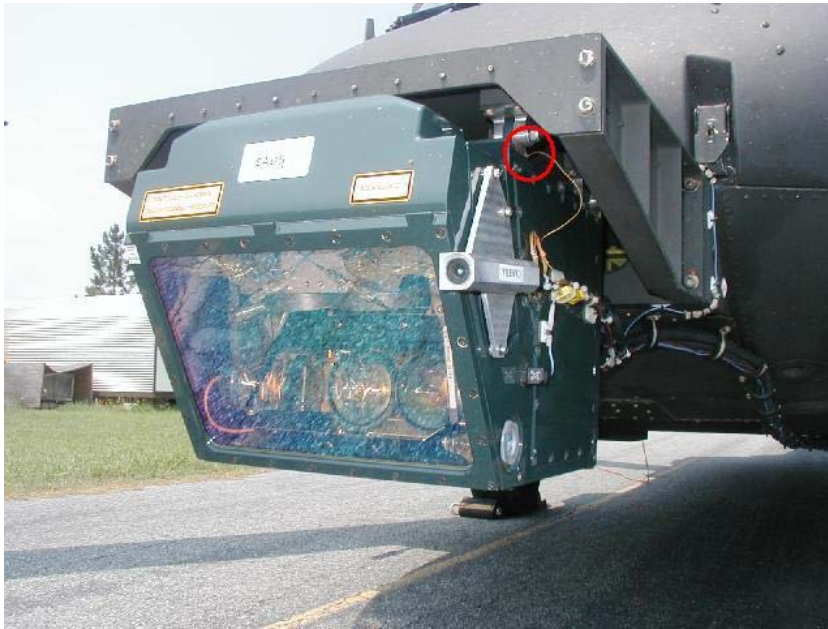
**FIGURE 13: THERMOCOUPLE #1 BONDED TO TOP OF CASE**

The HELLAS laser was equipped with two thermocouples placed at the exhaust of the laser and taped to the top surface of the HELLAS case. See the following pictures:

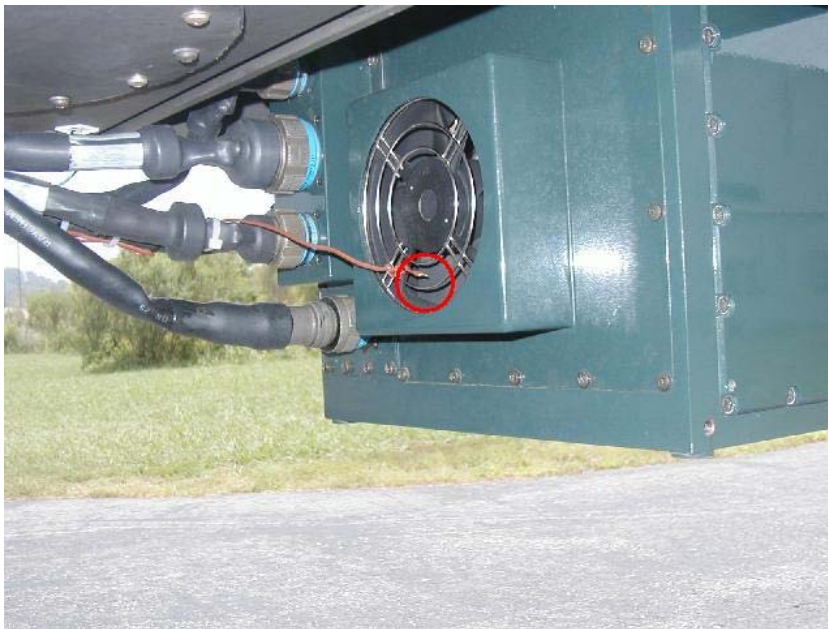
**FIGURE 14: THERMOCOUPLE #2 MOUNTED TO EXHAUST FAN**
