# **Synthetic Fuel Lubricity Evaluations**

## **INTERIM REPORT TFLRF No. 367**

**U.S. Army TARDEC Fuels and Lubricants Research Facility (SwRI)  
Southwest Research Institute  
San Antonio, TX**

**September 2003**

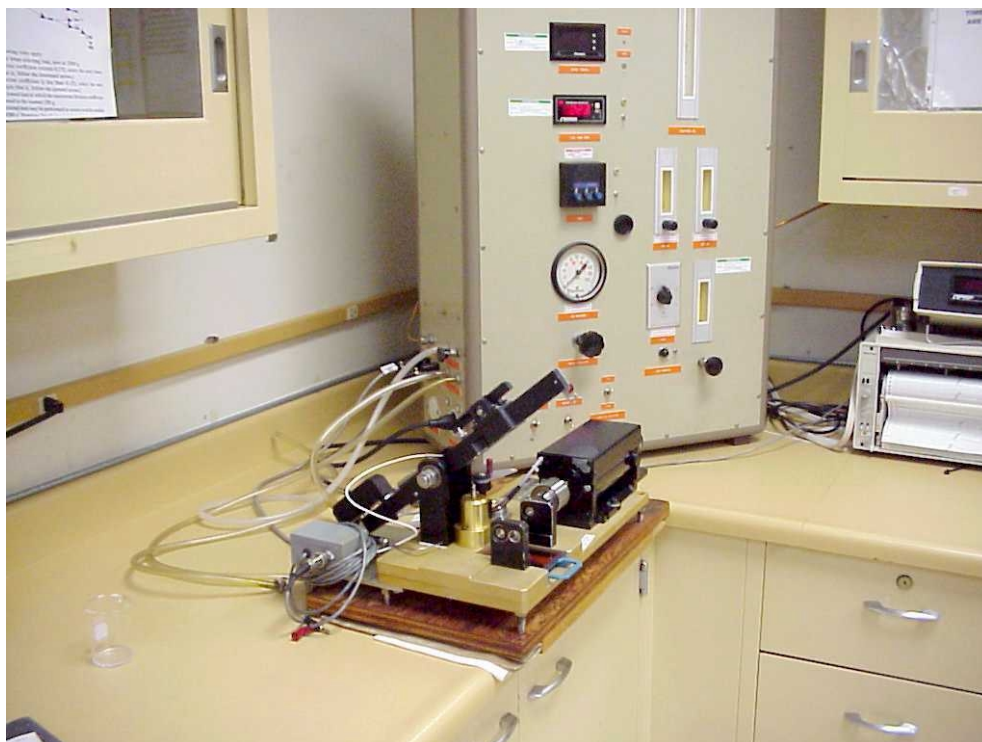
**Figure 1. Instrument for BOCLE and Scuffing Load BOCLE Tests**

- Ball-On-Cylinder Lubricity Evaluator (BOCLE) Test, ASTM D5001 (Figure 1)
- Scuffing Load BOCLE Test, ASTM D6078 (Figure 1)
- High Frequency Reciprocating Rig (HFRR) Test, ASTM D6079 (Figure 2)

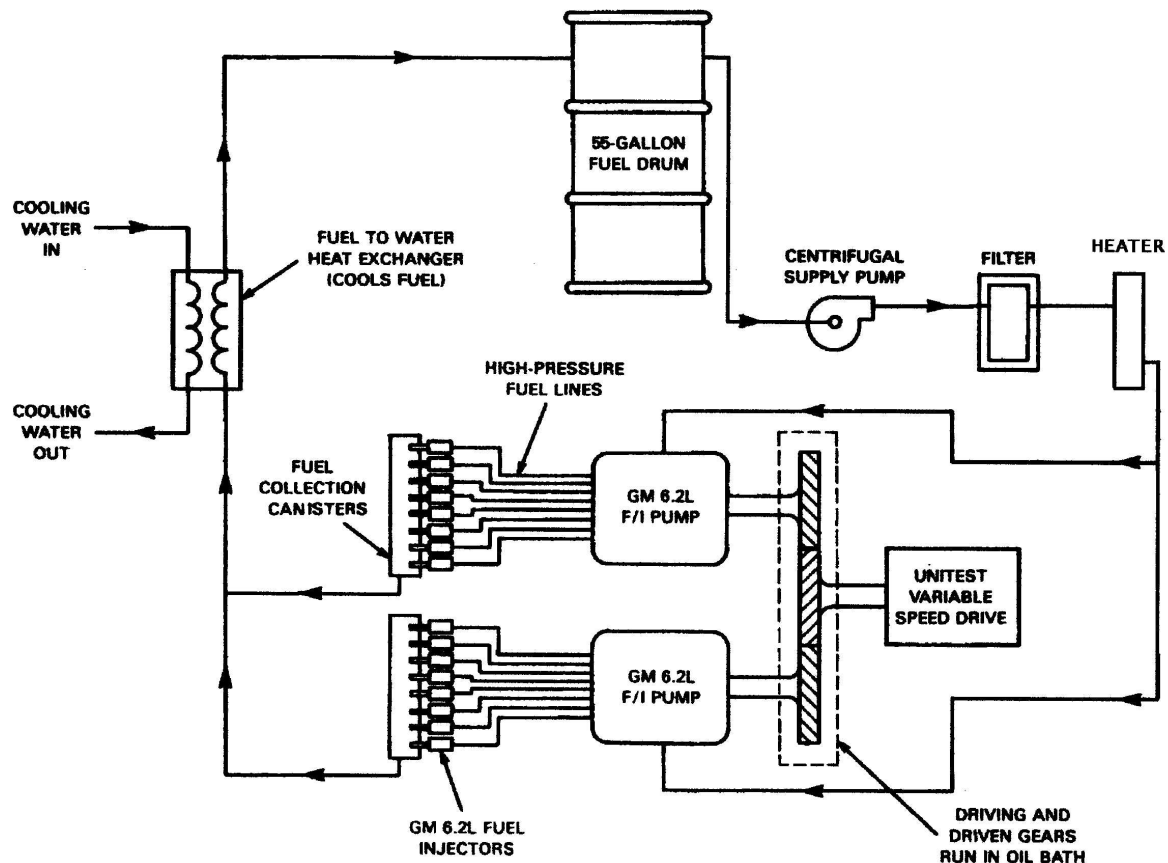
Figure 4. Fuel System Schematic

The rotary pumps were tested on a Unitest stand with a common fuel supply. The fuel system used for the tests is depicted in Figure 4 and the test stand is shown in Figure 5.

To insure a realistic test environment, the mounting arrangement and drive gear duplicate that of the 6.2L engine. The fuel was maintained in a 55-gallon epoxy-lined drum and continuously recirculated throughout the duration of each test. A centrifugal pump provided a positive head of 3 psi at the inlet to the test pumps. A cartridge filter corresponding to that used in the 6.2L engine in the HMMWV was used to remove wear debris and particulate contamination. Finally, a 5-kW Chromalox explosion-resistant circulation heater produced the required fuel inlet temperature.

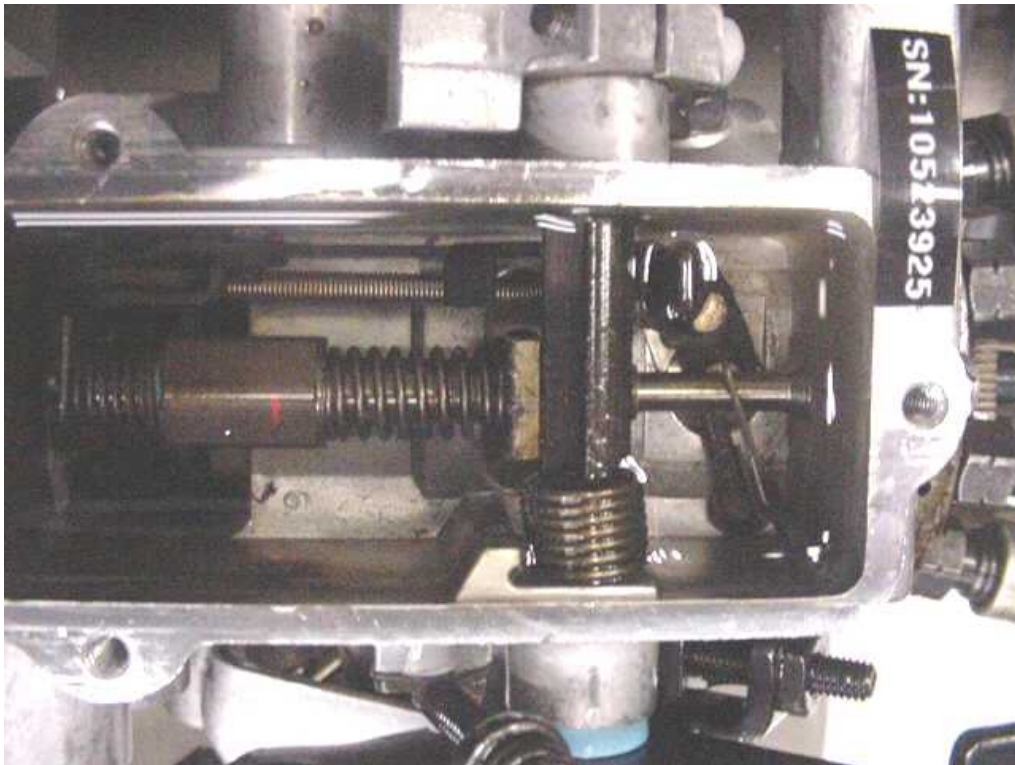
**Figure 6. Test 1 Pump 1: Pump Chamber Wear Debris**

Approximately 46 hours into the test, recorded data revealed that the inlet fuel pressure on Pump 1 increased to 11 psi and fuel flow decreased to 43cc, indicating that some event was causing extreme accelerated wear. Fuel flow continued to increase on Pump 2, indicating accelerated wear on this pump also. All other parameters remained at normal ranges; however, in order to preclude a complete seizure of the head and rotor assembly on Pump 1, the test stand was shut down at 95.6 hours of testing. The top cover on Pump 1 was removed for inspection. Slight metal debris was observed in the top chamber of the pump (Figure 6). Metal debris was also found in the top cover electric shut-off solenoid (Figure 7). Pump 1 was removed from the test stand, and testing resumed with Pump 2.

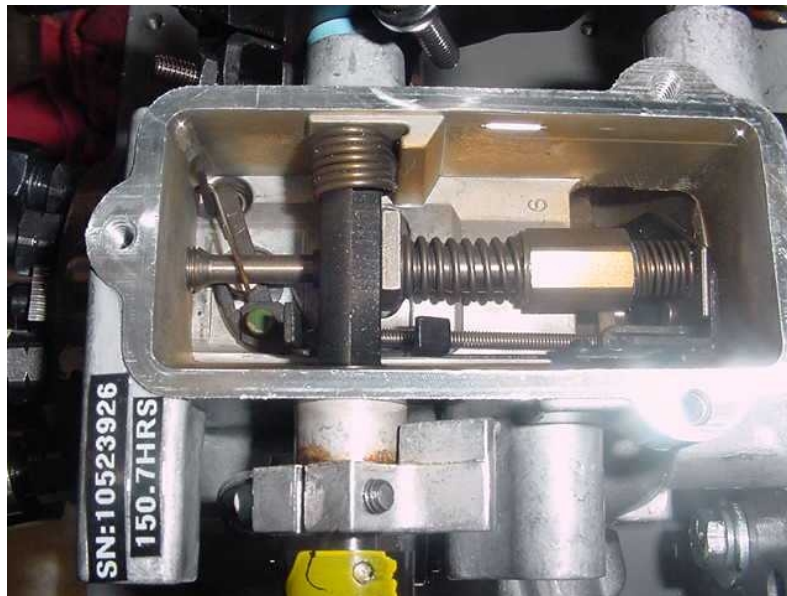
**Figure 8. Test 1 Pump 2: Debris Free Pump Chamber**

The test progressed until the test stand shut down after 151 hours. Logged data revealed that increased fuel outlet temperature triggered the automatic shutdown of the test stand solenoid, which is used to prevent imminent seizure of the head and rotor assembly. The top cover was removed from Pump 2; however, there was no evidence of wear debris in the chamber or the electric shut-off solenoid (Figures 8 and 9).

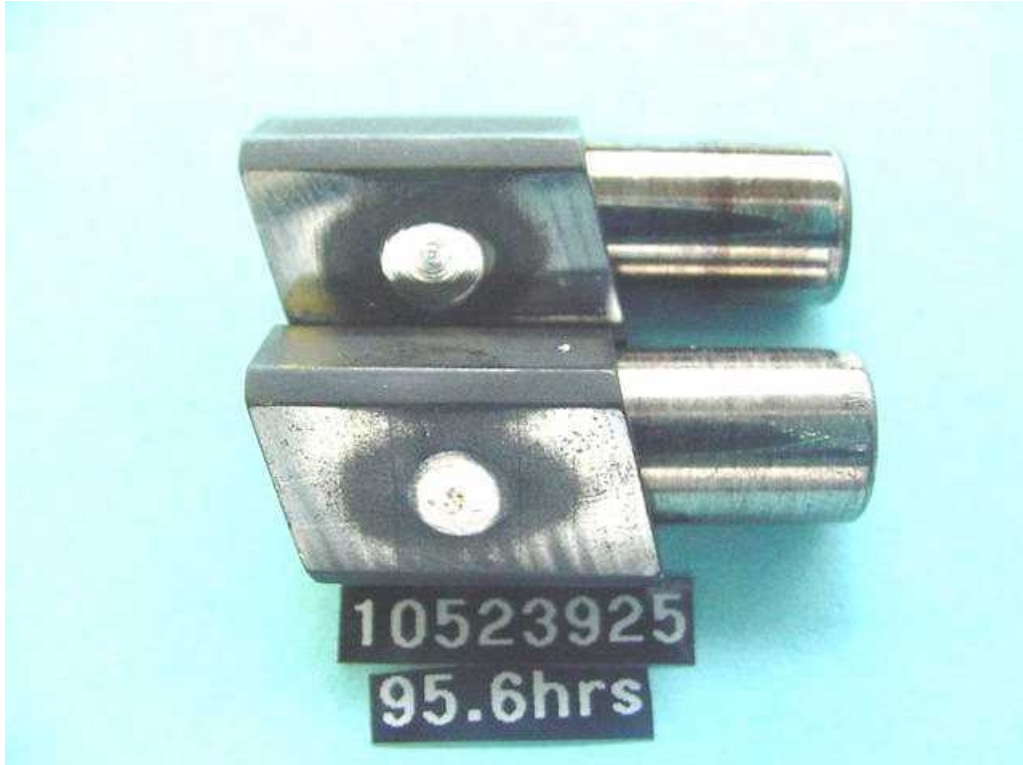
**Figure 12. Test 1 Pump 1: Shoe Back and Roller Wear**

Figures 10 through 15 show the shoe and roller assemblies, the back of the shoe holders, and the fuel plunger assemblies. The chipped shoe assembly can be seen in Figure 10 while the seized plunger is shown in Figure 14. Figure 16 shows deep scarring at the upper ports of the rotor shaft on Pump 1, and light scarring can be seen at the bottom of the rotor shaft in Figure 17.

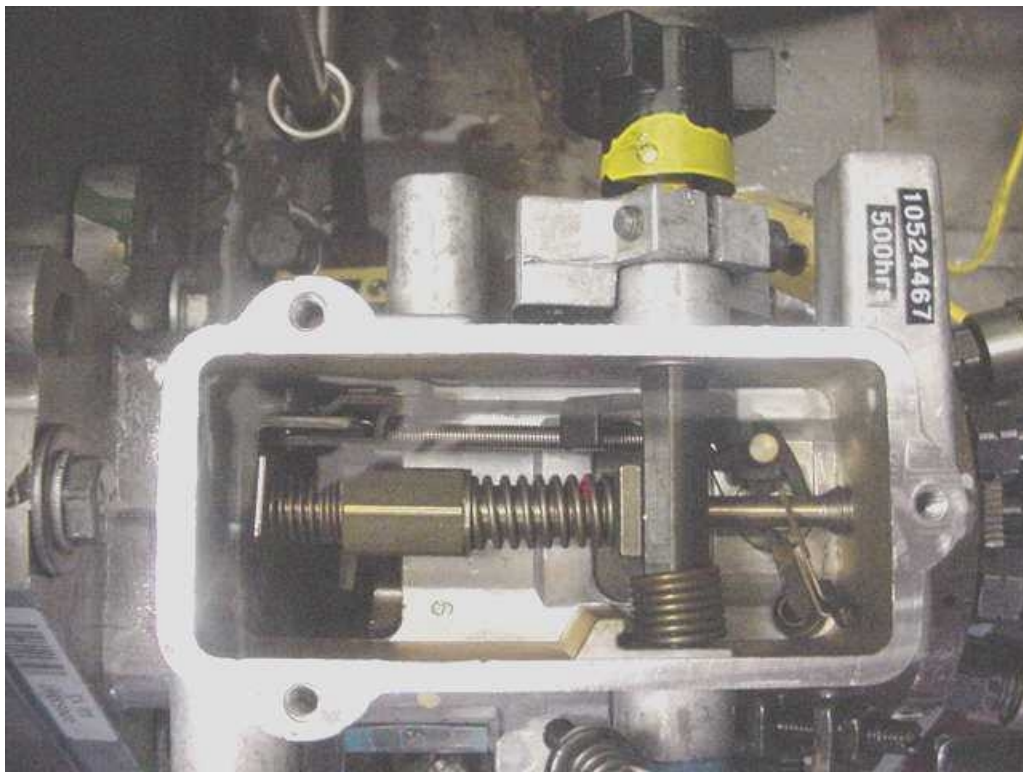
**Figure 18. Test 2 Pump 4: Pump Chamber**

The pumps were removed from the test stand after 500 hours of operation, and the top housing covers were removed on all four pumps. No wear debris was found in any of the pumps. Figure 18 presents a representative view of the top chamber of all of the pumps. The pumps were flushed and prepared for post-test performance evaluations. As shown in Tables 5 and 6, only slight performance degradation occurred with each pump. Each of the pumps had out-of-specification fuel flow at low idle speed, which resulted from

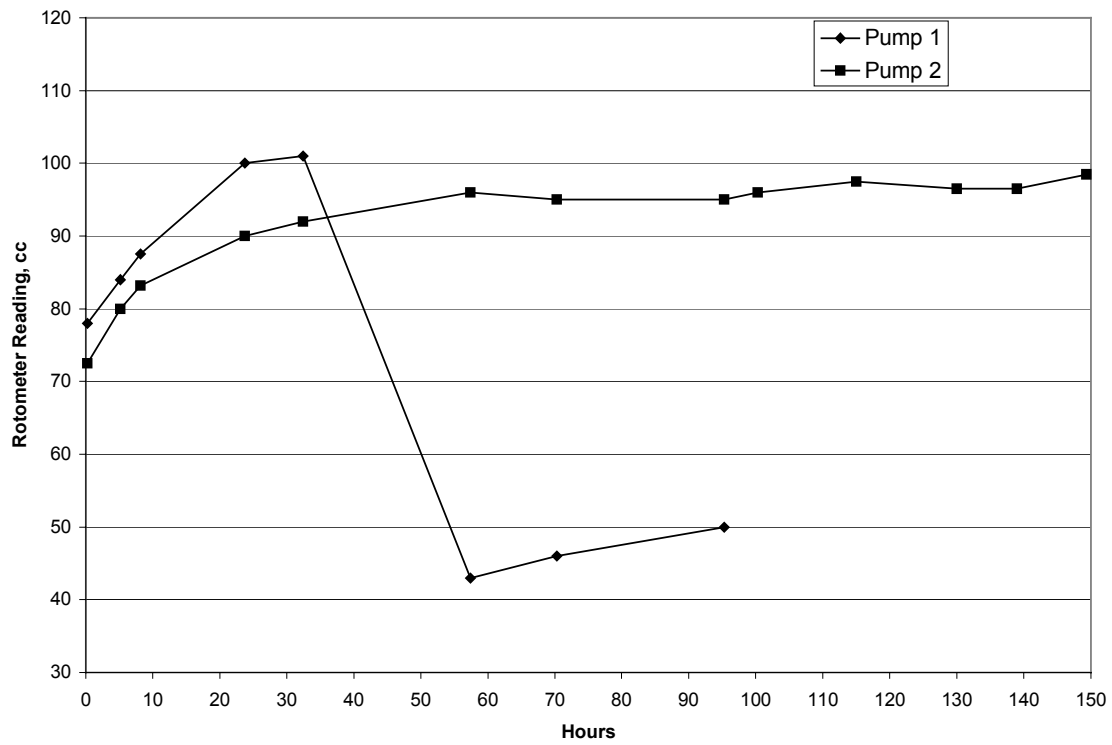
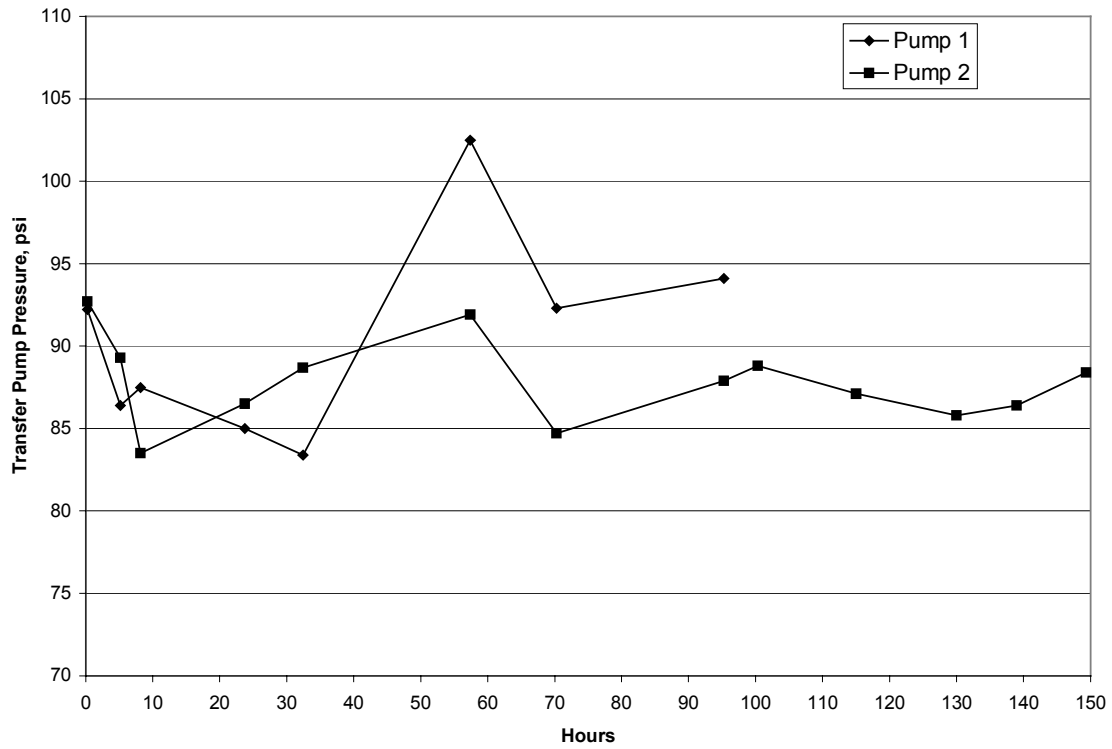
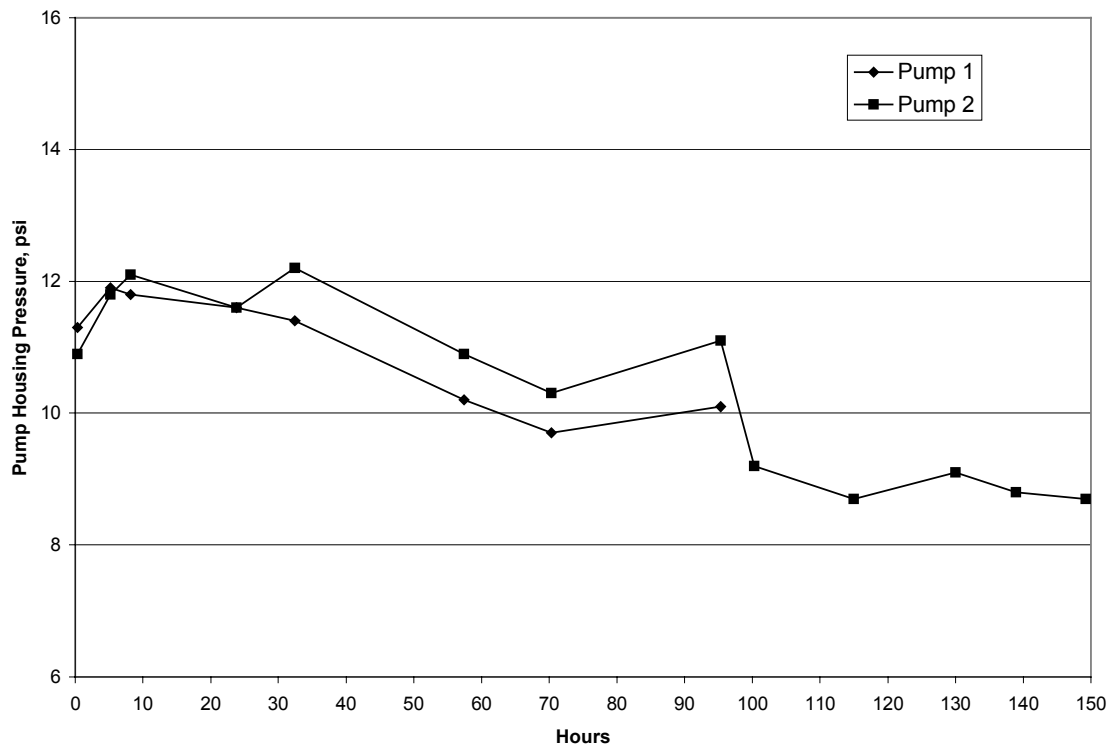
**Figure A-1. Test 1 - Rotameter Readings**

**Figure A-2. Test 1 - Fuel Return and Inlet Temperatures**

**Figure A-3. Test 1 - Transfer Pump Pressures**

**Figure A-4. Test 1 - Pump Housing Pressures**

Test stand parameter plots in Appendix A (Figures A-1 through A-4) show that both pumps exhibited a marked increase in rotameter fuel flow readings and a corresponding increase of fuel-return temperatures at the onset of the test. These parameters are precursors in accelerated pump wear. Pump 1 shows a significant increase in transfer pump pressure when the rotameter fuel flow decreases.

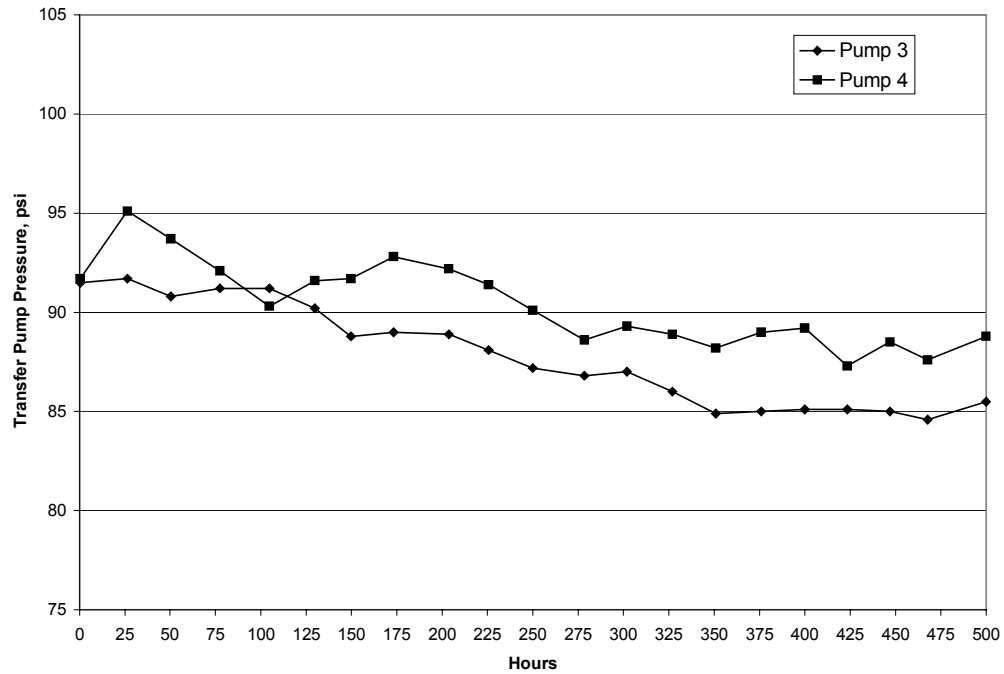
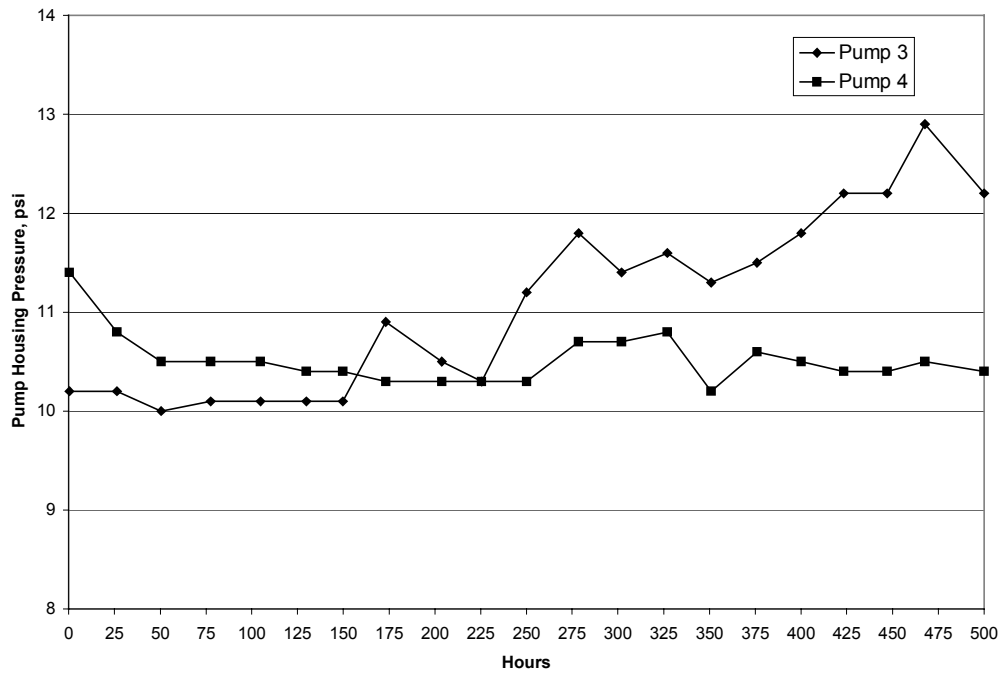
**Figure A-5. Test 2 - Rotameter Readings**

**Figure A-6. Test 2 - Pump Return Fuel and Inlet Temperature**

**Figure A-7. Test 2 - Transfer Pump Pressures**

**Figure A-8. Test 2 - Pump Housing Pressures**

Figures A-5 through A-12 (Appendix A) are plots from initiation to 500 hours of the fuel flow, fuel return, inlet temperatures, transfer pump, and pump housing pressures. The only notable difference from start to finish of testing can be seen in Figure A-8 where the pump housing pressure in Pump 3 shows a slight increase at approximately 400 hours. Elevated pump housing pressure results when clearances in plunger and bores and the hydraulic head and rotor assemblies increase due to wear and allow internal pump leakage. High housing pressure can reduce metered fuel and retard engine timing.

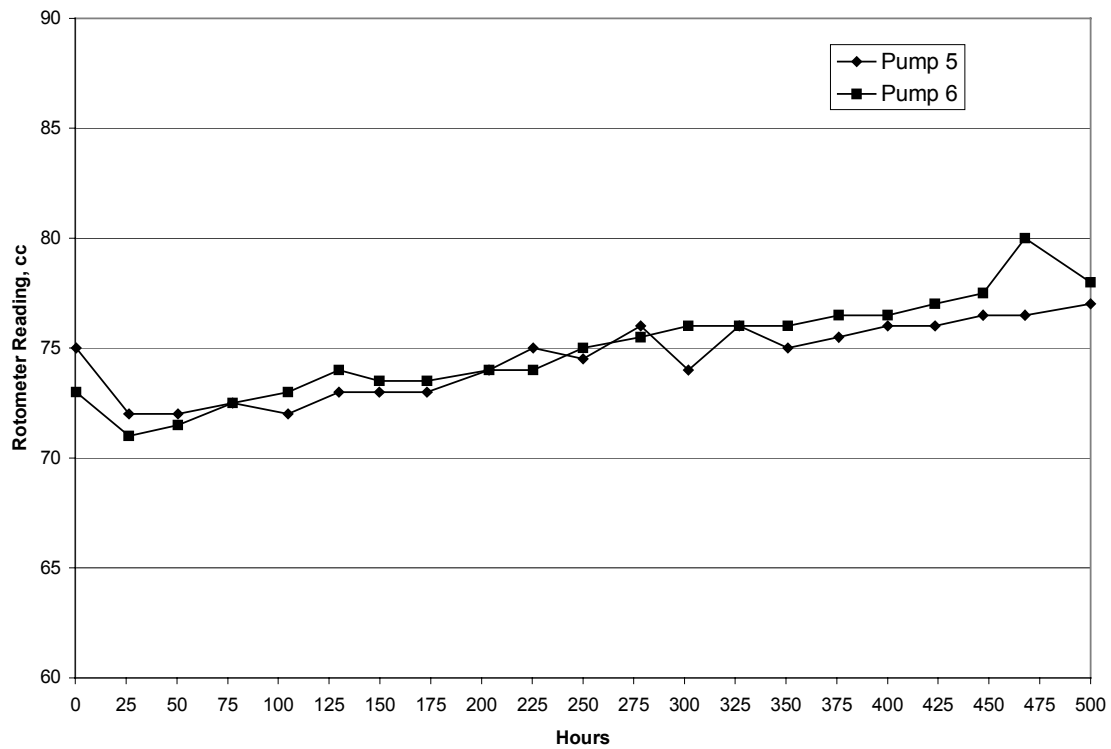
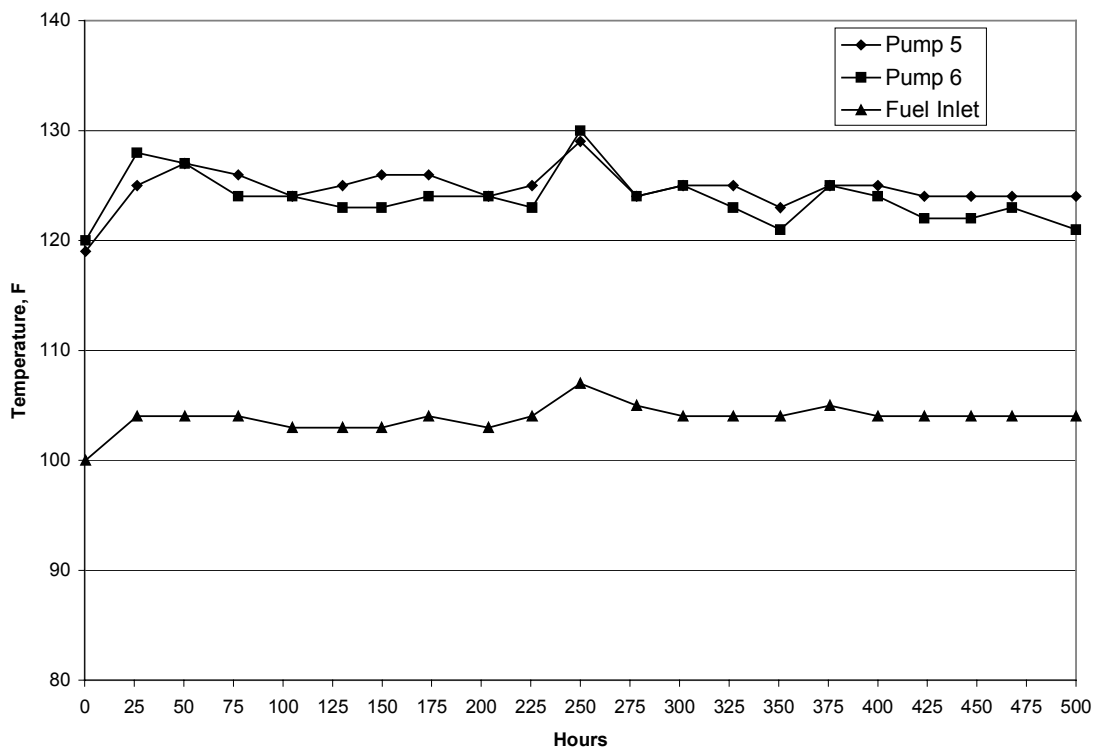
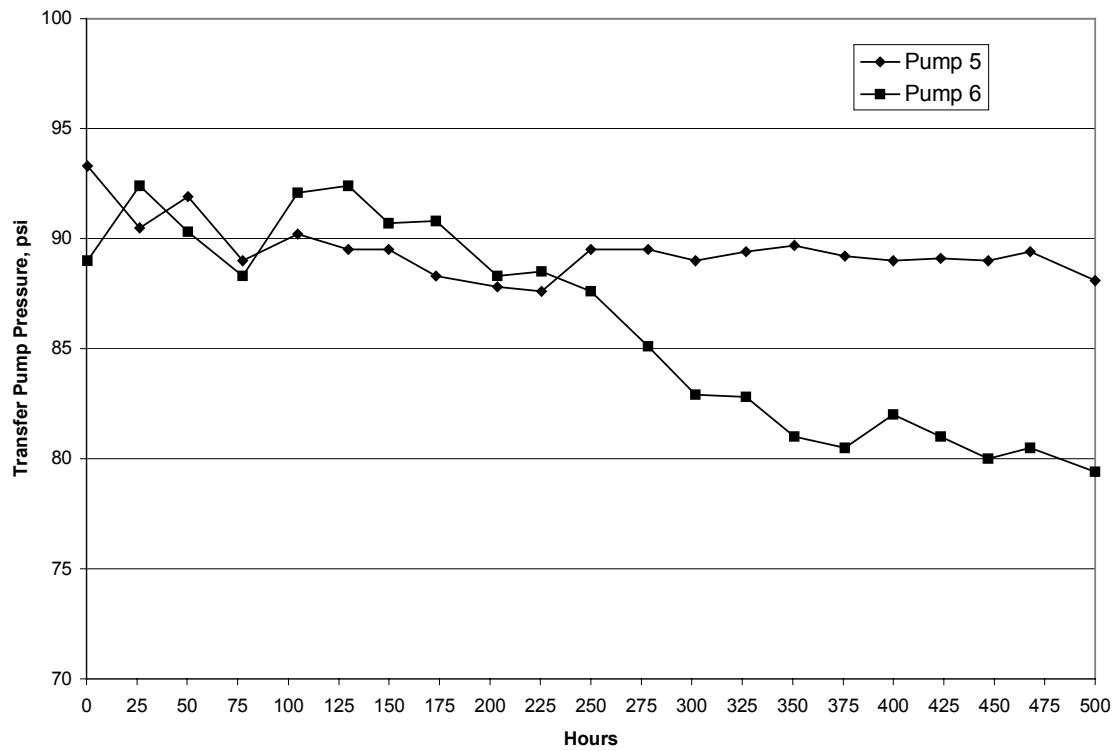
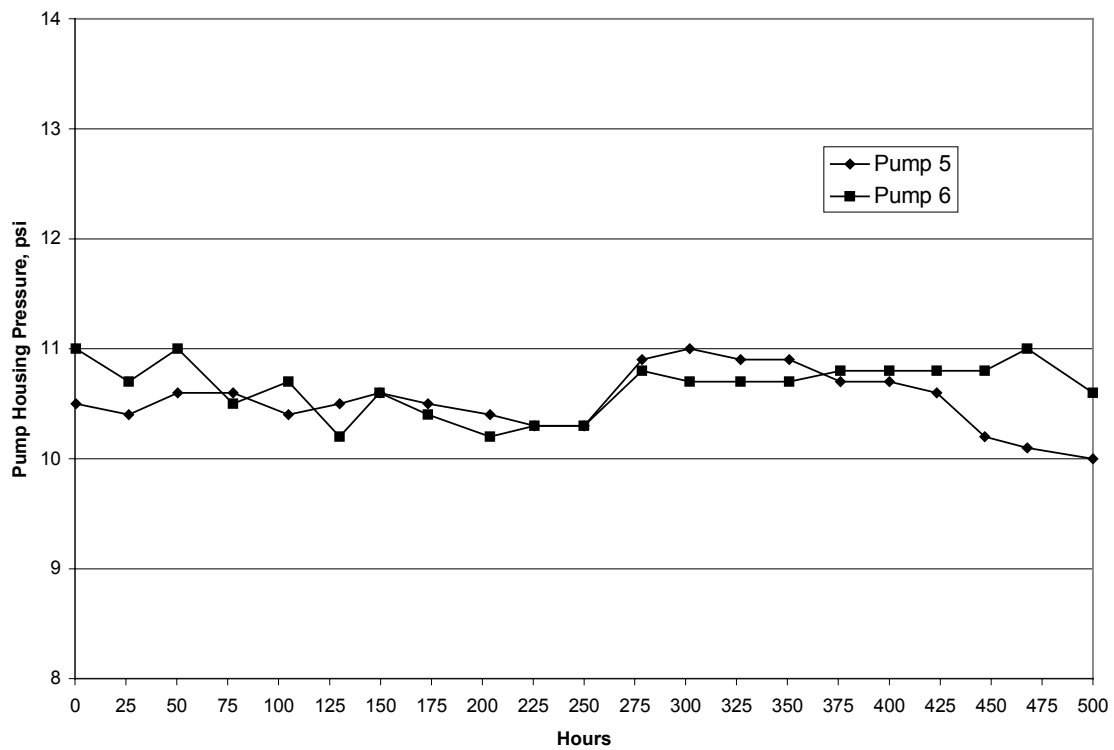
**Figure A-9. Pump Test No. 3 - Rotameter Readings**

**Figure A-10. Test 3 - Pump Return Fuel and Inlet Temperatures**

**Figure A-11. Test 3 - Transfer Pump Pressures**

**Figure A-12. Pump Test 3 - Pump Housing Pressures**
