**AN EVALUATION OF VEGETATED
ROOFING TECHNOLOGY: APPLICATION
AT AIR FORCE PLANT FOUR, BUILDING 15**

Benjamin J. Morgan, Captain, USAF

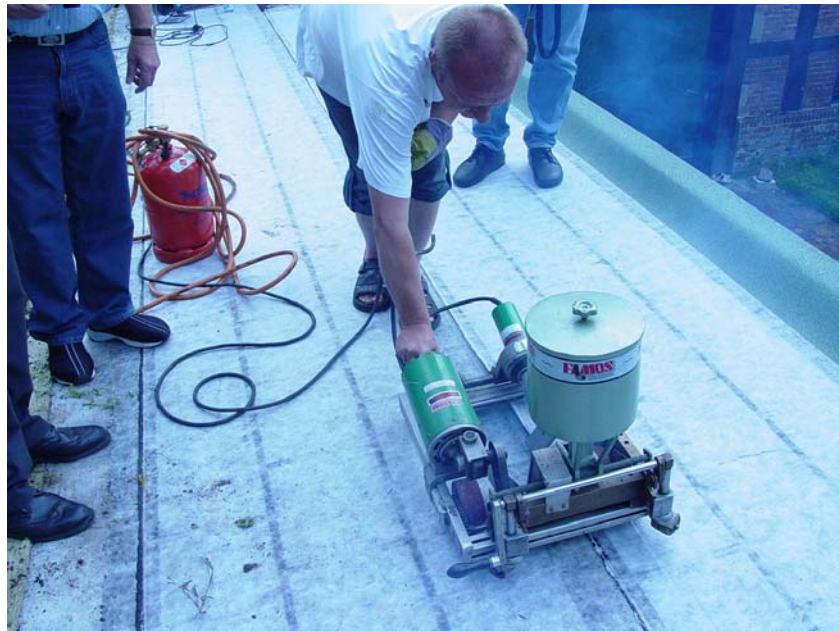
Figure 2.5 Famogreen Ret. This water proofing membrane has inherent root protection and uses gel crystals to provide water retention capabilities.

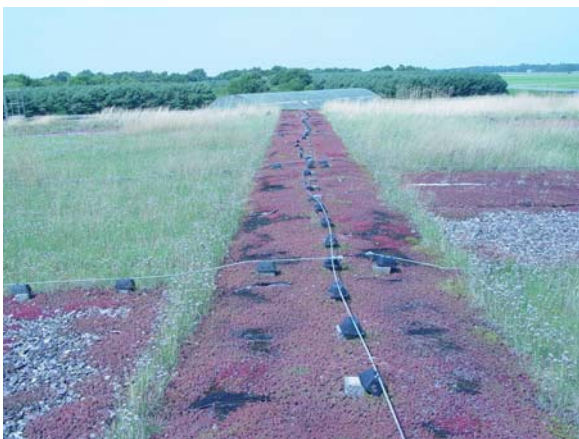
Figure 4.19 Building 3. The Building 3 roof has varying conditions such as exposed gravel, no soil, and multiple soil depths.

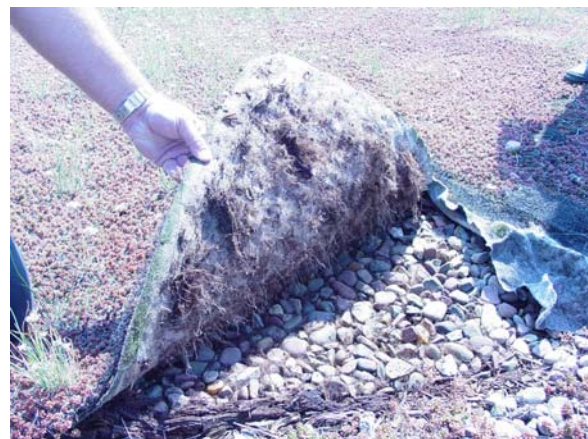
Figure 4.20 Building 3. Only sedums remain on the portions of the roof with only gravel and no soil.

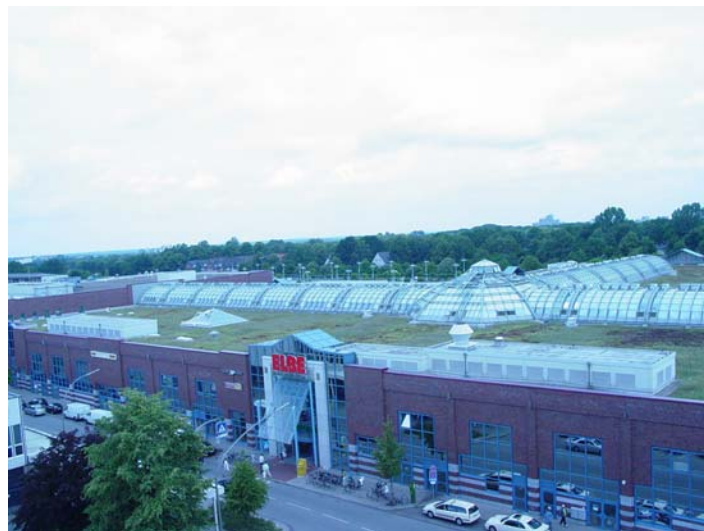
Figure 4.26 Elbe Center Department Store. The cooling benefits of the roof and the ventilation from the open skylights eliminates the need for air conditioning.
