FINAL REPORT
FOR AFOSR GRANT # F49620-00-1-0378
 (CUNY RF 47435-00-01)
Period Covered: 9/15/00 – 3/14/04

- Title of the Grant:
 "Detection of incipient metal corrosion and cracking beneath paints using near infrared ultrafast photonic techniques"
- Grant Number:
 AFOSR # F49620-00-1-0378 (CUNY RF47435-00-01)
- Name and Address of the Institute:
 The Institute for Ultrafast Spectroscopy and Lasers
 Department of Physics
 City College of the City University of New York
 Convent Avenue at 138th Street
 New York, NY 10031
- Principal Investigators:
 P.I.: Dr. R. R. Alfano, Distinguished Professor in Science and Engineering
 Co-P.I.: Dr. M. K. Kassir Prof. at Dept. of Civil Engineering, CCNY
- Researchers:

The objective of this research project is to test the concept of a nondestructive and noninvasive optical method to determine metal corrosion and cracks underneath paint layers using infrared spectral polarization imaging.

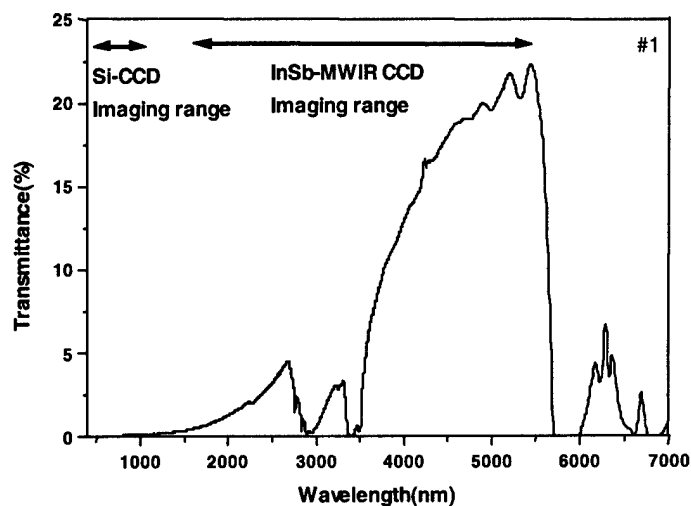
Fig.1 The transmission spectrum of military paint system #1 in the spectral range from 0.4 μm to 7.0 μm . The paint system #1 consists of the Strontium Chromate Epoxy Primer and the Polyurethane Topcoat Paint. The insert shows the spectral response ranges for InSb-based mid-IR and Si-based visible-NIR CCD cameras.

The measured absorption spectra of the military and commercial paints show that there are three major transmission zones for paints: (1) 1.0 μm – 2.9 μm peaked at 2.65 μm ; (2) 3.5 μm – 5.7 μm peaked at 5.2 μm ; and (3) 6.0 μm – 6.5 μm peaked at 6.25 μm . Although all of these transmission zones can be used for corrosion and crack detection, the second zone of 3.5 μm – 5.7 μm is the best transmission window for imaging. The transmittance at the second peak (5.2 μm) is almost 5 times larger than that at the first peak (2.65 μm) and the third peak (6.25 μm), and therefore the penetration and detection depth using this best mid-IR transmission window (3.5 μm – 5.7 μm) is estimated to be at least 2 times larger than that using other two transmission zones.^{3,4}
