AFRL-ML-TY-TR-2004-4528

**AFPDS Bagged Propellant Fire Suppression
Evaluations**

Steven Wells, Applied Research Associates, Inc.
P.O. Box 40128
Tyndall AFB, FL 32403

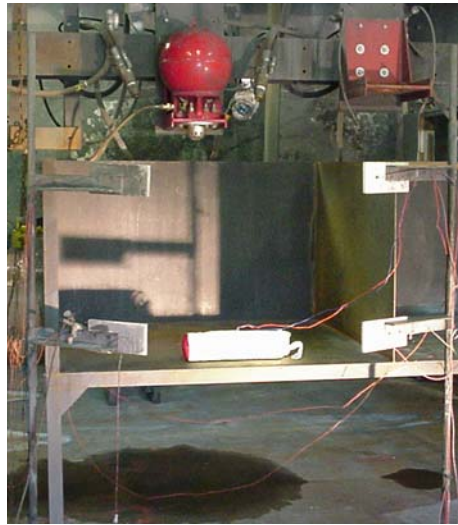
Figure 1: Suppression System and Table with M3 Propellant

All evaluations were conducted in the NATO facility at AFRL/MLQ Test Range II. This test facility was set-up with an AFPDS suppression system. The suppression system consisted of one 10L sphere extinguisher, two 1¼-inch Pyrotech solenoid nozzles and one Fire Sentry high-speed flame detector. The bottom of the sphere nozzle was located 35 inches above the table and the solenoid nozzles were 42 inches above the table. The flame detector was mounted 12 inches behind the sphere nozzle and 40 inches above the table.

An existing table was placed under the suppression system and the propellant was placed on this table. The table top was ¼-inch steel with dimensions 52 inches wide and 48 inches deep. The table had three 30-inch high, ¼-inch steel walls. Initial plans were to conduct two suppressed fires on the table, then to remove the left and right walls and continue with the remaining fires. However, the initial fires were not extinguished immediately. The propellant bags were forced off of the table by the water spray and continued to burn or reignited after they were outside of the protection of the water spray. The decision was made to keep the walls in place for the remaining evaluations and to add a four-inch rim to the table edge to contain the propellant and the water.

One bag of M3 propellant was located on the table, 35 inches below and 30 inches in front of the sphere nozzle (See Figures 1 and 6). The M3 bag consists of five charges, three small charges in the middle and two large charges on the outside. A single electric match failed to ignite the material; so two electric matches were connected in parallel. After ignition, the fire was detected 34 ms after the detectable event. Water discharged from the sphere 36 ms after the detectable event. Due to the location and size of the fireball, the fire was never contained, and although the water spray impacted the propellant, the density was not great enough to extinguish the fire. The spray did prevent the fire propagation to the two outside propellant charges that remained intact after the test. The propellant was pushed off the table and continued to burn on the floor for six seconds. Afterwards the propellant grains from the three inside charges were scattered across the floor in front of the table.

This was a repeat of Test 1. One bag of M3 propellant was located on the table, 35 inches below and 30 inches in front of the sphere nozzle (See Figures 1 and 6). A single electric match (different manufacturer than test 1) was used to ignite the material. After ignition, the fire was detected 22 ms after the detectable event. Water discharged from the sphere 24 ms after the detectable event. The fire appeared to be suppressed 60 ms after detection, however the flame came back 213 ms after detection with a fireball over seven feet high. Again, the low density of water spray contributed to the fireball coming back with such intensity. The fire went out eight seconds after detection. Afterwards, propellant grains from the three inside charges and one outside charge were scattered across the floor in front of the table. The remaining outside charge remained intact.

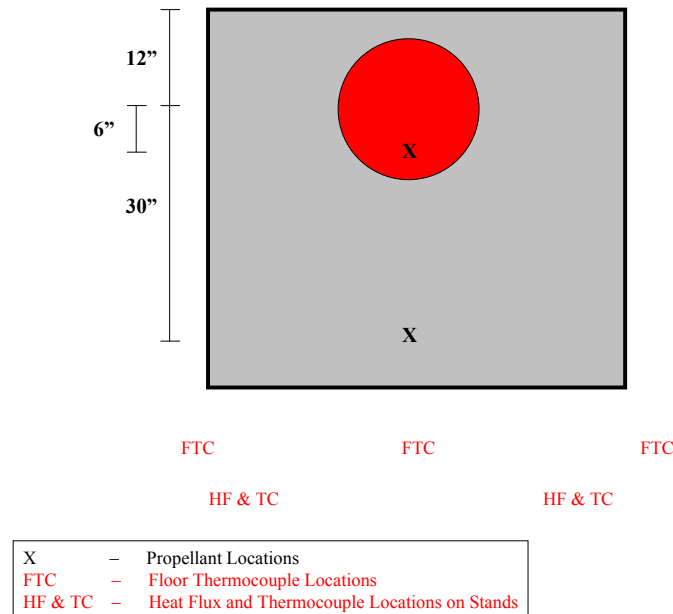
Figure 5: Test Setup (Top View)

A data acquisition system was set-up to record temperature, heat flux and detector response times. Temperatures and heat flux were measured with K-type thermocouples and Thermogage™ heat flux transducers at five locations where a workers hand and face may be during a fire. These sensors were located on stands seen in Figure 1 on the left and right front of the table. Temperatures were also measured at three locations on the floor in front of the table. Regular speed video of all tests was recorded from three angles and high-speed video was recorded from the front side of the table.

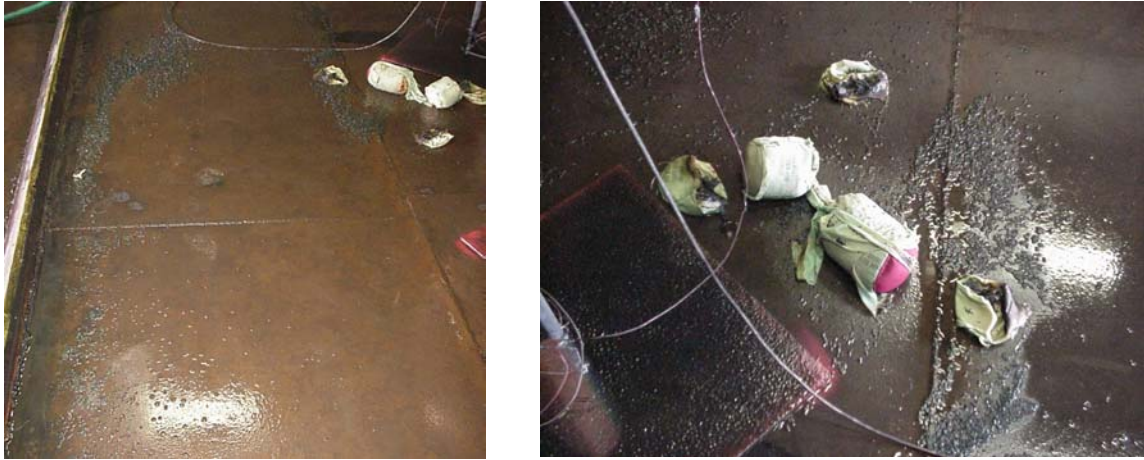
Figure 12: Test 4 Results

This was a repeat of Test 2. One bag of M3 propellant was located on the table, 35 inches below and six inches in front of the sphere nozzle (See Figures 7 and 8). A single electric match was used to ignite the material. After ignition, the fire was detected 24 ms after the detectable event. The fire was suppressed on the table 35 ms after detection, however as in Test 2, the fire reignited on the floor. Unlike Test 2, all of the propellant was washed off the table. The fire went out five seconds after detection. Afterwards, propellant grains from the three inside charges were scattered across the floor in front of the table. The two outside charges remained intact.

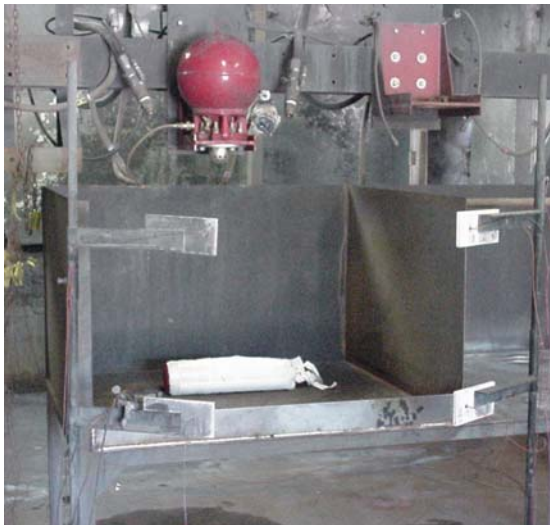
Figure 13: Tests 5-7 Setup

After Test 4, the table was modified with a four-inch tall, ¼-inch steel rim. The rim was installed to contain the propellant and prevent combustion of propellant that is washed onto the floor. Also, the propellant was placed as shown in Figure 13 for the remaining evaluations. This modification worked so well that it is recommended for all applications involving munitions inspections on tables.

One bag of M4 propellant (13 lbs) was located on the table, 35 inches below and six inches in front of the sphere nozzle (See Figure 13). After a single electric match did not ignite the propellant, 10g of smokeless powder was added to the match to ignite the

One bag of M3 propellant (5.5 lbs) was located on the table, 35 inches below and six inches in front of the sphere nozzle (See Figure 13). A single electric match was used to ignite the propellant. After ignition, the fire was detected 23 ms after the detectable event and suppressed 25 ms after detection. The four-inch rim prevented the propellant bag and most of the grains from washing off the table. A few grains did end up on the floor as seen in Figure 15. The propellant bag sustained more damage than in other evaluations. Propellant grains from the three inside charges and one outside charge were scattered around the table. The other outside charge remained intact.

One unsuppressed burn of M4 propellant (13 lbs) was conducted to determine the effect of the suppression system. The propellant was located on the table, 35 inches below and six inches in front of the sphere nozzle (See Figure 13). An electric match with 10g of smokeless powder was used to ignite the material. The material burned completely.

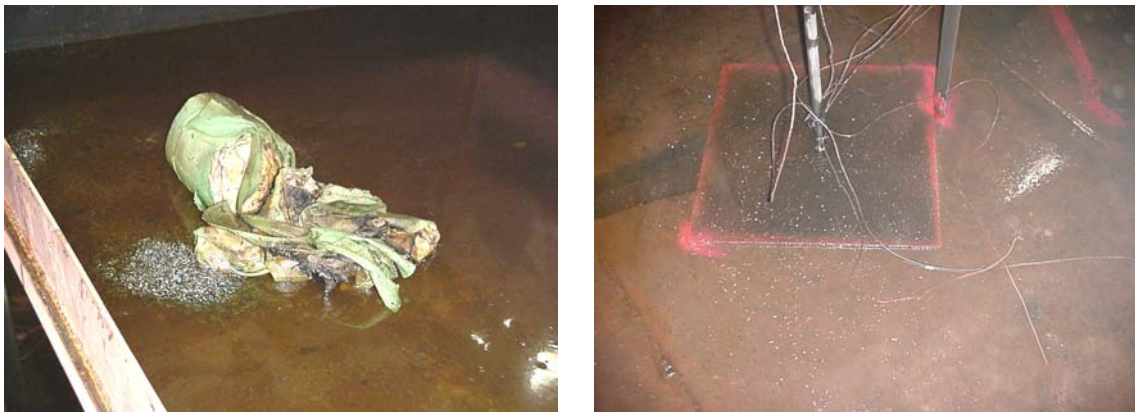
Figure 15: Test 6 Results

There was more smoke generated in this test than in other tests. It appears from the video that the material in the bag smoldered after extinguishment generating a significant amount of smoke.

After modifying the table with a four-inch rim, the last M3 fire, in Test 6, was extinguished 25 ms after flame detection. The propellant bag sustained more damage in Test 6 than in other evaluations, however, the fast and thorough extinguishment of the propellant showed a greater level of protection for workers in the area.
