**A Health Assessment of
Lubricating Oil in Two Australian
Army CH-47D Helicopters**

DSTO-TR-1594

Air Vehicles Division
Platforms Sciences Laboratory

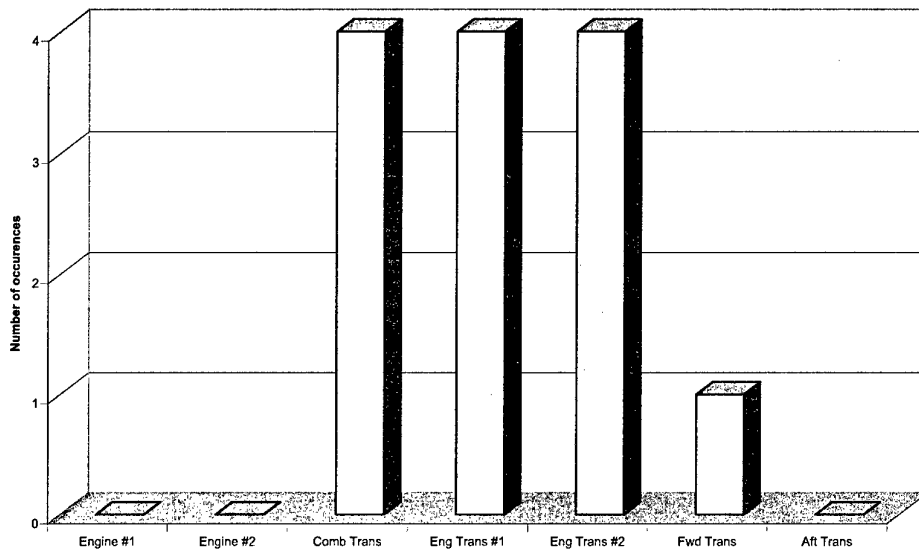
Figure 4: Distribution of Severe Visual Contamination

shows the distribution of the samples graded as Severe and shows that the majority of instances were recorded from samples taken from the Combining Transmission and Engine Transmissions (as previously stated there is a common segmented housing for the reservoirs of these transmissions).

However, severe visible silicon-based grit contamination was identified repeatedly in some lubricating systems. In particular the Combining Transmission and Engine Transmission lubricating systems regularly featured visible contamination. In addition the bulk colour of the patches indicated that, in some cases, unacceptable fine wear debris was present (based on hydraulic system standards). In contrast, the majority of samples analysed from the Forward and Aft Transmissions were free from visible contamination and visible wear debris. The higher level of filtration applied to the engine lubricating systems appeared to limit the visible particulate to Trace or Slight in all cases. The overall patch colour, however, indicated that wear metal was still present in the lubricant in significant quantities and, in one case, the patch was assessed as unacceptable (see Appendix A). The visible contamination results unexpectedly showed that assemblies with relatively low operating hours accounted for the majority of contamination.

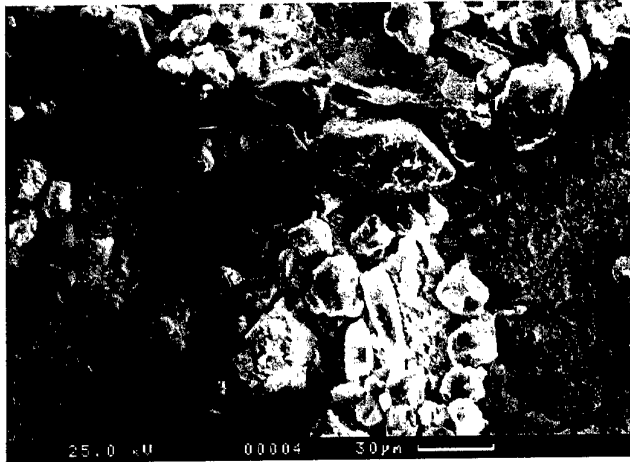
Figure 8: SEM image of typical debris

Figure 8 shows a typical SEM image of the severe visible contamination found during this investigation. Figure 9 shows the Energy Dispersive Spectroscopy (EDS) spectrum from a typical contaminant and shows the dominant silicon peak.

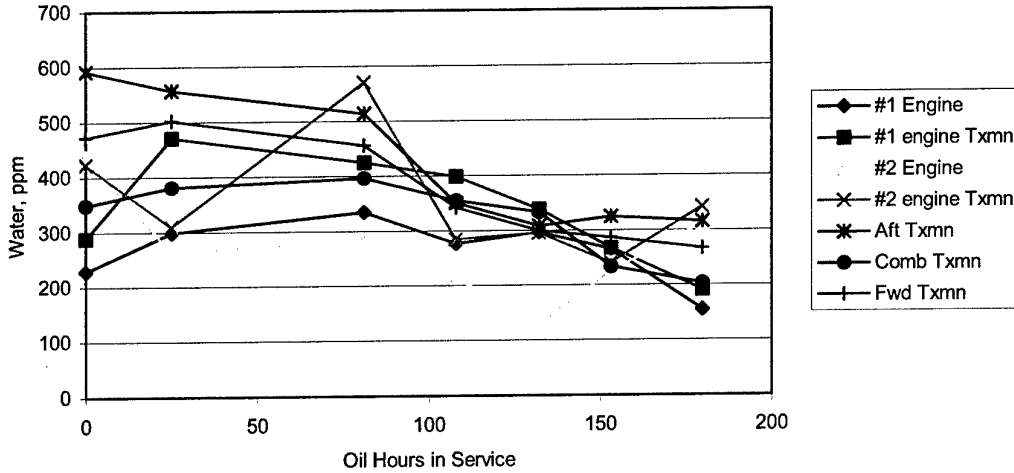
Figure B1.2 A15-102 Water trend data

A15-102 Water Concentration with Time in Service

The oil water content for both aircraft has been maintained well below the 1500ppm maximum. A corrosion-inhibited version of the O-156 oil is available which would offer improved resistance to static corrosion if the aircraft was to sit idle for extended periods.

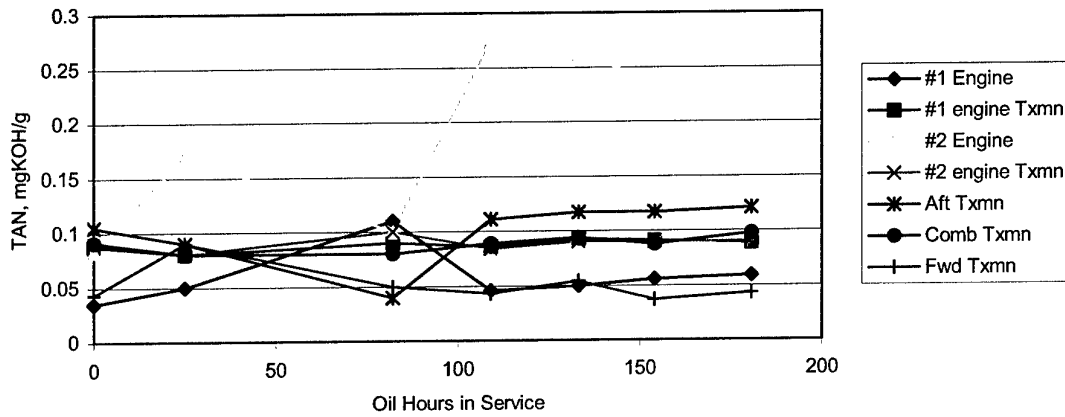
Figure B1.3 A15-102 TAN trend data

A15-102 Total Acid Number with Time in Service

Fresh O-156 oil will normally have a TAN in the range 0.05-0.1 mgKOH/g. The TAN of the oils in both aircraft are well under the in-service maximum of 2.0 mgKOH/g recommended in AAP 7210.009-2-16 (Chapter 4. Oil Condition Analysis). The No. 1 Engine for A15-202 (Figure B2.3) and No.2 engine for A15-102 (Figure B1.3) showed an increase in TAN, which is consistent with normal engine operation. The No. 2 Engine of A15-202 TAN was lower than expected but 14 quarts of top up oil had been added to this system. The addition of top-up oil maintained a low TAN in the oil system.
