## **Strengthening of Concrete Beams with Fasteners and Composite Material Strips—Scaling and Anchorage Issues**

Lawrence C. Bank, David T. Borowicz, Dushyant Arora,  
Anthony J. Lamanna, Gerardo I. Velázquez,  
and James C. Ray

July 2004

Final report

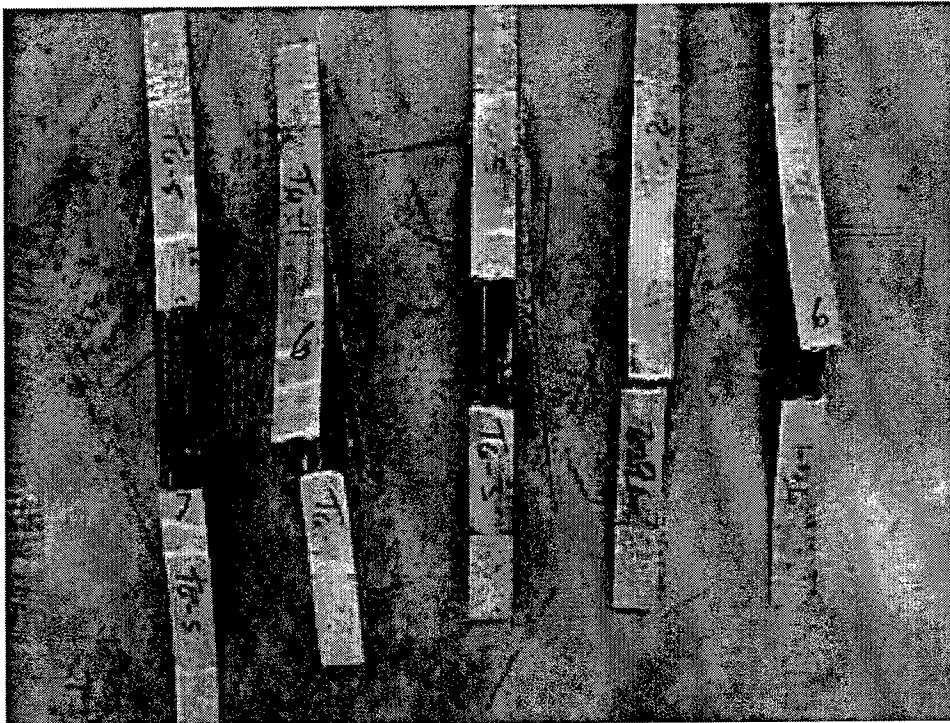
Figure 21. Typical failure mode for tension test specimens

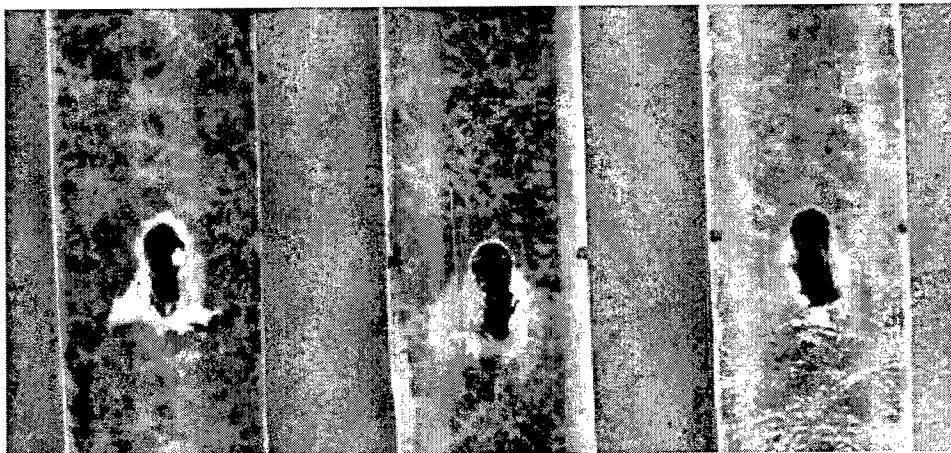
Figure 26. Typical bearing failure mode observed

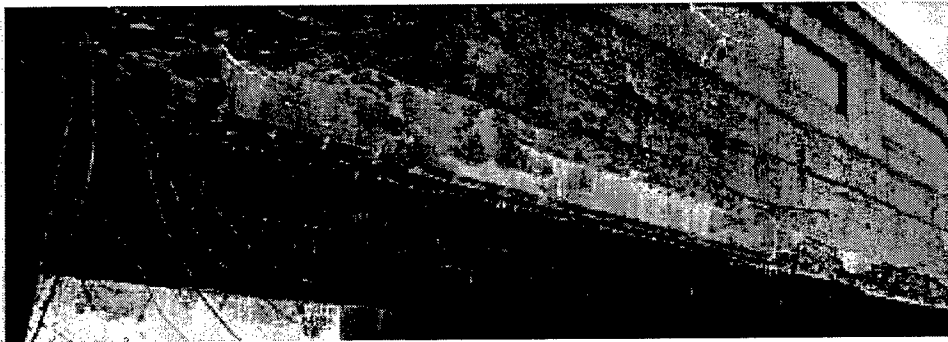
Figure 34. Large amount of stalactites and efflorescence seen on the bottom surface of the slab of P-53-702

Upon preliminary assessment, the underside of the bridge looked in reasonable (but deteriorated) condition with a clearance of 4 to 5 ft. A large number of stalactites were seen on the underside of the slab and one of the edges showed some section loss. Figure 34 shows the underside of the bridge.

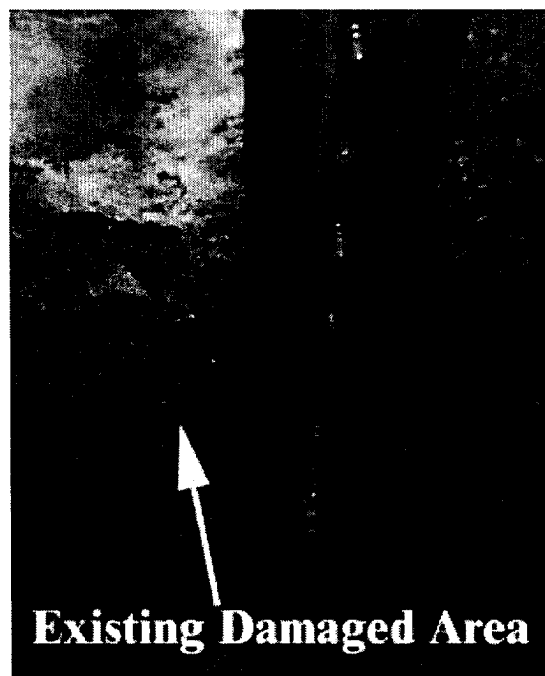
Figure 58. Relocated FRP strip near existing local damaged area

In a situation where the row of fasteners was anticipated to achieve improper embedment the FRP strip was slightly re-positioned. Figure 58 shows the position of the FRP strip in close proximity to a local damaged area. The strip was moved a few inches to avoid the damaged area.

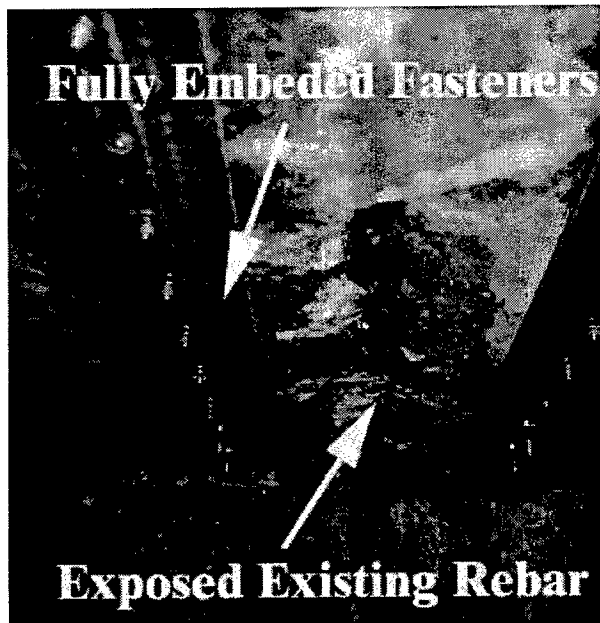
Figure 59. Existing damaged area in the bridge with the exposed steel reinforcement

Local damage in the existing concrete substrate did not cause a problem with the fastening of the FRP strip. Figure 59 shows an existing damaged area in the bridge with the exposed steel reinforcement.
