Hardening and Testing the Video Transmitter and Camera for the Shoulder-Fired Video Imager

ARL-TR-3353

November 2004

Weapons and Materials Research Directorate, ARL

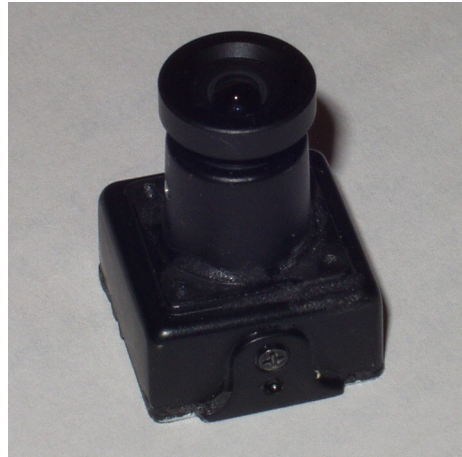
The camera intended for use is the Supercircuits PC182XS. This camera uses Sony's new Ex-View charged-coupled device (CCD) chip set which allows for low light visibility and high resolution. The camera uses a 3.6-mm lens and includes an electronic shutter that can vary the exposure from 1/60 to 1/100,000 second. The camera and its specifications are shown in figure 2 and table 2.

Figure 2. PC182XS camera.

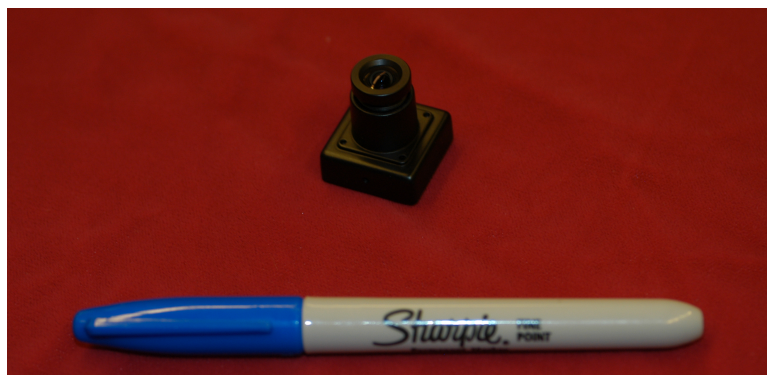
Because of the failure of the camera during shock tests, as detailed in the following sections, a second camera was selected and tested. The Supercircuits PC72XS camera, shown in figure 3, was successfully used by John Condon of ARL in a separate gun-launched application (Condon, McLaughlin, & Mitchell, 2001). For this application, the 4.5-mm micro-lens model was used. The PC72XS camera specifications are listed in table 3.

Figure 3. PC72XS camera.

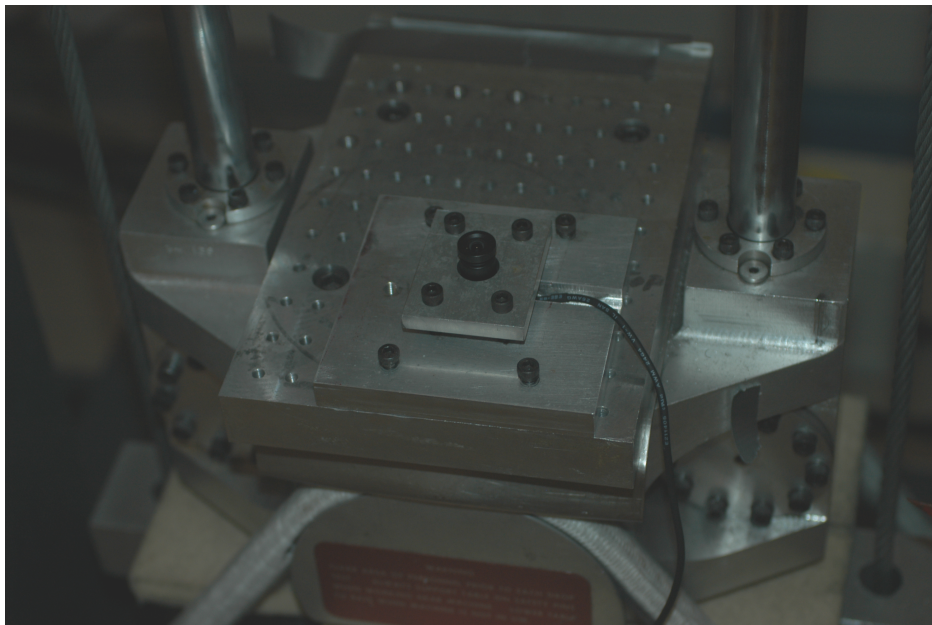
The camera was mounted to the shock table in its shock fixture, shown in figure 12, and shock tested to a peak acceleration of 8085 g's, as measured by an accelerometer mounted to the fixture. The video output of the camera was observed on a black-and-white monitor during the shock event. The camera survived the shock event, as noted by the clear video image on the monitor after the test.

Figure 12. Camera fixture mounted to MTS shock table.

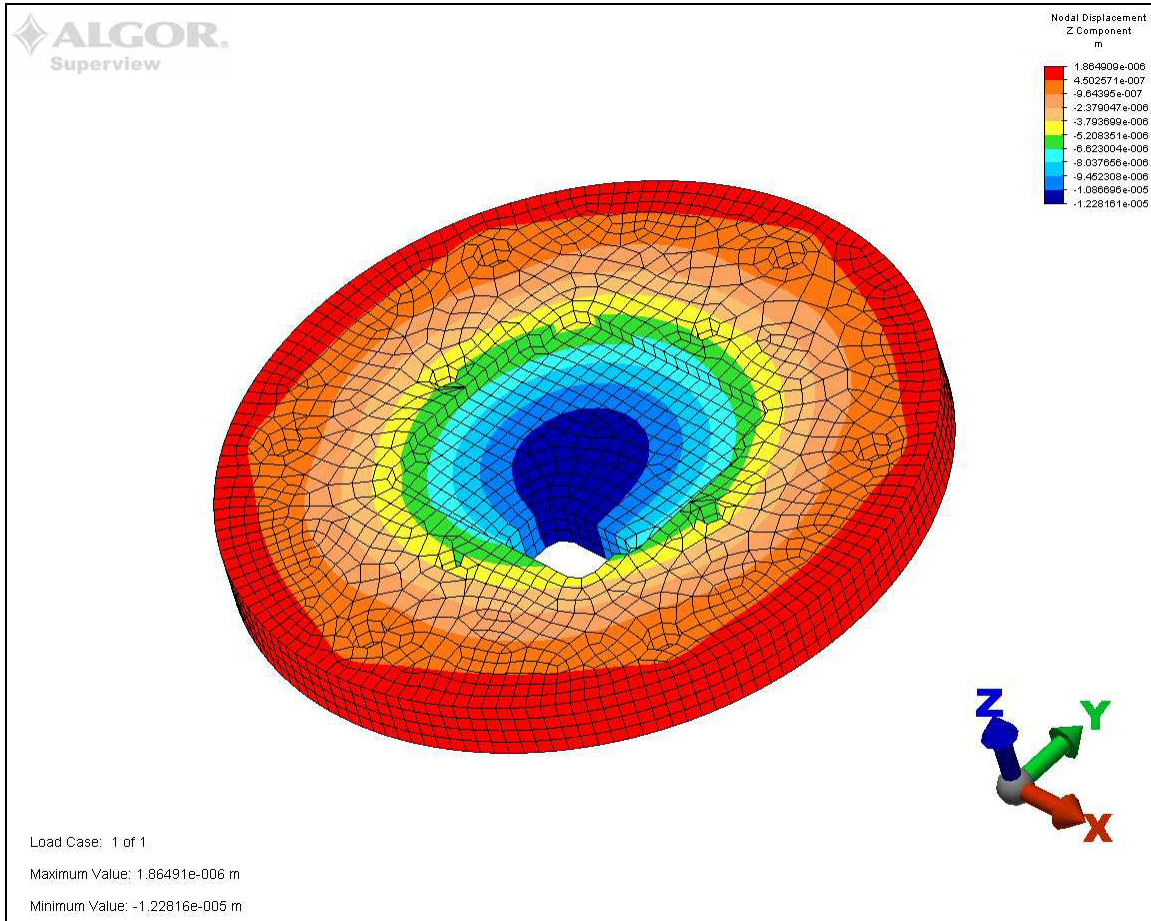
In an attempt to determine the cause of failure, FEA was performed on both the camera mounting plate and the camera mounting box with ALGOR¹². A static analysis was conducted on the camera mounting plate. The plate was constrained from movement in the axial direction of the round by the screw holes. A force of 525 newtons was applied to the pocket where the camera sits. The analysis, shown in figure 15, predicts that the maximum deflection of the plate in the axial direction occurs at the center of the pocket and is equal to 1.228×10^{-5} m.

Figure 15. Displacement graph of the camera mounting plate from FEA.

The top piece of the camera shock fixture was analyzed and ALGOR predicted a displacement of 9.9×10^{-7} m. The difference in displacement is apparently the cause for the camera failure. While the deflection of the camera mounting plate and mounting box is small, a component of the acceleration present in these parts, which was not present in the more rigid shock fixture, likely caused a failure of one or more of the camera components.

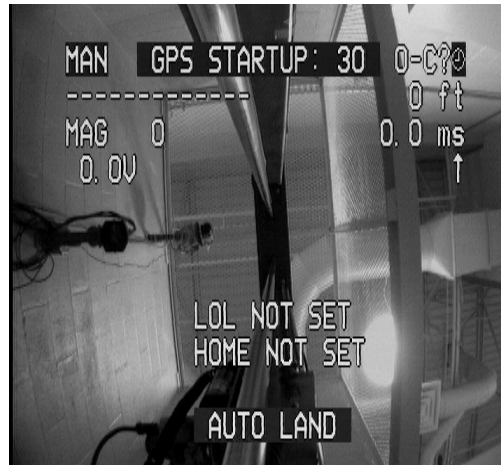
Another shock test was conducted of the entire unit after assembly. The maximum acceleration of this test was 7347 g's. As before, the video output was recorded and the pre-shock and post-shock images are shown in figures 20 and 21.

These images are seemingly identical, indicating that the camera and transmitters survived shock without failure. The second video imager unit was similarly assembled and tested and the transmitter and camera survived the shock without incident.

Figure 20. Pre-shock video image.

Figure 21. Post-shock video image.
