Aquatic Plant Control Research Program

Vol A-04-1

November 2004

Aquatic Vegetation Restoration in Drakes Creek, Tennessee

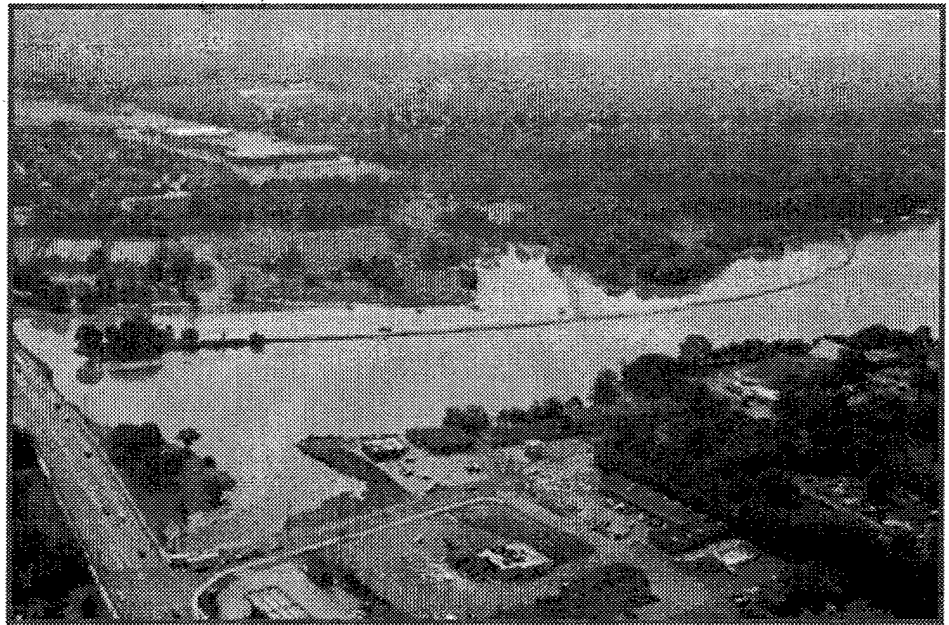
Figure 2. Aerial view of Drakes Creek restoration site (Phase 1)

The Lewisville Aquatic Ecosystem Research Facility (LAERF), U.S. Army Engineer Research and Development Center (ERDC), participated in Phase 1 of this project, employing techniques developed for establishing native aquatic plants in man-made reservoirs. In Phase 1, geo-tubes were filled with sediments dredged from approximately 17 acres of degraded (silted-in) aquatic habitat. The geo-tubes were installed to partially isolate a portion of the creek adjacent to Memorial Park from the main channel, thereby reducing silt deposition (Figure 2).

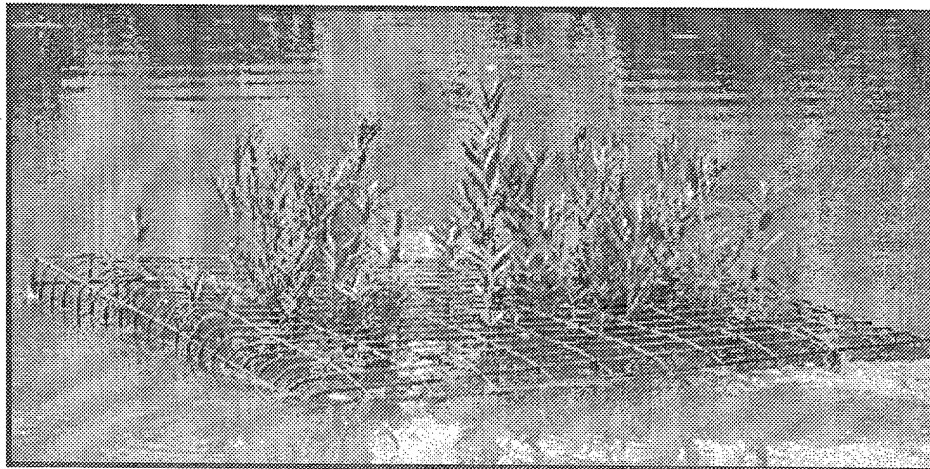
Figure 8. Water willow was used to replace plants that faired poorly in tray cages

Water willow (*Justicia americana*) established well in tray cages in which it was planted, replacing American bulrush as well as some bulltongue, arrowhead, and creeping burhead, and had grown to fill 75-100 percent of each cage (Figure 8). In a few cases, plants were beginning to grow outside protected areas. No evidence of herbivory was noted on this species.
