## **Field Evaluation of Self-Lubricated Mechanical Components for Civil Works Navigation Structures**

Timothy D. Race, Ashok Kumar, and  
L.D. Stephenson

June 2004

## Final Report

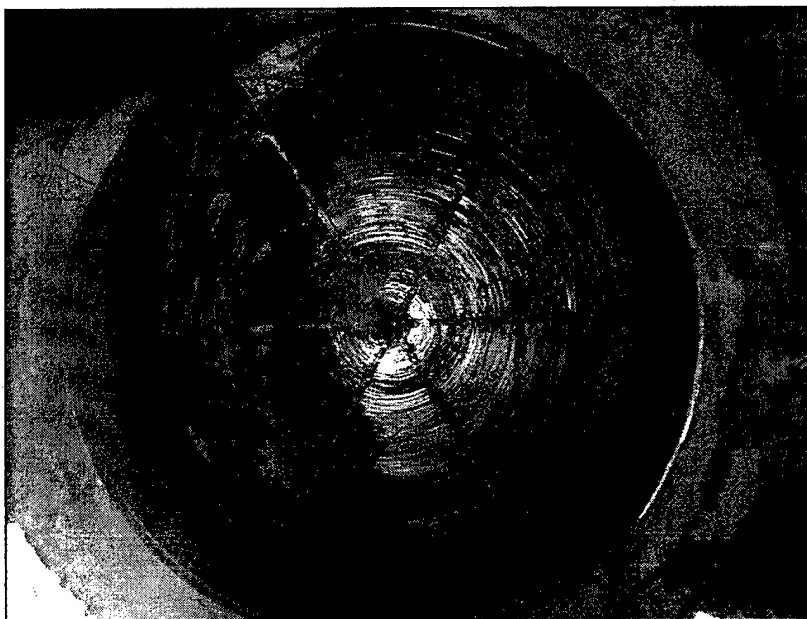
Figure 1. Self-lubricating pintle bearing with Thordon SXL material installed at Cannelton Lock in 1994; removed/replaced in July 2002; self-lubricating Thordon SXL material was approximately 80% eroded after 8 years.

The only self-lubricating bearing material used in an actual pintle application was for one of the upper miter gate leafs for Cannelton Lock on the Ohio River, Tell City, IN (Louisville District). The bushing material was Thordon SXL. Although it performed well, after 8 years of service it was 80 percent eroded and was removed and replaced with a similar material. Figure 1 shows that the pintle bushing displayed signs of severe wear and was completely worn away in several places. Note, however, that the pintle was undamaged (Figure 2).

| Manufacturer | Product | Cost (US \$) | Material | Accelerated Testing Results* | Field Experience (as of August 2003) |
|---|---|---|---|---|---|
| Thordon | HPSXL<br>SXL | 9,000 to 11,000 | Polyurethane | Thordon HPSXL survived 200,000 cycles; clumping of wear debris shows signs of impending breakdown | Thordon SXL material performed well up to 7 yr in Ohio River (Cannelton Lock, Tell City, IN; Louisville District); 80% eroded after 8 yr |

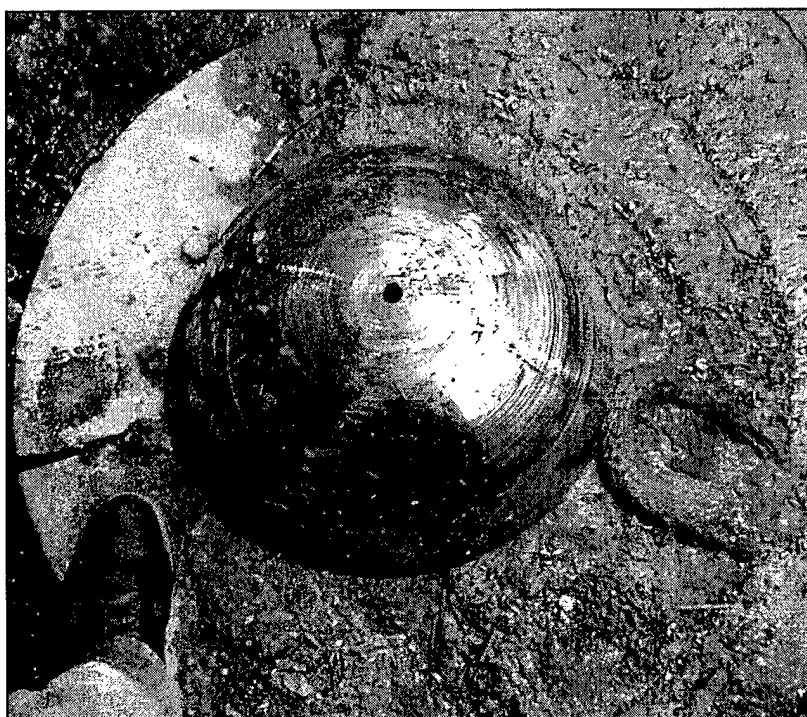
Figure 2. Pintle that mated with bearing shown in Figure 1 shows very little wear after 8 years.

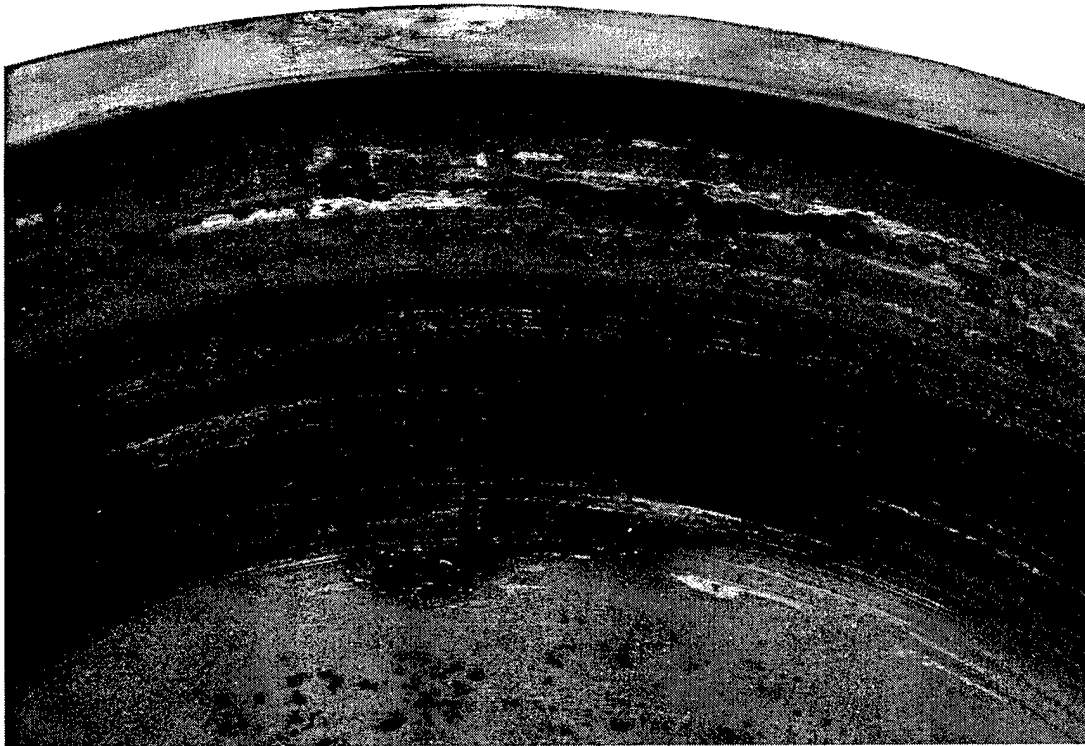
**Figure B9. Close-up view above image on loaded side. Note accumulation of wear debris above darker contact area.**

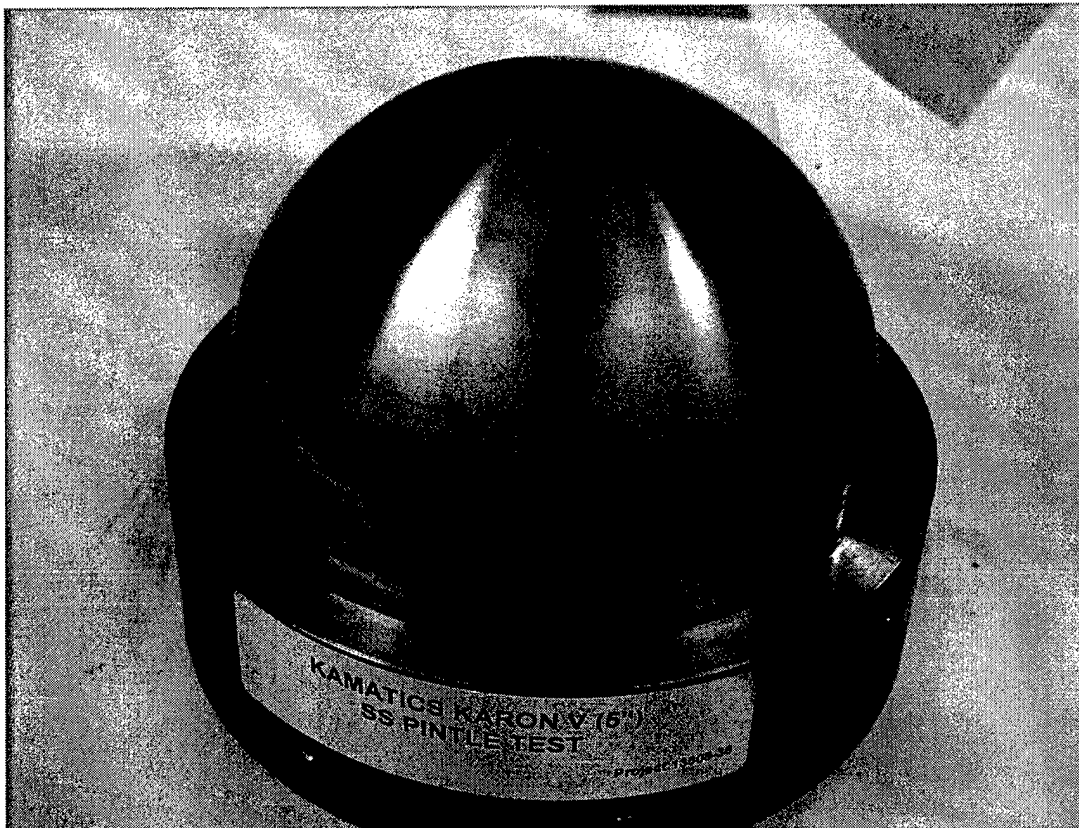
**Figure C1. Close-up view of 5" pintle from Kamatics Karon V test.**

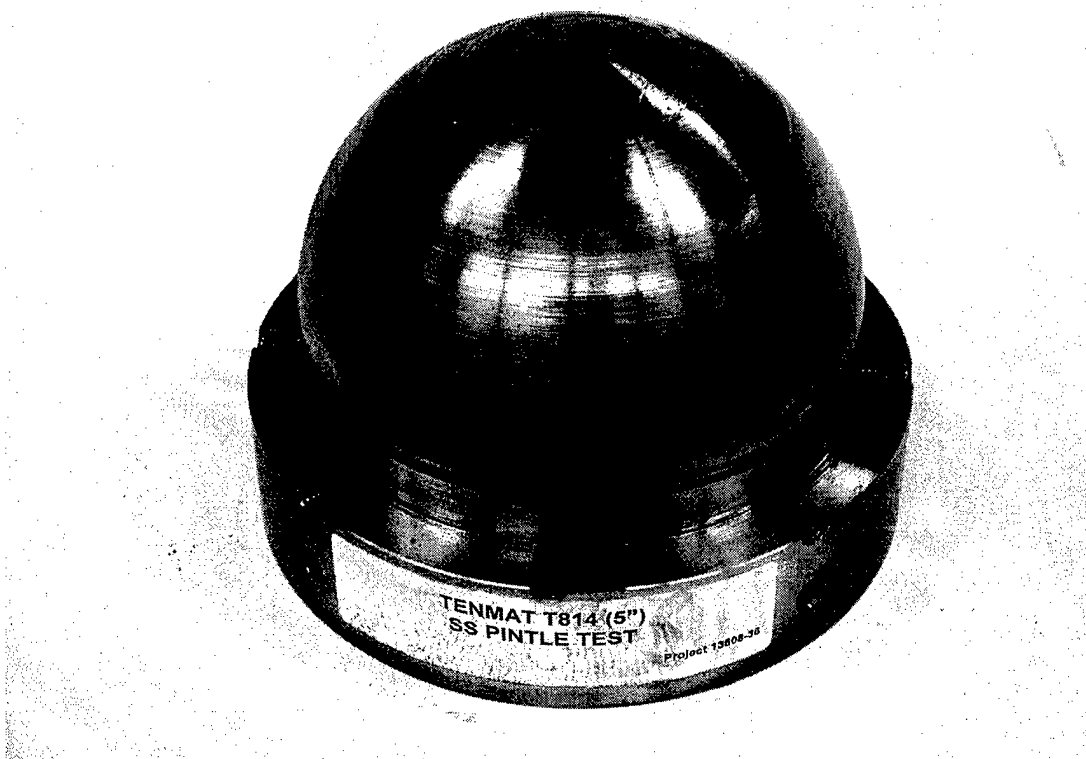
Figure D1. Overview of 5" Tenmat T814 pintle. Due to the thickness of the bushing-retaining ring, the first row of pintle anchoring holes had to be machined away.

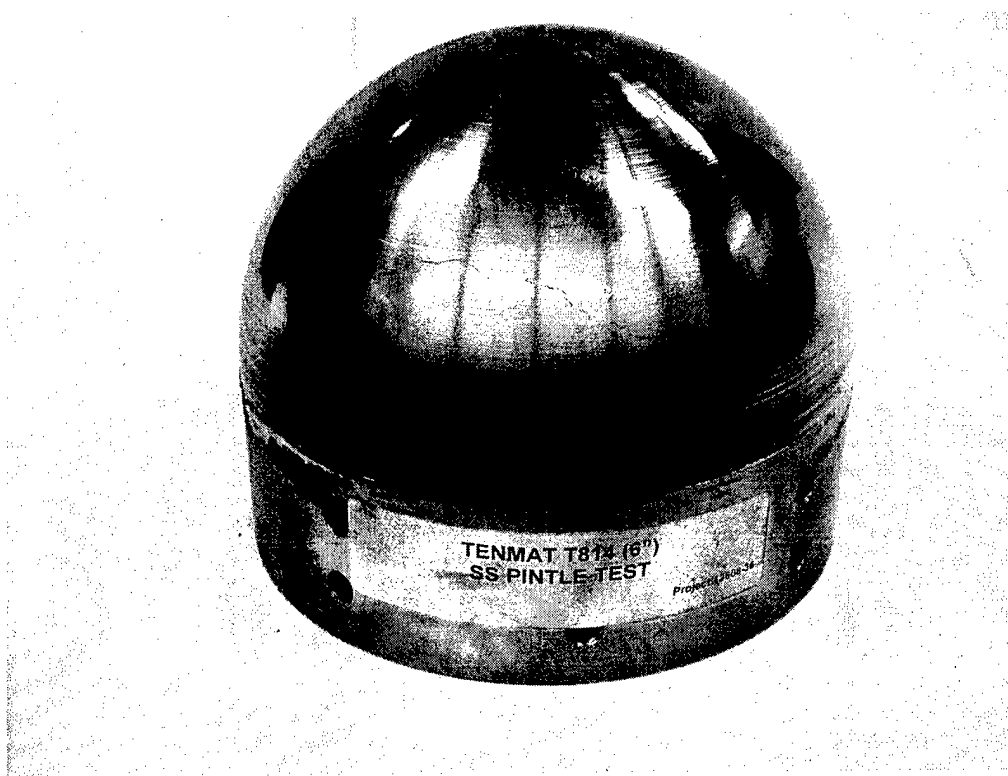
**Figure D7. Overview of 6" Tenmat T814 pintle. Note transferred lubricant material on side of pintle contact surface.**

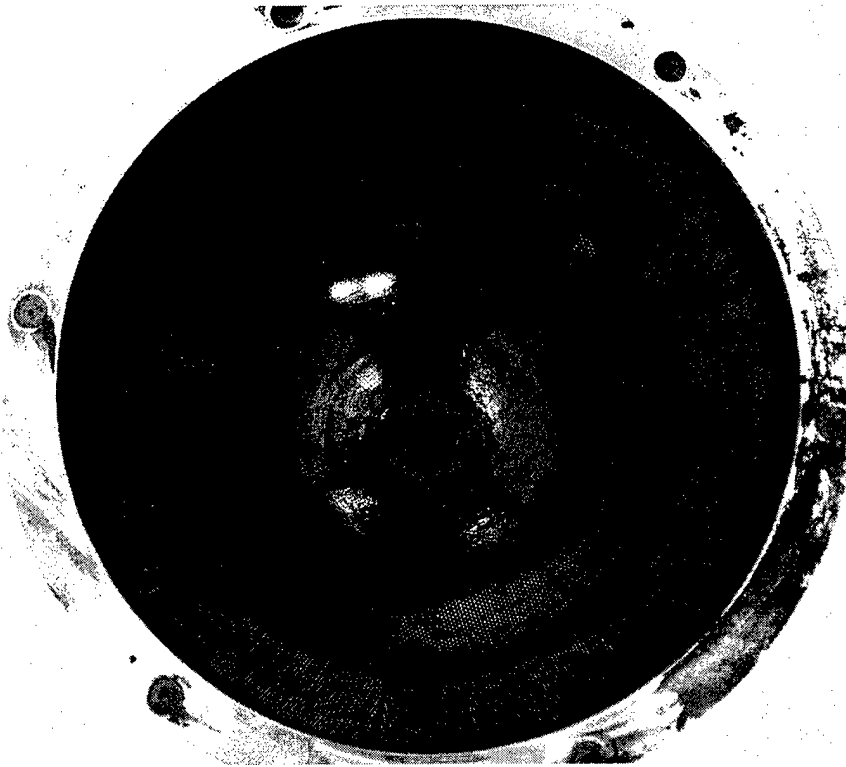
**Figure D8. Close-up view of 6" bushing. There is no indication damage to the bushing.  
Contact is over 95% of the bushing surface.**

The bushing contact surface was polished smooth. The loaded side of the bushings was darker in colour and corresponded to the same area on the pintle (Figure D8). The bottom of the bushing appears to have a build-up of dark wear material. Otherwise, the bushing is similar in appearance to the five (5) inch combination and does not appear to be stressed by the test regime.
