# **Evaluation of an Army Aviator's Ability to Conduct Ingress and Egress of the RAH-66 Comanche Crew Station While Wearing the Air Warrior Ensemble**

**ARL-TR-3404**

**December 2004**

**Human Research and Engineering Directorate, ARL**

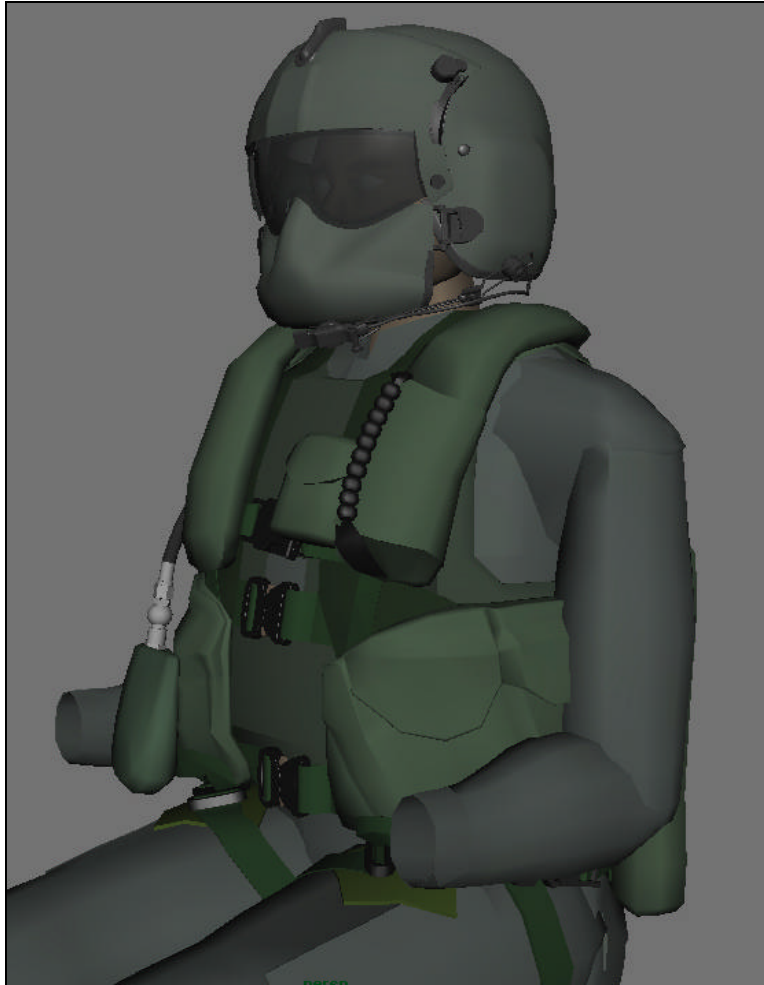
Figure 6. Example of digitized AW ensemble on 3-D human figure model.

Other researchers from ARL modeled AW during its development to gain an understanding of how the ensemble would affect human performance, both cognitive and physical. Kozycki (1998) argued that, over time, growing burdens from a pilot's ALSE have begun to severely degrade helicopter operator performance. Kozycki described an approach to assess the operational impact of AW using three-dimensional (3-D) graphical anthropometric human figure models fitted with digitized ALSE in a software program called Jack<sup>4</sup>. This method of 3-D human figure modeling minimizes the need for an actual aircraft or physical mock-up early in the design process. This is particularly important in the case of the RAH-66 since only two prototypes are available, and access to these is very limited. See figure 6 for a recent example of the AW ensemble applied to human figure model in Jack.

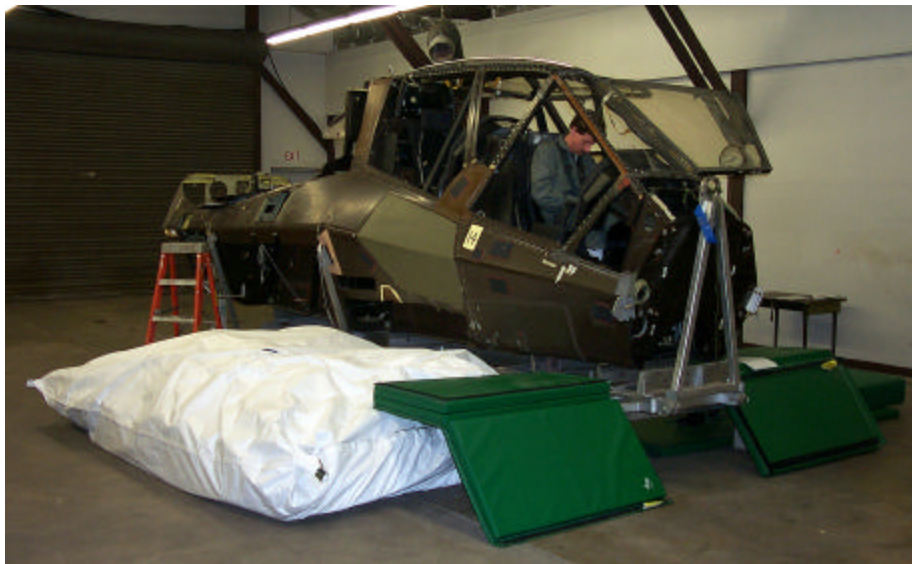
Figure 8. Comanche structural test article (STA) mock-up. (Note the foam mats and Tyvek bag for safety.)

Several safety measures were in place during the conduct of the evaluation. First and foremost, at least two (sometimes three) spotters were next to the aircraft during all trials to assist, even support, the participants if necessary for safety reasons. However, the spotters did not support the weight of a participant unless injury was imminent. Mats were placed around the mock-up to minimize injuries to participants if they fell during the trials. A 12- by 10-foot mass of foam blocks, enclosed in a Tyvek<sup>6</sup> protective cover, was positioned underneath the appropriate side for emergency egress trials. See figure 8 for an image of some of the safety matting used.

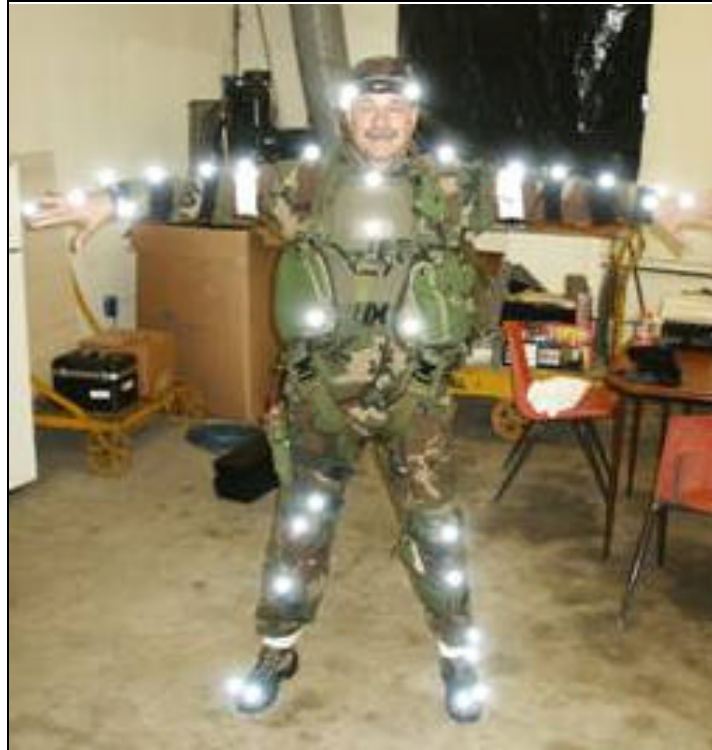
Figure 9. Large male wearing the motion capture body markers.

markers were attached to the participants with tape and elastic bands to keep them as close to the body as possible. The foot markers had to be taped onto the boots near the foot landmarks. For the head, the markers had to be attached to the HIDSS instead. Another problem encountered with markers was that some of them frequently became dislodged from their attachment points as the participants came into contact with crew station components or canopy frame structure during trials (especially emergency egress trials).

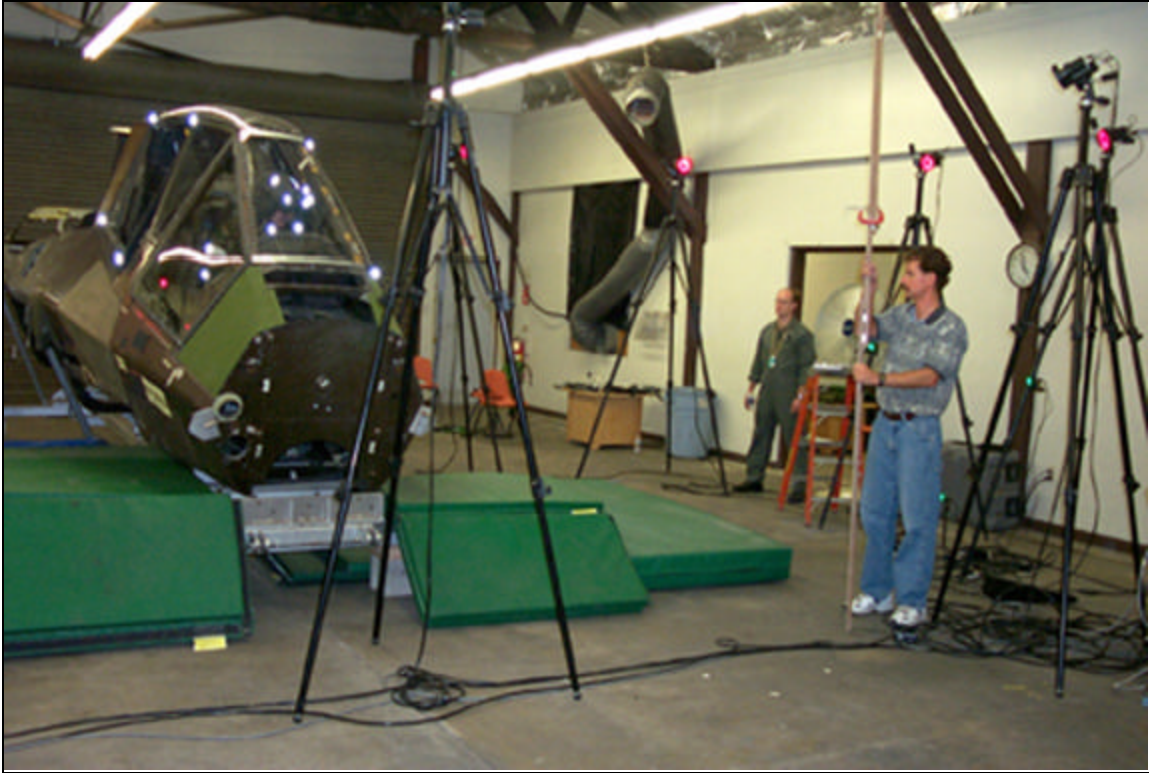
Figure 10. Placement of the infrared motion capture cameras around the STA.

The most challenging problem with collecting motion capture data for this evaluation was the obscuration of the markers to the cameras. Most motion capture applications usually take place in an open, unobstructed environment. For this evaluation, the Comanche crew station components, canopy frame structure, safety spotters, and even the safety mats often obscured the markers from the cameras, especially those markers on the lower extremities. The standard infrared cameras were set up on tripod mounts elevated approximately 10 feet off the ground in order to gain optimal exposure to the markers (see figure 10).

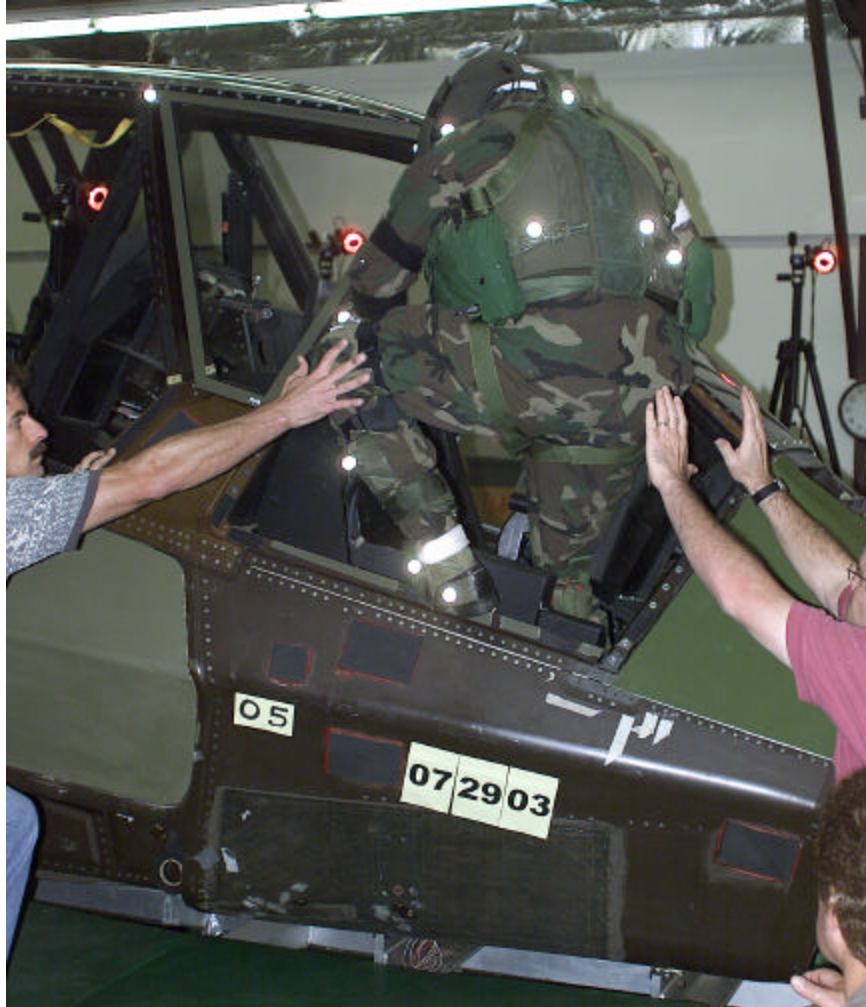
Figure 11. Large percentile male participant conducts an emergency egress from the front crew station through the right window by standing on the edge of the window. (If the participants had stood to full height, the rotor system on a real aircraft would have likely contacted his head. This situation would have been exacerbated by an egress from the rear crew station.)

The STA mock-up lacks nearly every normal subsystem that would typically be installed on a helicopter. In particular, there is no rotor blade system, and the lack of one became especially highlighted during the pilot study conducted in early June 2003. During the pilot study and formal trials, several people conducted emergency egress trials out the right window by actually standing up on the edge of the right window (instead of simply swinging their legs over and sitting) before jumping out and to the safety mats below. As they stood up to almost full height, each became aware that his or her head would have almost certainly come into contact (probably fatally) with the still-spinning rotor system, even if it had little kinetic angular velocity and energy remaining as it wound down (see figure 11). For this evaluation, subjects were briefed about the lack of a rotor system and to be cognizant of where the tip-path plane of the rotor blades would likely be during an emergency egress.

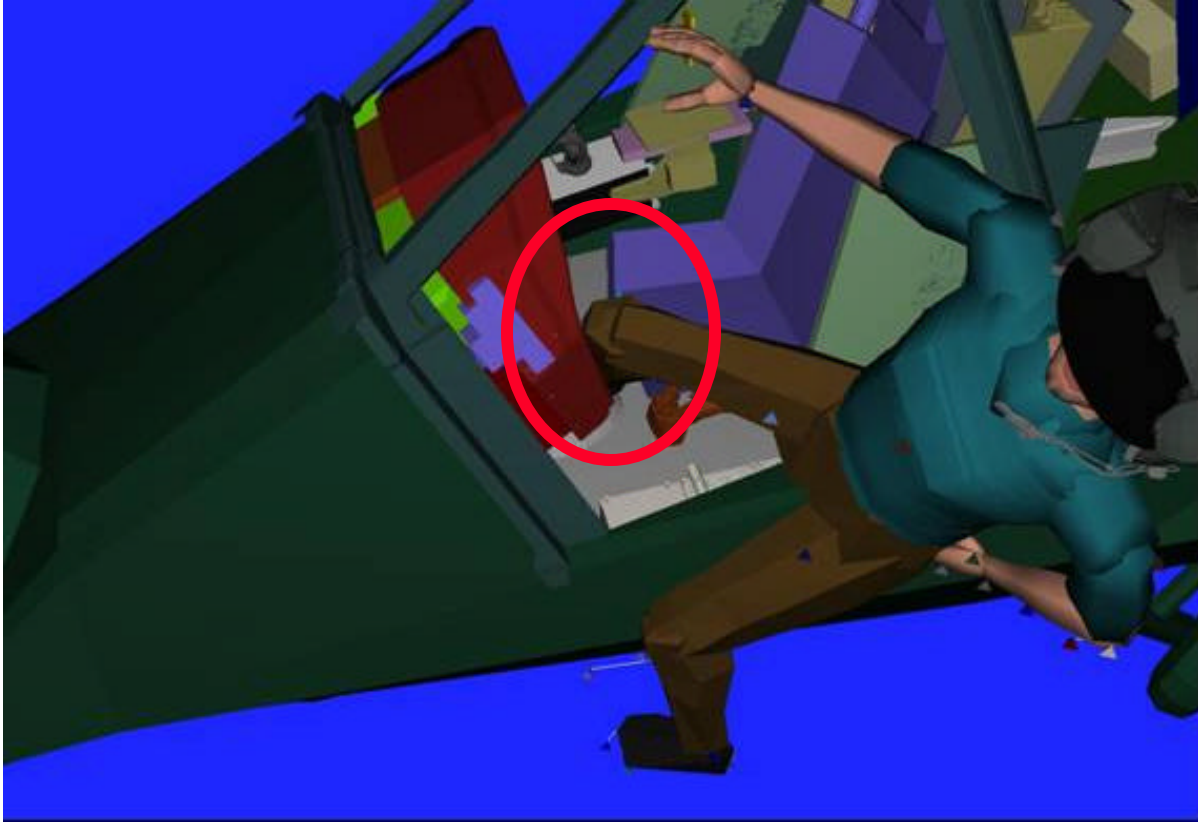
Figure 14. Jack and motion capture data show problem with the LMPD and glare shield by the large male pilot.

Even with the difficulties encountered in collecting motion capture data, a replay of the motion capture from various viewing angles with the Jack software helped us to detect some of the problems encountered by the large male pilot during the early trial exercises. In particular, during egress of the forward crew station, the motion capture clearly shows how the large male pilot had some difficulty clearing the knee and foot past the outboard edge of the glare shield on the left-hand side of the instrument panel (see figure 14). This analysis graphically confirms observations from the participants and authors during multiple trials.

Results show that the combination of human figure models and motion capture data can prove to be a useful tool in analyzing the complex biomechanical motions required for crew station ingress and egress.
