AFRL-VA-WP-TR-2004-3057

**EFFECT OF PREEXISTING
CORROSION ON FATIGUE CRACKING
OF ALUMINUM ALLOYS 2024-T3 AND
7075-T6**

**CC Technologies Laboratories, Inc.
2704 Sawbury Boulevard
Columbus, OH 43235**

Final Report for 01 February 1993 – 01 August 1995

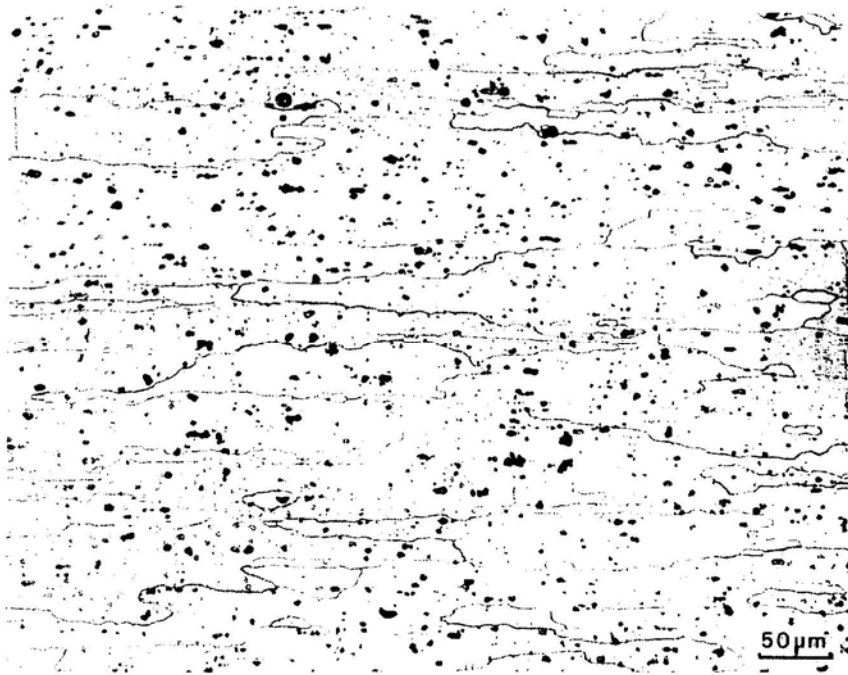
Figure 2. Optical Micrograph of Cross Section through Aluminum Alloy 2024-T3 Showing Elongated Grains and Constituent Particles

Corrosion in aircraft aluminum alloys occurs in several different forms.²⁻³ Pitting and crevice corrosion are most common in the 2000- and 7000-series aluminum alloys which are the principal materials of construction. Pitting corrosion is a form of localized corrosion that occurs on exposed surfaces of passive metals under relatively stagnant conditions. Pitting may also occur on relatively film free metals at local metallurgical imperfections such as inclusions or constituent particles.⁴ Although the mechanism of pit nucleation is not well understood, there is some evidence in aluminum alloys, that constituent particles act as nucleation sites. Wei and coworkers⁵ have demonstrated that in 2000-series alloys, pitting nucleates at Al-Cu-Mg- and Al-Cu-Mn-Fe- containing particles, with the former particles acting as anodic sites, and the latter as cathodic sites. Figure 2 shows a typical microstructure of aluminum alloy 2024-T3 showing the elongated grains with a significant number of constituent particles.

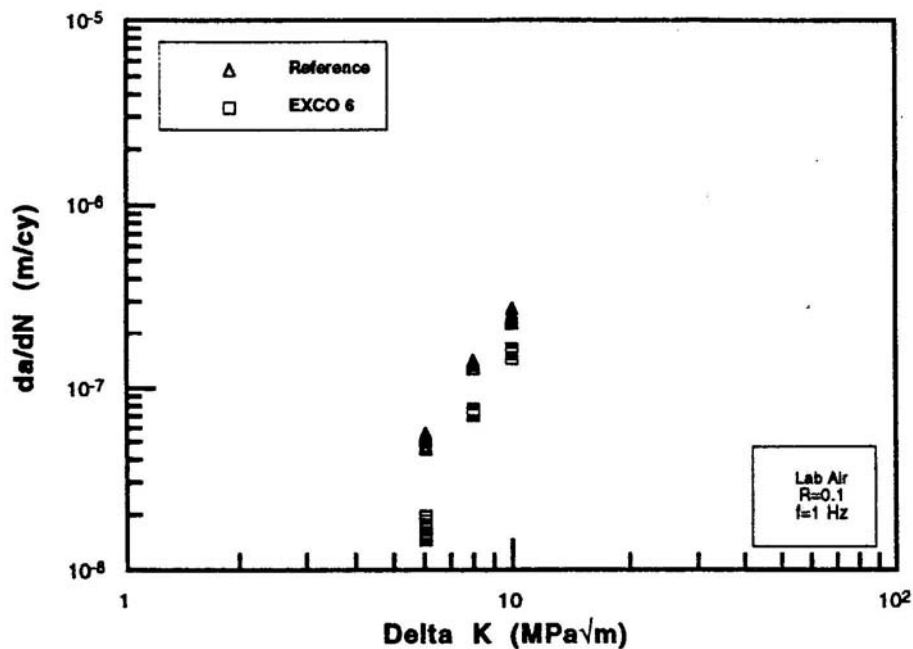
Figure 56. Fatigue Crack Growth Data for Aluminum Alloy 7075-T6 CT Specimens in As Received Condition and Precorroded in the EXCO Solution for 2 Days; Fatigue cracked at Three(3) Constant ΔK Levels

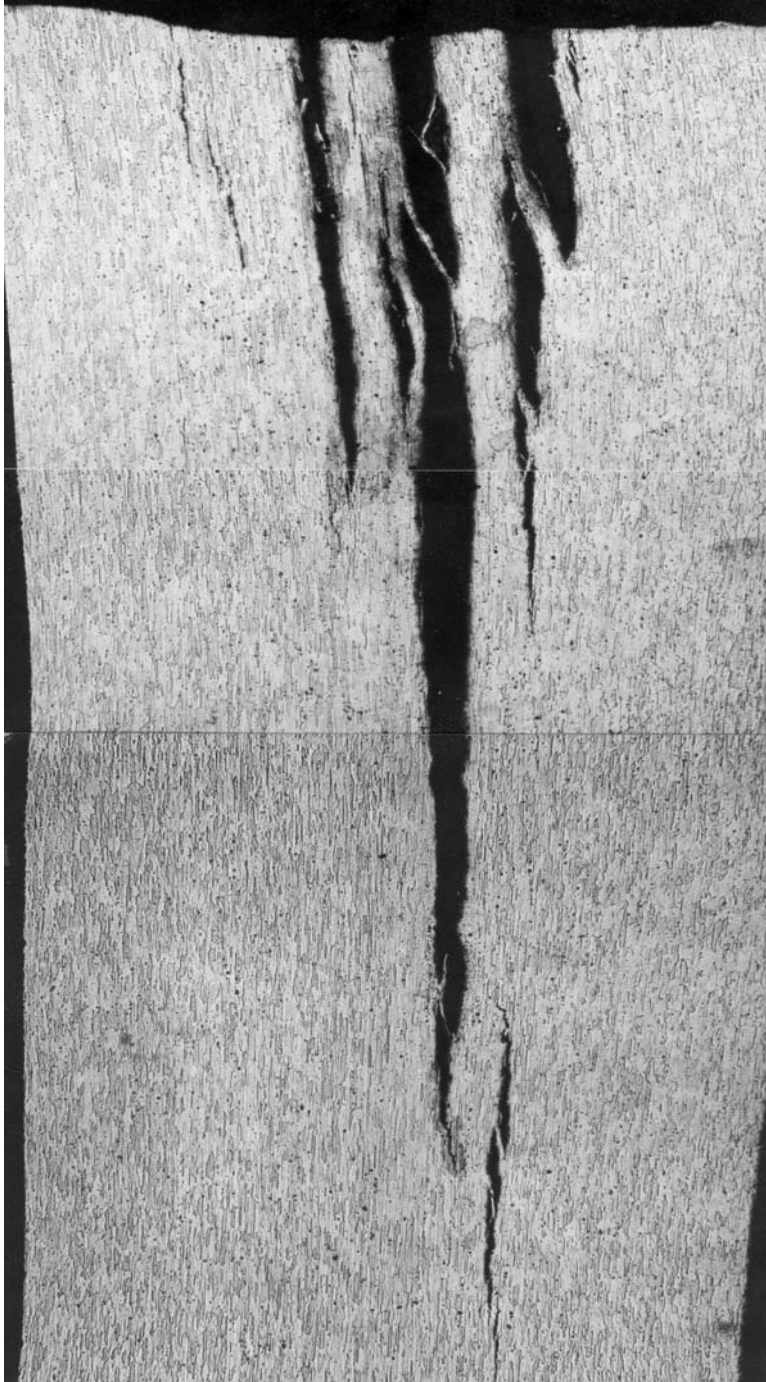
Figure 73. Optical Micrograph of Metallographic Cross Section Across the Secondary Crack Shown in Figures 71 and 72

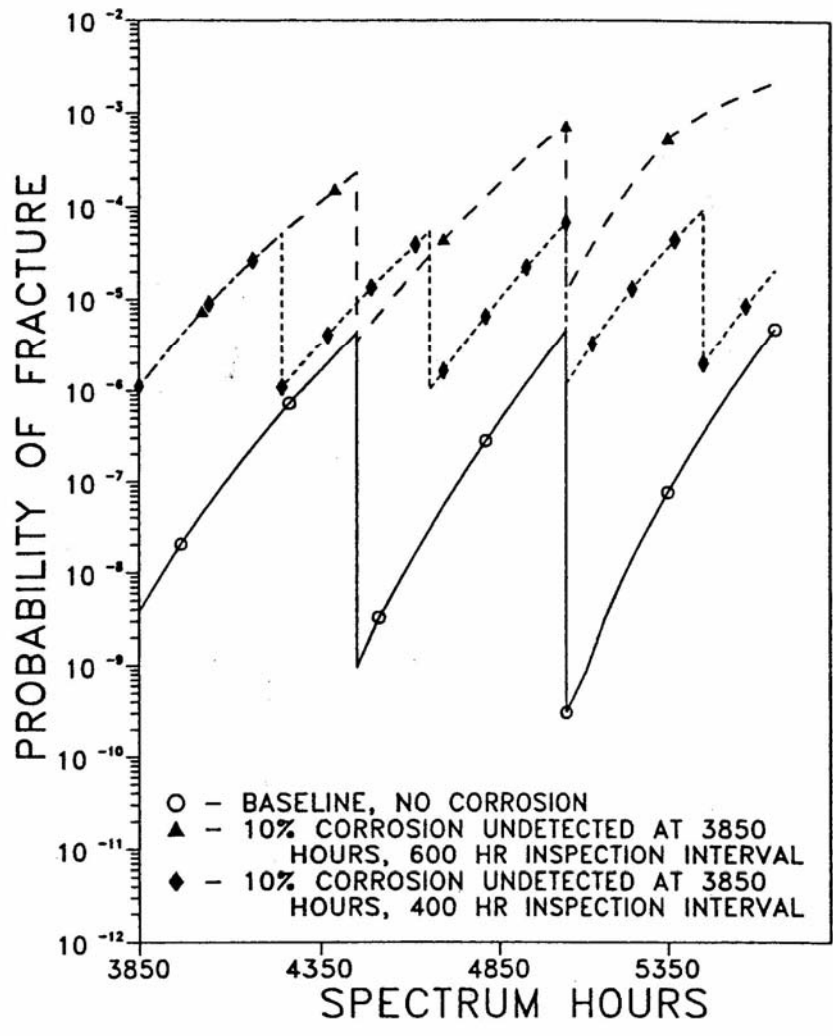
Figure 96. Fracture Risks for Baseline Conditions, 5 Percent Corrosion Undetected at 2,050 Hours, and 5 Percent More Corrosion Undetected at 3,850 Hours - Two Inspection Intervals
