**ERDC/CRREL TR-05-1**

# **Improved Performance of Unpaved Roads During Spring Thaw**

February 2005

Prepared for VERMONT AGENCY OF TRANSPORTATION AND  
FEDERAL HIGHWAY ADMINISTRATION

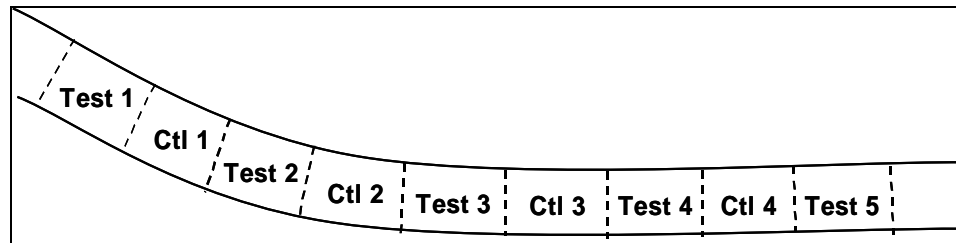
**Figure 1. Typical site layout, showing test sections interspersed with control sections. Sections were typically 100 ft long.**

With the guidance of the project team, towns installed test sections on roads that experience severe thaw weakening, manifested as deep ruts that disrupt traffic. The control sections were left untreated. The project team then observed and documented conditions of both the control and the test sections through two thaw seasons (2002 and 2003).

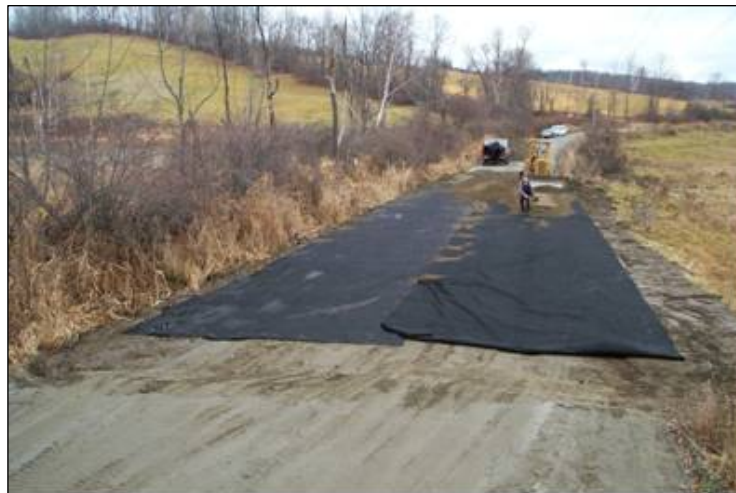
**Figure 12.** Top geotextile layer of geowrap during construction in Windsor, Area 3.

The “geowrap” section was built on November 26, 2001, by excavating 18 in., placing separator geotextile, placing a 6-in. layer of clean sand on the geotextile, and placing separator geotextile on top of that. The sand placed between the geotextile layers had less than 5% passing the #200 sieve. The geotextiles overlapped by about 18 in. (Fig. 12). Windsor closed the road for this construction, which resulted in a faster and higher-quality installation than when constructed one lane at a time. A loader and bulldozer were used to place the sand and surface material layers. This worked very well.

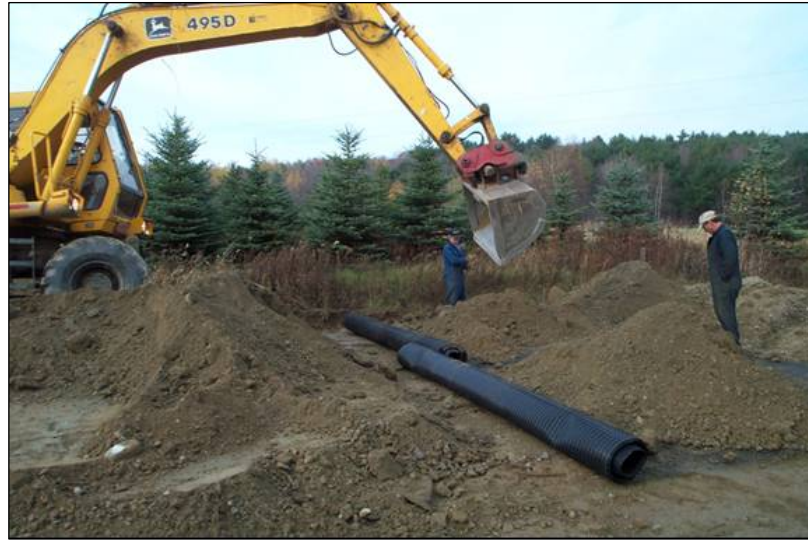
**Figure 19. Westford Geogrid test section during construction, showing original road surface material being placed on the grid.**

The Geogrid test section was built on November 1, 2001. Construction of this 100-ft test section involved first removing 12 in. of road surface and temporarily stockpiling the material. Two different strengths of biaxial geogrid were used in the test section. Both were Tensar<sup>®</sup> products. The “weaker” grid (BX 1100) was placed under the southbound lane, and the “stronger” grid (BX 1200) was placed under the northbound lane of the road. The road crew stretched the grid during placement as best they could, since the manufacturer recommends that the product be installed in such a way as to be actively in tension. The original road gravel was placed over the geogrid layers as they were held in their stretched condition (Fig. 19). A thermocouple string was placed in the middle of the 100-ft test section.

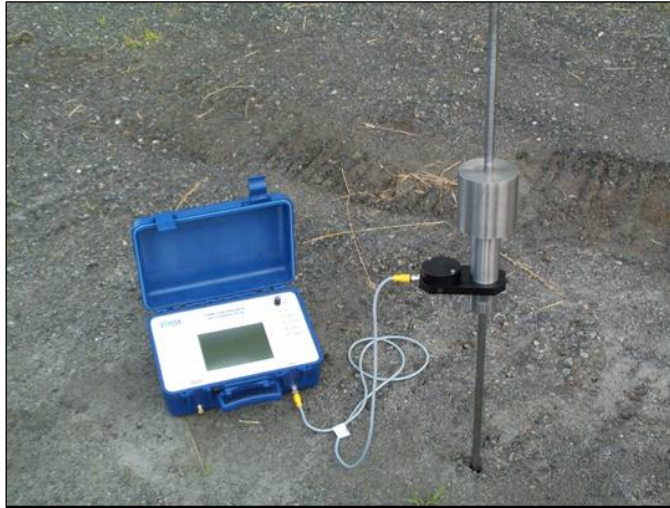
**Figure 22. Dynamic cone penetrometer (DCP) for determining soil strength as a function of depth.**

collected most DCP data using a DCP data acquisition system (DCP-DAS) (Fig. 22). The DCP-DAS counts blows and measures displacement during a DCP test, storing the data for several tests in digital data files that can be later downloaded to a PC.

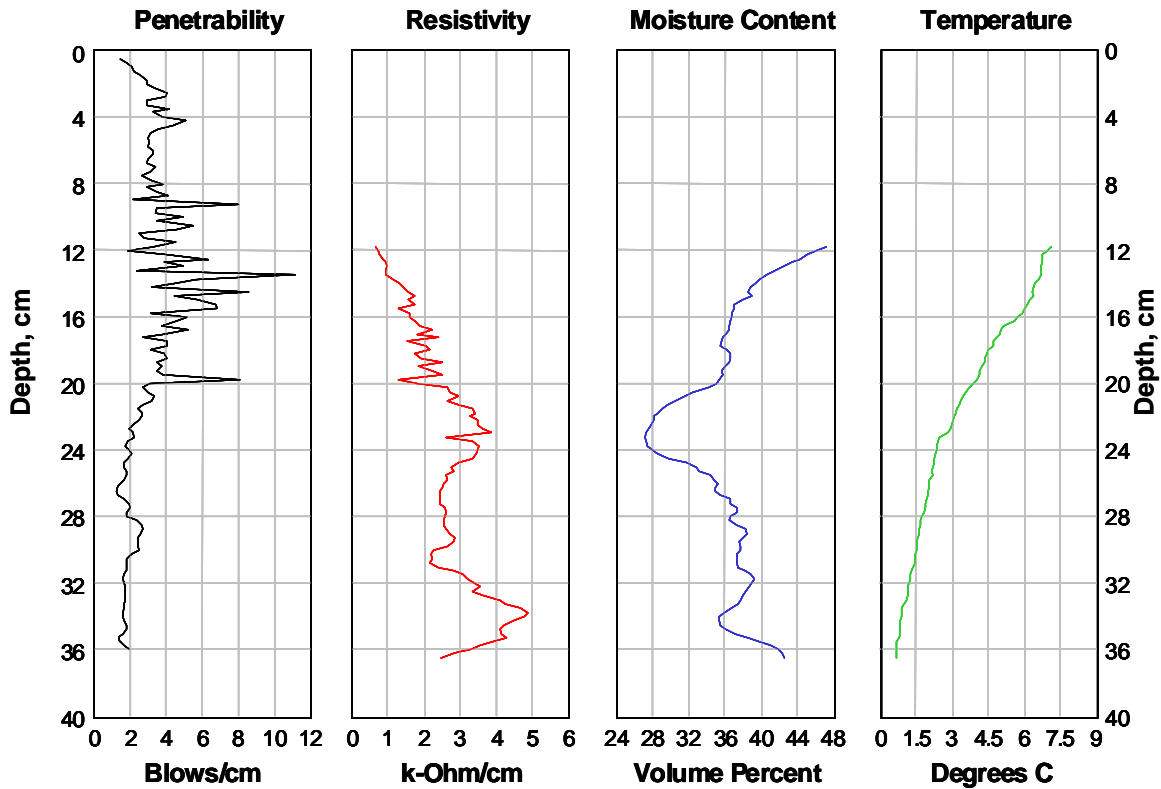
Figure 23. Sample soil moisture, temperature, and resistivity profile obtained using a SMRT probe.

In addition to DCP testing, we drove an instrumented probe (SMRT probe) to acquire profiles of soil moisture, electrical resistivity, and temperature during 2003 in Westford. An example of such data is shown in Figure 23.

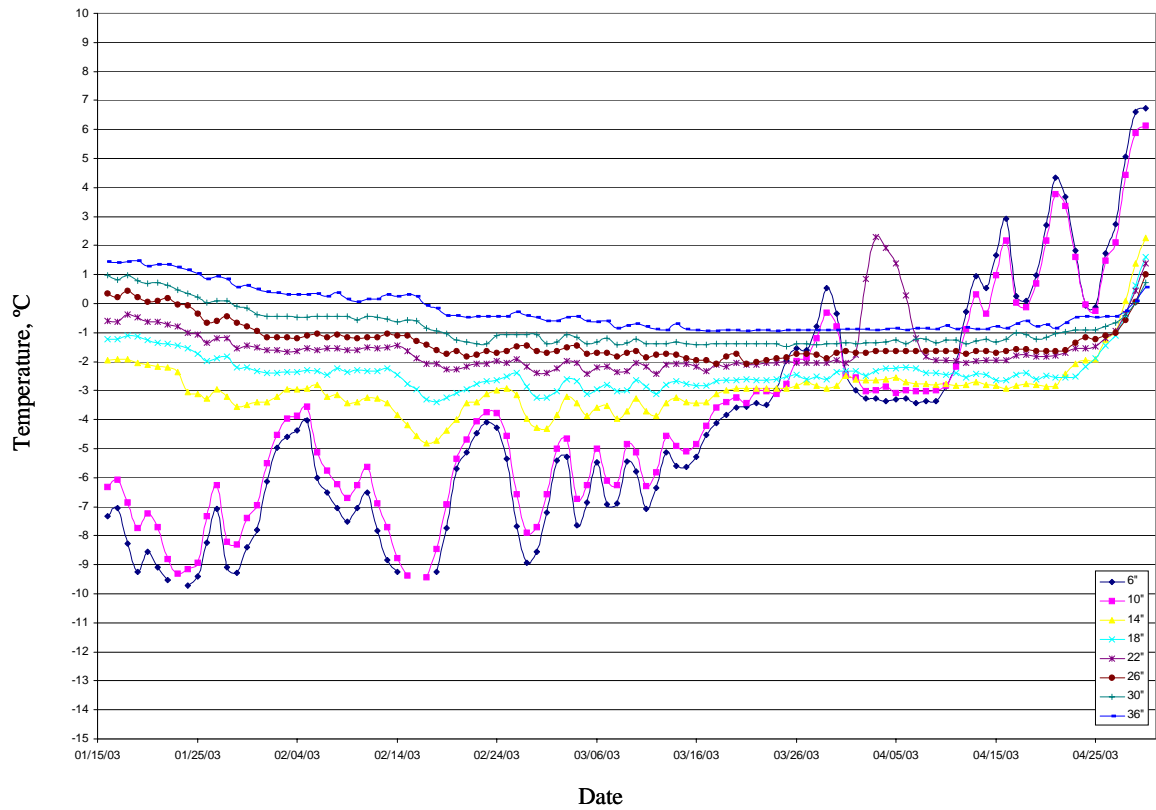
Figure 26. Example plot of temperature monitoring data, obtained from the GCBD test section in Windsor, spring 2003.

Plots of temperature versus time at each monitored depth in each instrumented section appear in Appendix A for all data collected. An example plot from Appendix A is shown in Figure 26.

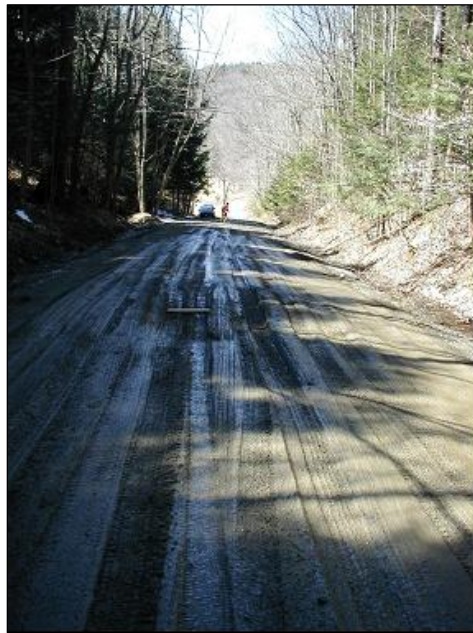
**Figure 29. Control East (CE) of Area 4 on April 2, 2002, showing the differences in moisture content of the road surface due to degree of sun exposure.**

One general observation during monitoring was that on sunny days the surface of the road that remained in the shade retained a lot of moisture compared to the road surface exposed to the sun (Fig. 29). This sometimes made it difficult to differentiate improvements due to treatment from improved performance due to sun exposure if the border between shade and sun was at or near a section edge.

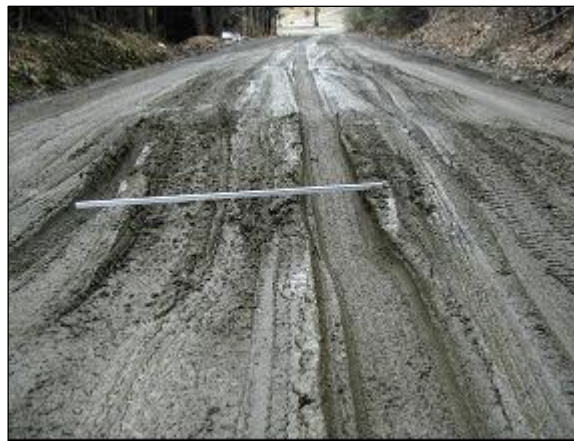
**Figure 30. Area 4, looking west, after about 6 in. of “gravel” was added on April 2, 2002. Adding the gravel resulted in deeper ruts.**

On March 4, 2002, in Area 4, we observed that adding “gravel” to a section of the road that was badly rutted actually worsened the condition of the road—the added material resulted in more mud that then heaved and rutted (Fig. 30). A similar condition occurred at Area 2 on April 8, 2003, when added material made the road temporarily impassable to passenger vehicles. This appeared to be because the added material mixed with the over-saturated road surface material, resulting in an increased volume of saturated material (i.e., according to the old adage that “mixing a bucket of gravel with a bucket of mud makes two buckets of mud.”)

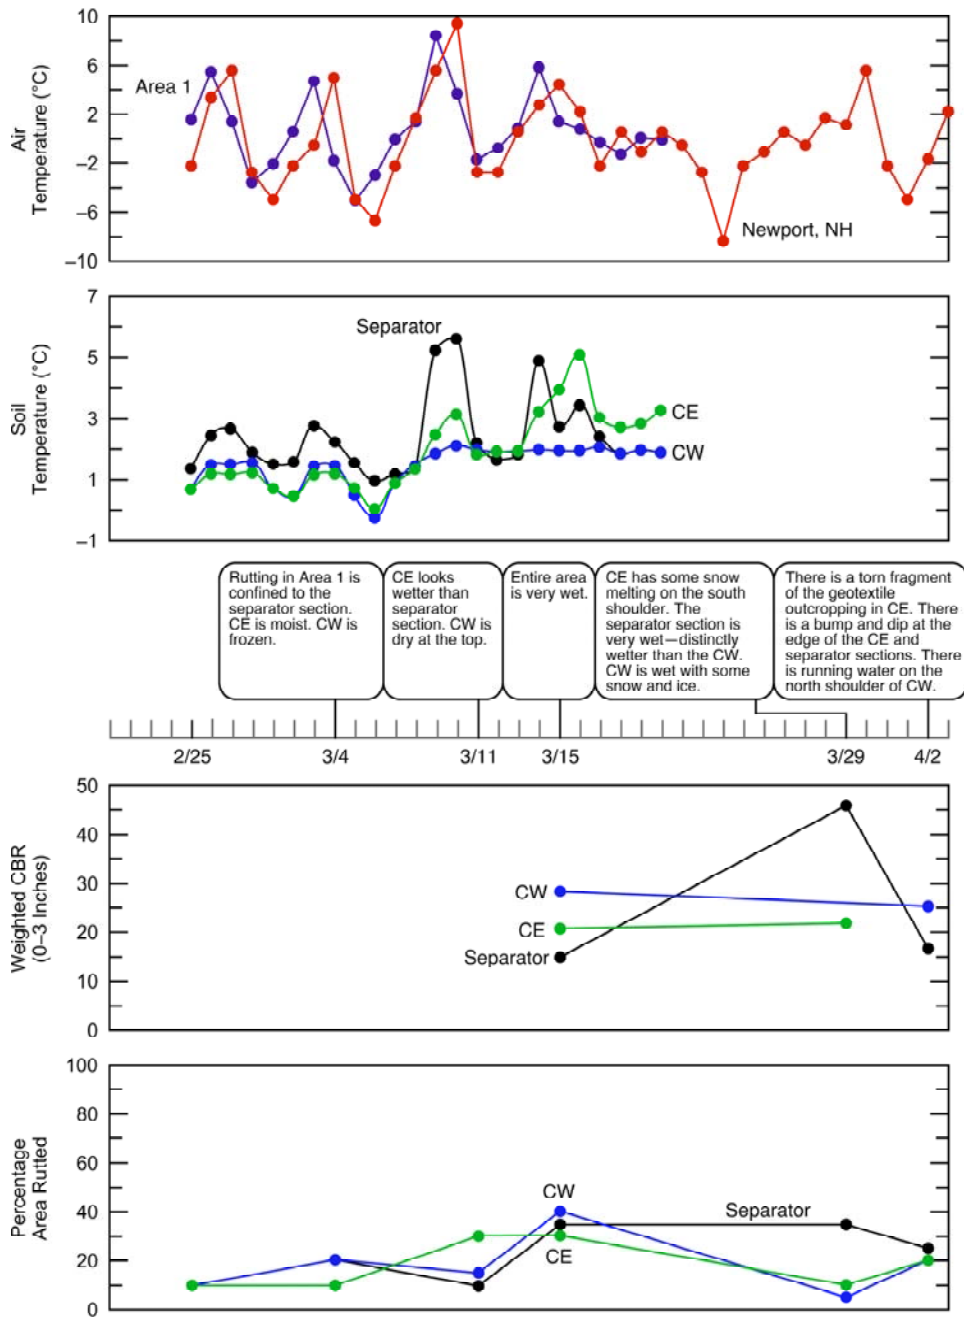
**Figure 31. Air temperatures at Newport and datalogger enclosure temperature (top graph), temperature measurements in the soil at 6 in. depth (second from top), annotated timeline, weighted CBR determinations for the top 3 in. of the road surface, and percentage of the test section rutted for Area 1, 2002 mud season.**

The following sections provide information and data for February 25 to April 3, 2002, and for March 14 to April 18, 2003, for Areas 1 through 4 (Fig. 31–34). The information for each section for each year is summarized on one figure, comprising a series of graphs and a timeline. The average daily temperatures recorded in the datalogger enclosure and the mean daily temperatures measured by the NWS in Newport, NH, are shown on the top graph. Daily average temperatures at the shallowest thermocouples in the test and control sections are shown on the second graph from the top. Note that degradation of the road surface and rutting occurred prior to the indication of thawed temperatures at the 6 in. depth and that thawed conditions existed above shallow thermocouples on most dates in which the test sections were monitored. Comments recorded during inspections are shown on the timeline, and average weighted CBR values and percentages of the test section covered by rutting are shown in the bottom two graphs, respectively. For Area 3, there were only a few records of air and soil temperatures successfully recorded; therefore, there are no soil temperature graphs for this section.

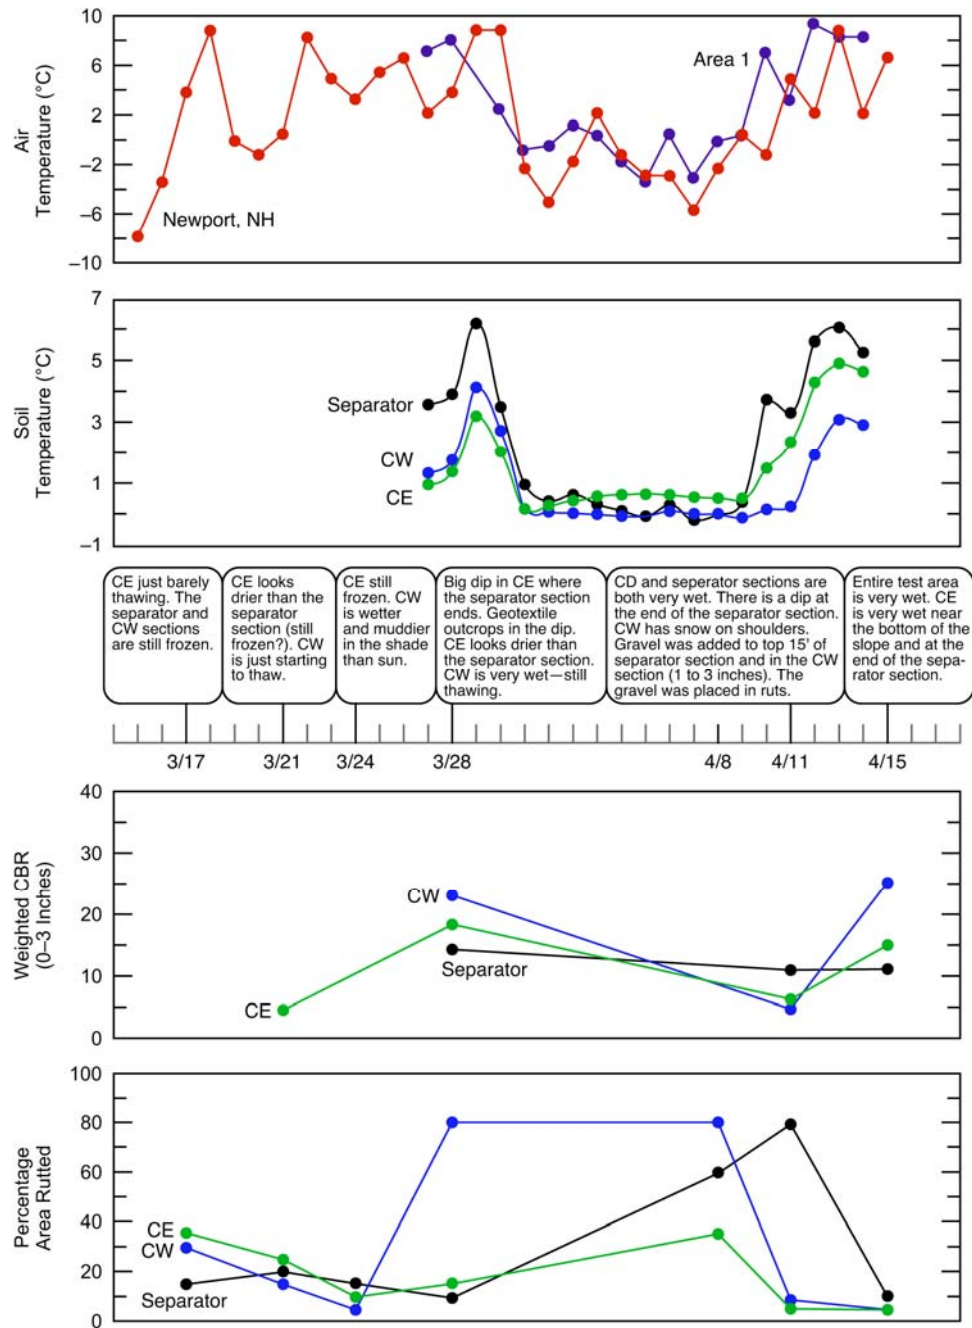
**Figure 32. Air temperatures at Newport and datalogger enclosure temperature (top graph), temperature measurements in the soil at 6 in. depth, annotated timeline, weighted CBR determinations for the top 3 in. of the road surface, and percentage of the test section rutted for Area 1, 2003 mud season.**

In 2003, the CE test section shallow thermocouple indicated thawed conditions from March 27 onward. The shallowest thermocouple in the Separator section indicated freezing on April 5, and the CW test section was frozen (at the 6-in. depth) on April 4 and 5.

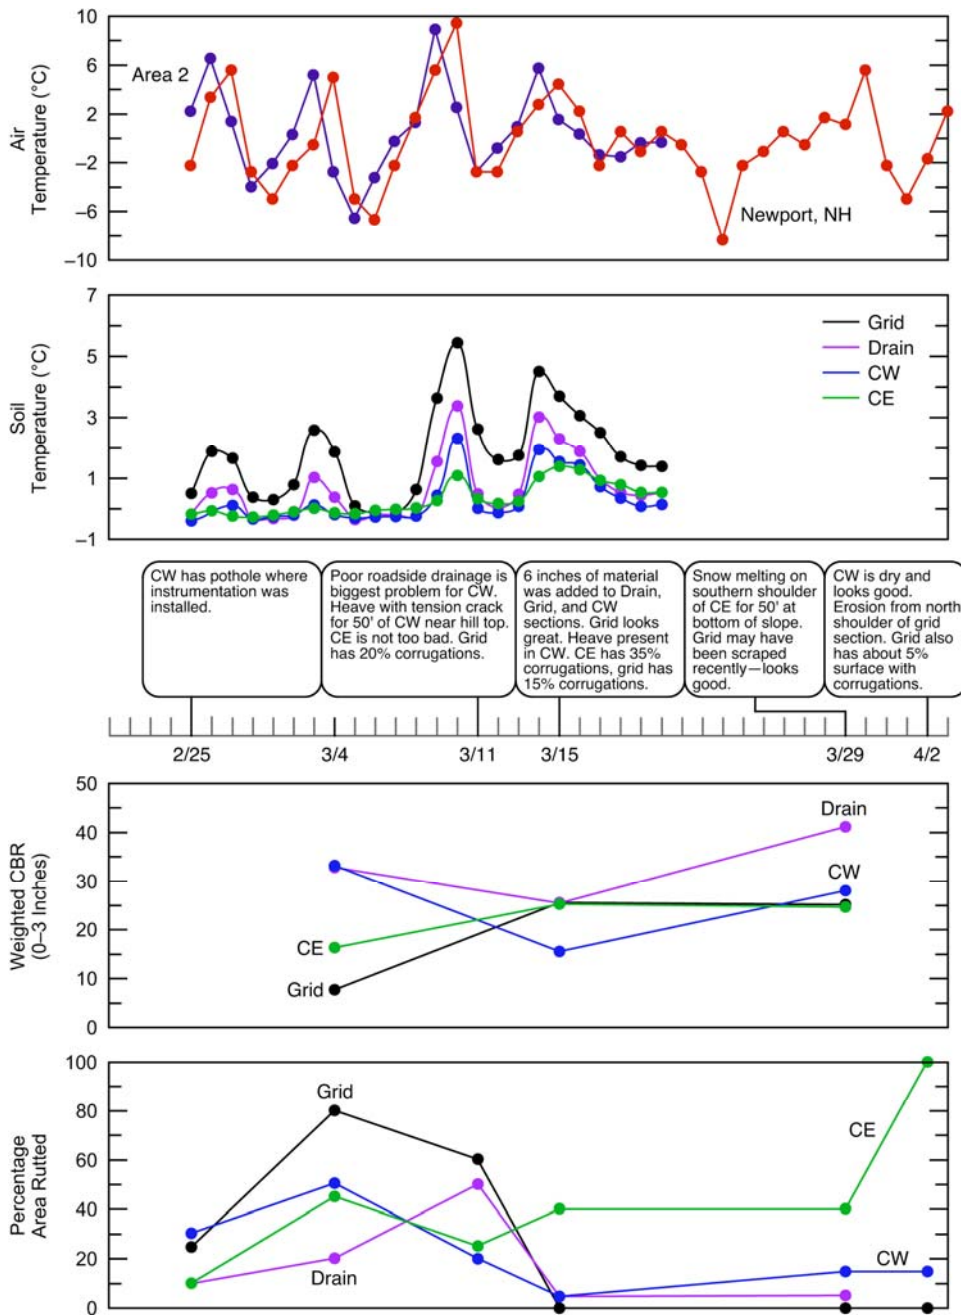
**Figure 33. Air temperatures at Newport and datalogger enclosure temperature (top graph), temperature measurements in the soil at 8 or 12 in. depth (for Grid section), annotated timeline, weighted CBR determinations for the top 3 in. of the road surface, and percentage of the test section rutted for Area 2, 2002 mud season.**

CBR readings and rut measurements in 2002 suggest a slightly improved performance in the Drain section and poor performance of the Grid section compared to the controls. Early in the thaw season of 2002, e.g. March 4, the Grid section was particularly distressed compared to the other sections, in which the surface had not been disturbed by construction during the previous fall (Fig. 35). In 2003 there is no evidence of either the Grid or Drain sections performing better or worse than the adjacent control sections. The improved CBR reading on April 8, 2003, of the Grid and Drain sections compared to the two controls must be discounted because of the presence of frozen soil at a few inches depth.

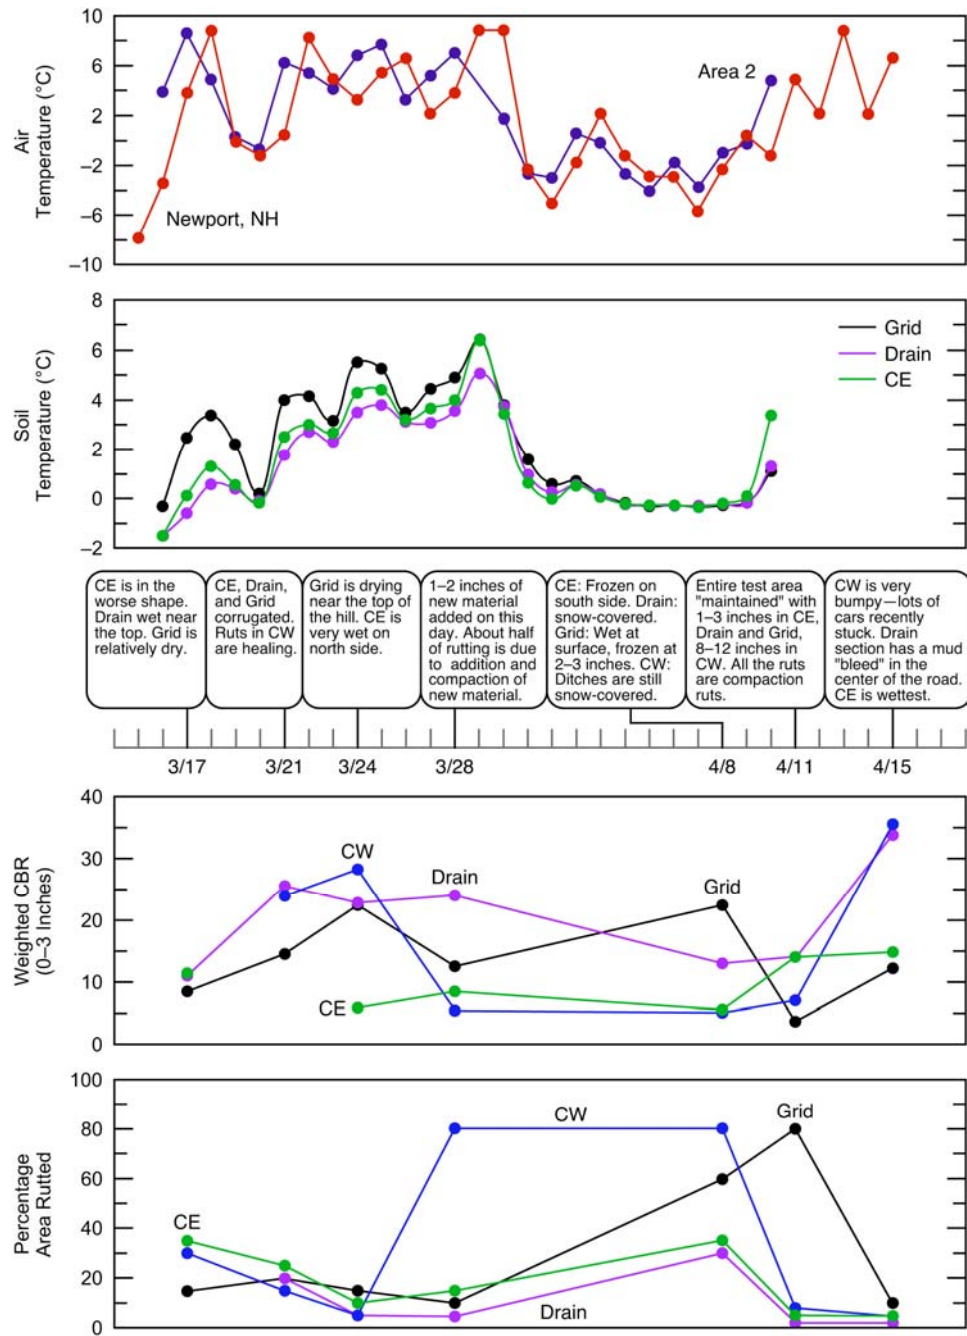
**Figure 34. Air temperatures at Newport and datalogger enclosure temperature (top graph), temperature measurements in the soil at 8 or 12 in. depth (for Grid section), annotated timeline, weighted CBR determinations for the top 3 in. of the road surface, and percentage of the test section rutted for Area 2, 2003 mud season.**

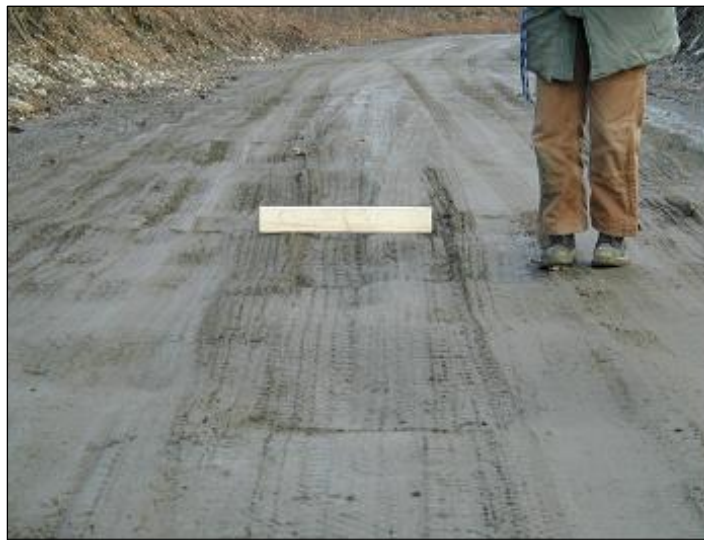
**Figure 35. Corrugations and potholes on the Grid section, Area 2, March 4, 2002. The Drain section is visible in the background, showing little surface distress.**

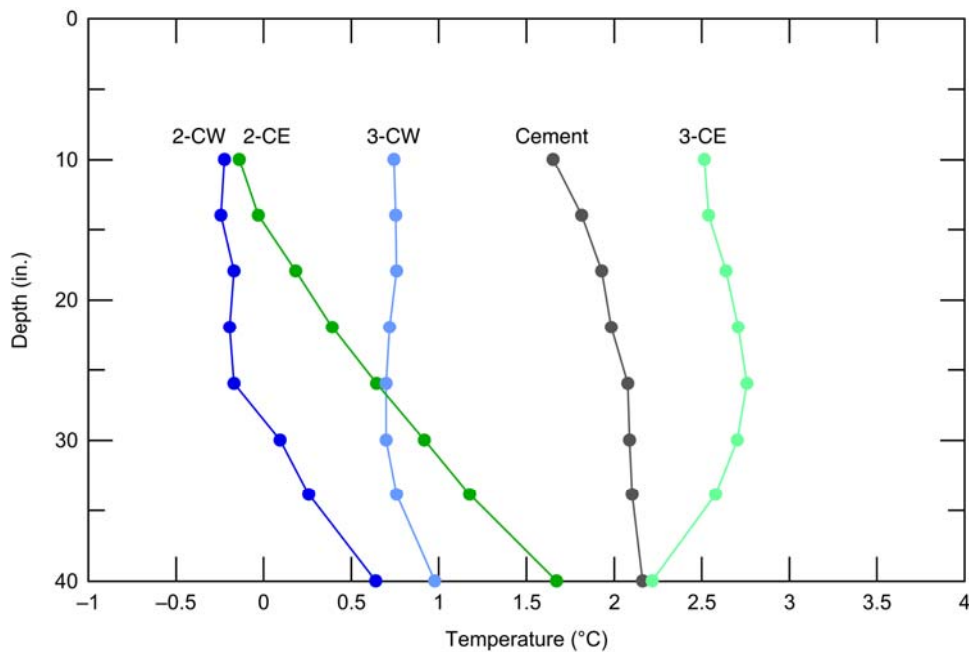
**Figure 36. Temperature profiles on March 12, 2002, in test sections located in Areas 2 and 3 in Windsor, Vermont.**

sistently, the temperatures from Area 3 that were recorded on March 12, 2002, the only day for which temperature averages could be determined, indicate that the section was completely thawed, whereas Areas 1 and 2 still had considerable freezing (Fig. 36). Average datalogger enclosure temperatures on March 12, 2002, were  $-0.7^{\circ}\text{C}$  for Area 1,  $-0.8^{\circ}\text{C}$  for Area 2, and  $+4.3^{\circ}\text{C}$  for Area 3. During site visits, we observed that Area 3 thawed from east to west, with CE section thawing first and CW thawing last.

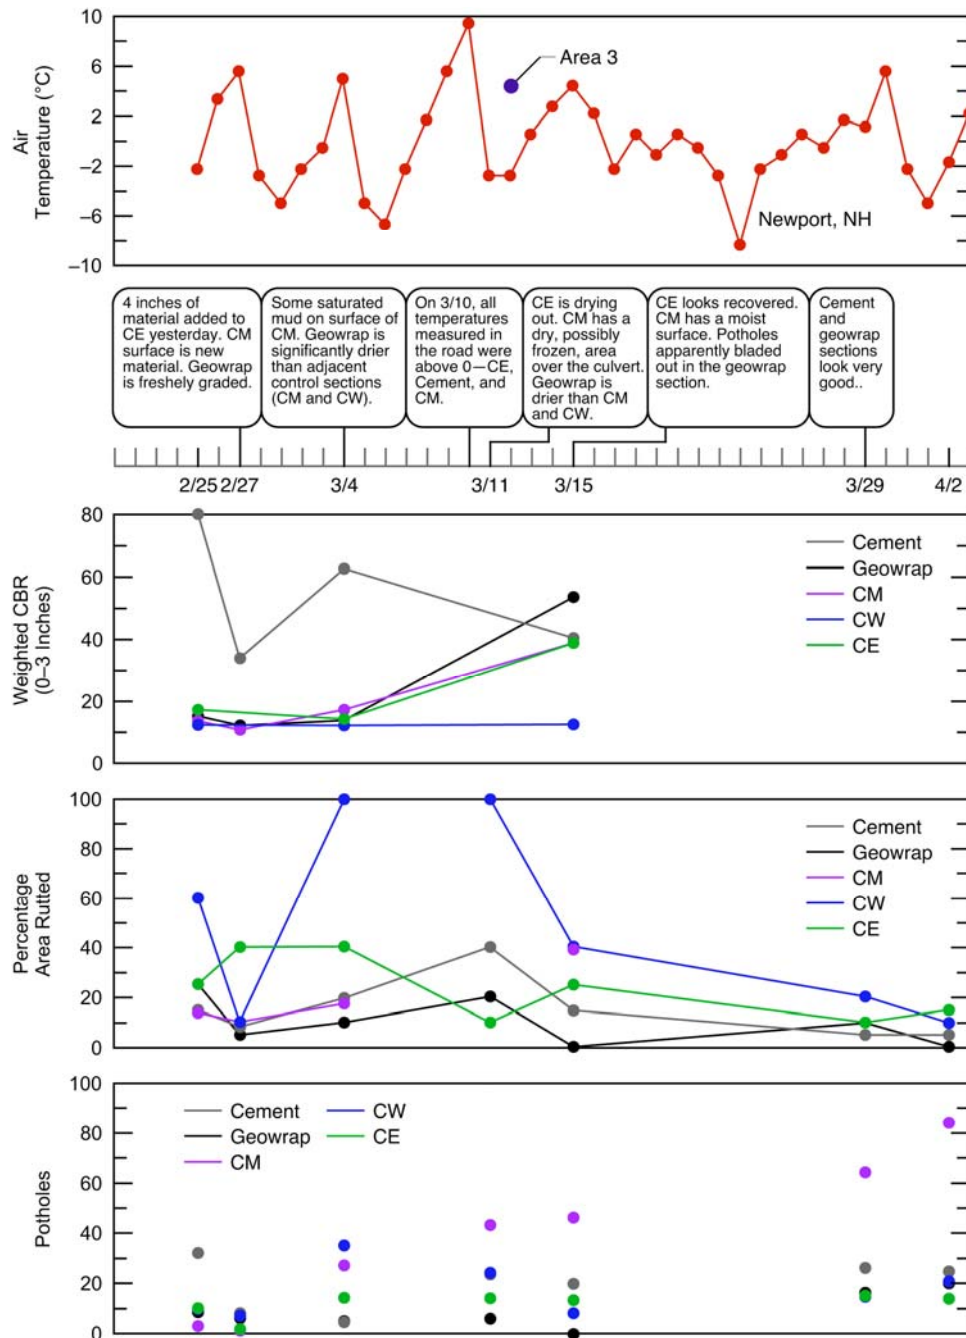
Figure 37. Air temperatures at Newport and datalogger enclosure temperature (top graph), annotated timeline, weighted CBR determinations for the top 3 in. of the road surface, percentage of the test section rutted, and number of potholes in the test sections for Area 3, 2002 mud season.

The performance of the Cement and the Geowrap sections stands out, both with respect to the CBR determinations and with respect to the rut development (Fig. 37 and 38). These sections were often visibly significantly drier at the surface than the adjacent control sections (Fig. 39 and 40). However, sometimes they contained as many potholes as the adjacent controls. The Cement section always had high CBR values near the surface, associated with relatively low rut formation. The Geowrap section recovered more rapidly than the two adjacent control sections (CM and CW). CBR determinations for the Geowrap section were similar to those of the control sections earlier in the thaw season, but the values rose more quickly over time.

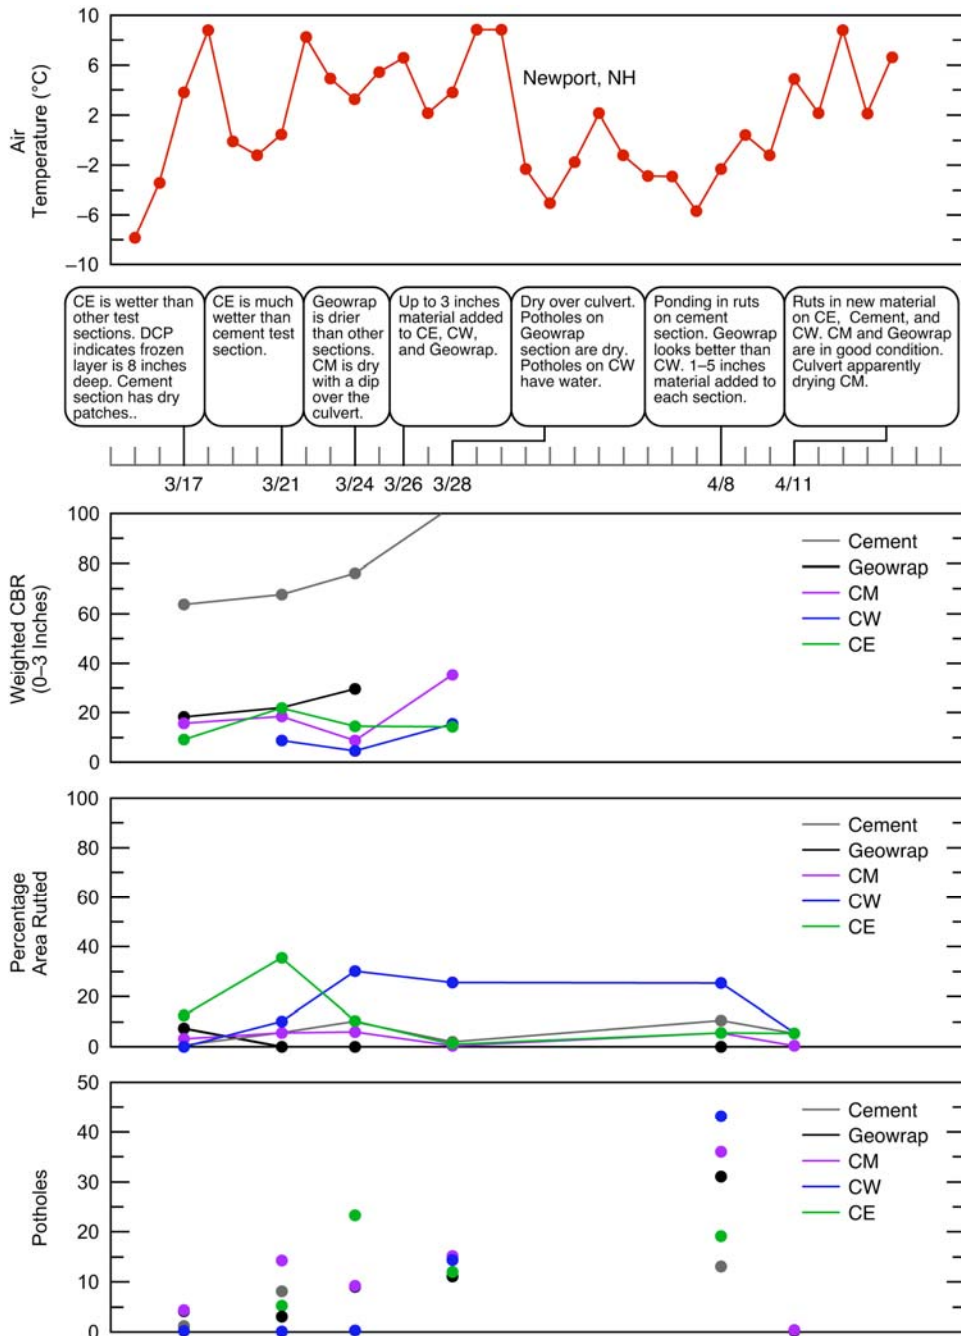
Figure 38. Air temperatures at Newport (top graph), annotated timeline, weighted CBR determinations for the top 3 in. of the road surface, percentage of the test section rutted, and number of potholes in the test sections for Area 3, 2003 mud season.

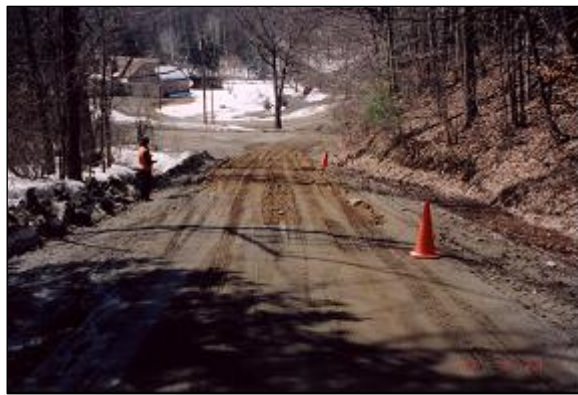
**Figure 41. CW of Area 4 on March 24, 2003, showing its sunny exposure. The orange cones mark the ends of the test section. Note that new material was added to this section. The GCBD section is in the foreground.**

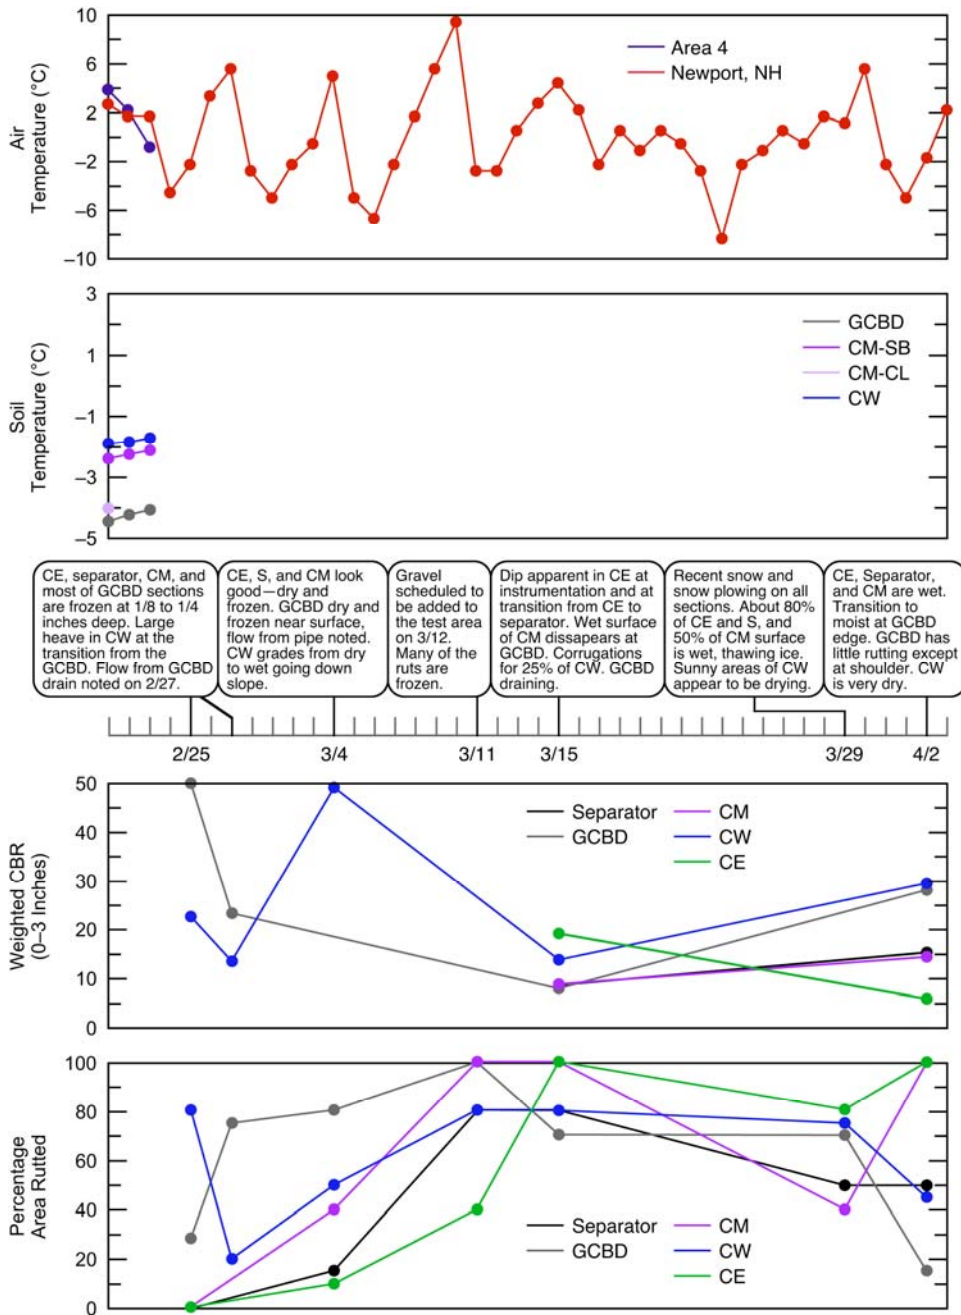
**Figure 42. Air temperatures at Newport and datalogger enclosure temperature (top graph), temperature measurements in the soil at 6 in. depth, annotated timeline, weighted CBR determinations for the top 3 in. of the road surface, and percentage of the test section rutted for Area 4, 2002 mud season.**

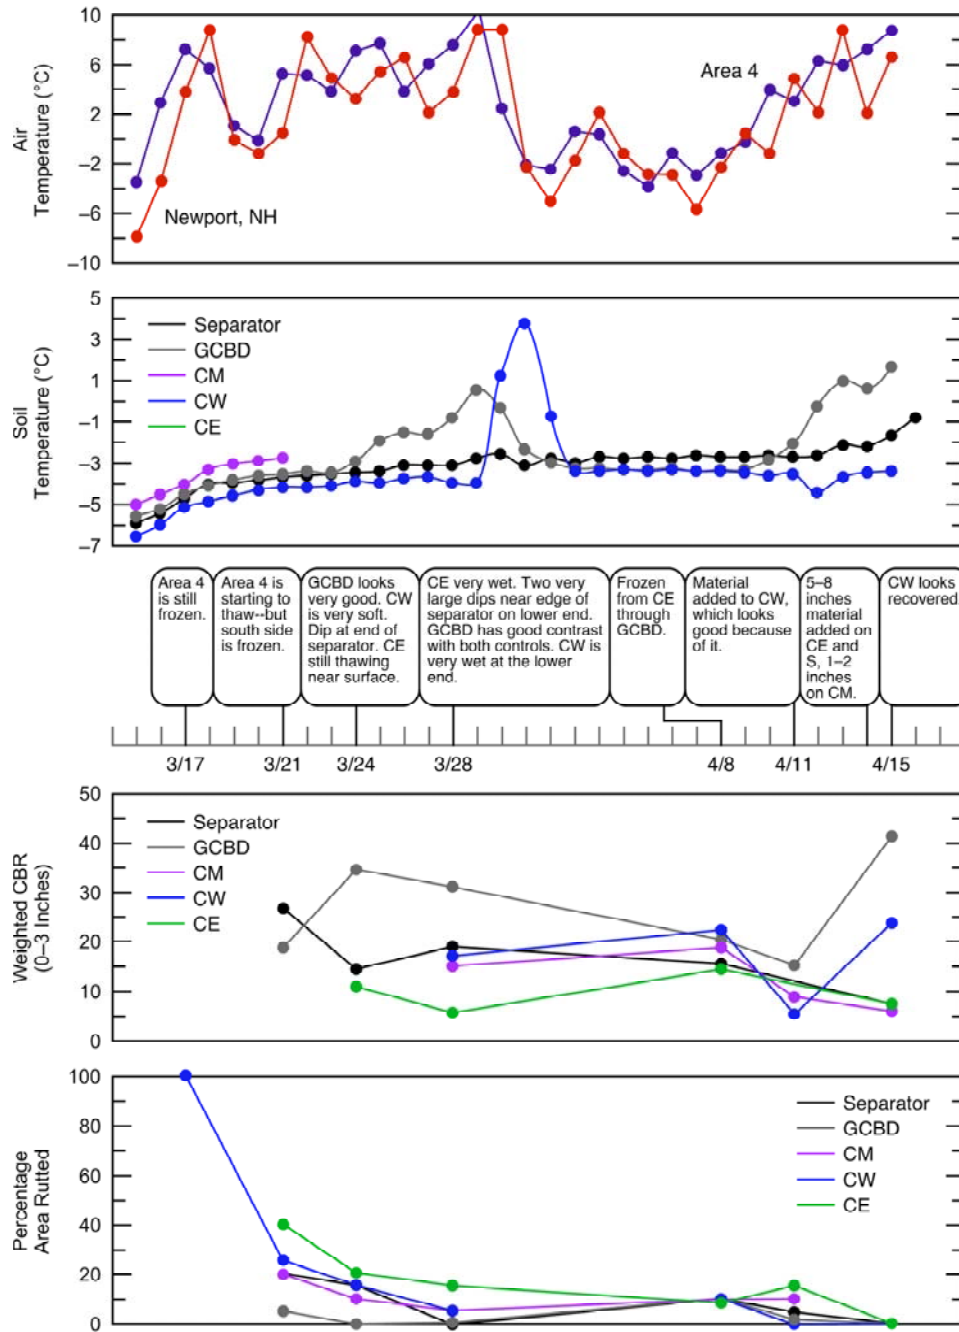
**Figure 43. Air temperatures at Newport and datalogger enclosure temperature (top graph), temperature measurements in the soil at 6 in. depth, annotated timeline, weighted CBR determinations for the top 3 in. of the road surface, and percentage of the test section rutted for Area 4, 2003 mud season.**

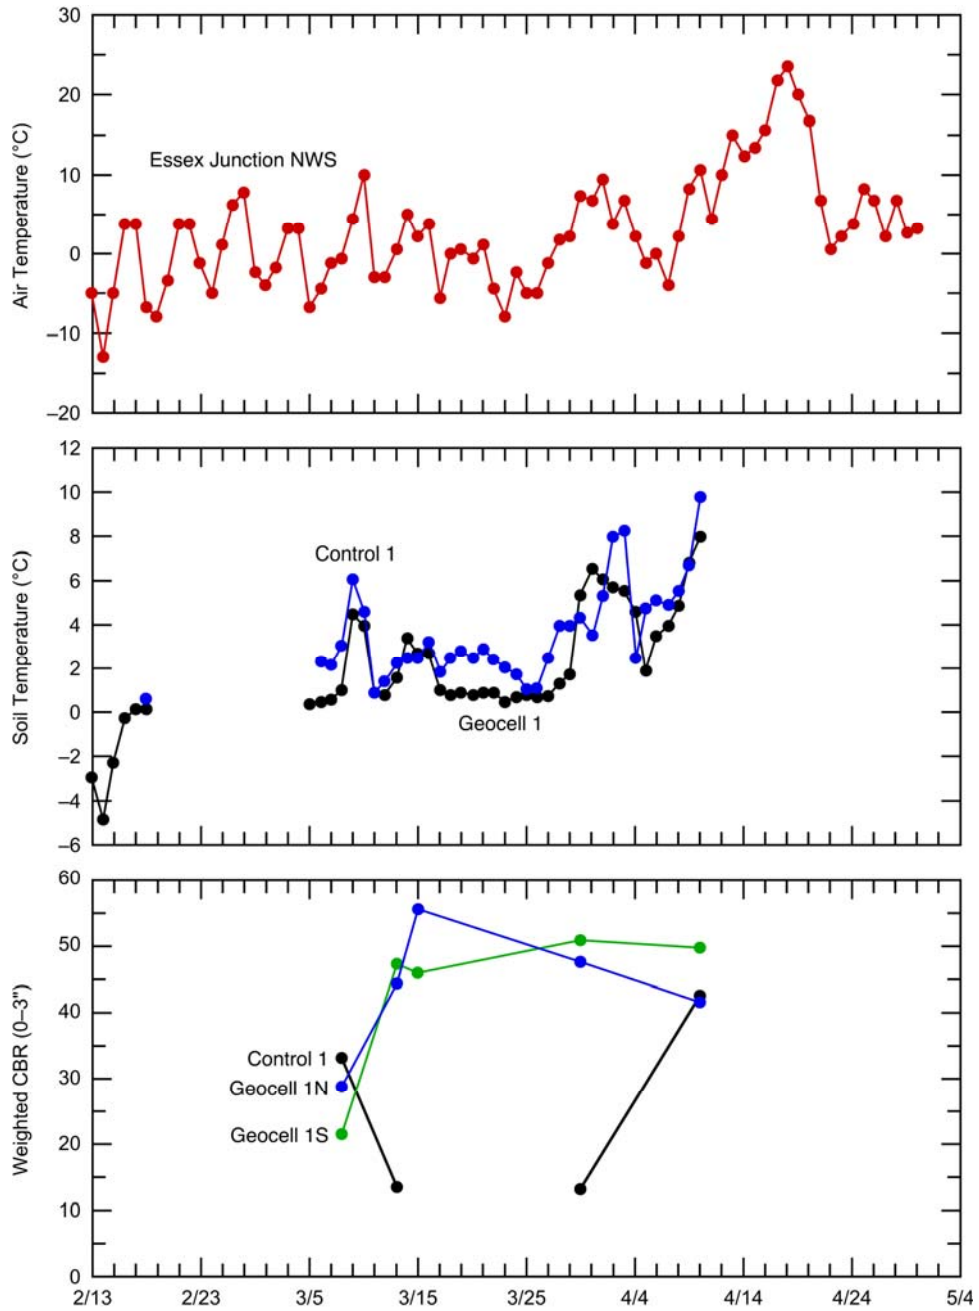
**Figure 44. Air temperatures at Essex Junction, temperature measurements in the soil at 6 in. depth, and weighted CBR determination for the top 3 in. of the road surface for the Geocell 1 test section, 2002 mud season. Geocell 1 N and 1 S readings were taken approximately 25 ft from the north and south edges of the test section, respectively.**

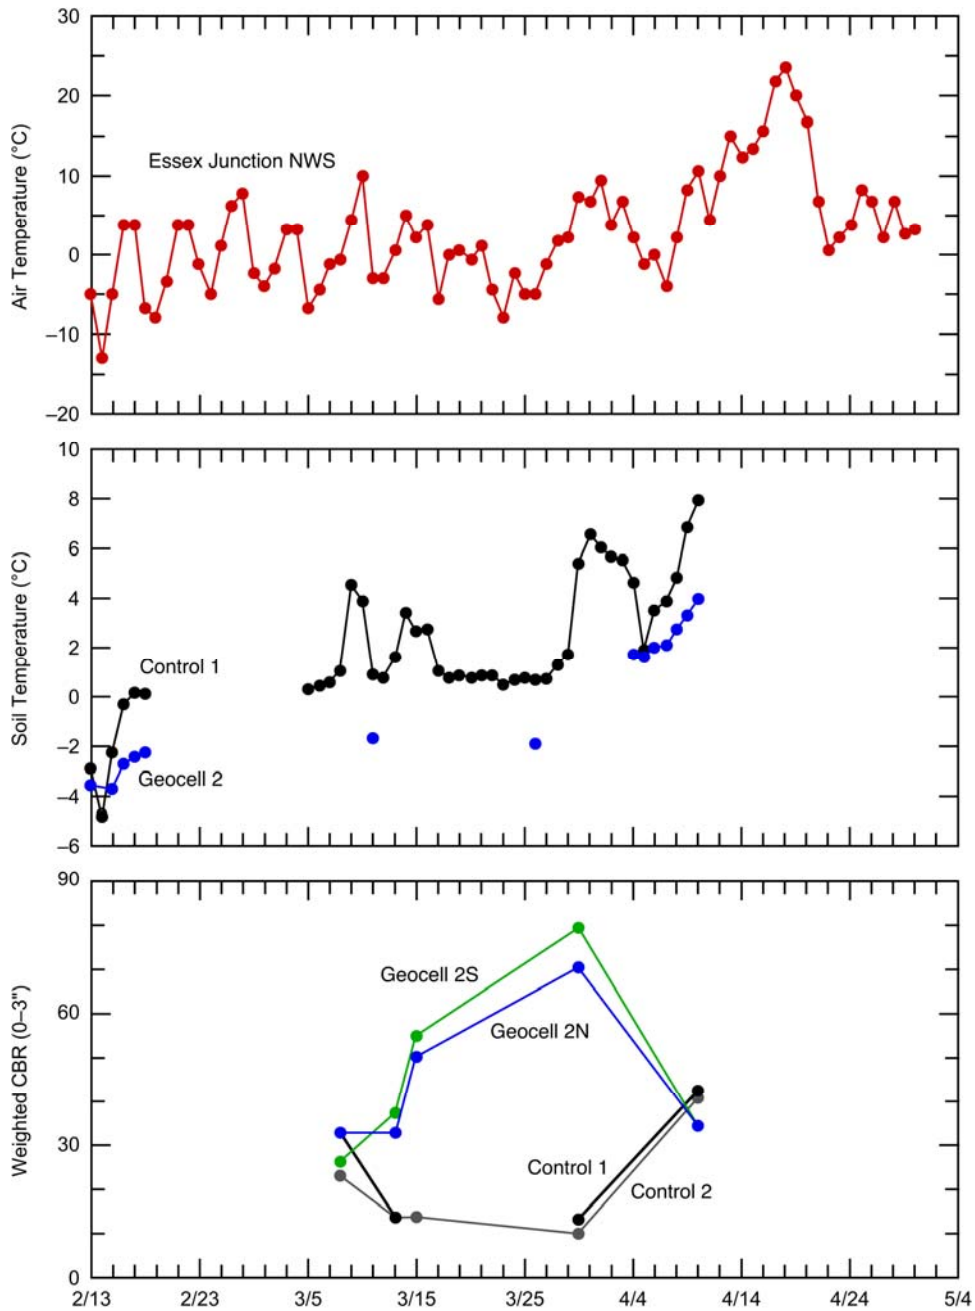
**Figure 45. Air temperatures at Essex Junction, temperature measurements in the soil at 6 in. depth, and weighted CBR determination for the top 3 in. of the road surface for the Geocell 2 test section, 2002 mud season. Geocell 2 N and 2 S readings were taken approximately 25 ft from the north and south edges of the test section, respectively.**

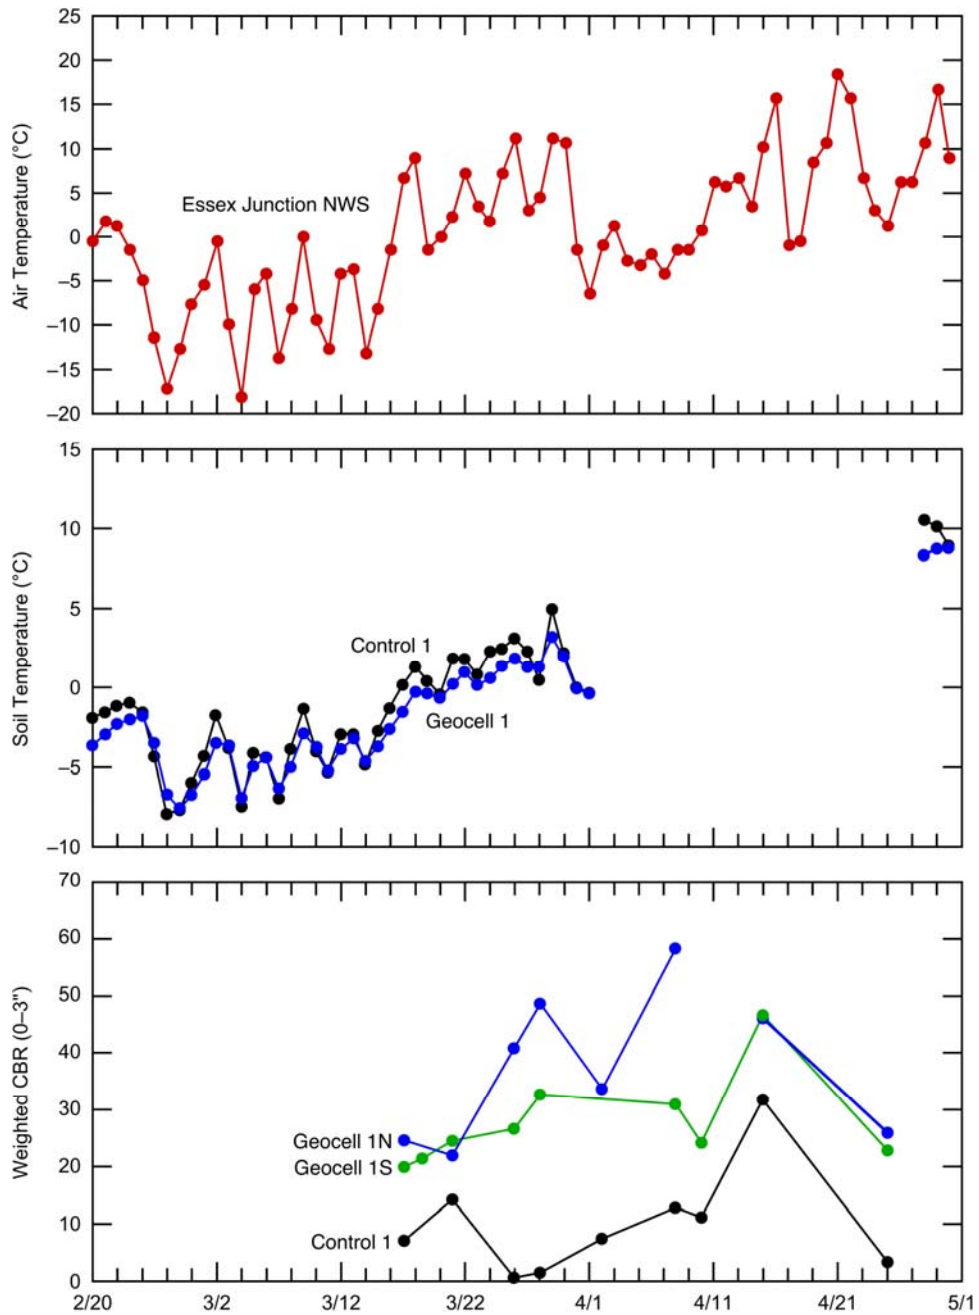
**Figure 46. Air temperatures at Essex Junction, temperature measurements in the soil at 6 in. depth, and weighted CBR determination for the top 3 in. of the road surface for the Geocell 1 test section, 2003 mud season. Geocell 1 N and 1 S readings were taken approximately 25 ft from the north and south edges of the test section, respectively.**
