**ERDC/CRREL TR-05-1**

# **Improved Performance of Unpaved Roads During Spring Thaw**

February 2005

Prepared for VERMONT AGENCY OF TRANSPORTATION AND  
FEDERAL HIGHWAY ADMINISTRATION

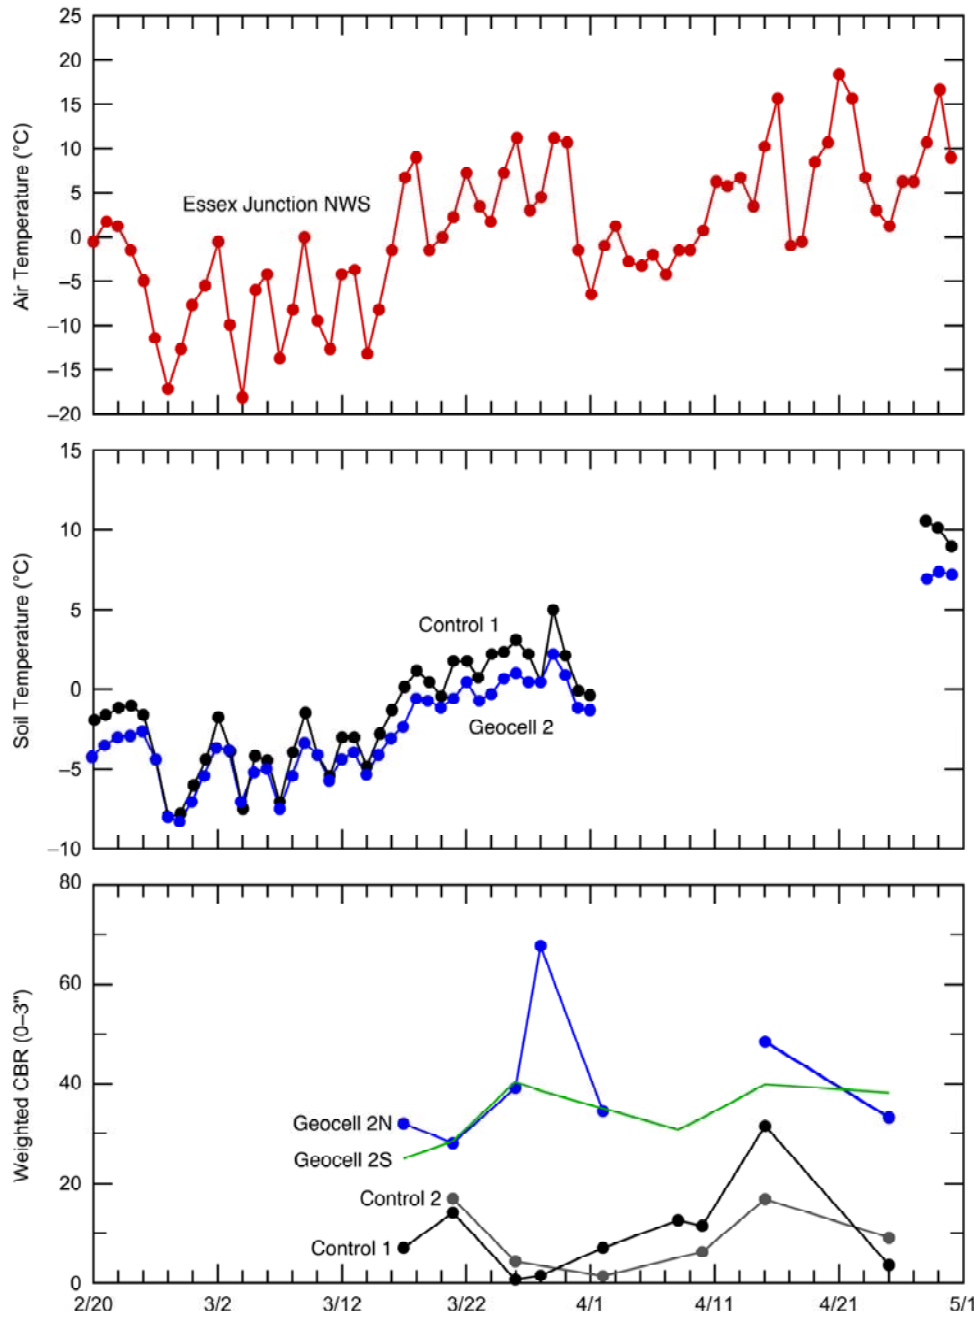
**Figure 47. Air temperatures at Essex Junction, temperature measurements in the soil at 6 in. depth, and weighted CBR determination for the top 3 in. of the road surface for the Geocell 2 test section, 2003 mud season. Geocell 2 N and 2 S readings were taken approximately 25 ft from the north and south edges of the test section, respectively.**

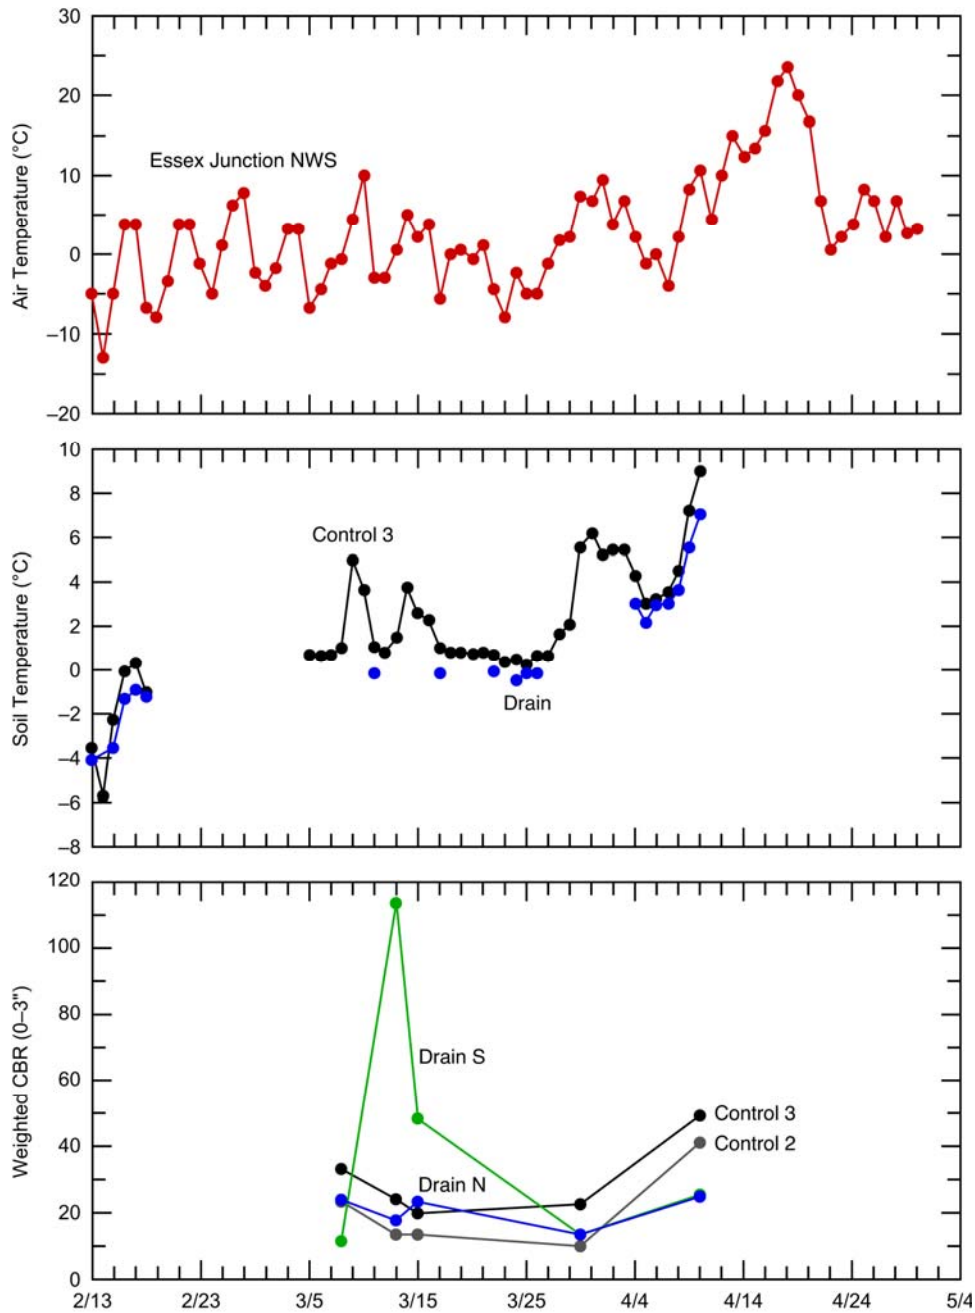
**Figure 48. Air temperatures at Essex Junction, temperature measurements in the soil at 6 in. depth, and weighted CBR determination for the top 3 in. of the road surface for the Drain test section, 2002 mud season. Drain N and S readings were taken approximately 25 ft from the north and south edges of the test section, respectively.**

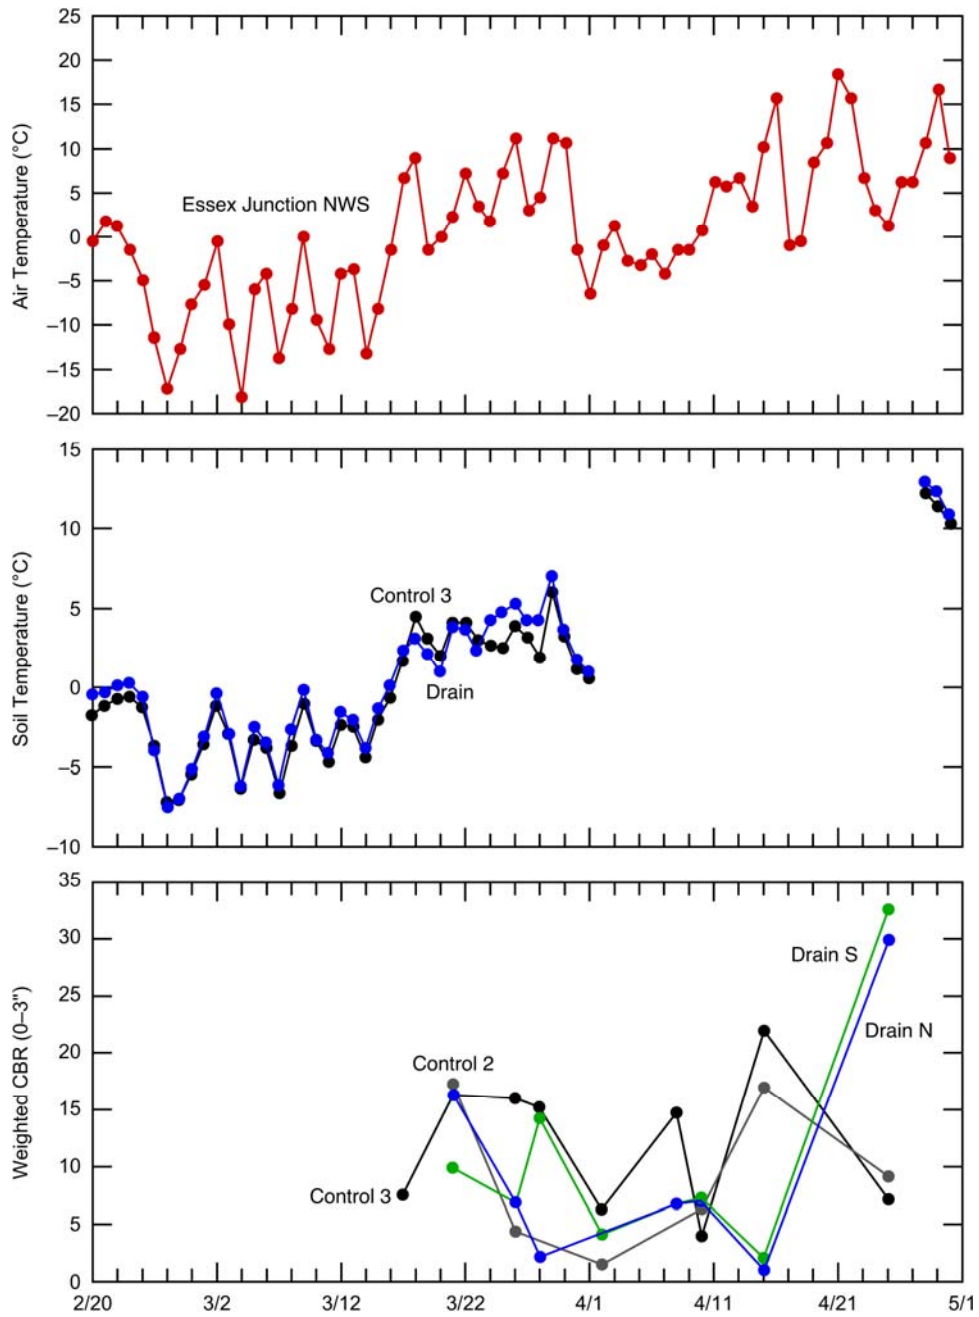
**Figure 49. Air temperatures at Essex Junction, temperature measurements in the soil at 6 in. depth, and weighted CBR determination for the top 3 in. of the road surface for the Drain test section, 2003 mud season. Drain N and S readings were taken approximately 25 ft from the north and south edges of the test section, respectively.**

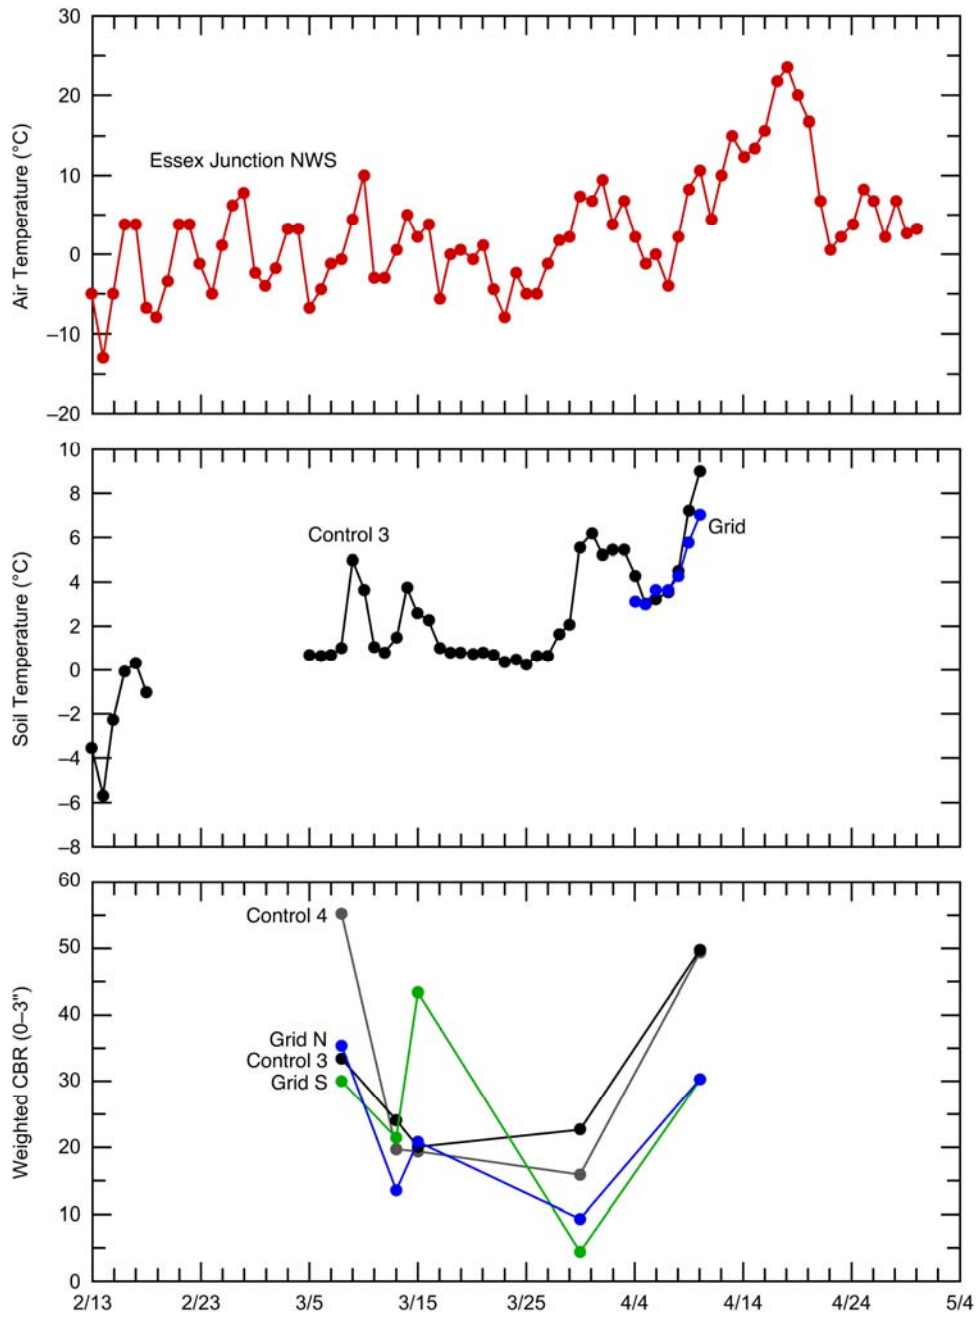
**Figure 50. Air temperatures at Essex Junction, temperature measurements in the soil at 6 in. depth, and weighted CBR determination for the top 3 in. of the road surface for the Grid test section, 2002 mud season. Grid N and S readings were taken approximately 25 ft from the north and south edges of the test section, respectively.**

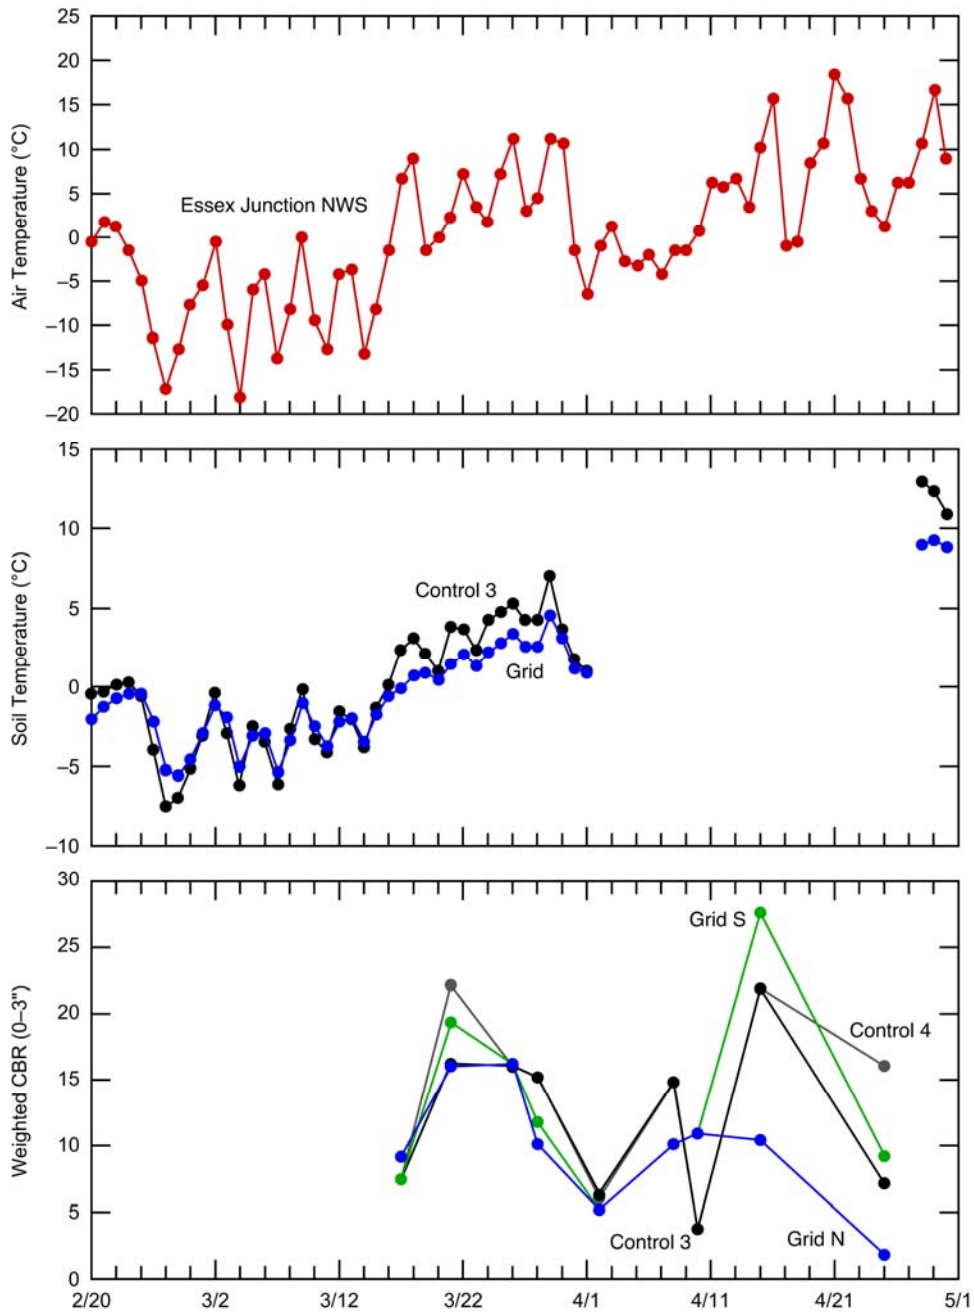
**Figure 51. Air temperatures at Essex Junction, temperature measurements in the soil at 6 in. depth, and weighted CBR determination for the top 3 in. of the road surface for the Grid test section, 2003 mud season. Grid N and S readings were taken approximately 25 ft from the north and south edges of the test section, respectively.**

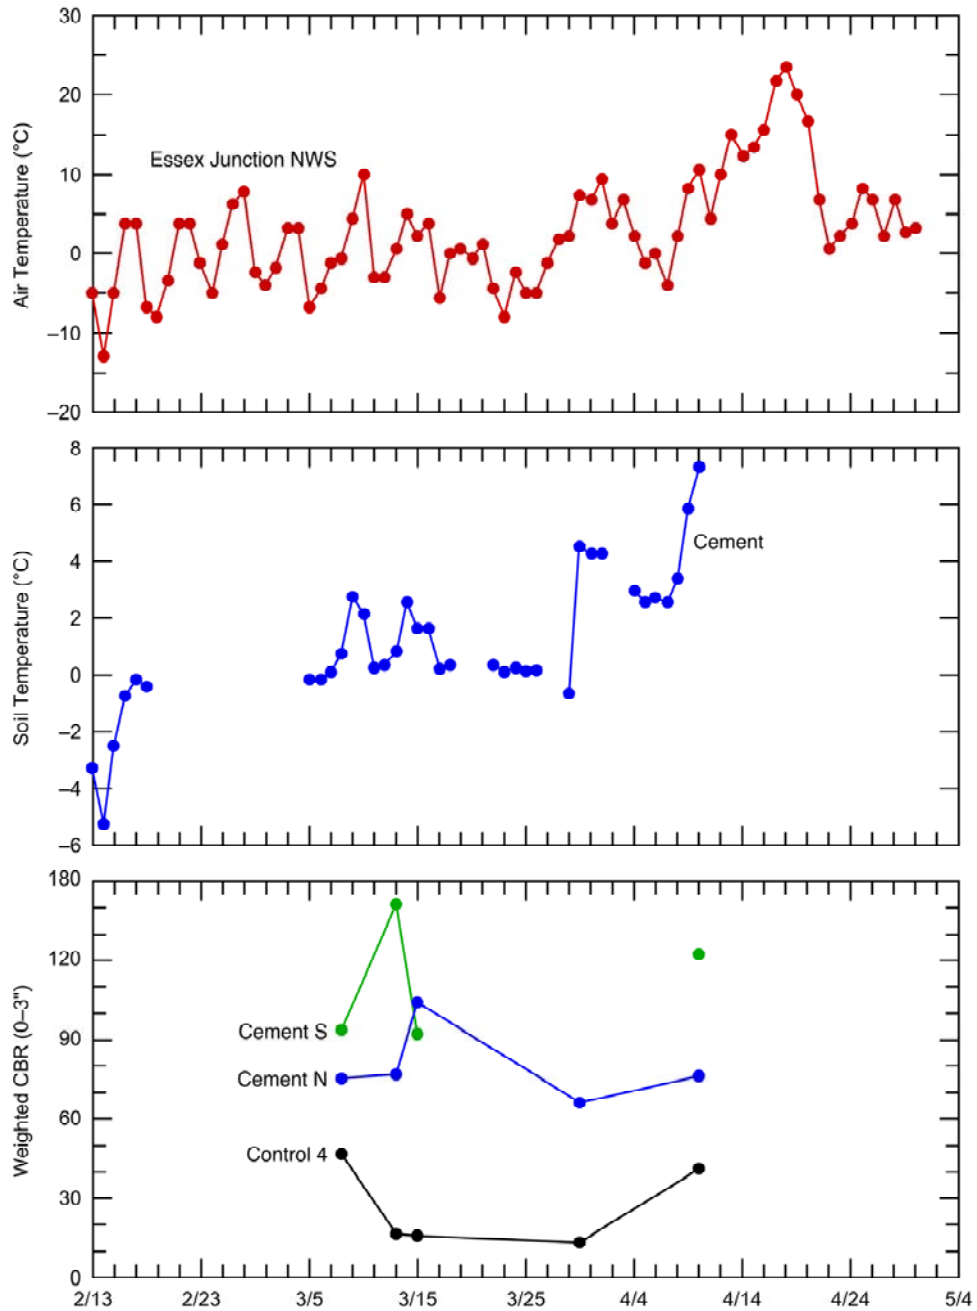
**Figure 52. Air temperatures at Essex Junction, temperature measurements in the soil at 6 in. depth, and weighted CBR determination for the top 3 in. of the road surface for the Cement test section, 2002 mud season. Cement N and S readings were taken approximately 25 ft from the north and south edges of the test section, respectively.**

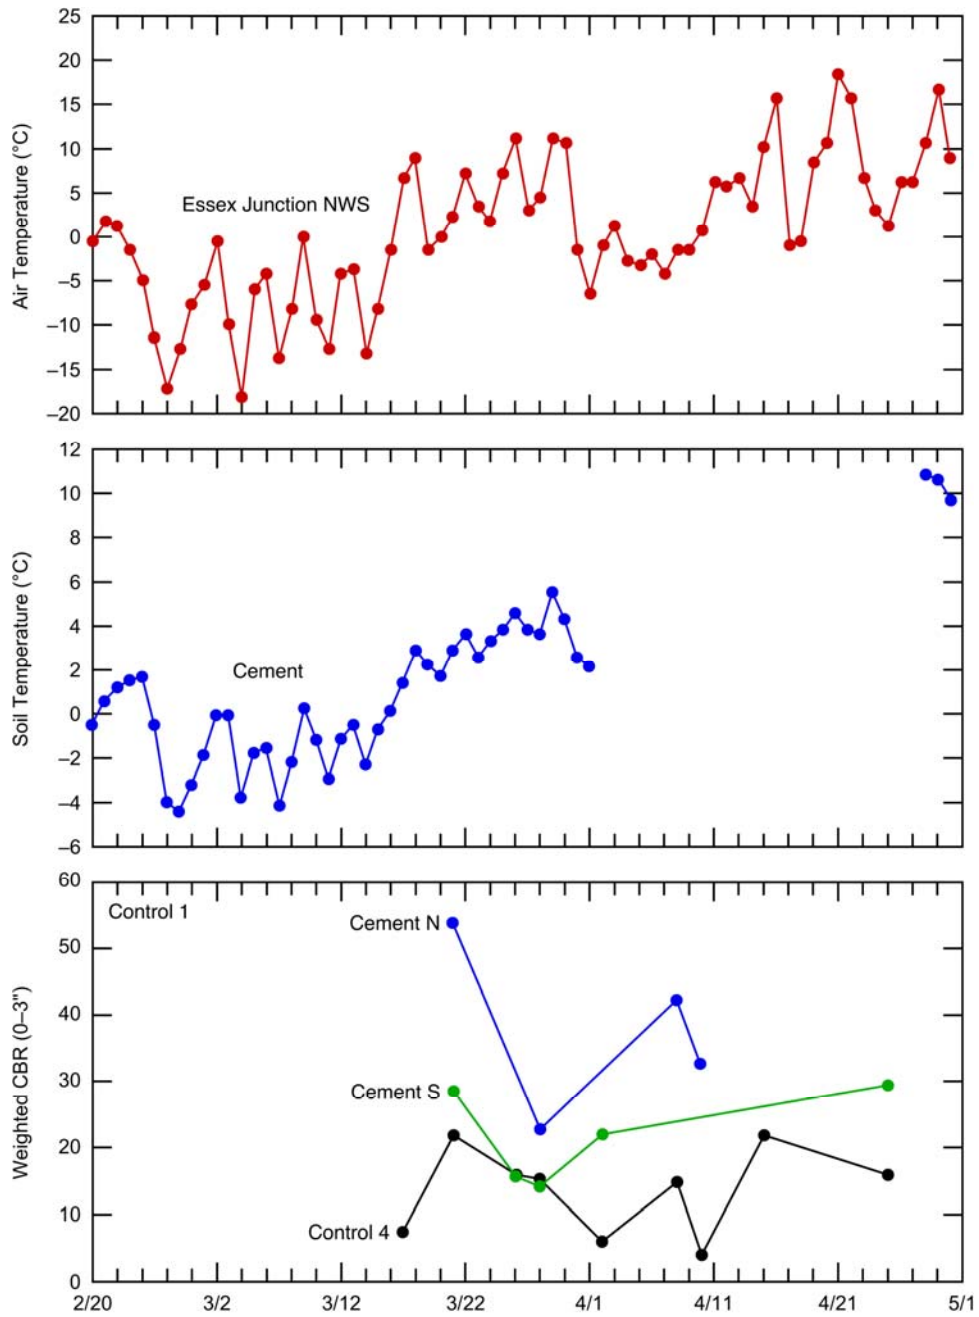
**Figure 53. Air temperatures at Essex Junction, temperature measurements in the soil at 6 in. depth, and weighted CBR determination for the top 3 in. of the road surface for the Cement test section, 2003 mud season. Cement N and S readings were taken approximately 25 ft from the north and south edges of the test section, respectively.**
