# Attic Ventilation Guidelines to Minimize Icings at Eaves

BY WAYNE TOBIASSON, JAMES BUSKA AND ALAN GREATOREX

**I**N COLD REGIONS, ICICLES AND ICE DAMS may develop on roofs that slope to cold eaves. Ventilating the space below the snow-covered roof with outdoor air to create a "cold" ventilated roof is often an effective way to avoid such problems. Several buildings in northern New York were instrumented to

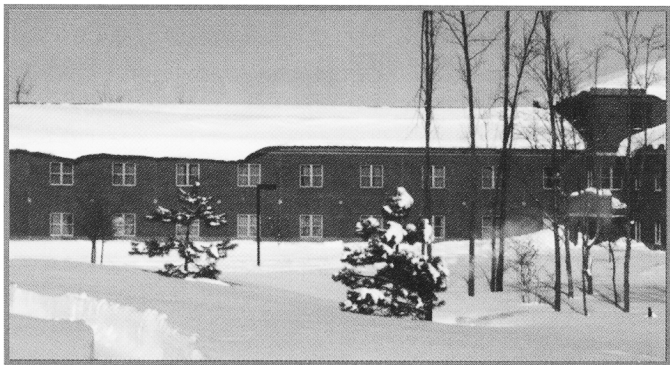
Figure 2: Some creep of snow and cornicing is evident, but no icings occurred on this roof.

A few years ago, many buildings were built at Fort Drum near Watertown, NY. All these buildings have standing seam metal roofing systems above ventilated attics. Standing seam metal roofing systems have both strengths and weaknesses when used in cold regions<sup>6</sup>. Some of these roofs have remained clear of icicles and ice dams (Figure 2). Several have experienced some problematic icicles and ice dams (Figure 3)

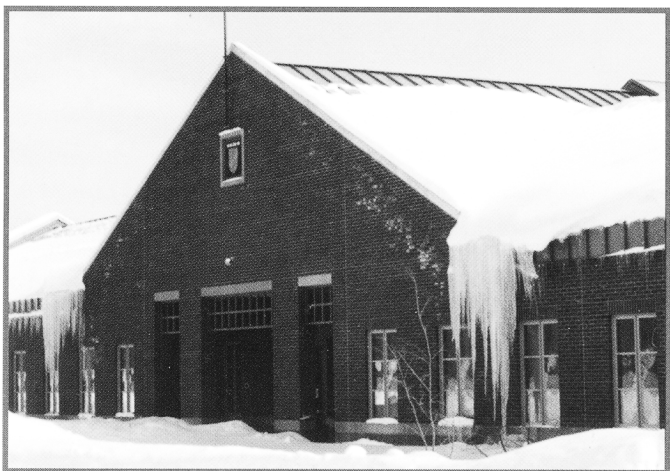
Figure 3: Minor icings occurred along the eaves of this roof and problematic icings developed at the base of valleys.

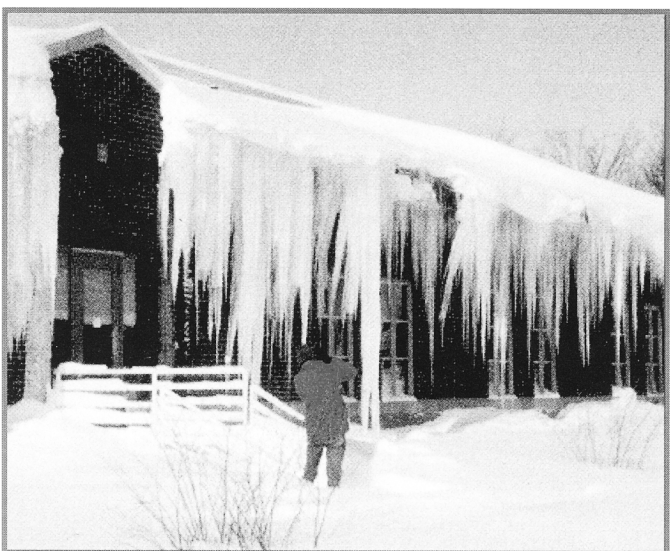
Figure 4: Severe, problematic icings developed all along the eaves of this dining facility.

and others have experienced severe icicles and ice damming (Figure 4). The range in performance is related to the ability of each building's attic ventilation system to remove heat that enters the attic from the warm building below and heat produced by HVAC equipment located in the attic.

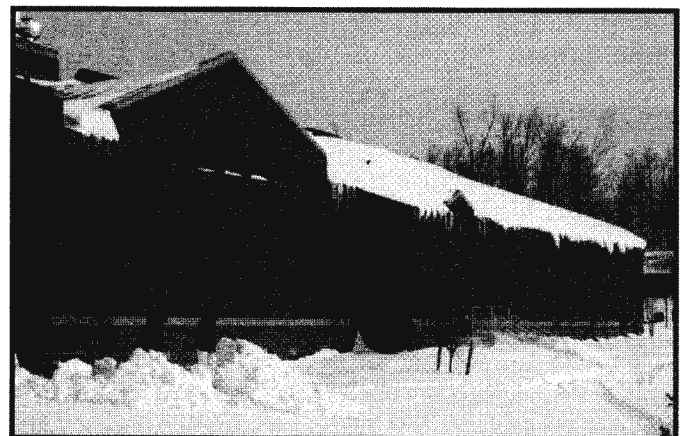
Figure 11: Both buildings from Figure 10 photographed at the same time. The unmodified building shown at the left was experiencing severe icings. The other building with improved attic ventilation had no icing problems.

*Figure 11* shows the two buildings just discussed on the same date (Jan. 12, 1994). The unmodified building is subjected to severe icings all along its eaves. There are only a few small icicles at the base of the valleys of the building with improved attic ventilation. All other irregularities along the eaves of that roof are snow cornices, not icicles.
