**Remediating and Monitoring  
White Phosphorus Contamination  
at Eagle River Flats  
(Operable Unit C),  
Fort Richardson, Alaska**

**FY 00 Report**

**Cold Regions Research and  
Engineering Laboratory  
72 Lyme Road • Hanover • New Hampshire 03755**

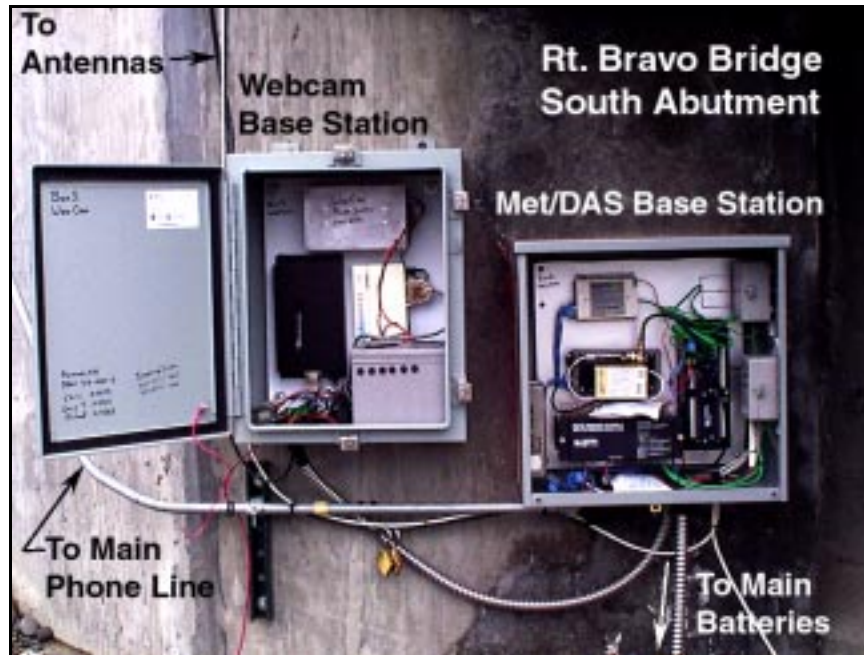
Figure III-1-2. Rt. Bravo Bridge remote monitoring base station.

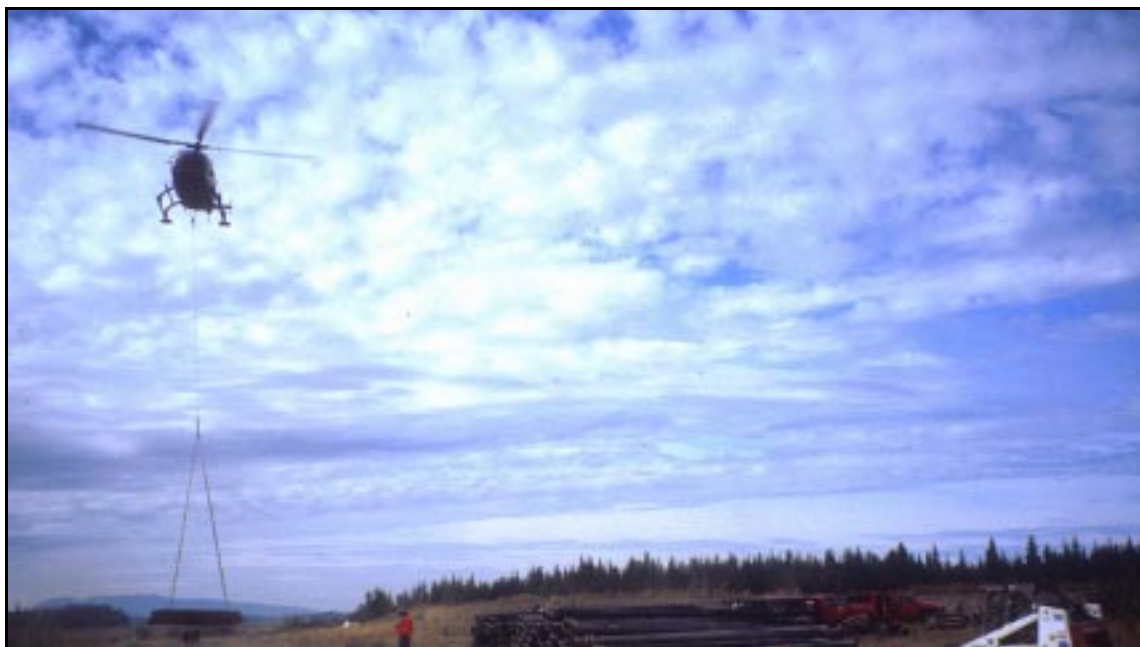
Figure III-1-3. Retrograde of pipe to EOD Pad using slings.

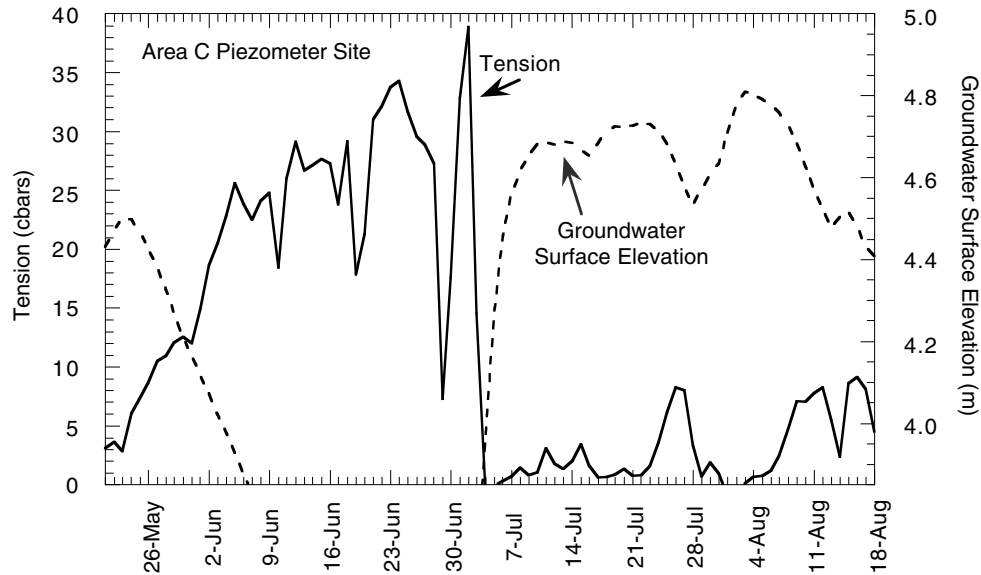
Figure III-2-10. Groundwater surface elevation in the piezometer well located in Area C and the corresponding moisture content (tension) of the surface sediment (elevation 4.77 m). A rise in tension indicates drying.

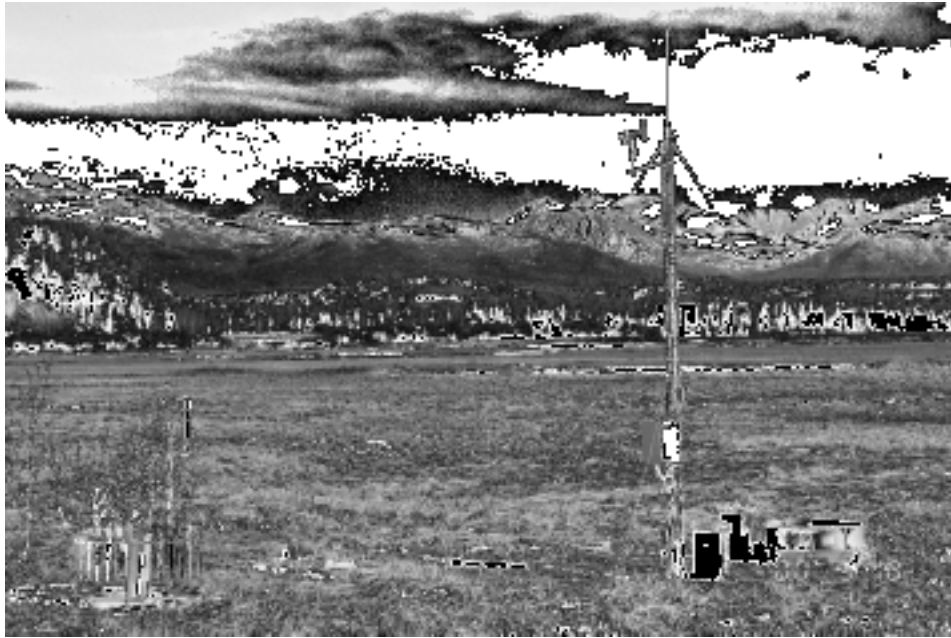
*Figure III-4-1. Eagle River Flats meteorological station located off the edge of the EOD Pad. The 4-m tower is located in the right center, the 1.22-m-diameter evaporation pan is located to the right, and the shielded rain gage is located to the left.*

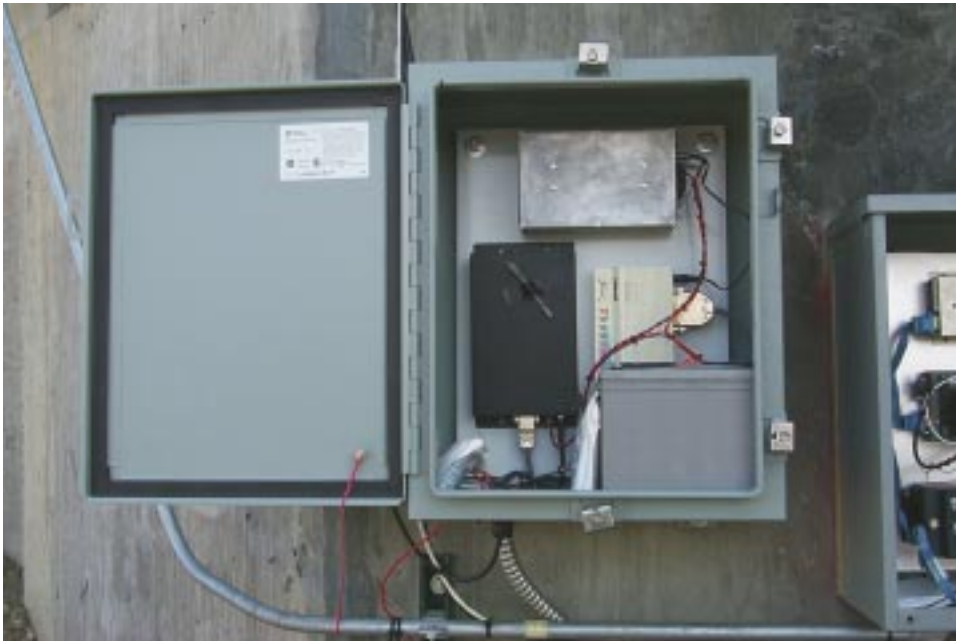
Figure III-5-5. Base station.

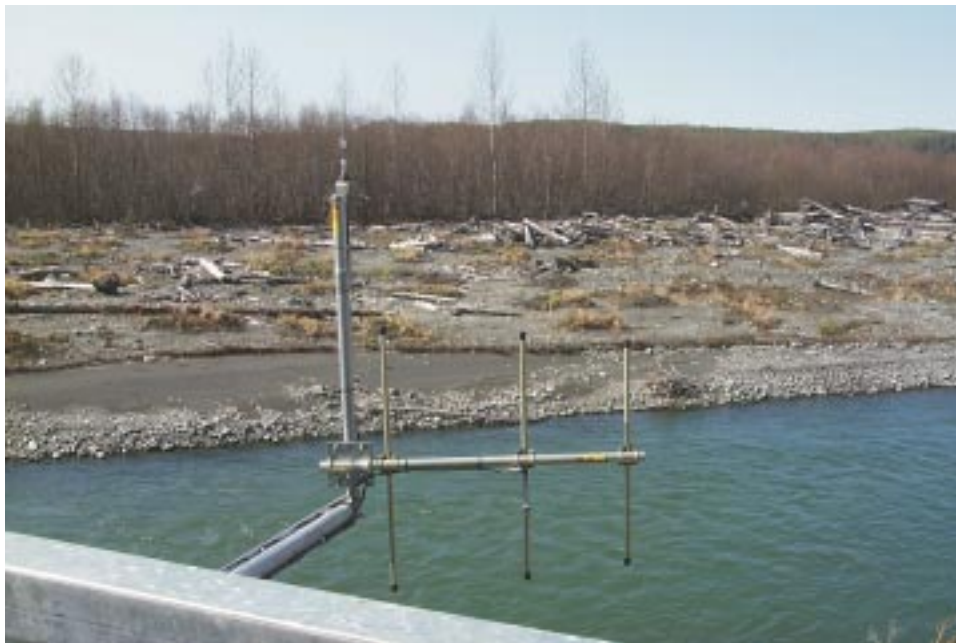
Figure III-5-6. Base station antennas.
