Space Shuttle OV-105 Subnominal Bond Investigation

Anna E. Gunn-Golkin
U.S. Air Force Academy, USAFA, CO, 80841

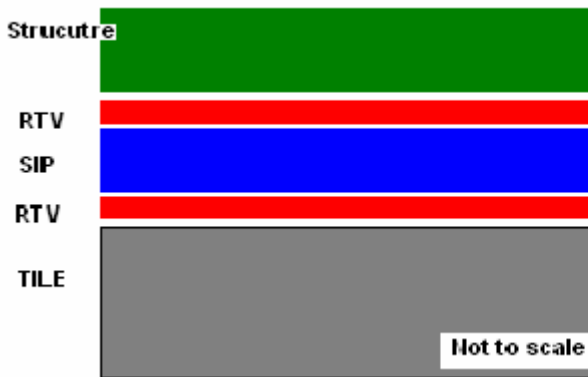
Figure 2. Cross Section of Tile Adhesive.

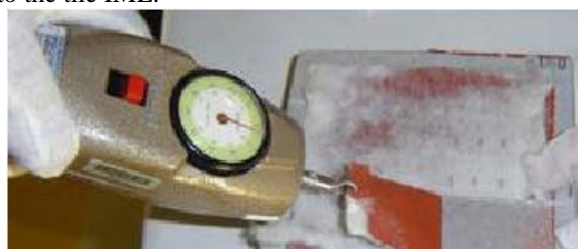
As there is no RTV adhesive peel requirement, this was an engineering evaluation only: a peel value greater than 4 in/lb was considered acceptable. The peels were performed using a chatillion force gauge attached with a hook to pull 1 inch strips of SIP normal to the tile IML.

Figure 6. Peel Test set-up.

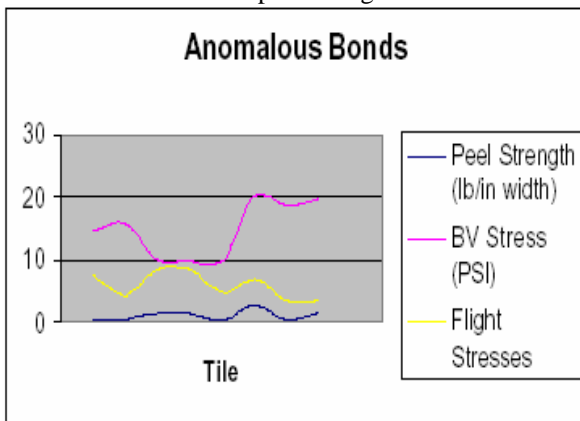
The BV Check and Peel Test on the initial anomalous bonds show that only 7.5% of variation in BV strength is related to peel strength. A majority of discrepant tiles had an additional BV to 10 PSI or 20 PSI prior to removal. The tensile properties are the critical design limit stress on a tile bond, so it is favorable that all subnominal peel strength bonds still passed a BV check. While a typical peel strength for a nominal tile bond is greater than 4 lb/in , anomalous tiles revealed a peel strength as low as 0.5 lb/in.

Figure 7. Anomalous Bond Tiles.

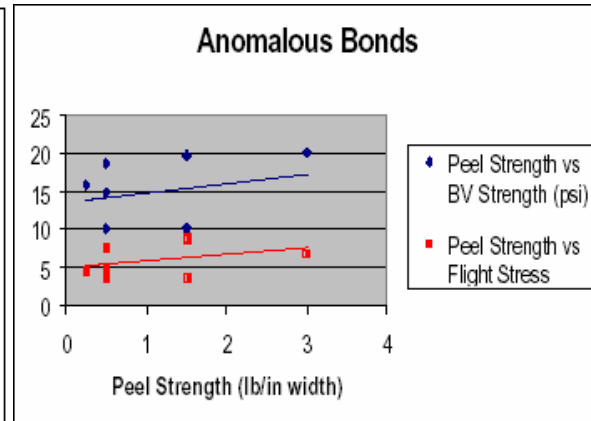
Figure 8. Anomalous Bond peel strength.

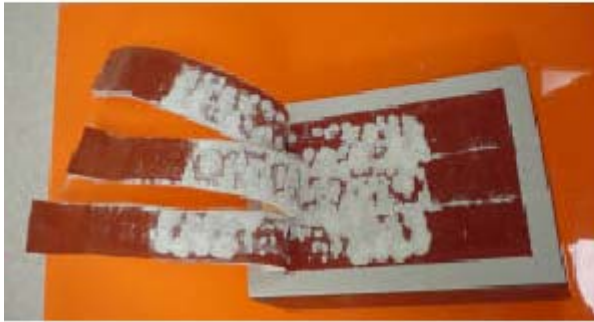
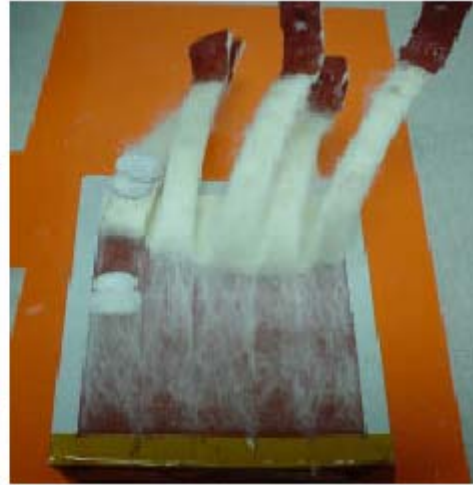
The silane used in the factory waterproofing process could have been impure. This remains an option as silane is an integral part of producing a nominal SIP/IML bond as demonstrated in the test peels for MISC-794-479. However, the peel strength values are still not nearly as low as those observed in the subnominal SIP/IML adhesive bonds on OV-105.

Figure 18. Peel without silane (avg peel = 6 lb/in). Figure 19. Normal peel (avg peel = 22lb/in).

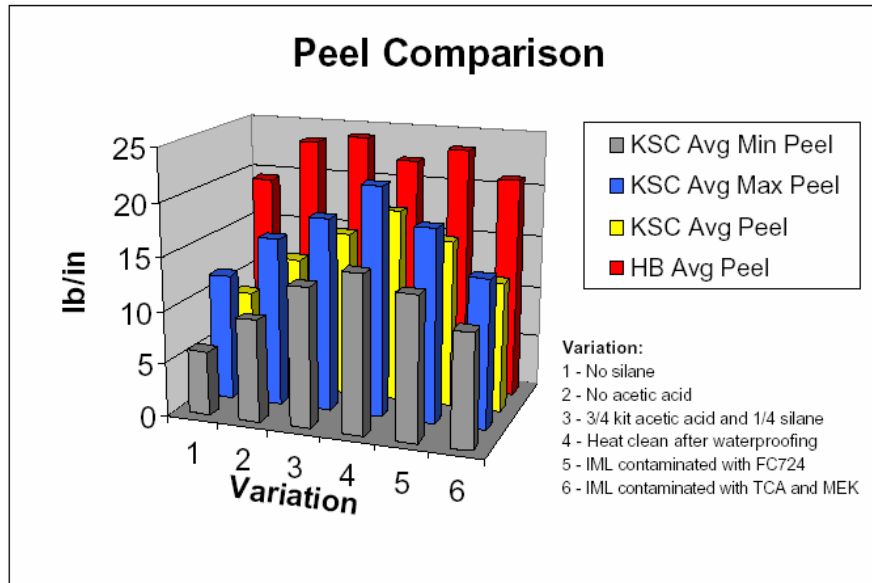
The labs at KSC and HB did not fully coordinate subnominal bond research, and contaminant peel tests were conducted under different conditions. No repeatable procedure was available for the data acquired from HB. In order to accurately gauge the affect of Saran, Sizing, and BHT contamination on the SIP/IML bond, those tests should be recreated under standardized, controllable conditions and in a manner such that they can be properly compared to other contamination investigations. Additionally, future testing at multiple facilities should be coordinated by all parties involved to avoid inefficacious results.

Figure 26. Comparison of testing at different facilities.
