**CREEP BEHAVIOR OF AN OXIDE/OXIDE COMPOSITE WITH MONAZITE
COATING AT ELEVATED TEMPERATURES**

THESIS

Department of Aeronautics and Astronautics

March 2005

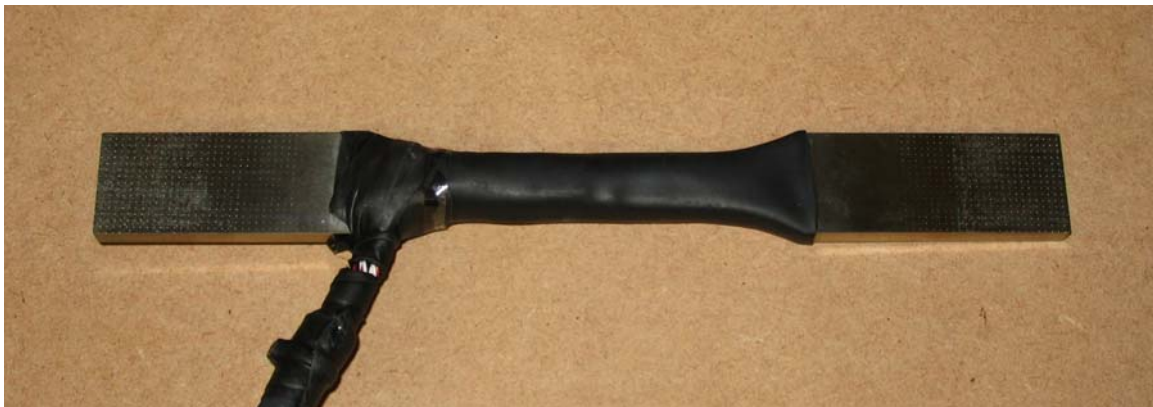
Figure 12. MTS 609 Alignment Fixture

Prior to testing, the grips were aligned using an MTS 709 Alignment System consisting of an MTS 609 Alignment fixture fitted with twelve strain gages and MTS 709 Alignment Software. The alignment specimen's strain levels were zeroed out, and then gripped under no load. The position and rotation of the right grip was then adjusted using the alignment fixture until the strain levels were again close to zero. This procedure eliminated any bending or twisting stresses on test specimen caused by improper alignment of the grips. The MTS Alignment Fixture is shown in Figure 12.

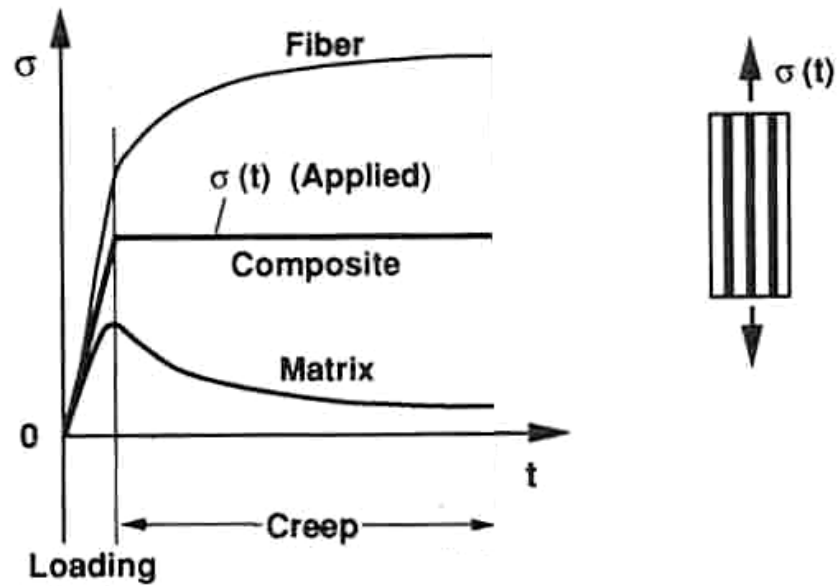
Figure 19. Stress Redistribution during Creep

During creep-rupture testing, differences in elastic constants, creep rates, and stress-relaxation behavior between the fiber and the matrix can cause a time dependent redistribution of stress. When creep is present, the creep resistance mismatch causes a higher stress in the component with higher creep resistance and a decrease in stress for the less creep resistant component. Figure 19, from Holmes and Wu (19), illustrates the stress redistribution in a 0° layer of a composite with a more creep resistant fiber, which is typically the case (19:194).

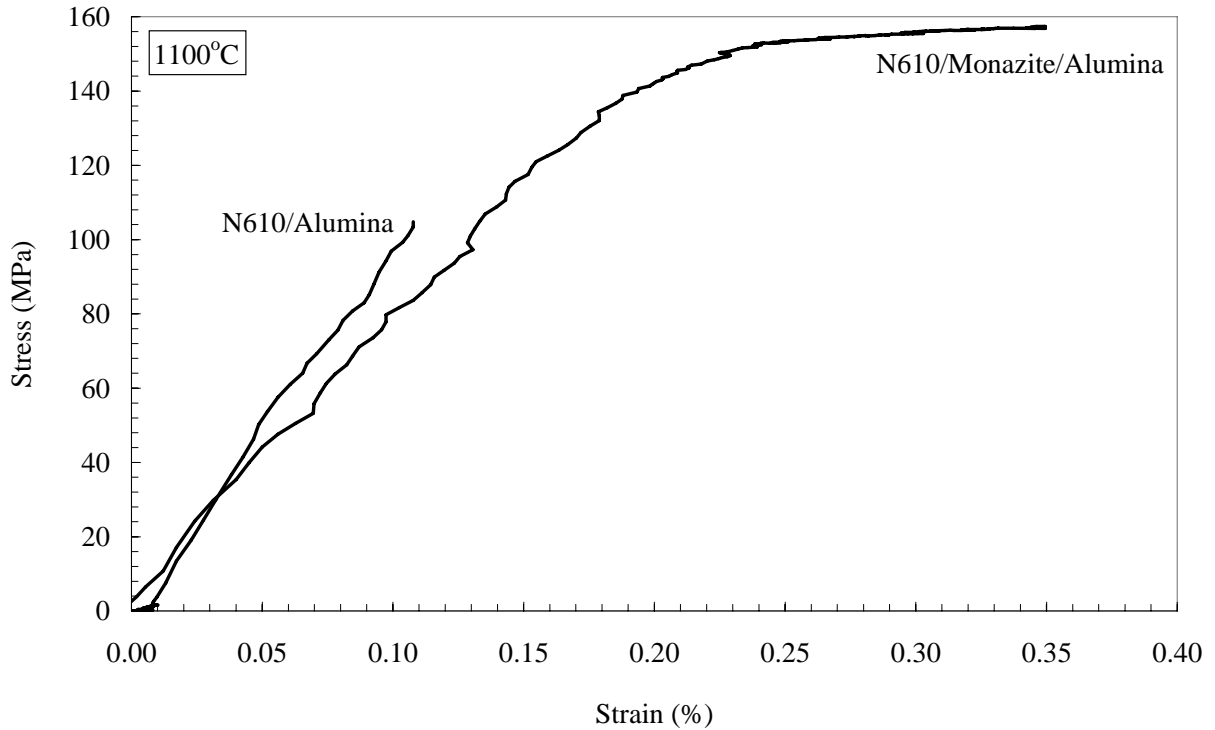
Figure 26. Stress-Strain Curves at 1100°C

The effect of the monazite coating is more clearly seen in Figure 26, depicting stress-strain curves for both composites at 1100°C.

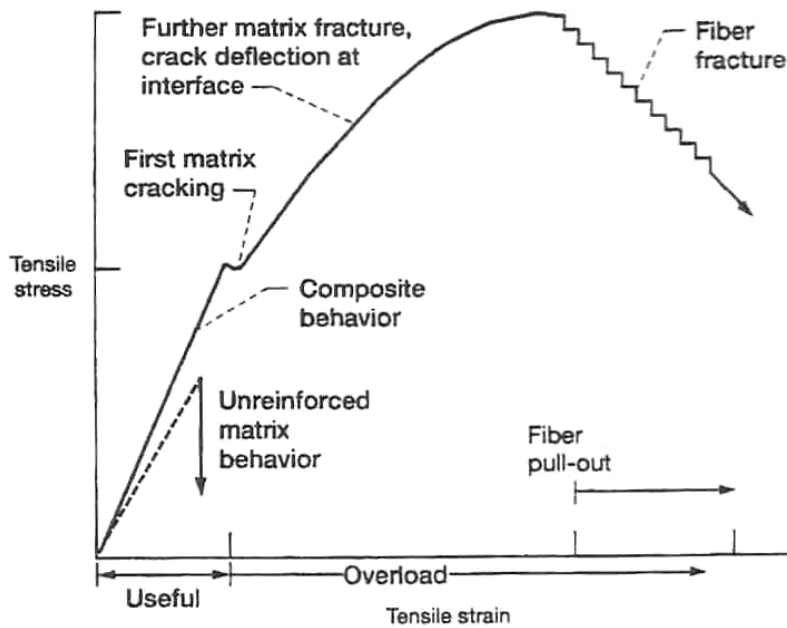
Figure 27. Ideal Stress-Strain Behavior of a CMC

This behavior is supported in Figure 27, from DiCarlo et al (14), which depicts the ideal stress-strain behavior of a continuous fiber reinforced ceramic composite.

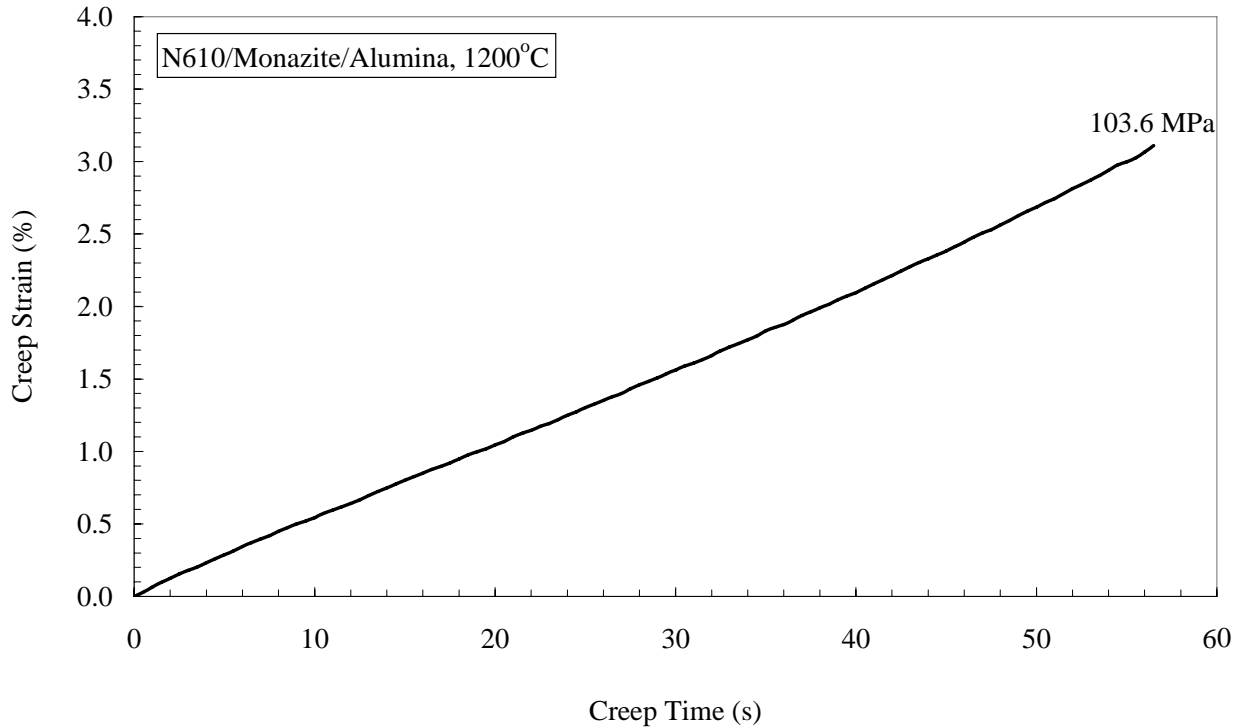
Figure 49. Creep of N610/Monazite/Alumina at 1200°C

Only one stress level was tested at 1200°C due to the extremely short creep life, even for 80% UTS. The creep-rupture curve can be seen in Figure 49.

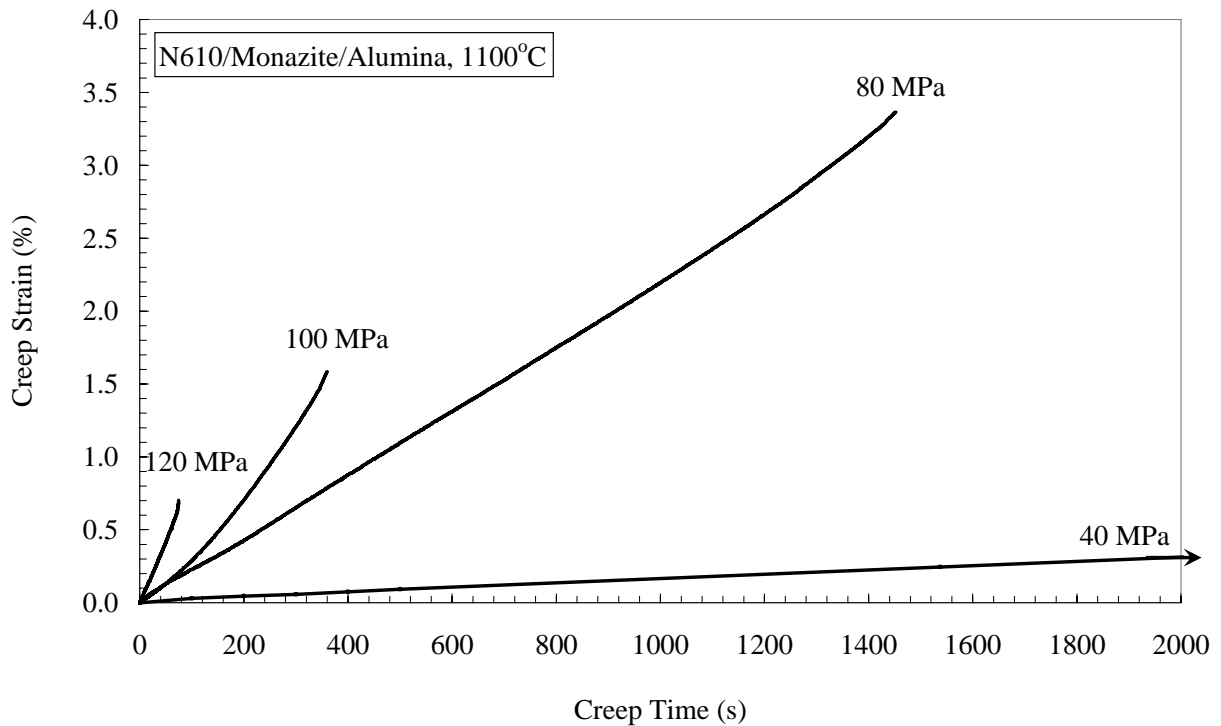
Figure 50. Creep of N610/Monazite/Alumina at 1100°C

Creep-rupture curves at 1100°C and stress levels of 40, 80, 100, and 120 MPa are shown in Figure 50. The time scale of the plot has been truncated to more clearly view the curves for stress levels above 40 MPa. The arrow at the end of the visible portion of the 40 MPa curve indicates that the curve continues past 2000 s.

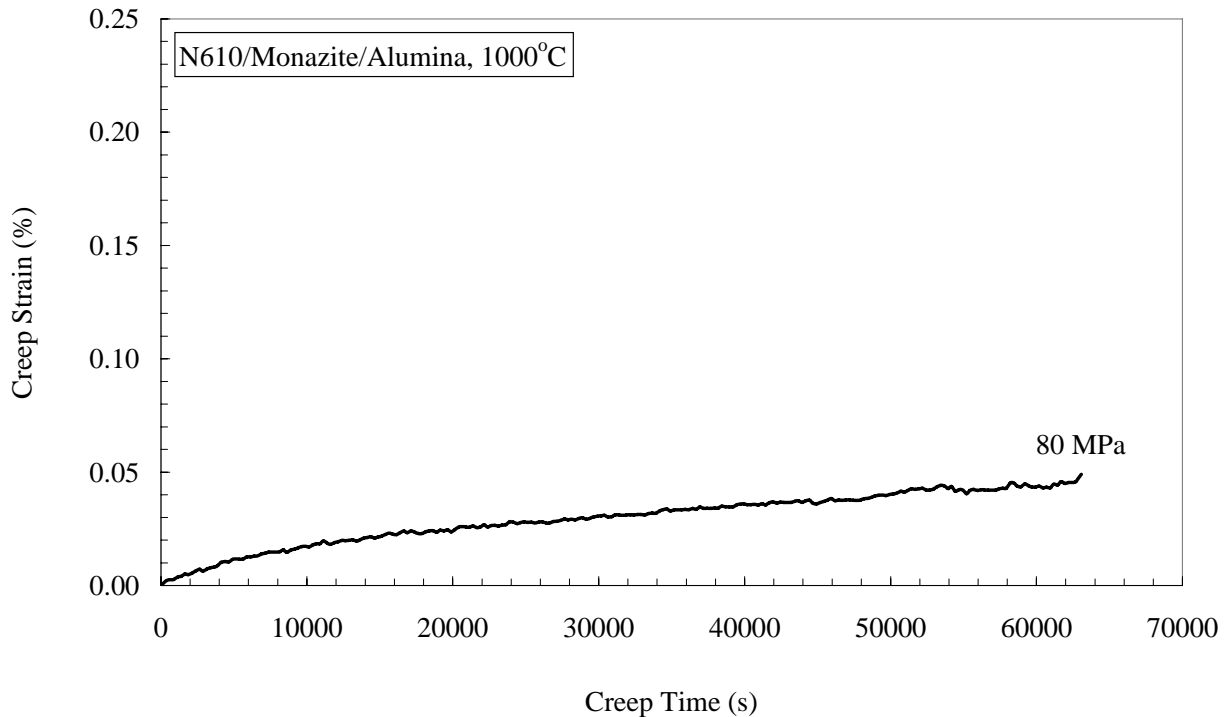
Figure 51. Creep of N610/Monazite/Alumina at 1000°C

The creep-rupture curve obtained at 1000°C with a creep stress of 80 MPa can be seen in Figure 51.

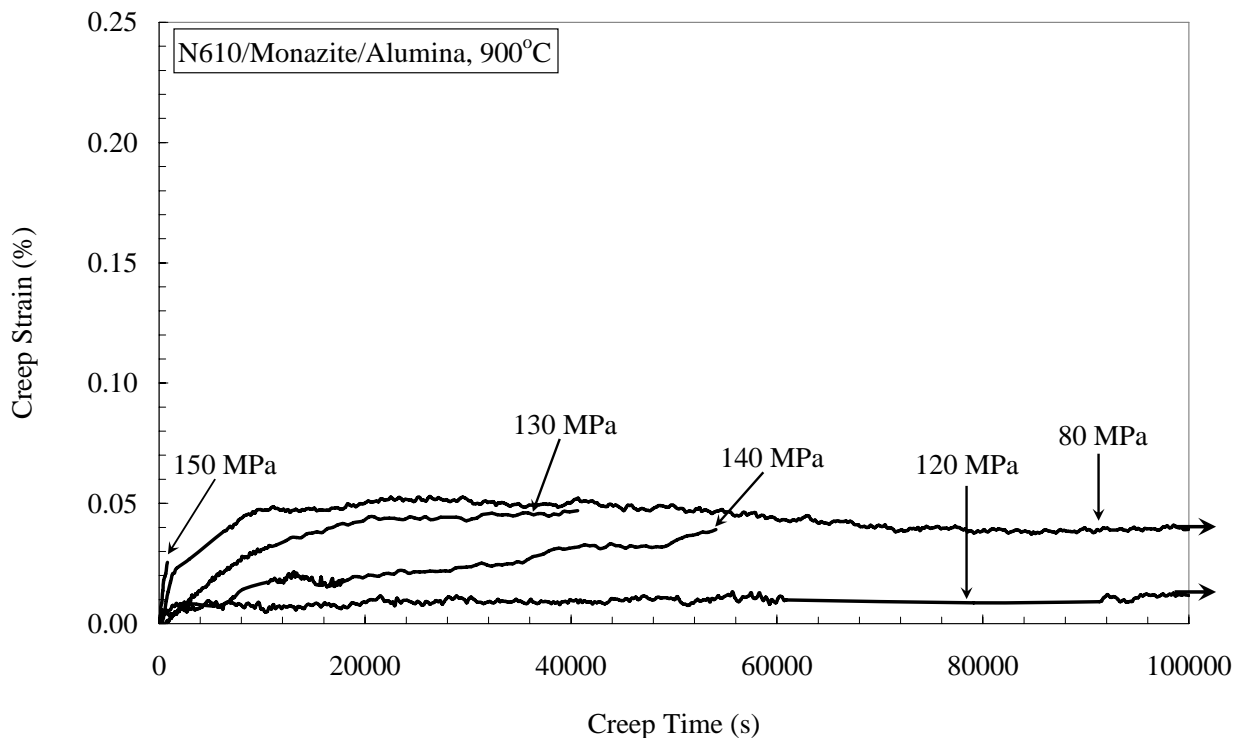
Figure 52. Creep of N610/Monazite/Alumina at 900°C

Creep-rupture curves for 900°C are shown in Figure 52. Again, at the creep stress of 80 MPa a runout was achieved, and the test was interrupted after 164 h.

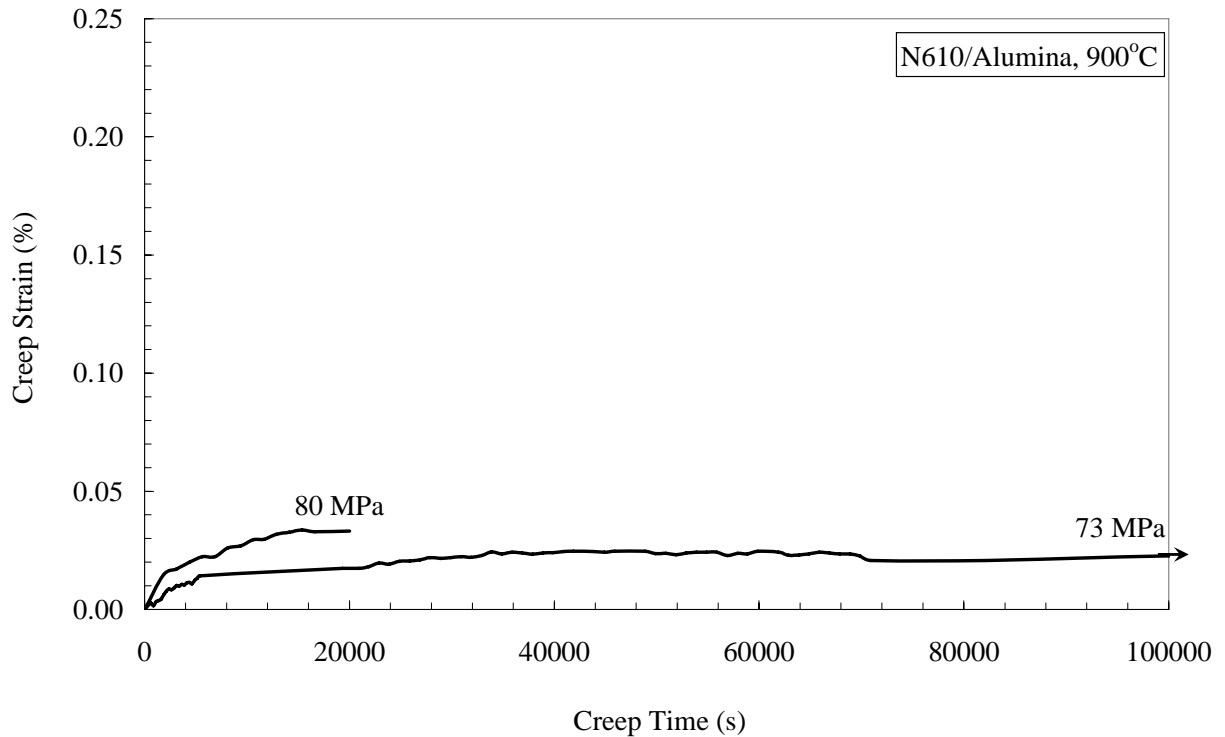
Figure 53. Creep of N610/Alumina at 900°C

Creep-rupture tests were also performed at 900°C on the N610/Alumina composite at creep stresses of 73 and 80 MPa. Those curves can be seen in Figure 53, on the same scale as the results for the N610/Monazite/Alumina at 900°C.

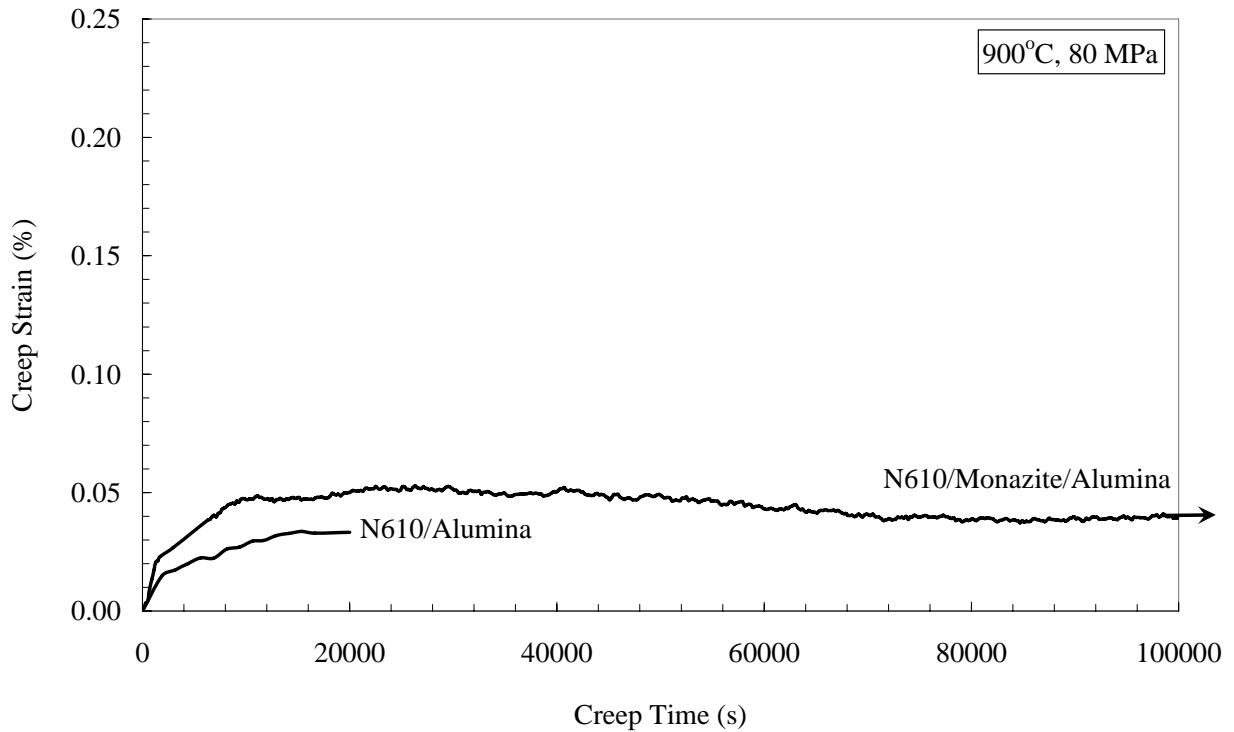
Figure 54. Creep at 900°C, 80 MPa

clearly seen in Figure 54 which shows the creep-rupture curves for both composites at 900°C and creep stresses of 80 MPa.

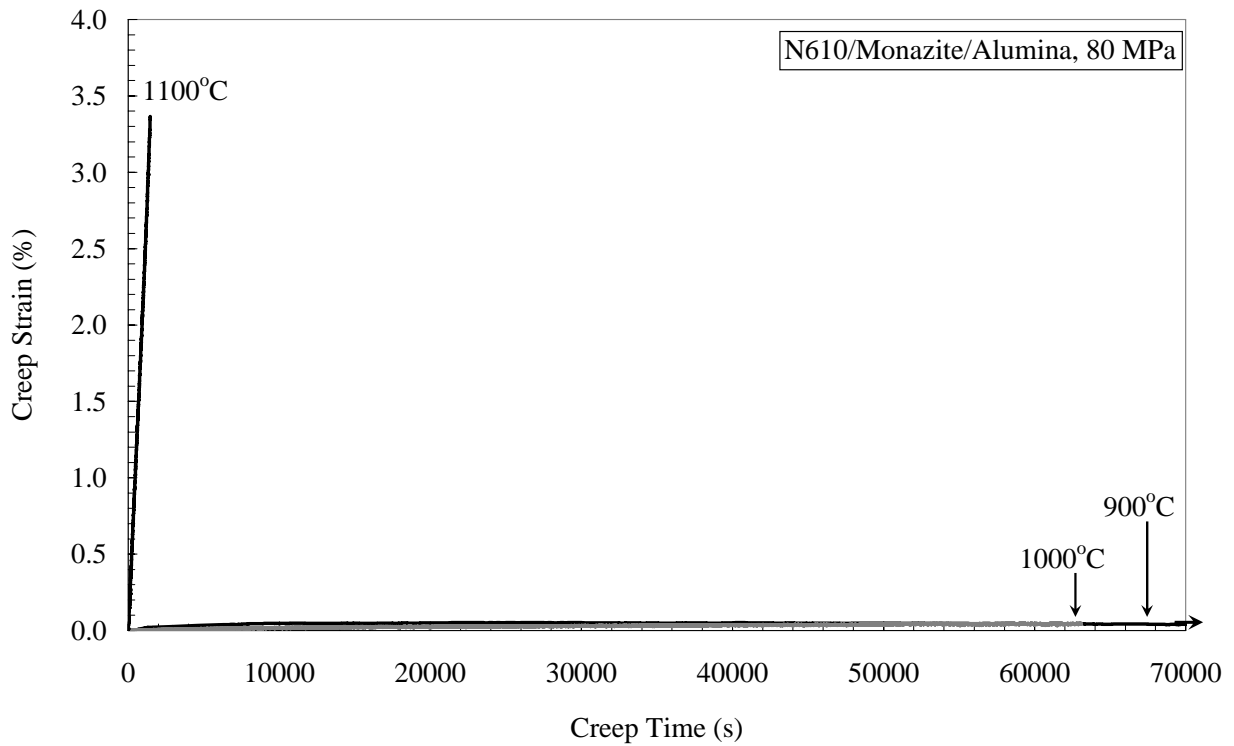
Figure 56. Creep of N610/Monazite/Alumina at 80 MPa Creep Stress

By comparing creep-rupture curves at the same creep stress levels, measured in MPa, the effect of temperature on creep life can be determined for that stress level. Figure 56 shows curves for N610/Monazite/Alumina at a stress level of 80 MPa at test temperatures of 900, 1000, and 1100°C. Creep-rupture curves for specimens C3, C6, and C7 are displayed.

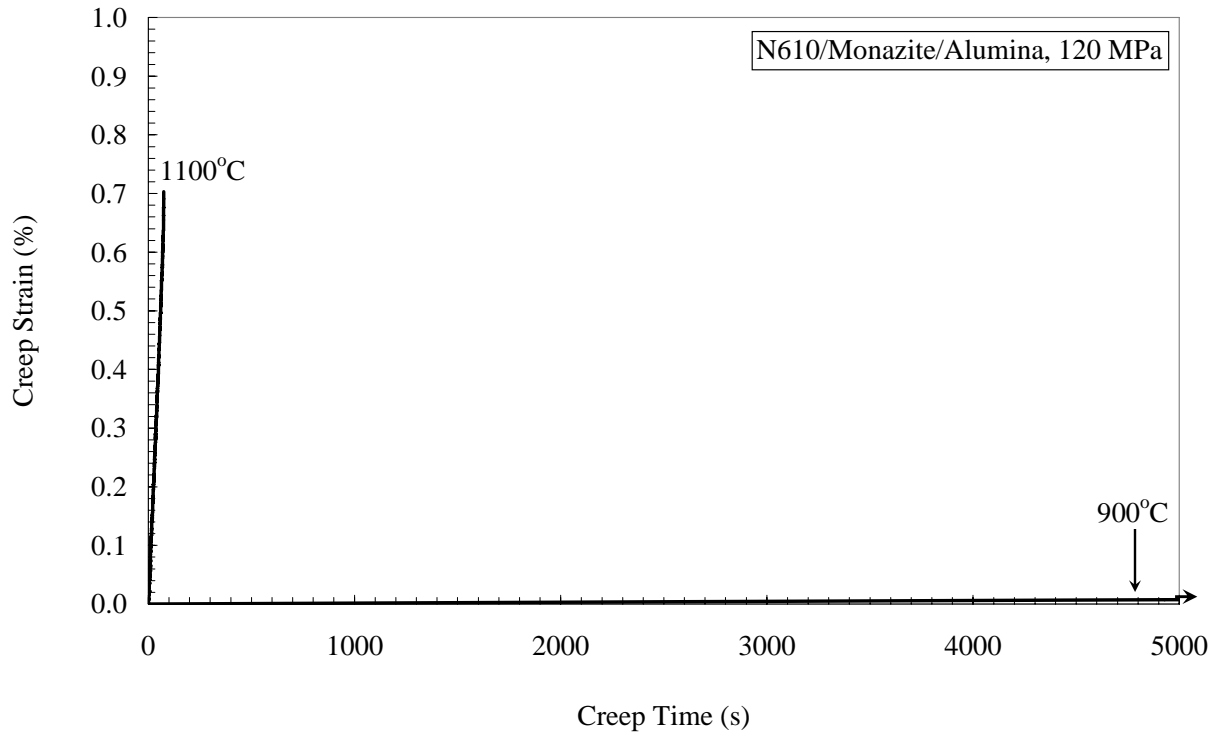
Figure 57. Creep of N610/Monazite/Alumina at 120 MPa Creep Stress

Creep-rupture curves for N610/Monazite/Alumina at temperatures of 1100 and 900°C for a creep stress of 120 MPa are shown in Figure 57. Creep-rupture curves for specimens C5 and C8 are displayed.

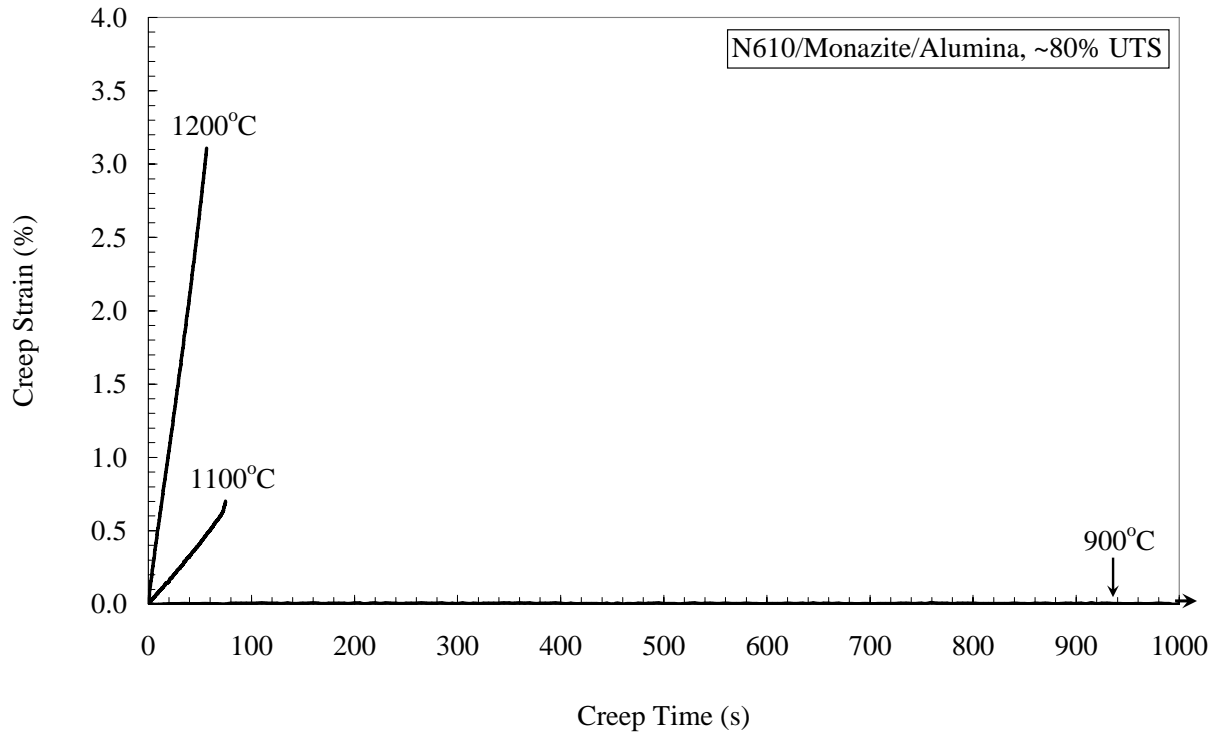
Figure 59. Creep of N610/Monazite/Alumina at ~80% UTS Creep Stress

Figure 59 shows the effect of temperature at a stress level of ~80% UTS. Creep-rupture curves for specimens C1, C5, and C10 are displayed.

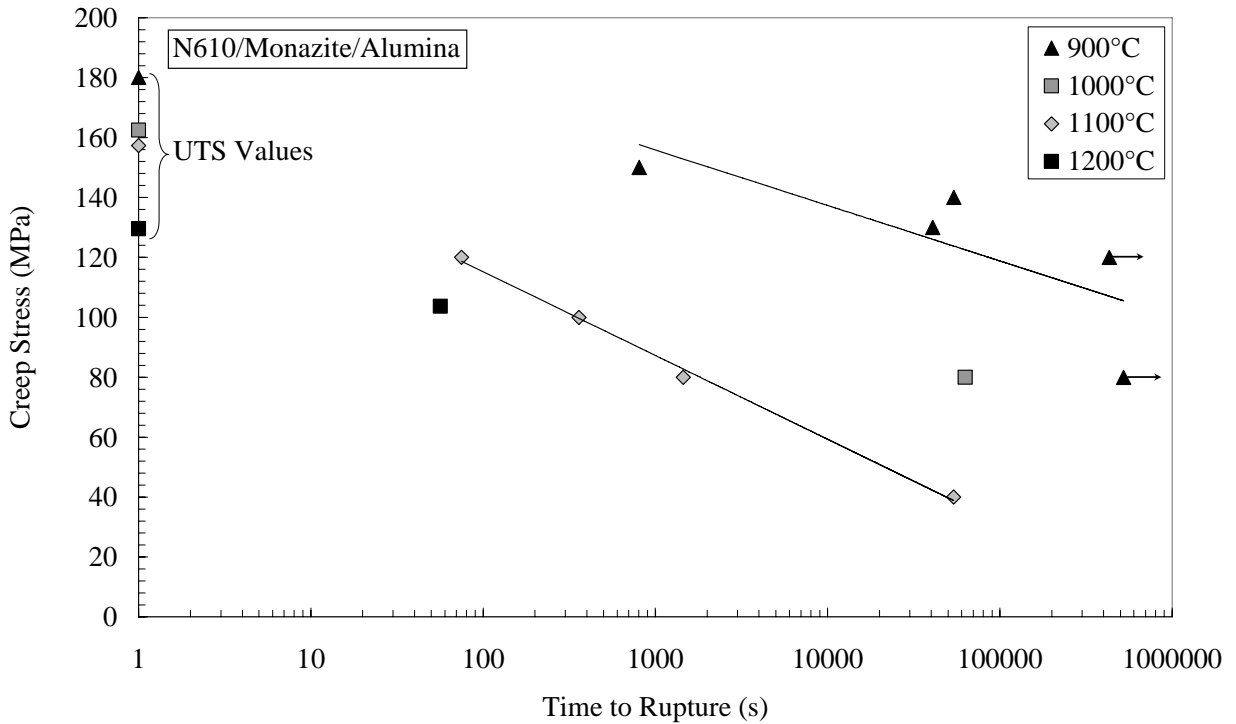
Figure 60. Creep Stress (MPa) vs. Time to Rupture for N610/Monazite/Alumina

Creep stress, in MPa, is plotted versus time to rupture for N610/Monazite/Alumina at test temperatures of 900°C, 1000°C, 1100°C, and 1200°C in Figure 60.
