# **Surf and Coastal Area Measurement Platform (SCAMP)**

## **USACE Demonstration Survey Final Report**

**November 10, 2000**

**Areté Associates**

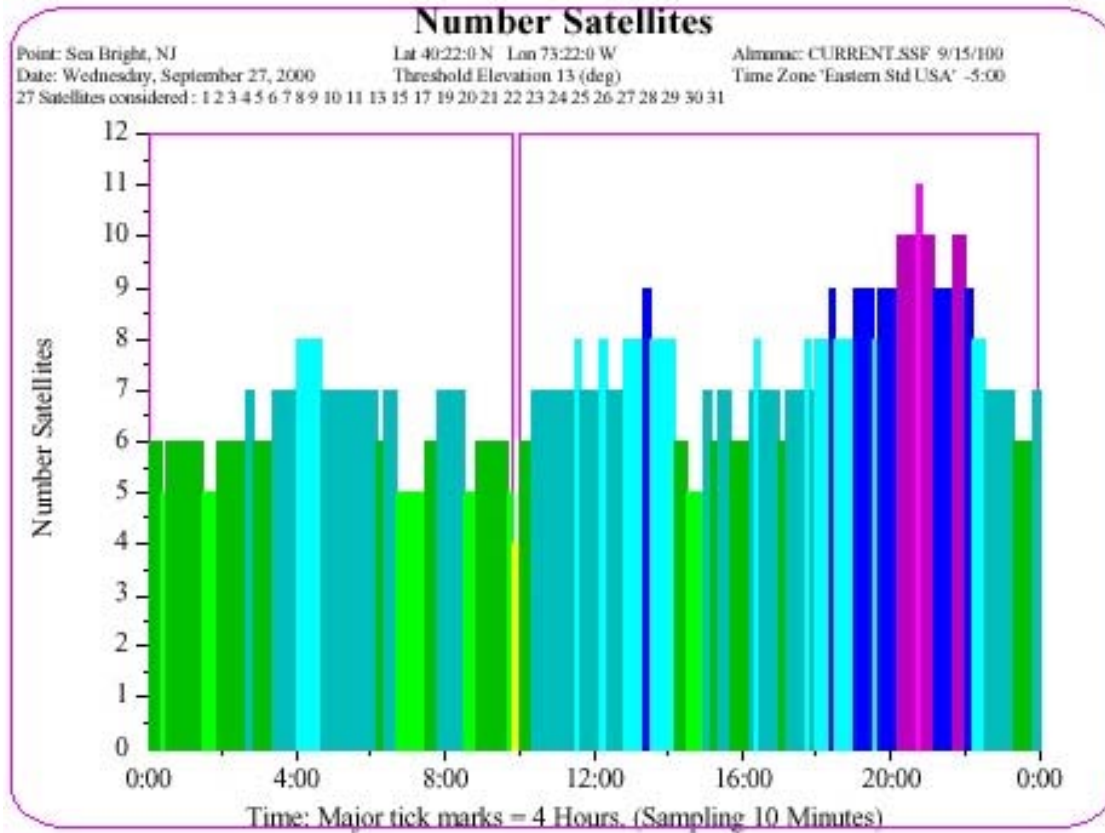
**Figure 1:** Number of GPS satellites in view on Sept 27, 2000 at Sea Bright NJ. The low number of satellites combined with several at low elevations proved to be a problem for KGPS positioning during early morning hours. Note time is EST.

- Areté participants summarized the GPS ephemeris predictions for local satellite coverage for the week. Marginal coverage could be expected for the morning operations (5 to 6 satellites) with a 20-minute down time at 11 a.m. EDT. This would be followed by improved coverage in the early afternoon (see Figure 1). Areté noted that they had successfully worked through such marginal periods in the past. In order to provide a SCAMP demonstration prior to the participants departing, it was decided the same would be attempted here. (In retrospect, this problem was underestimated. Not only was the GPS satellite coverage sparse, but several were at sufficiently low elevation angles to produce difficult operating conditions for RTK GPS positioning of the SCAMP, especially during the September 28 surf operations).

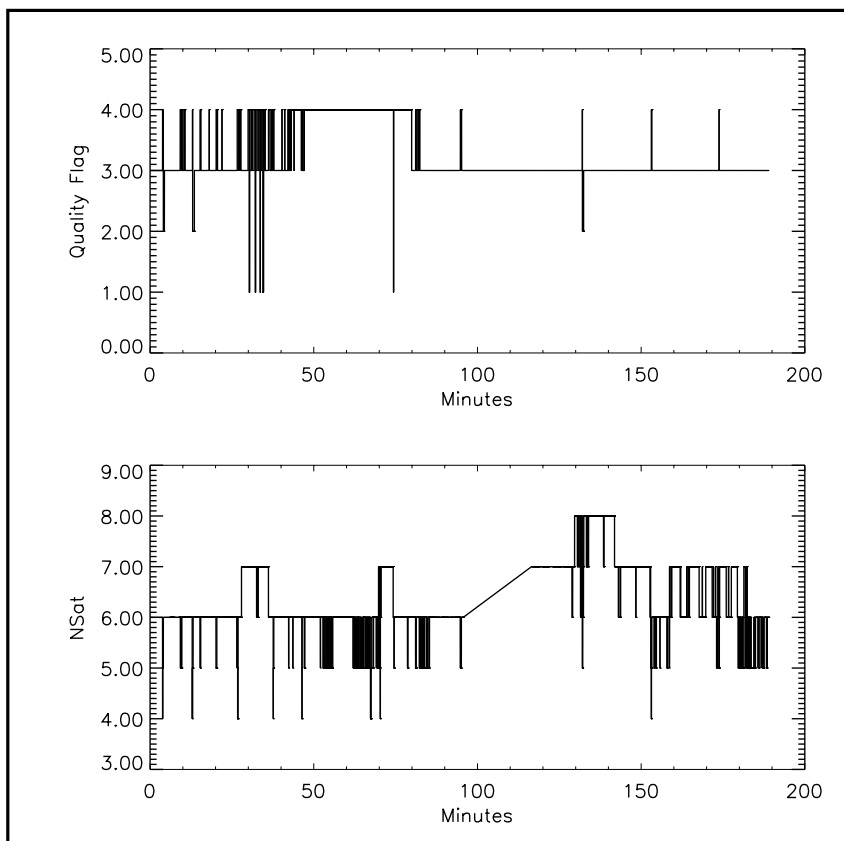
**Figure 2:** Time series of GPS quality flag and number of satellites used in determining each GPS position for September 27 deployment. Quality flag: 3=kinematic, 4=invalid or unavailable fix, 2=differential, 1=GPS stand-alone

After further analysis, it is believed that the poor RTK GPS positioning obtained on September 27 was due primarily to interference from local radio traffic rather than a result of insufficient satellite coverage as was the consensus while in the field. A summary of the recorded GPS status channels from September 27 is shown in Figure 2. The figure is a two-

panel time series, with the top panel showing the GPS ‘quality indicator’ (a 1, 2, 3, or 4 status) and the bottom panel listing the number of satellites being used to compute the GPS positions. It can be seen that for the first 90 minutes the quality indicator was predominately locked on 4 (Unknown). At the same time, the number of satellites being used to determine the GPS position seldom dropped below five, the minimum number needed to initialize RTK GPS, and never fell below four, the minimum number needed to maintain RTK GPS, once acquired. A nearly identical satellite configuration on September 29 produced excellent kinematic performance in an area 10 miles southeast of this site. As shown in Figure 2, after 90 minutes of poor performance the system abruptly attained RTK GPS positioning and performed nearly flawlessly for the rest of the deployment.

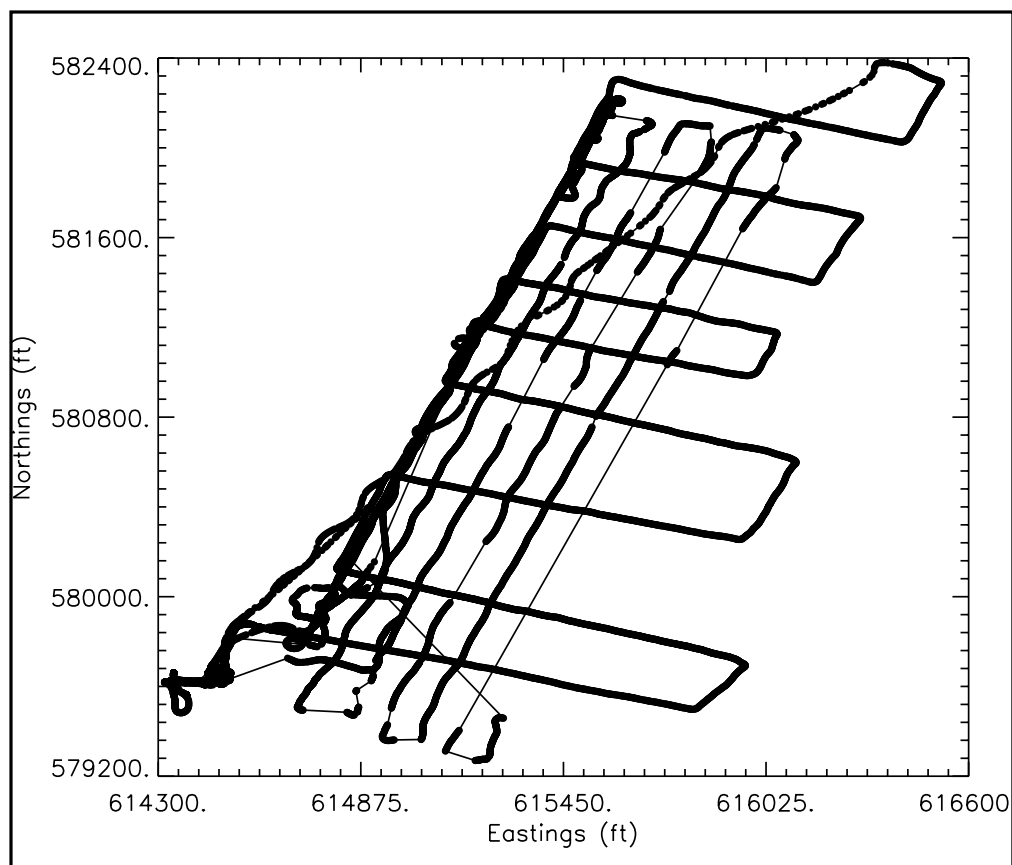
**Figure 3:** KGPS survey track obtained on September 27. The broken, incomplete track lines are a result of radio interference and (possibly) poor GPS satellite coverage.

The first two of these objectives were met. The line switching option worked flawlessly and the left/right indicator produced excellent results and elicited praise from the jet-ski operator. A quantitative assessment of the improved driving performance using the left/right indicator is shown in a following section. The third objective, however, was not successful. The modifications to the SCAMP drivers for the Trimble GPS and the Datasonics sounder led to significant data drop-outs, timing uncertainties and real-time operational problems. Unlike previous versions obtained from Coastal Oceanographics, this HYPACK®MAX driver did not display the Trimble GPS status flag at the monitor-station operator’s screen. This oversight has since been corrected, but for September 27 and 28, a determination as to how well the system acquired kinematic fixes was not available in the field. Only after post-processing the data was this problem quantified. One of the initial data-quality checks included in the evaluation is a track plot of the good (kinematic) positions obtained during the survey. The survey track for September 27 is shown in Figure 3. The broken line character of the survey track is a result of the system continually losing and then reacquiring kinematic-lock.

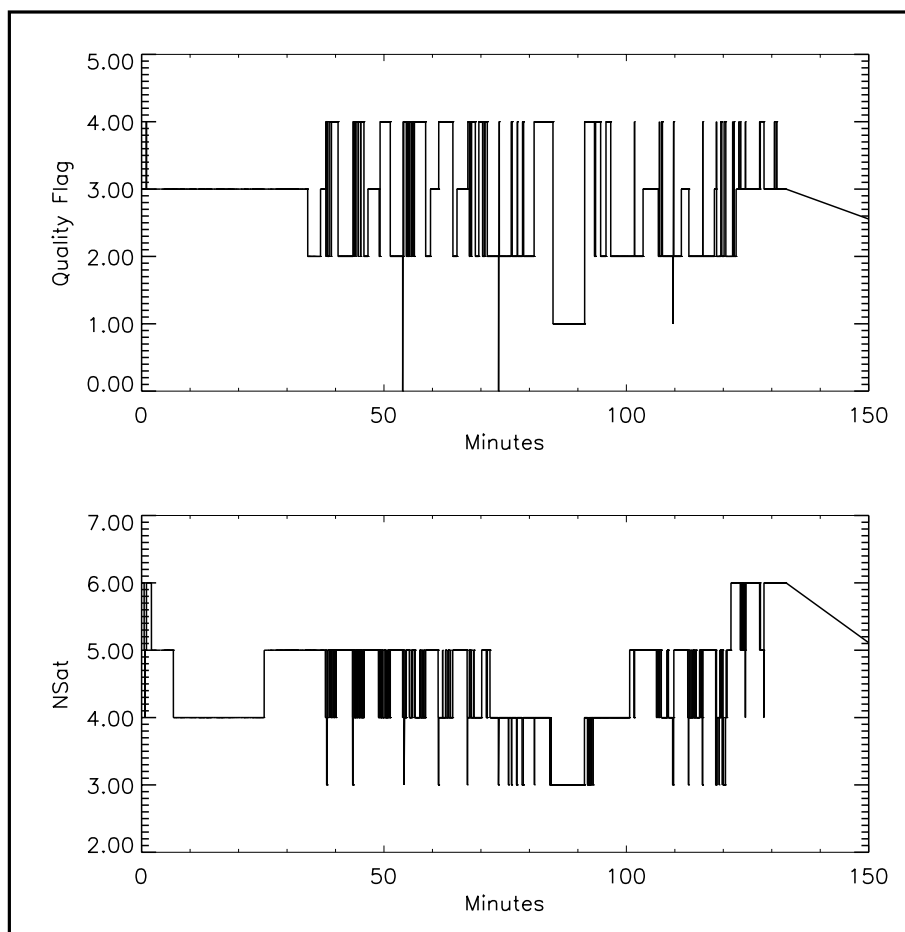
**Figure 4:** Time series of GPS quality flag and number of satellites used in determining each GPS position for September 28 survey. Due to the low number of available satellites the GPS system was generally in differential mode (quality flag 2).

During the pre-launch checkout, the SCAMP system appeared far more stable and more like previous experiences than had been experienced the previous day. However, the inability to monitor whether the system was acquiring RTK GPS positions while surveying again proved costly. The survey was conducted between 7:45 am and 10:00 am local time (1245 and 1500 UTC). The seas were calm ( $H_{mo} \sim 0.5m$ ) with light winds, and the SCAMP launch and recovery were uneventful. The actual time in the water to complete the survey was 90 minutes. It was learned later that day that very little of the September 28 survey data were obtained while acquiring RTK GPS positions. This was a result of the number of satellites that the GPS antenna was able to lock onto being too few for kinematic positioning. Although the GPS almanac listed a sufficient number of satellites in the sky field-of-view, the GPS receiver was not using them. Three of the six available satellites were 20 degrees or less elevation and this caused the jet-ski operator, located forward of the GPS antenna on the water craft, to block out the view of low-elevation satellites during maneuvers on the water. The number of satellites actually used was generally less than five, the minimum required for initializing kinematic navigation. A smaller number of satellites is required to provide differential GPS positioning. As a result, much of the survey was obtained while in differential mode (see Figures 4 and 5). The survey did (at least) provide an excellent demonstration of the effectiveness of the left/right indicator and line switching option.

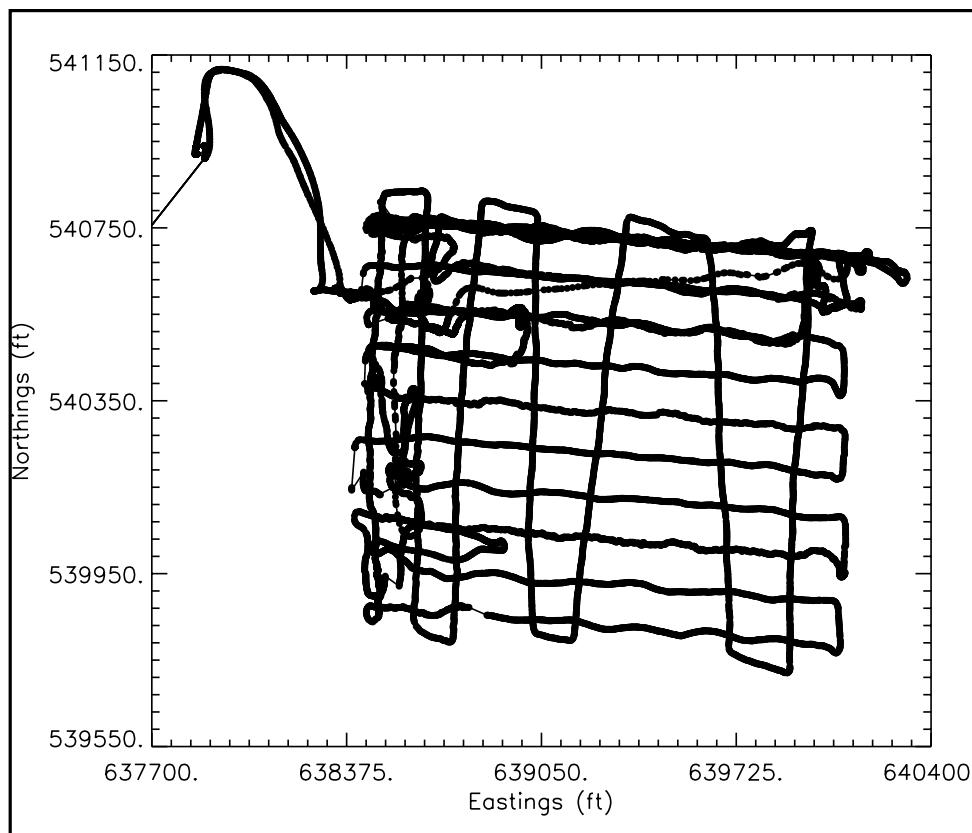
**Figure 5:** A plot of the full track (kinematic and differential) obtained on September 28. Although the GPS data were not sufficient for bathymetry processing, they did allow a performance analysis of the left/right indicator as an aid to navigating the programmed survey lines, one of the test objectives.

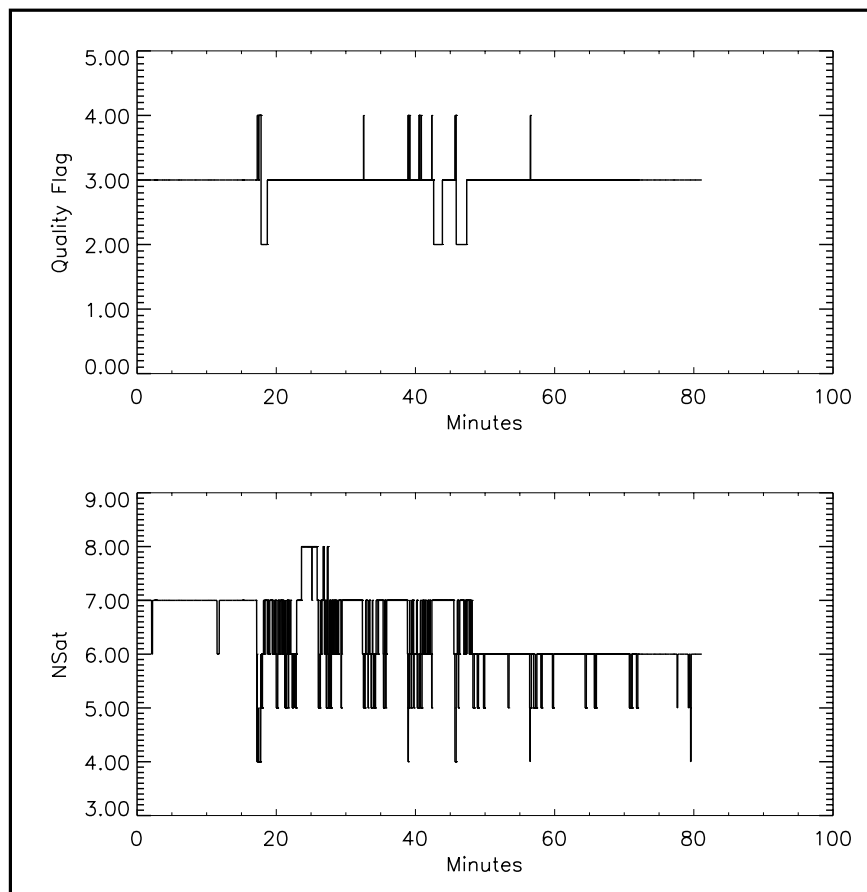
**Figure 6:** Time series of GPS quality flag and number of satellites used in determining each GPS position for September 29. The nearly constant lock onto quality flag of 3 reflects nearly constant kinematic positioning during the survey.

With these modifications accomplished, the survey was repeated on the morning of September 29. The wind had increased during the night, building the near-shore waves to a marginally operational 1.2 m  $H_{mo}$ . System set-up was begun at 7:30 a.m. EDT. The use of an older version of HYPACK® allowed the kinematic flag to be visually checked by the monitor-station operator during the survey. Whenever there was a loss of kinematic navigation noted, the jet-ski operator was instructed to repeat that section of the survey. By 10 a.m. local, the SCAMP field team had completed the survey, loaded the system for transit and was heading back to the Areté Arlington, VA office with what appeared to be a successful kinematic survey in hand. The data quality of the survey is summarized in Figures 6 and 7.

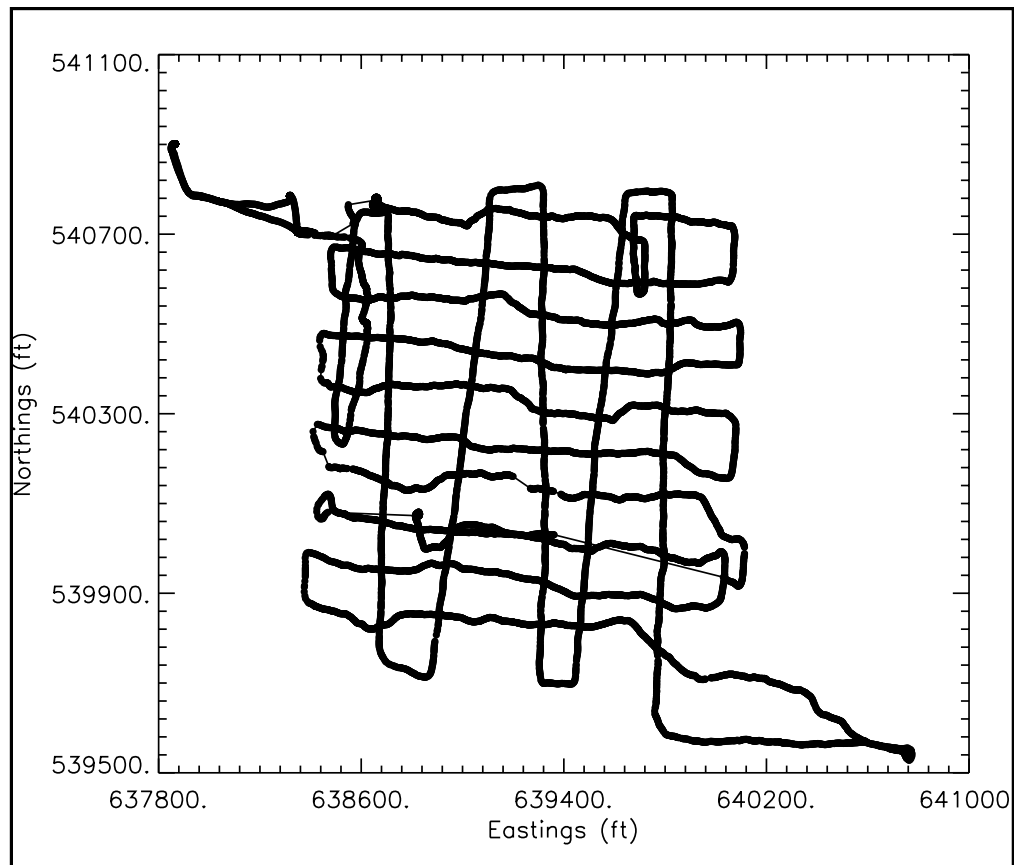
**Figure 7:** KGPS survey track obtained on September 29.

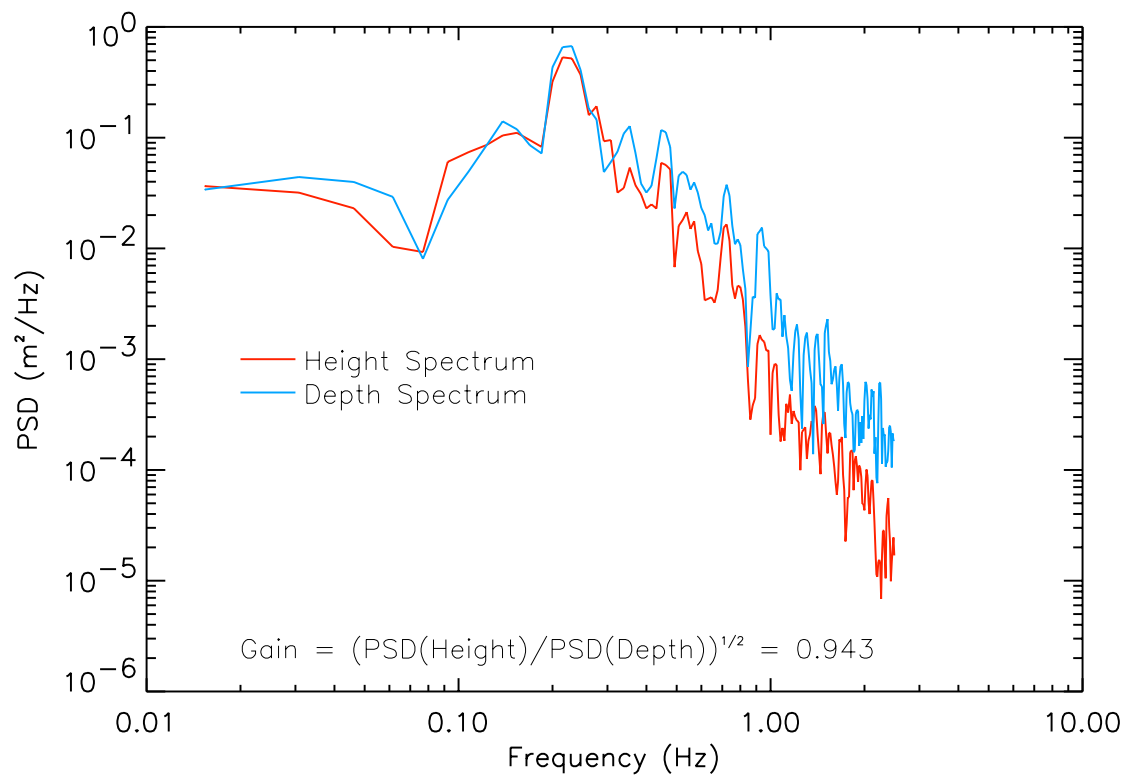
**Figure 8:** PSDs from GPS antenna height and sounder time series. Relative energy in wave motion band is used to normalize sounder output to local sound speed.

An estimate of the gain adjustment to resolve the first problem listed above is straightforward. The sound speed error can be determined by normalizing spectral amplitudes between the sounder and GPS antenna height in the wave motion band. The cause for the sounder gain adjustment is a little more problematic. It may be a result of internal clock drift, or (as suspected here) an unspecified reference speed used internally in the computation of the

estimated depth. Regardless of the cause, the RTK GPS antenna heights are sufficiently accurate to serve as an *in-situ* calibration of the sounder. The process is summarized in Figure 8. Power Spectral Density (PSD) curves are computed for concurrent RTK GPS antenna height and sounder depth time series, and the spectral levels are compared in the wave-induced boat motion band (in this instance 0.2-0.3 Hz). The square root of the ratio of the integrated variances over this band is the gain (relative sound speed) adjustment. This analysis in spectral space eliminates contributions from unwanted sources. The lower frequency measurements, such as from bottom topography changes, and the higher frequency variations, such as induced by boat roll or sensor digitization, are de-coupled in frequency space. Roll can be included in the de-coupling because each sensor responds to roll at two times the roll frequency and this moves that energy outside of the wave-motion band. Spectral energy peaks associated with roll can be seen in Figure 8 between 0.3 and 0.5 Hz. Normally, this process only would be used to validate the temperature/salinity-derived sound speed. In this instance the analysis is required to verify an apparent documentation error. The Datasonics sounder used in the SCAMP system has recently had a factory replacement e-prom installed. Prior to that install, the sounder-estimated depths were consistent with an assumed sound speed of 1500 m/s. This analysis, and the USACE sled data, indicates an assumed sound speed of 1450 m/s. Datasonics representatives do not yet confirm this, but it should be noted that a similar study two years ago uncovered another documentation error, when it was determined that the sounder reporting rate was 9.1 Hz and not the advertised 10 Hz.

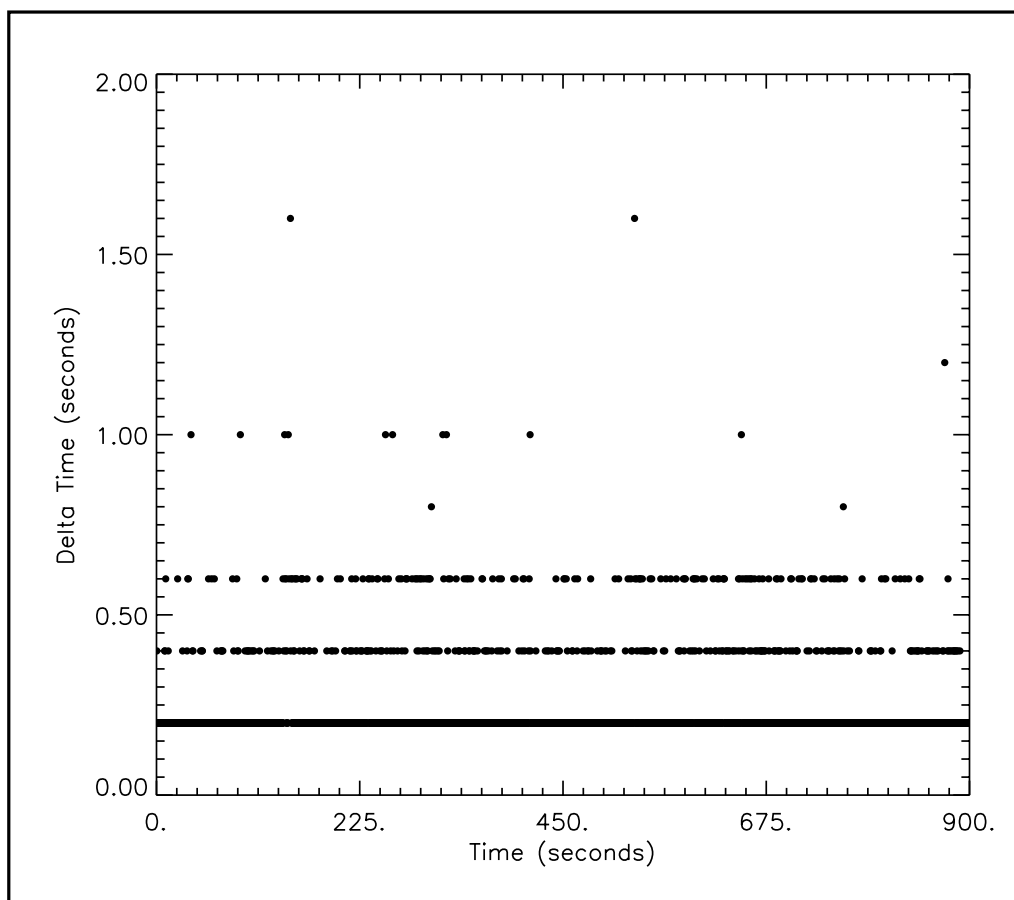
**Figure 9:** HYPACK delta-t between sequential data points. Reporting rate is 0.2 s. delta-t of 0.4=1 missed GPS update, 0.6=2 missed GPS updates.

The second problem noted above is mitigated in this test by acquiring GPS data at a 5 Hz rate. Had the same number of points (about 20%) been dropped for a data rate of 1 Hz, this problem would have been catastrophic, with two- and three-second time gaps routine. A summary of the HYPACK®MAX acquisition performance is shown in Figure 9. The missed positions are evidently a feature of the new SCAMP sensor HYPACK®MAX drivers created for this test. Though additional analysis is required for verification, there is an apparent correlation between the HYPACK®MAX handling of a sounder error flag and the subsequent skipping of GPS updates. The sounder error flag indicates either a no return from a ping (bubbles in the surf) or depth range exceeded (greater than 30 m). None of the HYPACK® drivers previously used has had difficulty dealing with this error condition.

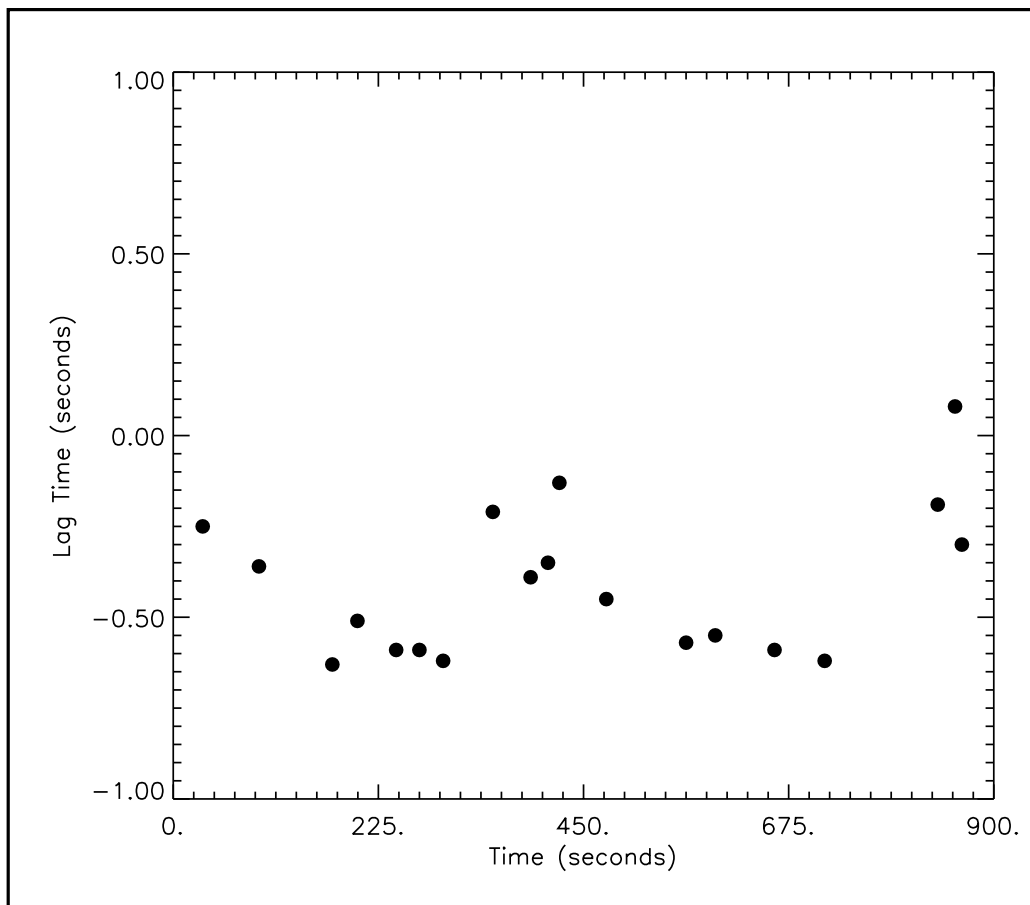
**Figure 10:** A plot showing the variability in computed lag between GPS height and sounder.

Figure 10 is a plot showing the temporal variability in computed lag between the GPS antenna height and sounder depth. The computed lags in the figure were obtained from two consecutive 15-minute data files on September 27. The computed lags are seen to vary by more than 0.5 seconds, a huge uncertainty when attempting to synchronize the two dynamic measurements. The cause of the HYPACK®MAX timing problem is not yet known, but the impact is easily illustrated. Figures 11 and 12 are similar SCAMP system sounder time series. Each figure depicts a demeaned sounder time series in red and the processed depth, after a synchronous subtraction of the antenna height, superimposed in blue. The performance during this demonstration survey, using the new HYPACK®MAX driver, is shown in Figure 11. The residual error about the trend is about 15 cm rms in seas of 1.2 m  $H_{mo}$ , typical for the September 29 data set. Figure 12 was obtained during a 1997 informal survey demonstration at USACE facilities in Duck, NC. That demonstration was run using an older version of HYPACK® for data acquisition. The processed depth-measurement curve has a variability of 5 cm rms, approximately the combined noise level of the RTK GPS height and the sounder measurements. This is typical of past operations. In those instances when SCAMP has been deployed in heavy seas ( $>1.4$  m  $H_{mo}$ ), the rms error has been somewhat larger due to the effects of roll, but the residual noise has never exceeded 7.5 cm rms. If the increased noise of Figure 11 were assumed due to a degraded sensor performance, it would not be expected to scale with the wave-induced boat motion. But on September 27, when the waves were considerably lower in the sound, the processed depth residual noise was also considerably lower at 9 cm rms. Abnormal performance from either the RTK GPS or the sounder is not indicated. What appears to have occurred is that the use of the HYPACK®MAX delta-t has incorrectly positioned the missing sounder profiles along the time line. The net effect is to shift the sounder data series forward in time at inappropriate locations, thus misarranging the synchronous measurements between sounder depth and RTK GPS height. The timing issues related to the HYPACK®MAX software have been addressed to Coastal Oceanographics and they are investigating the problem with USACE FRF at Duck, NC and Areté assistance.

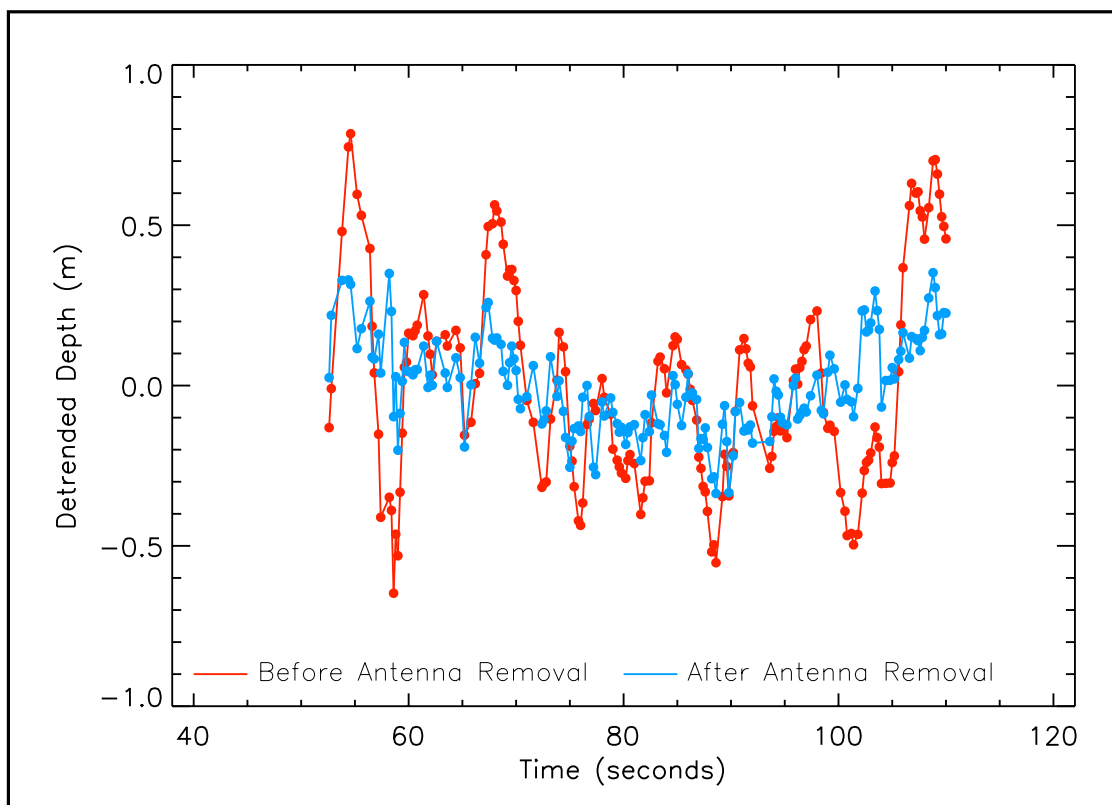
**Figure 11:** Raw sounder data from September 29 (red) and processed sounder data (blue). Unexpectedly large residual is due to HYPACK®MAX acquisition timing errors.

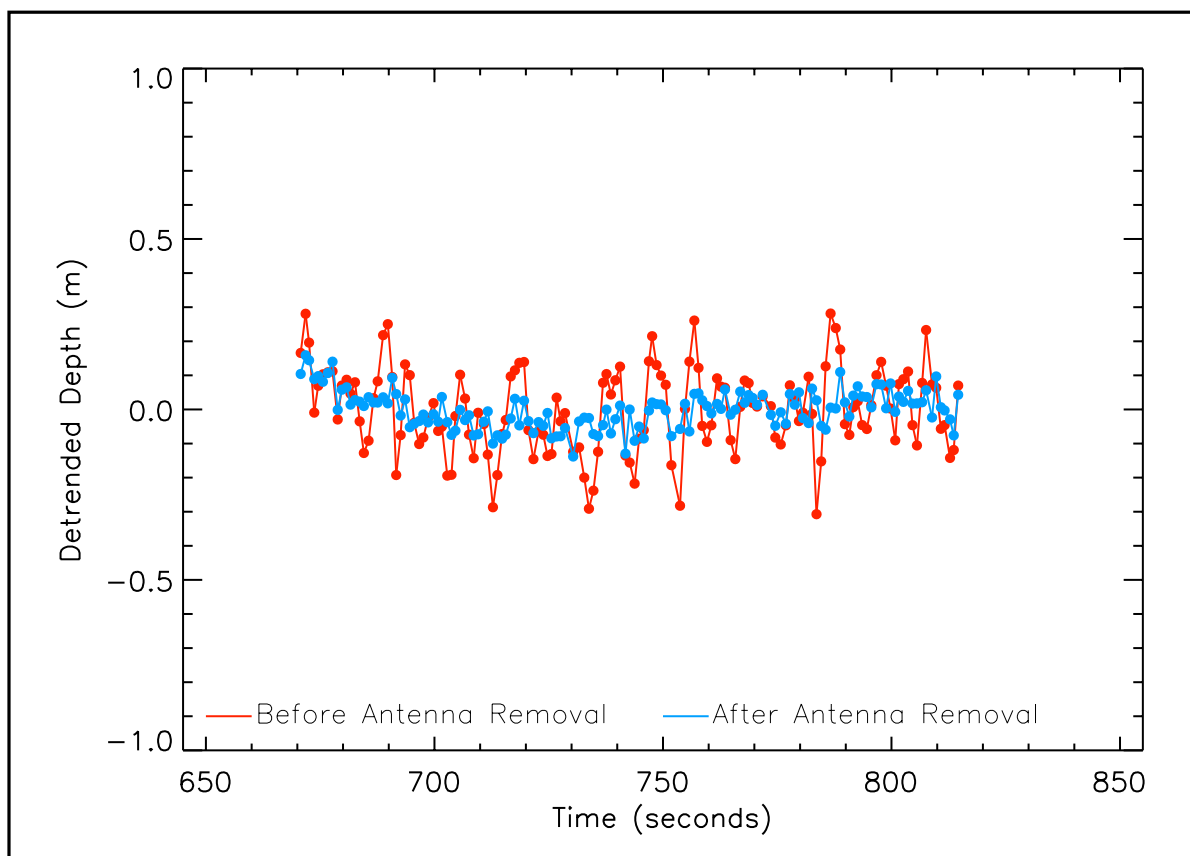
**Figure 12:** Similar to Figure 11, but obtained in 1997 using older version of HYPACK® acquisition.

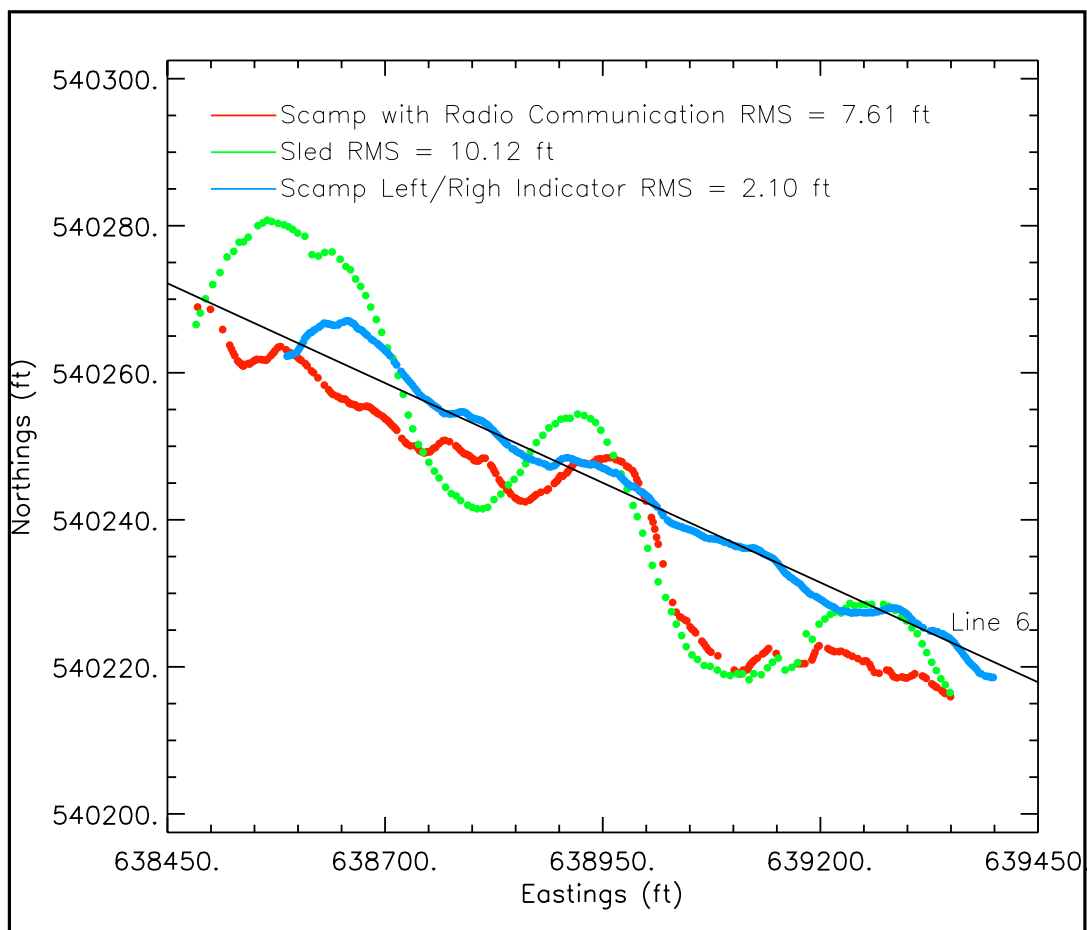
**Figure 13:** Comparison of line-following accuracy using SCAMP with left/right indicator (blue), SCAMP with voice coms (red), and USACE sled (green). Tracks are plotted in NJ State coordinates.

A substantial improvement in the jet-ski operator's ability to follow the survey line was made possible through the use of the left/right indicator. The left/right indicator was a USACE-requested modification to the SCAMP hydrographic system that was mounted on the steering column in clear view of the operator. Figures 13, and 14 quantify the performance improvement. Figure 13 is a comparison of the (typical) line-following accuracy showing the deviation from the survey line decreasing from 7.6 ft when relying on radio communications to 2.1 ft when using the left/right indicator. The path of the USACE sled (with a deviation from the track of 10.1 ft) also is shown in the figure for comparison. A cumulative probability distribution curve for the composite of all the tracks is shown in Figure 14, which is helpful in quantifying performance. For example, as shown by the two curves, 90% of the time the operator is able to remain within 2 m of the survey line while using the left/right indicator. However, the operator is only able to remain within that range 25-30% of the time when directed by the monitor-station operator by radio communications. The SCAMP operator has attested to an additional value to the use of the indicator. Not only was the navigation improved, but also an increase in the safety was afforded by this addition. According to the operator, while using the indicator as a steering command, the driving demand was simplified, enabling a more vigilant watch for rogue waves while in the surf-zone.

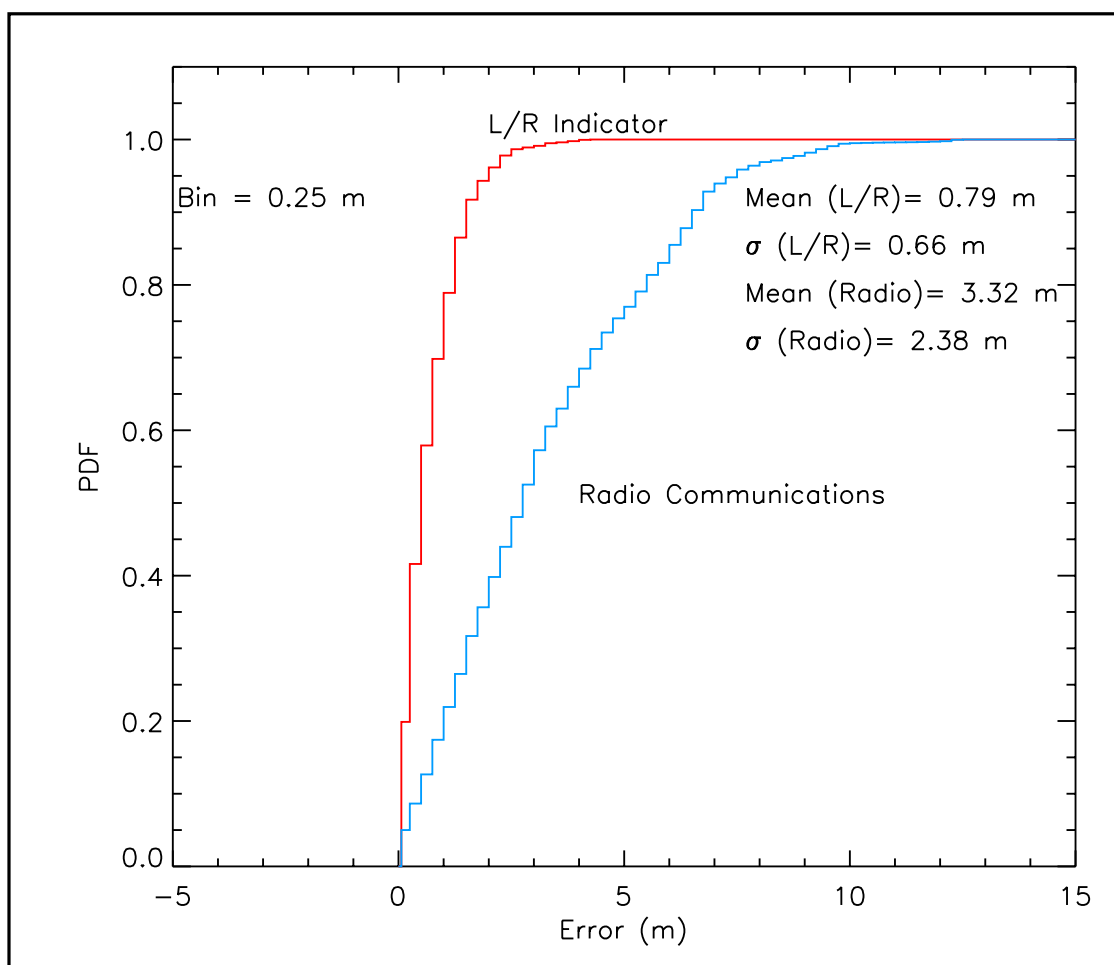
**Figure 14:** Cumulative distribution curves of distance from track line for two SCAMP driving techniques: using Left/Right indicator (red), and using voice radio communications (blue).

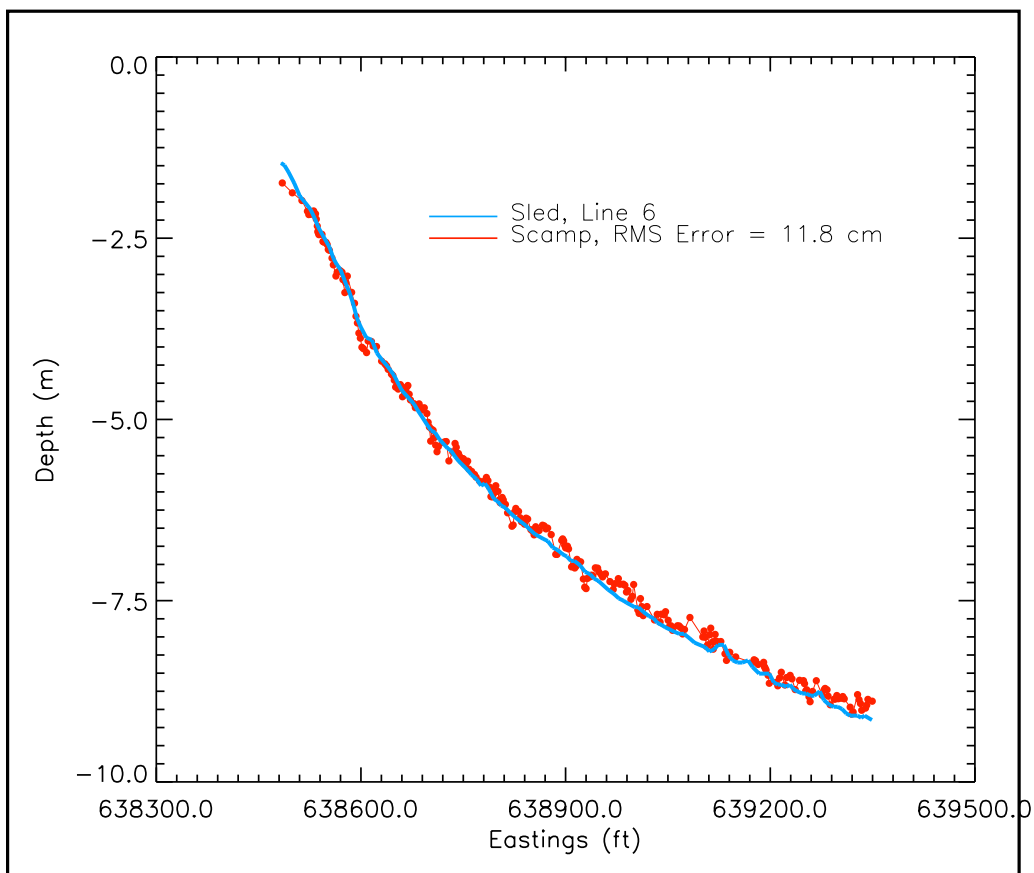
**Figure 15:** Comparison between USACE sled (blue) and SCAMP hydrographic system profiles obtained from line 6 of survey grid. Large rms error is largely due to the HYPACK®MAX timing problem.

The third demonstration objective, to obtain collocated bathymetric data and provide a comparative performance analysis between the SCAMP hydrographic system and the USACE standard towed sled, was not as successful as had been hoped. Excellent hydrographic profiles of the target survey lines have been obtained from the USACE New York District and compared to those obtained during the SCAMP demonstration survey. Two of the profile comparisons are shown in Figures 15 and 16. The relatively smooth blue line in each figure is a sled profile. Note in each figure that the SCAMP profiles generally follow the mean depth of the sled profiles but separate slightly at the deep end. This indicates a slight error in the sound speed adjustment of the SCAMP sounder. This is most probably caused by an underestimate of the RTK GPS height variance in the wave-motion band, a result of HYPACK®MAX's large number of missed GPS points. The more significant problem is that each of the SCAMP profiles is plagued with the large residual variance from the boat motion due to the HYPACK®MAX timing error discussed above. This produces the 10 to 22 cm sounder noise and that same value of rms error between the SCAMP and sled profiles. An example of an earlier (1997) informal comparison between the SCAMP hydrographic survey system and the USACE CRAB in Duck, NC is shown in Figure 17. The 1997 comparison was conducted using an older version of HYPACK® that did not exhibit the timing problem. At that time the comparison produced an rms error of 5 cm. It is most probable that the use of that older version of HYPACK® would have produced similarly acceptable results here.

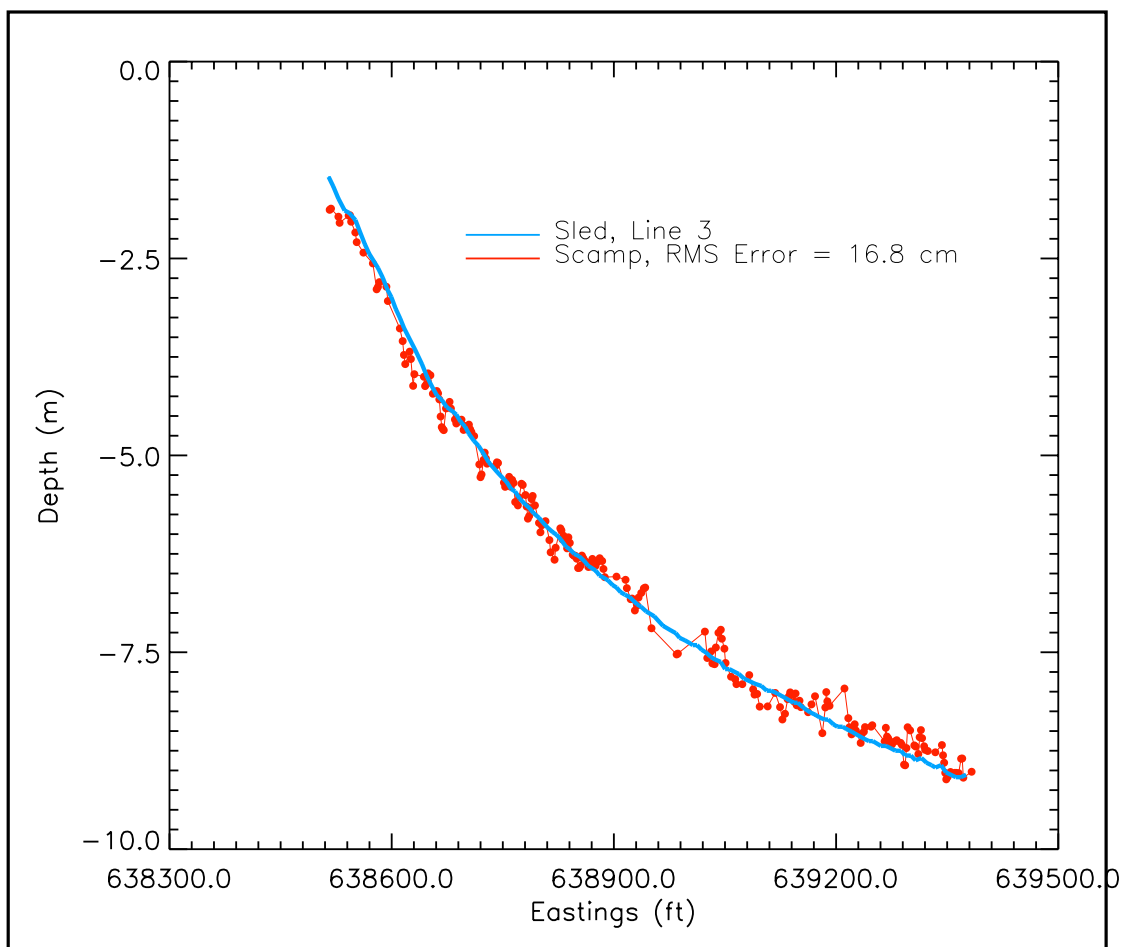
**Figure 16:** Similar to Figure 15. Residual noise from the HYPACK® timing problem varies with the number of incorrectly positioned time gaps. Here the rms error is near the largest observed, 16.8 cm.

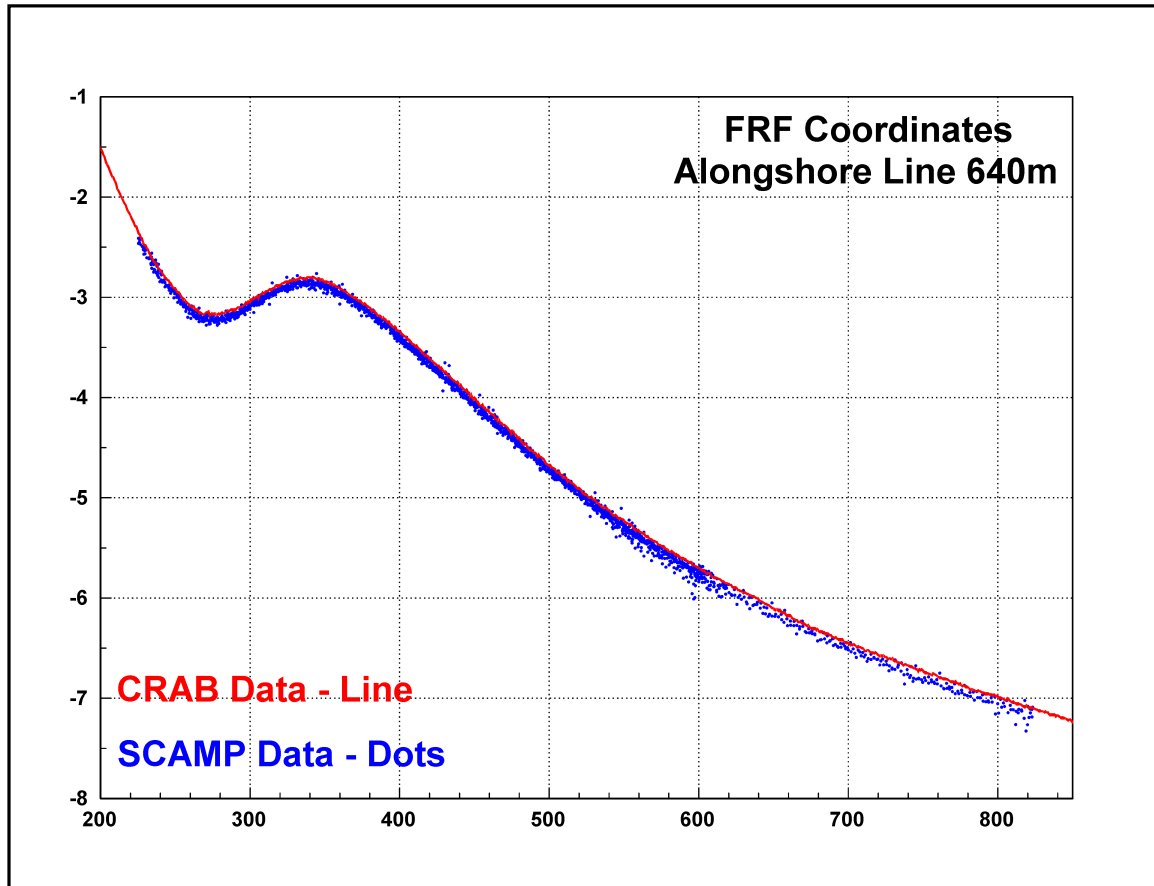
**Figure 17:** Profiles from an informal survey comparison between SCAMP (blue) and USACE CRAB in 1997. The comparison showed 5 cm rms error. SCAMP system included older version of HYPACK® acquisition software that did not exhibit the timing problems noted in this demonstration.
