**EFFECT OF TEMPERATURE AND STEAM ENVIRONMENT ON FATIGUE  
BEHAVIOR OF AN OXIDE-OXIDE CONTINUOUS FIBER CERAMIC  
COMPOSITE**

Chalene A. Eber, First Lieutenant, USAF

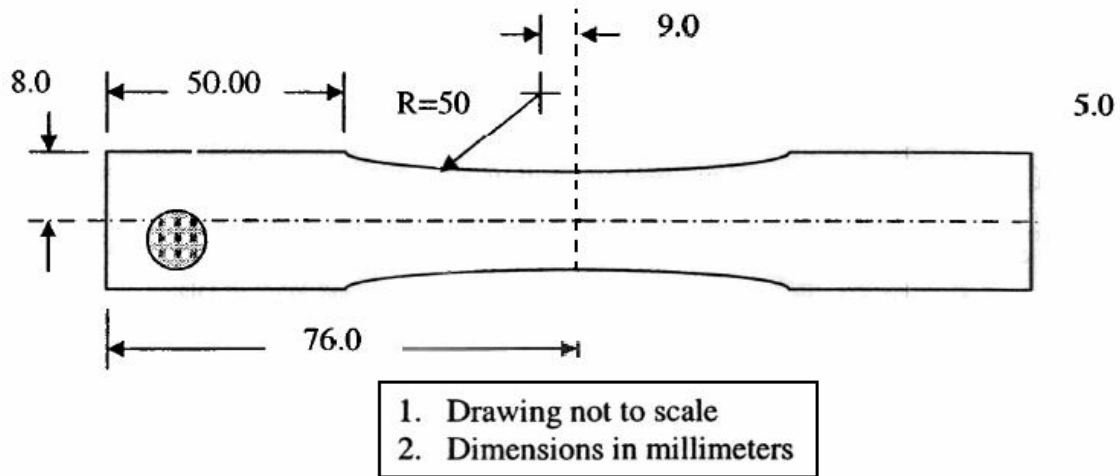
Figure 4. Tension-tension fatigue specimen, with cut-out showing fiber orientation.

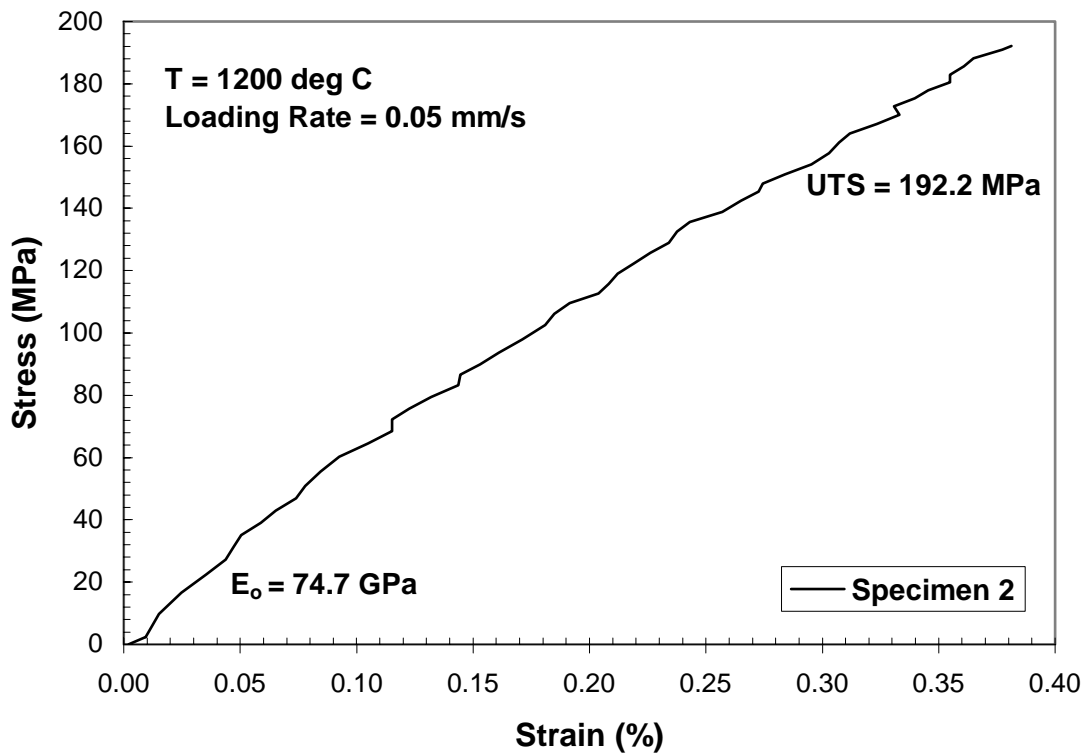
Figure 9. Tensile stress versus strain behavior for N720/A at 1200°C.

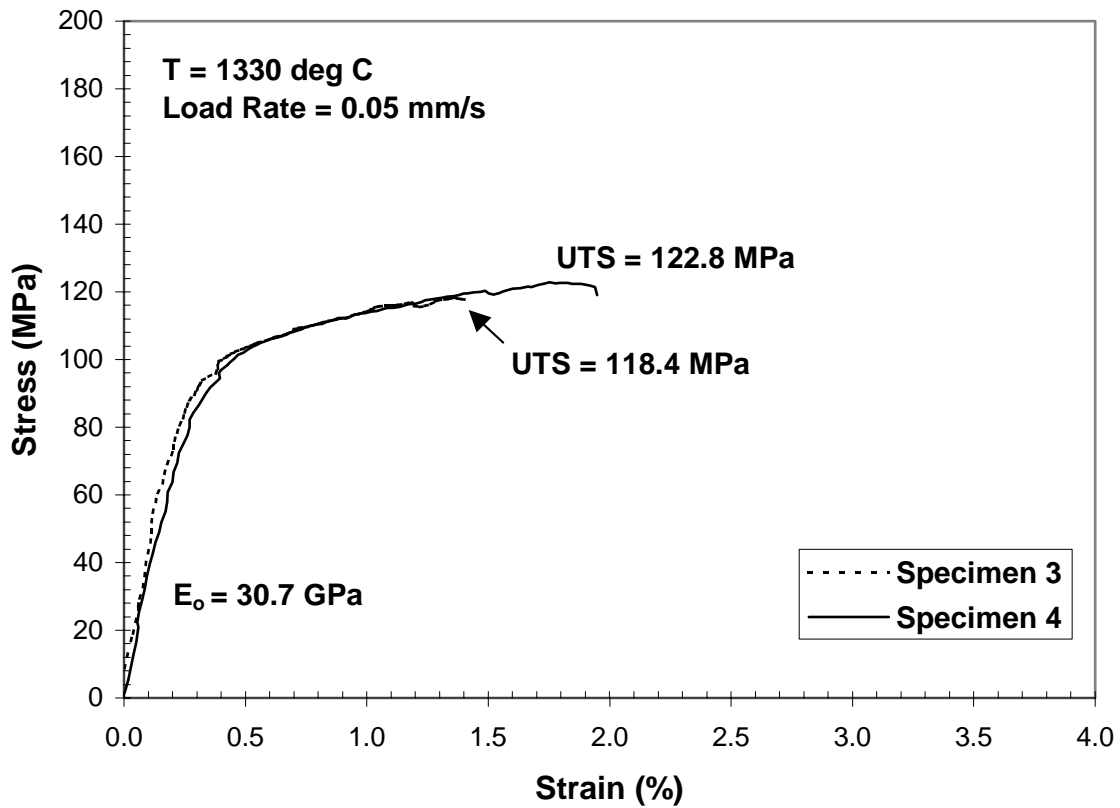
Figure 10. Tensile stress versus strain behavior for N720/A at 1330°C.

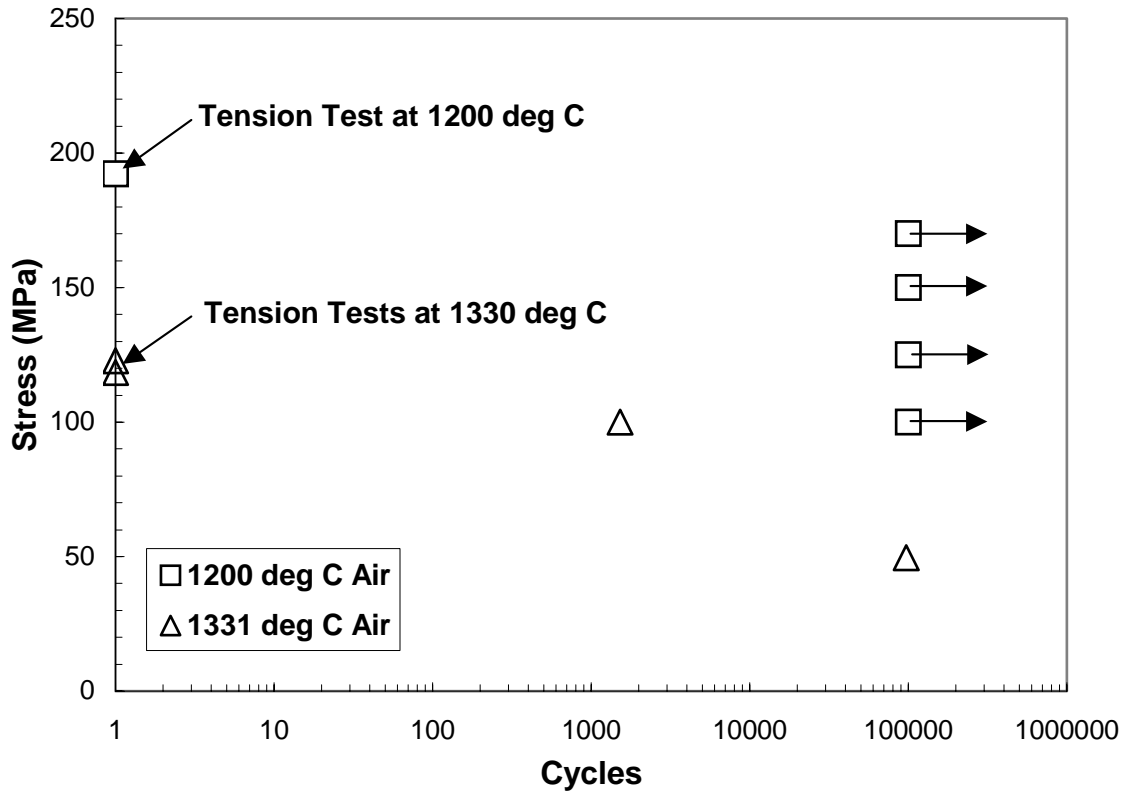
Figure 11. Fatigue plot for Nextel 720/A showing maximum stress versus cycles to failure for fatigue tests in air at 1200 and 1330°C.

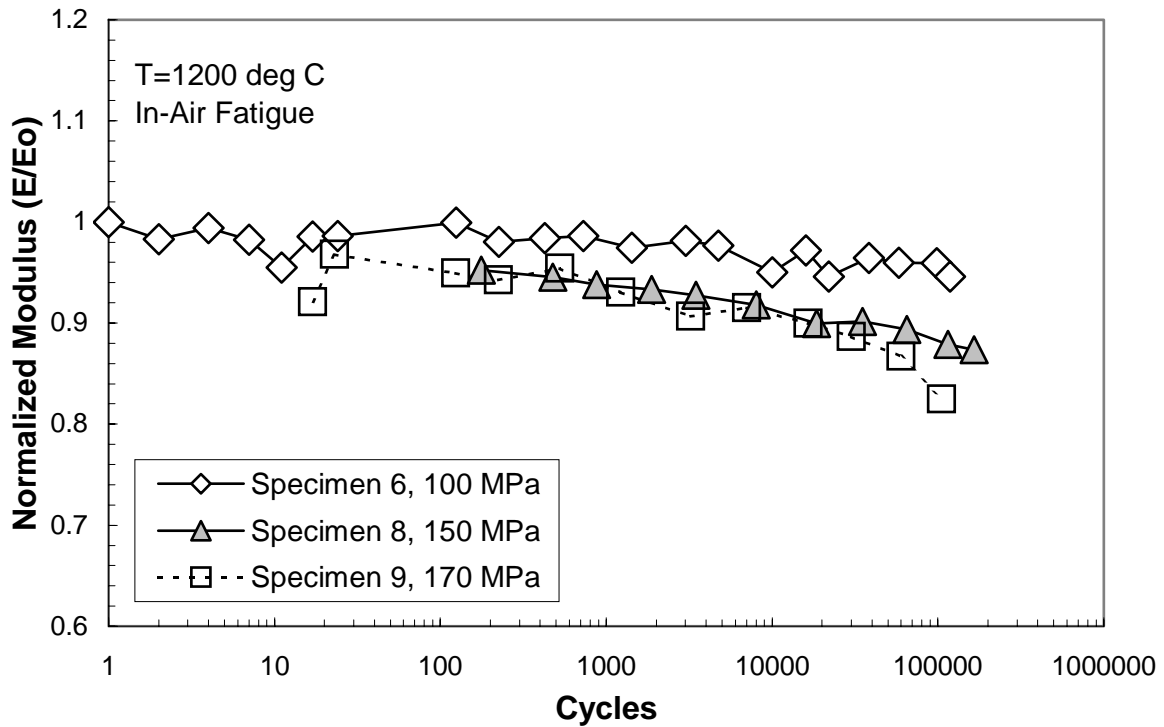
Figure 12. Normalized modulus versus fatigue cycles for specimens tested at 1200°C in air.

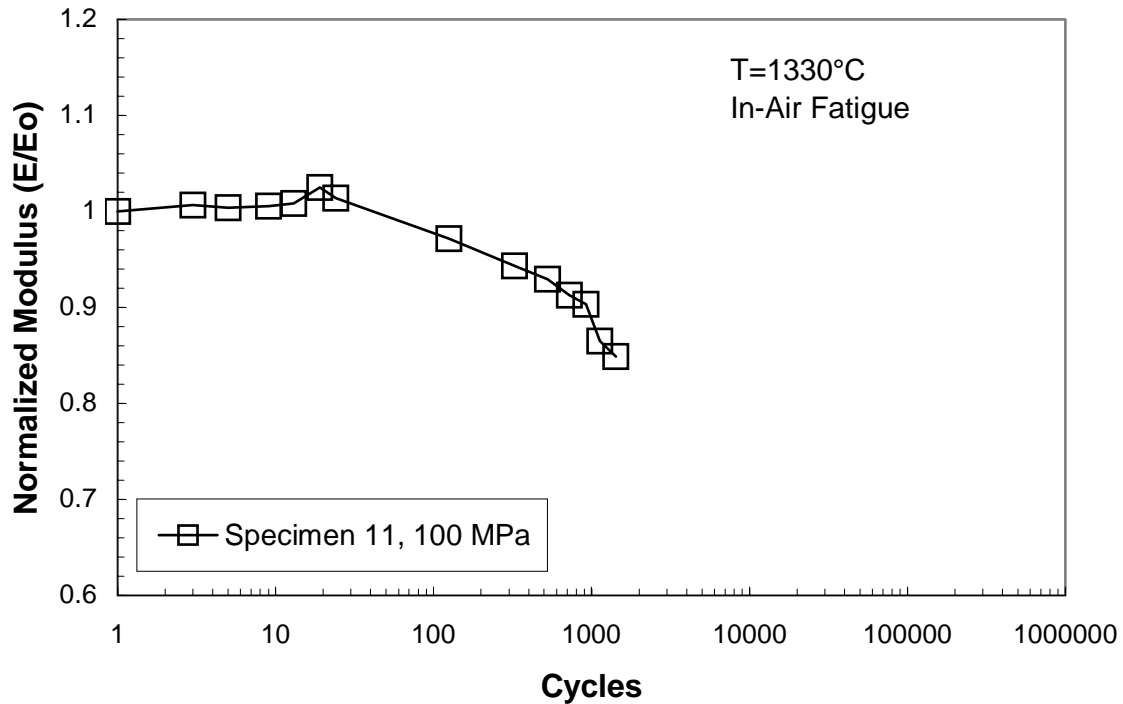
Figure 13. Normalized modulus versus fatigue cycles for specimen tested at 1330°C in air. Specimen failed at 1519 cycles.

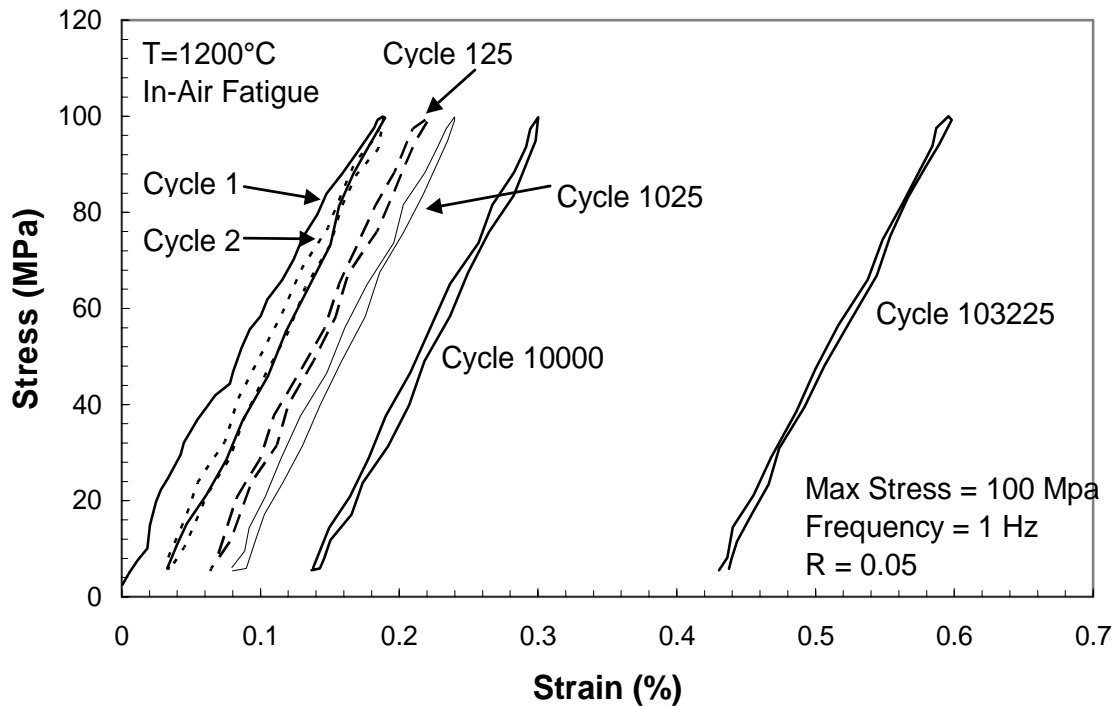
Figure 14. Evolution of hysteresis stress-strain loops with fatigue cycles for Specimen 6, tested in tension-tension fatigue at 100 MPa in air at 1200°C.

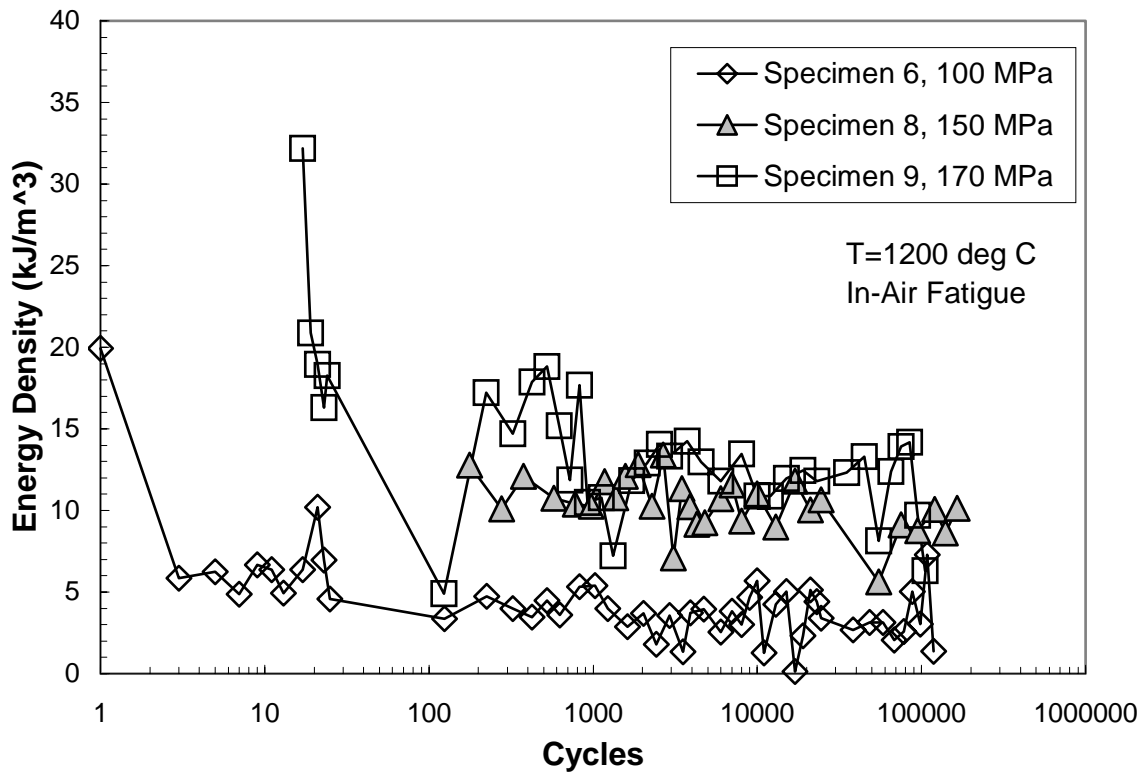
Figure 15. Hysteretic energy density versus fatigue cycles for specimens tested at 1200°C in air.

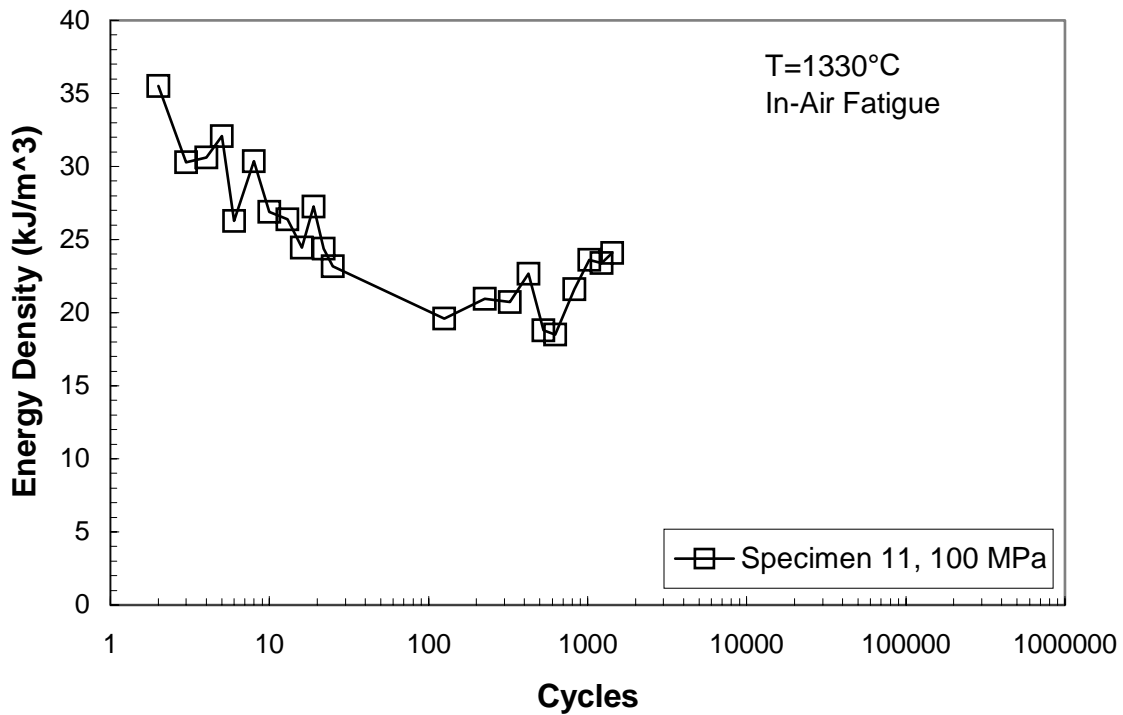
Figure 16. Hysteretic energy density versus fatigue cycles for specimen tested at 1330°C in air.

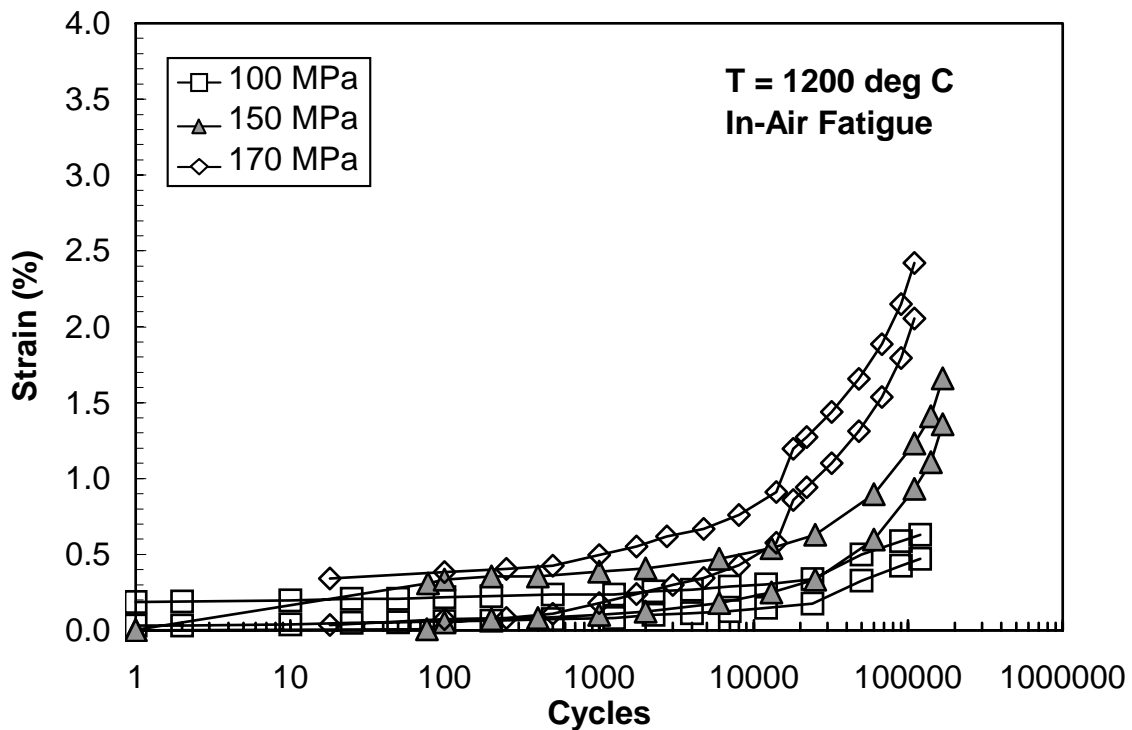
Figure 17. Maximum and minimum strain versus fatigue cycles at 1200°C in air. All three tests were run-outs.

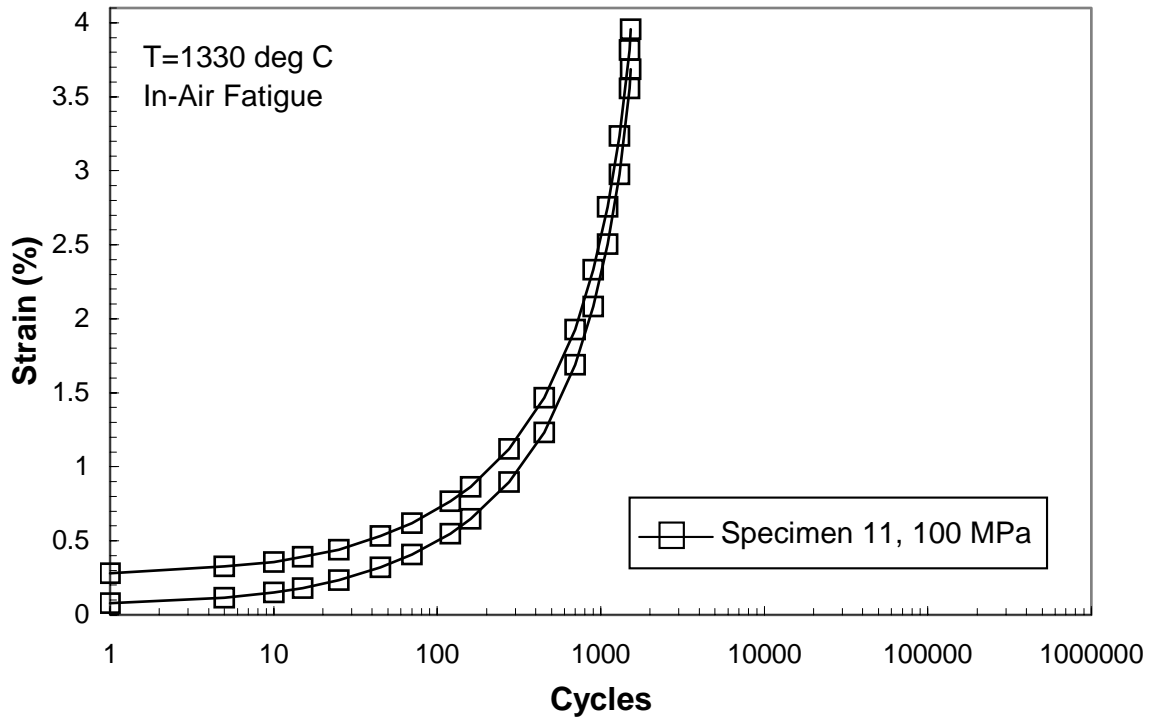
Figure 18. Maximum and minimum strain versus fatigue cycles at 1330°C in air. Specimen failed after 1519 cycles.

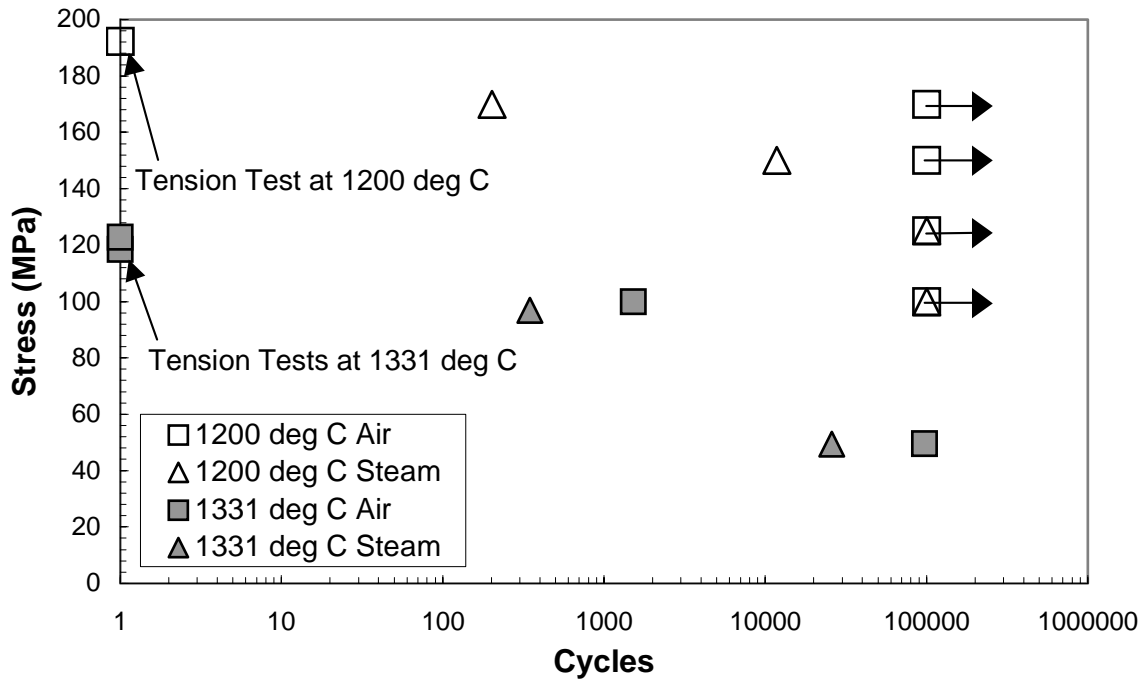
Figure 19. Effect of steam environment on fatigue life of Nextel 720/A at 1200 and 1330°C.

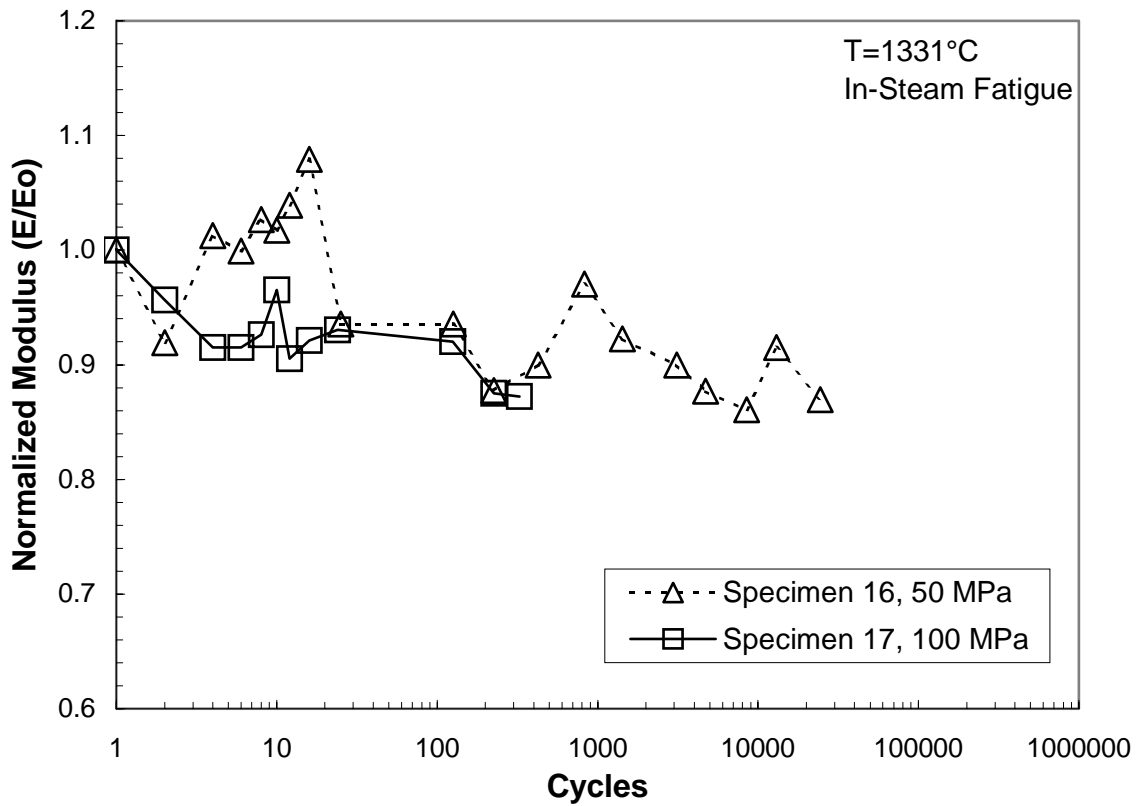
Figure 21. Normalized modulus versus fatigue cycles at 1330°C in steam environment.

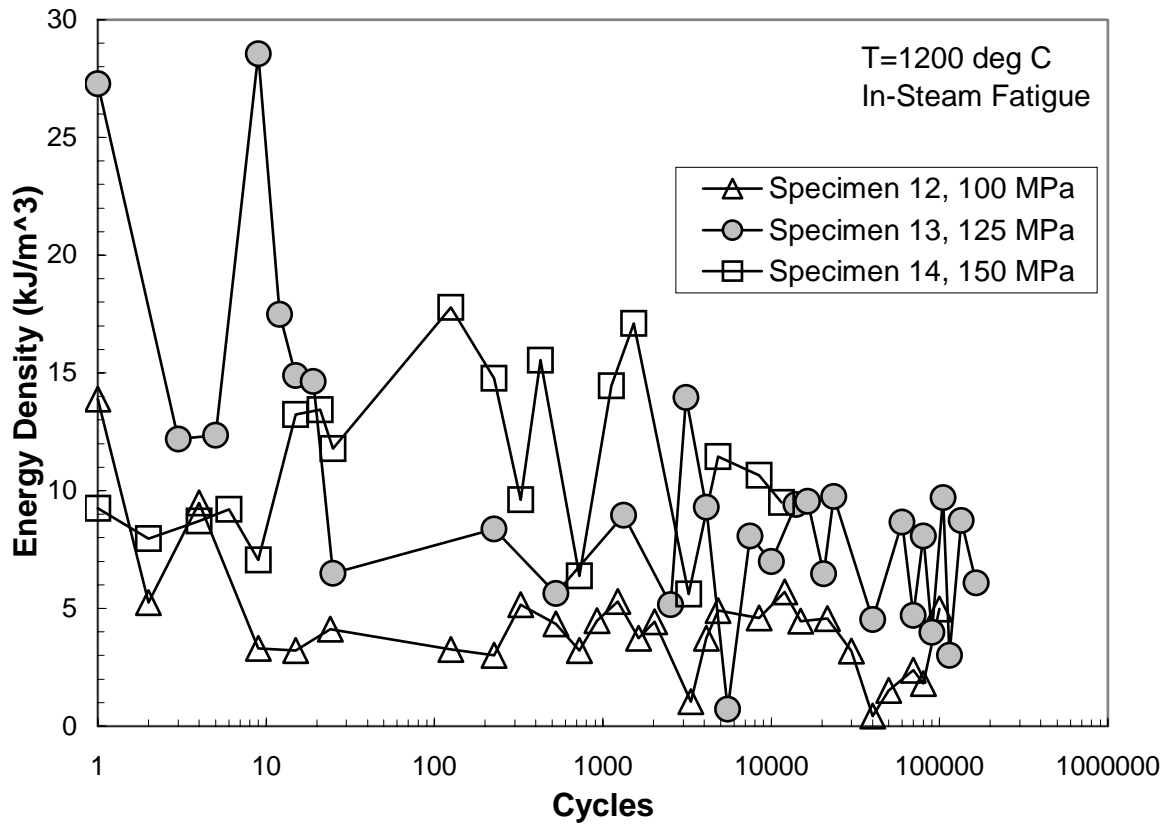
Figure 22. Hysteretic energy density versus fatigue cycles tested at 1200°C in steam environment.

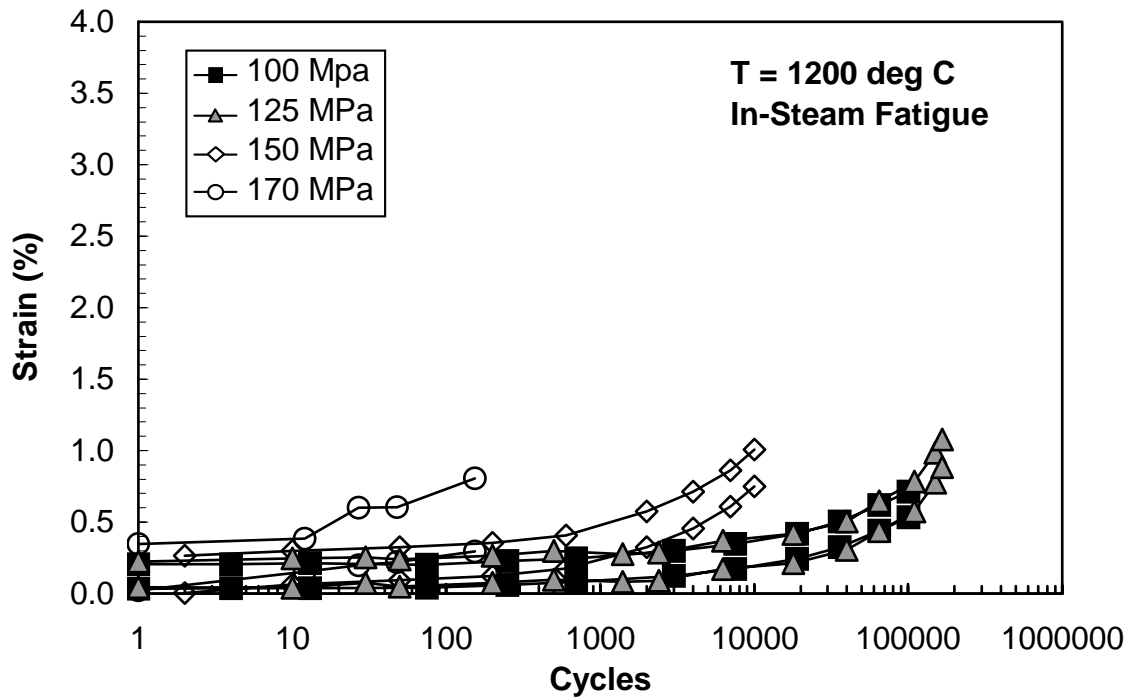
Figure 24. Maximum and minimum strain versus fatigue cycles at 1200°C in steam environment.

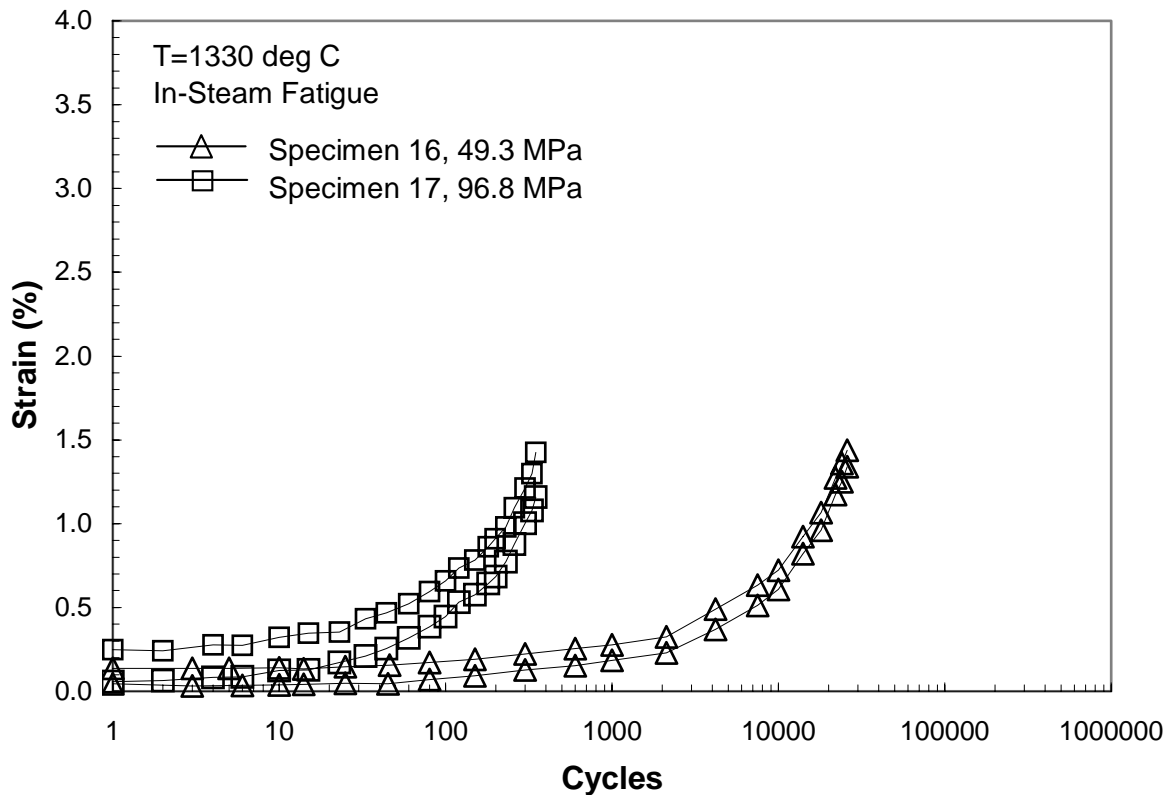
Figure 25. Maximum and minimum strain versus fatigue cycles at 1330°C in steam environment.

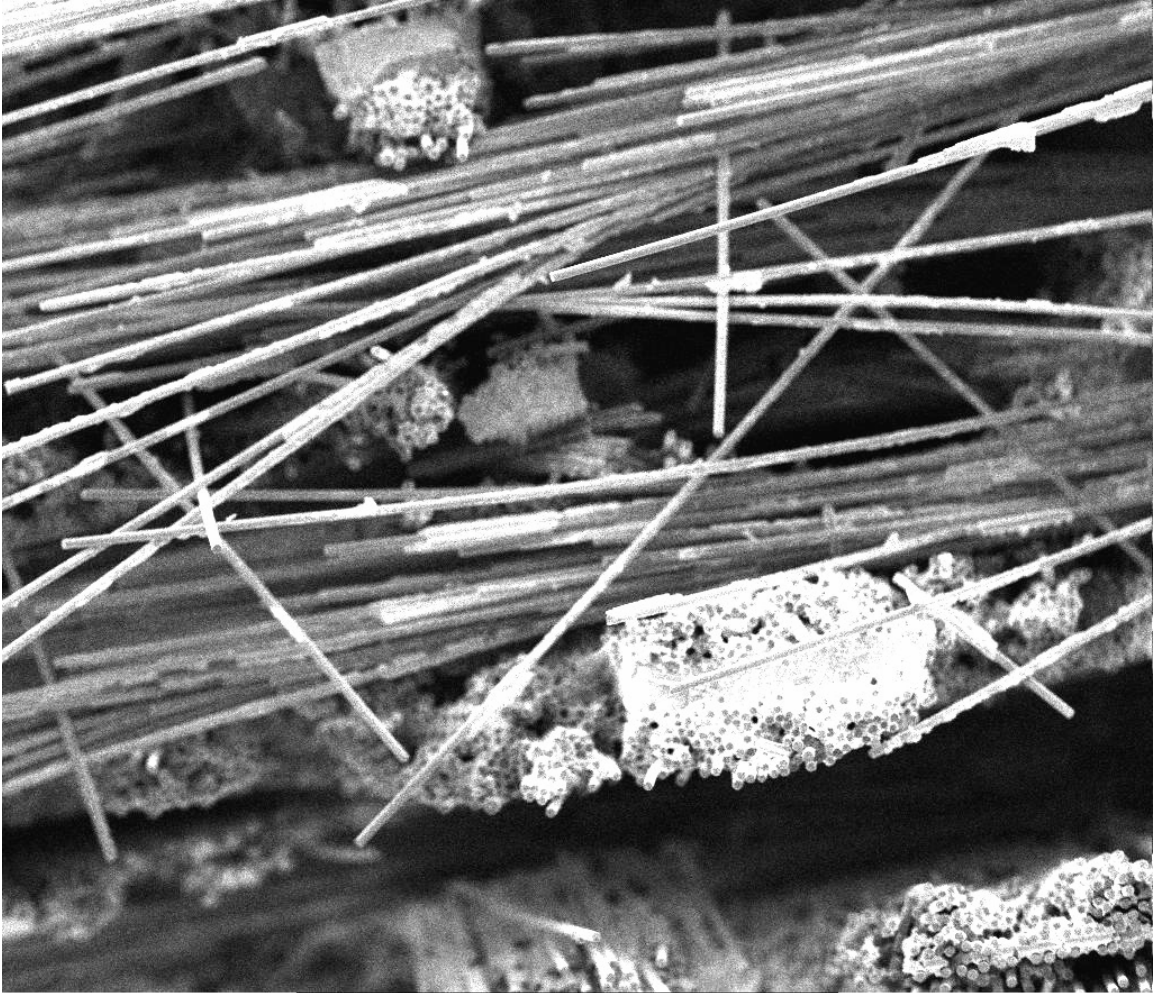
Figure 36. SEM micrograph of Specimen 6, failed in monotonic tension testing following 120,199 cycles of fatigue loading (defined as a run-out) with maximum stress of 100 MPa in air at 1200°C.

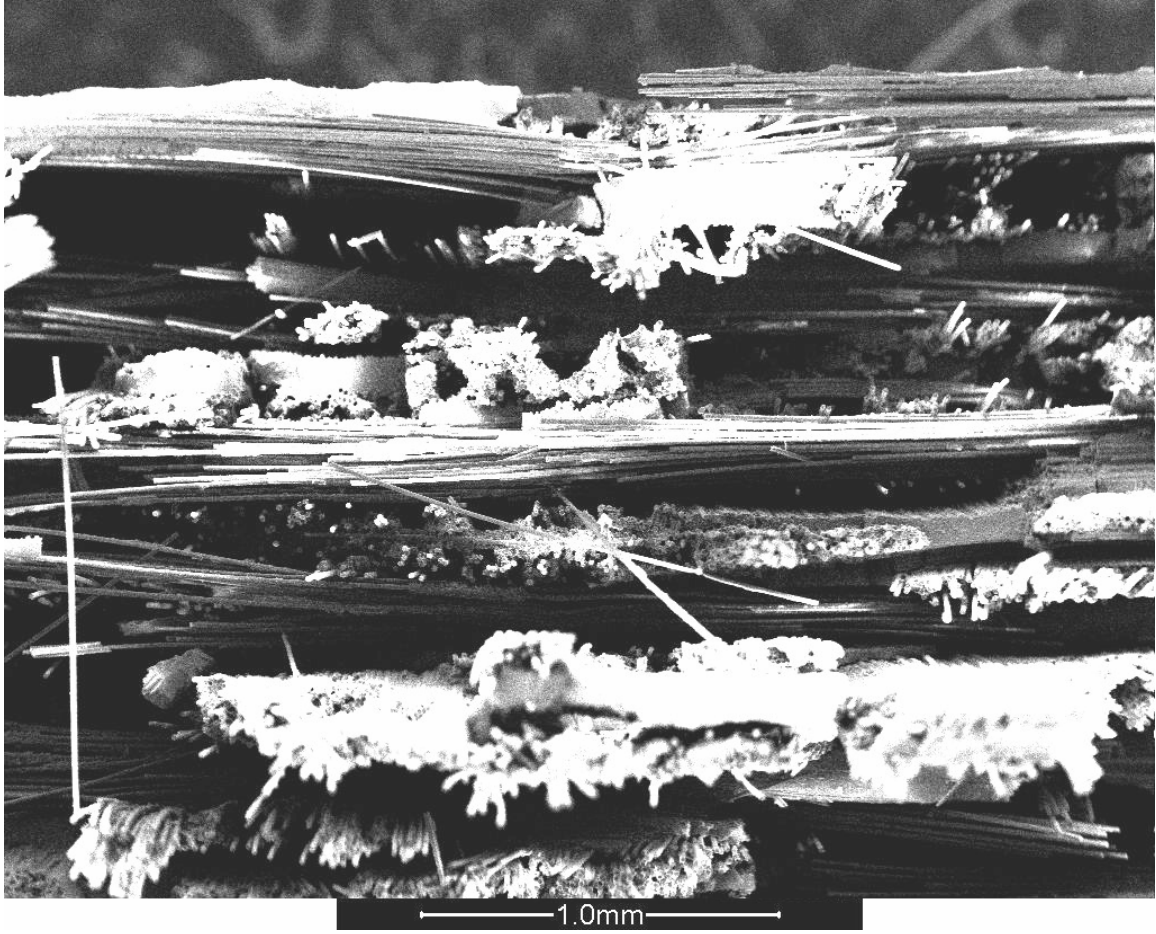
Figure 44. SEM micrograph of Specimen 12, failed in monotonic tension testing following 100,780 cycles of fatigue loading (defined as a run-out) with maximum stress of 100 MPa in steam at 1200°C.

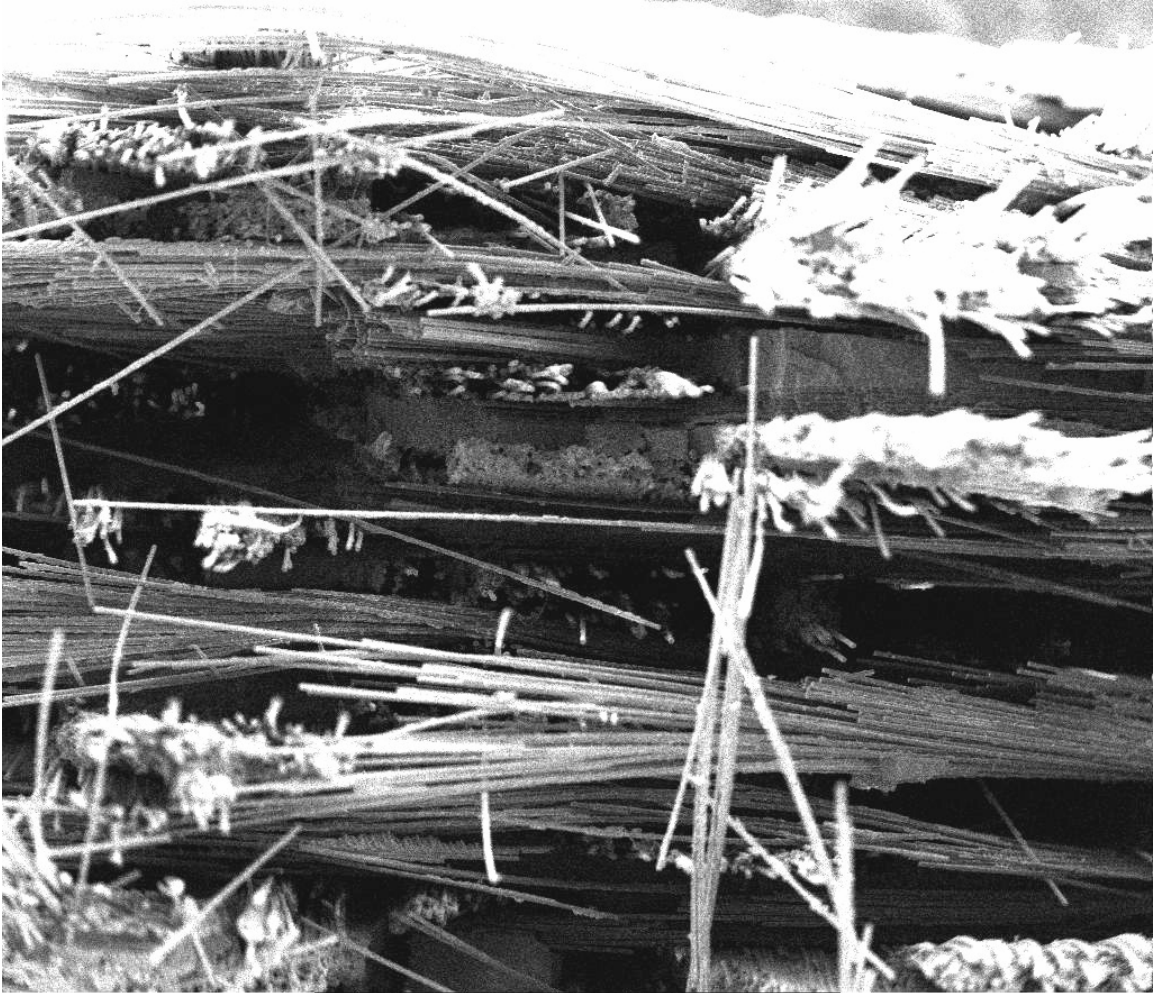
Figure 49. SEM micrograph of Specimen 14, failed in fatigue loading at 150 MPa in steam at 1200°C.

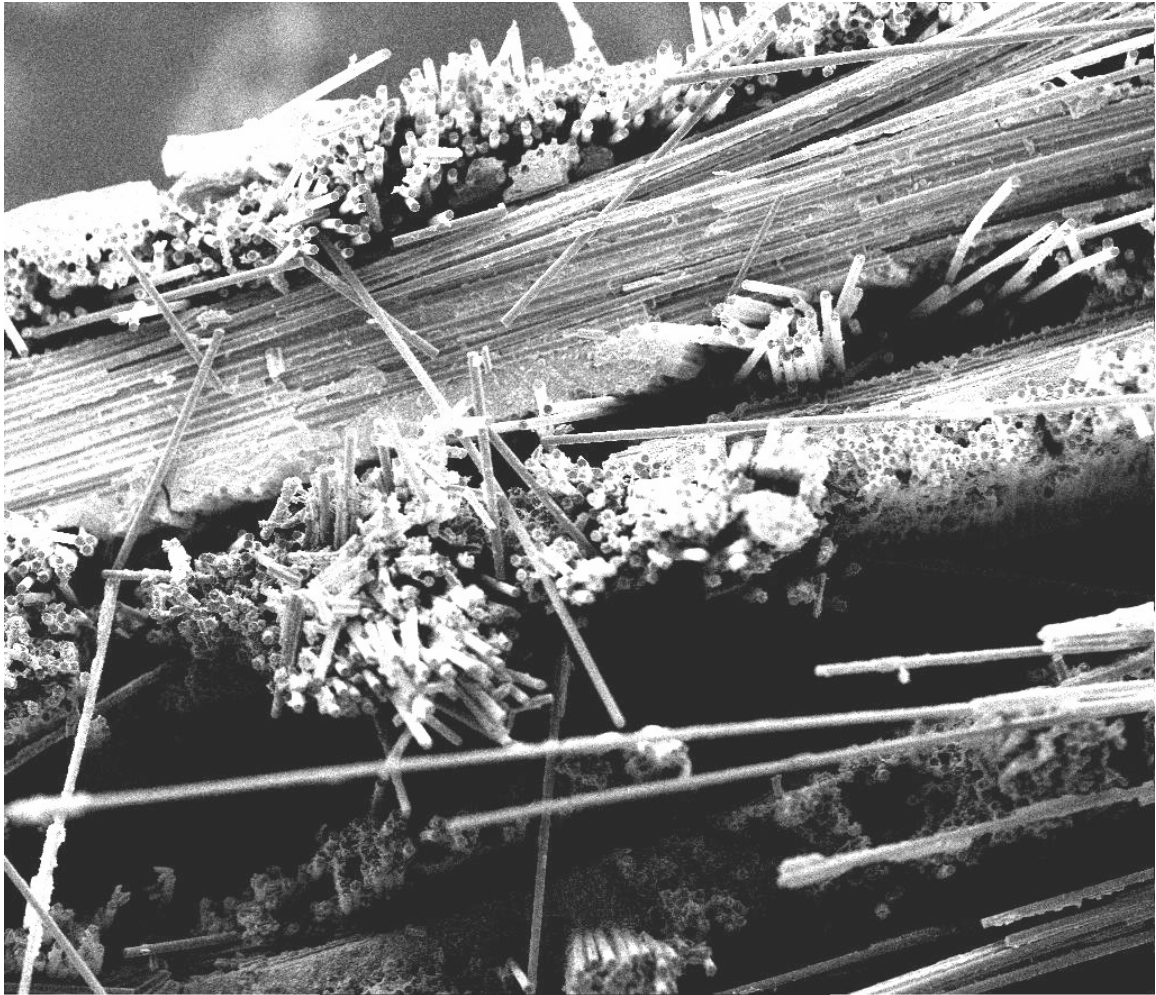
Figure 51. SEM micrograph of Specimen 15, failed during fatigue loading at 170 MPa in steam at 1200°C.

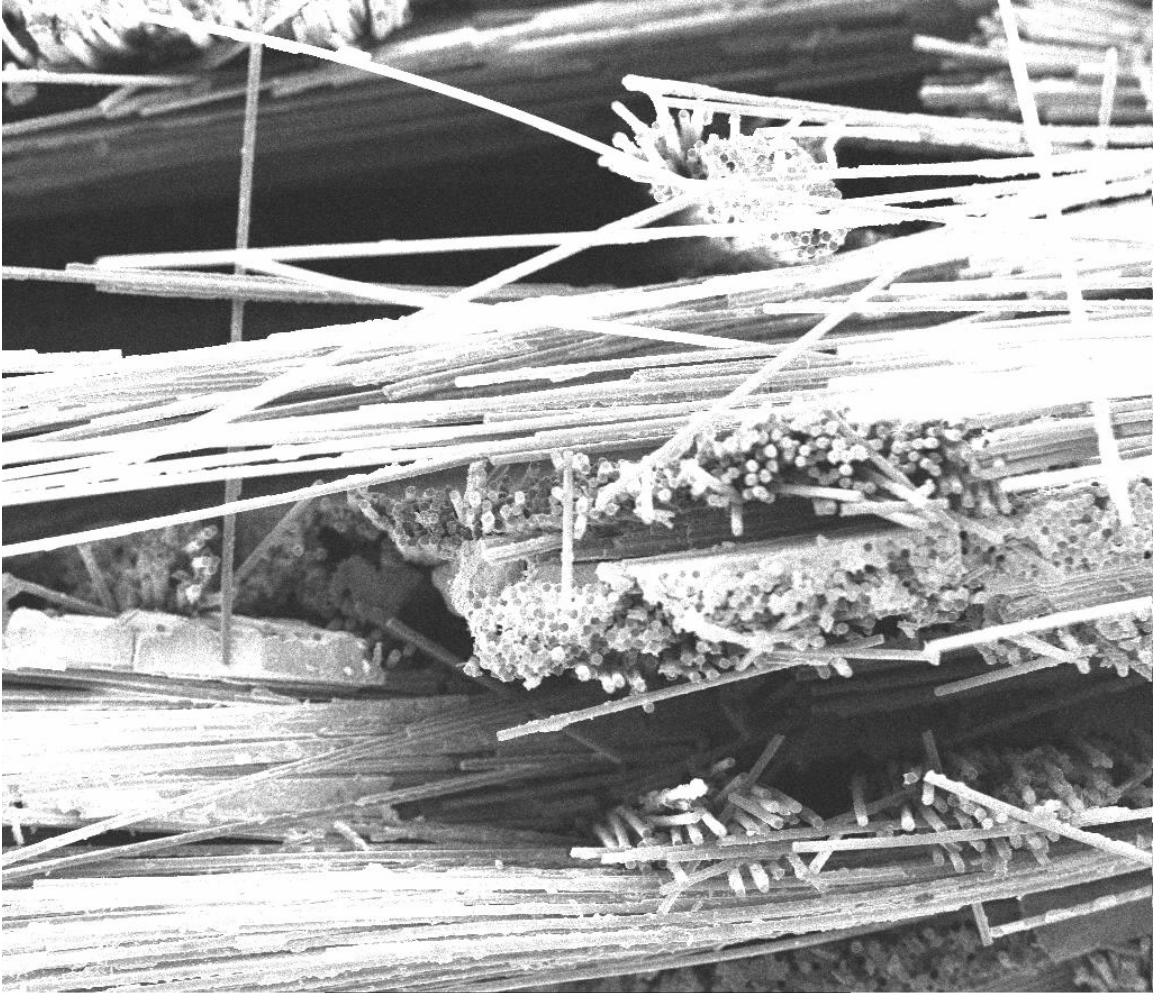
Figure 58. SEM micrograph of Specimen 11 failed under fatigue loading conditions with maximum stress of 100 MPa at 1330°C in air.

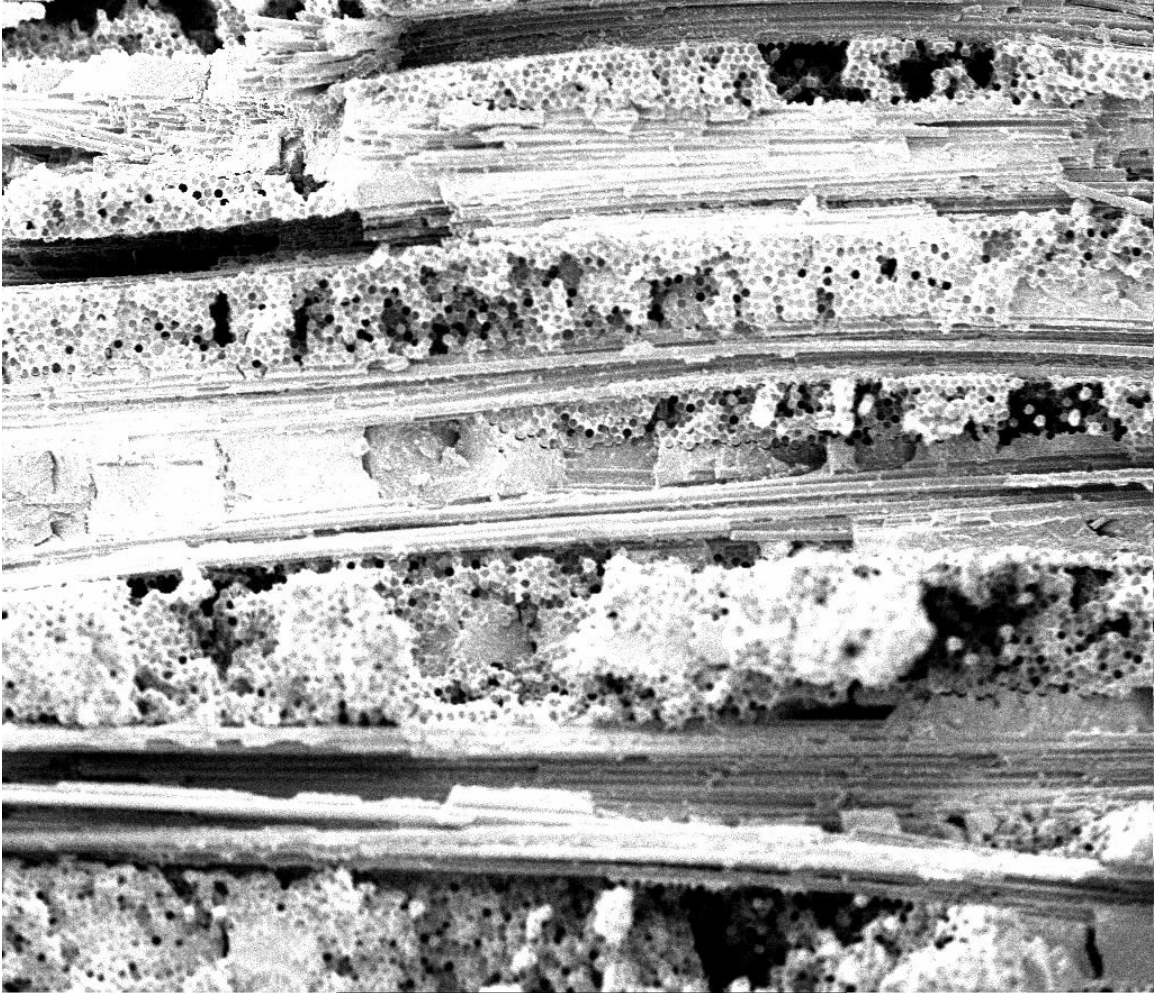
Figure 60. SEM micrograph of Specimen 16 failed under fatigue loading conditions with maximum stress of 50 MPa at 1330°C in steam.

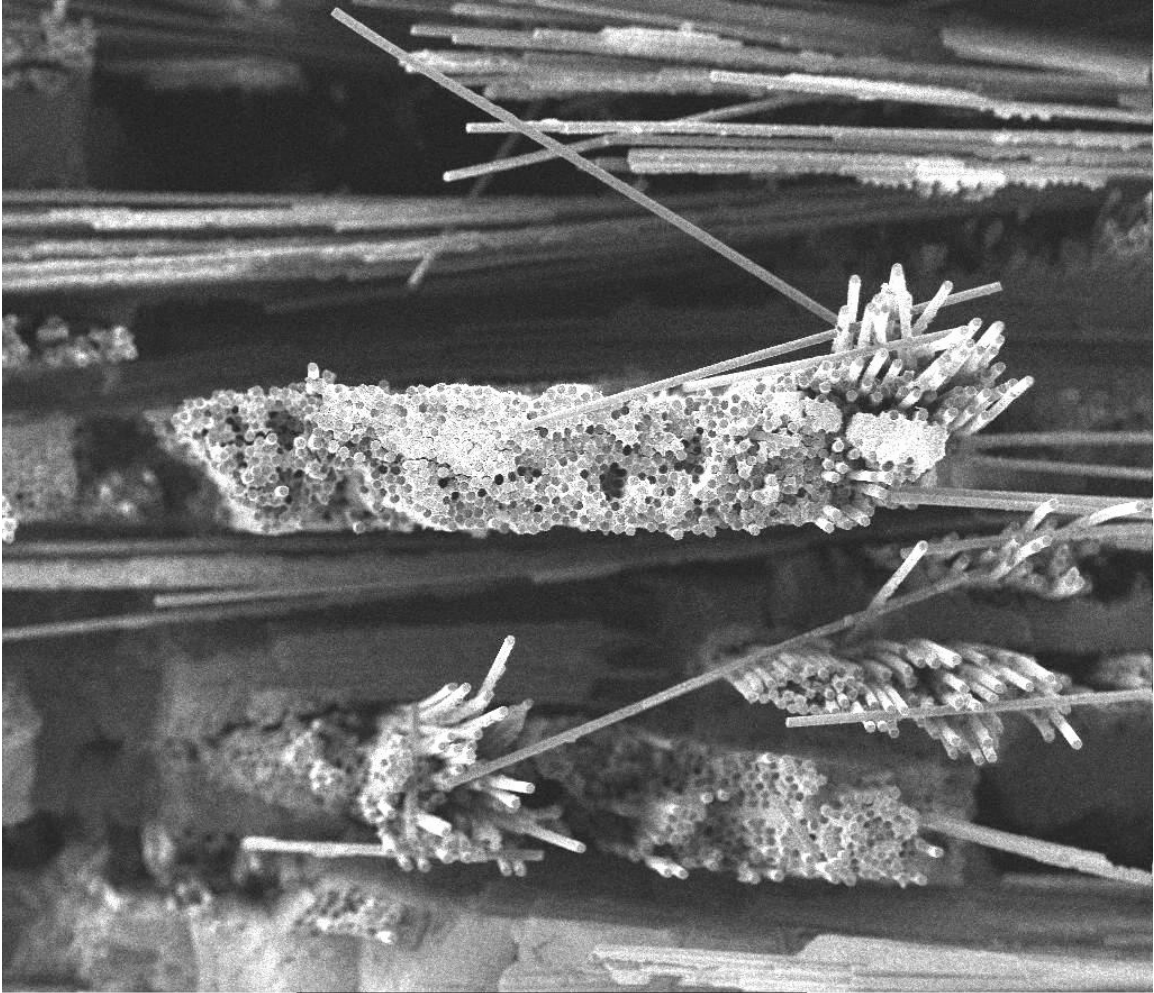
Figure 62. SEM micrograph of Specimen 17 failed under fatigue loading conditions with maximum stress of 100 MPa at 1330°C in steam.
