APD-IM-152

Adapting Conductance Technology for Military Application

Randy Swanson
Midtronics, Inc.

June 20, 2005

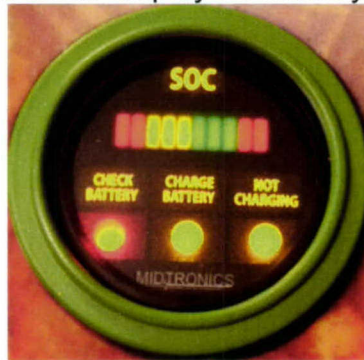
Figure 1: iBMS display for military vehicles

Since inGEN technology can monitor the battery's real-time State of Health and its decline over time, the useful life of the battery can be predicted. The driver's display supplied in the MIL112 version includes LEDs to indicate that batteries are reaching the end of their useful life and LEDs indicating a battery failure, which should be replaced. This will assist the crew in replacing worn or failed batteries in the safety and convenience of the depot or maintenance area instead of possibly becoming stranded on the battlefield.

A flashing Not Charging LED may be expected in situations such as silent watch where power is being required but the alternator is not running to provide that power. Note: When the Master Switch is first turned on, the DIM will assume there are no charging problems.
