*Monitoring Completed Navigation Projects Program*

## **Monitoring Stone Degradation on Coastal Structures in the Great Lakes – Summary Report**

June 2005

Final report

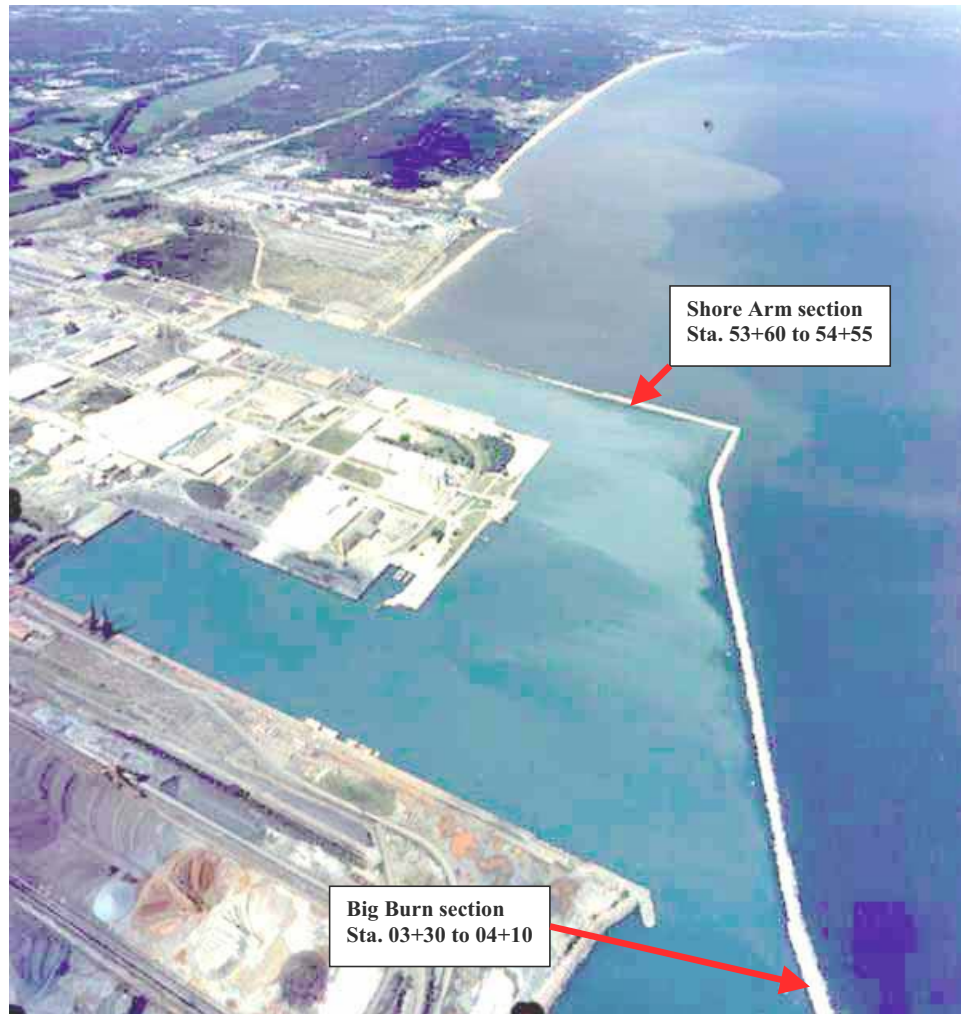
Figure 4. Burns Harbor breakwater, IN, monitored sections

**Burns Harbor breakwater, IN.** Burns Harbor, IN (Figure 4), is a deepwater harbor at the southern end of Lake Michigan that receives significantly greater wave heights than other navigation harbors around Lake Michigan. The breakwater, completed in 1968, consists of an east-west section (Big Burn section) connected to the shore by a north-south section (Shore Arm section), which is semiprotected from severe Great Lakes storms. The breakwater is a multilayer rubble-mound structure with two layers of randomly-placed Reed Quarry Salem formation cut limestone. The parallelepiped cut stone armor units, which range from 9,070 to 14,515 kg (10 to 16 tons) on the trunk and from 13,605 to 18,145 kg (15 to 20 tons) on the head, are typical for coastal structures in the Great Lakes, but the two-layer random placement is unusual. Numerous repairs have been necessary since about 1975 as the structure was unable to withstand the severe storm waves that it would experience. There exists uncertainty as to whether there is a single cause for the problems or whether there are multiple factors contributing to the need for repairs (e.g., foundation issues, material suitability, greater wave climate than originally believed, etc.) Over the years, repair stone has consisted of Reed Quarry cut limestone, McCook Quarry Niagaran series blasted dolomite, and Dempsey Quarry Waterloo formation blasted quartzite. For the monitored Big Burn section, Reed Quarry cut limestone was placed in 1970, and McCook Quarry blasted dolomite was placed in 1988. For the monitored Shore Arm section, Reed Quarry cut limestone and Dempsey Quarry blasted quartzite were placed in 1995.

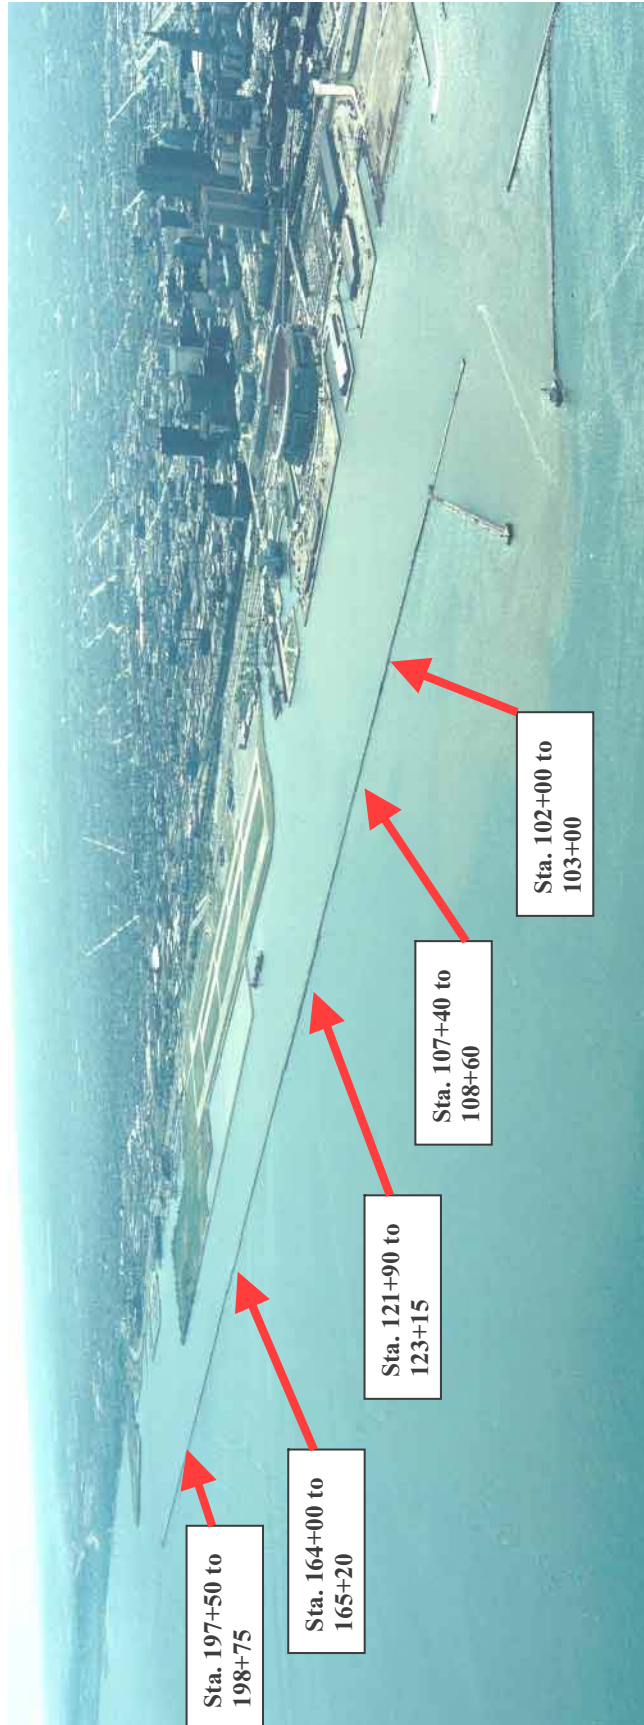
Figure 5. Cleveland Harbor east breakwater, OH, monitored sections

**Cleveland Harbor east breakwater, OH.** The original east breakwater at Cleveland, OH (Figure 5), was built between 1903 and 1905 as a laid-up structure from cut stone from one or more of the quarries now owned or formerly owned by Cleveland Quarries. One of these is the Johnson Quarry, Kipton, OH. The Johnson Quarry Berea formation cut sandstone blocks are still present in the structure, and form the base of the breakwater structure. In recent years, as the cut stone became more expensive, the U.S. Army Engineer District, Buffalo, has been maintaining the structure with rubble armor stone. This has created a somewhat less stable structure with the blocks of rubble rocking back and forth on the somewhat flat surface created by the laid-up cut stone. Additionally, the much larger blocks of rubble on top of the laid-up cut stone are destroying the stability of the laid-up structure. The Johnson Quarry cut sandstone in the monitored section had been placed over 30 years ago. The only fractures noted in the Berea sandstone are those created by movement of the structure as a result of placement of the less stable and larger rubble blocks.

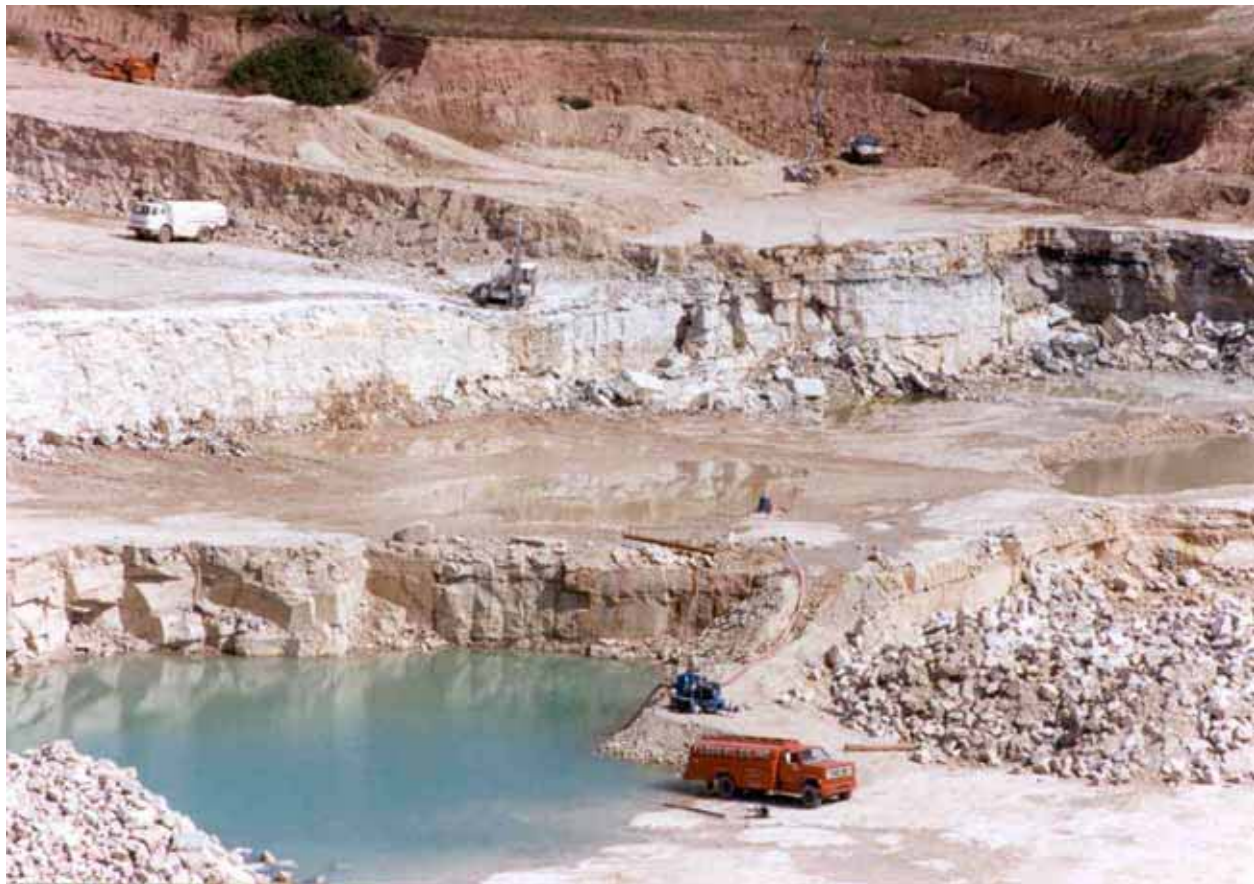
Figure 11. Valders Quarry, Valders, WI, overall view showing lower bench, middle bench (being drilled), and upper bench with glacial till drift overburden (after Rock Products Consultants 1995)

The Niagaran series dolomite quarried near Valders, WI, is one of numerous reef complexes that formed around the fringes of the Michigan Basin and northeast of the Wisconsin arch. Several lithological units are identified, including dolomitic mudstone interpreted as a supratidal, backreef environment and reef dolomite. The dolomitic mudstone intertongues with reef-like dolomite. Reef accumulations are more discontinuous, allocthonous, and thinner, as compared to the large pinnacle Niagaran reef structures found in Illinois. Early descriptions of the lithologies and paleoenvironments can be found in Shrock (1939) and Lowenstam (1950).

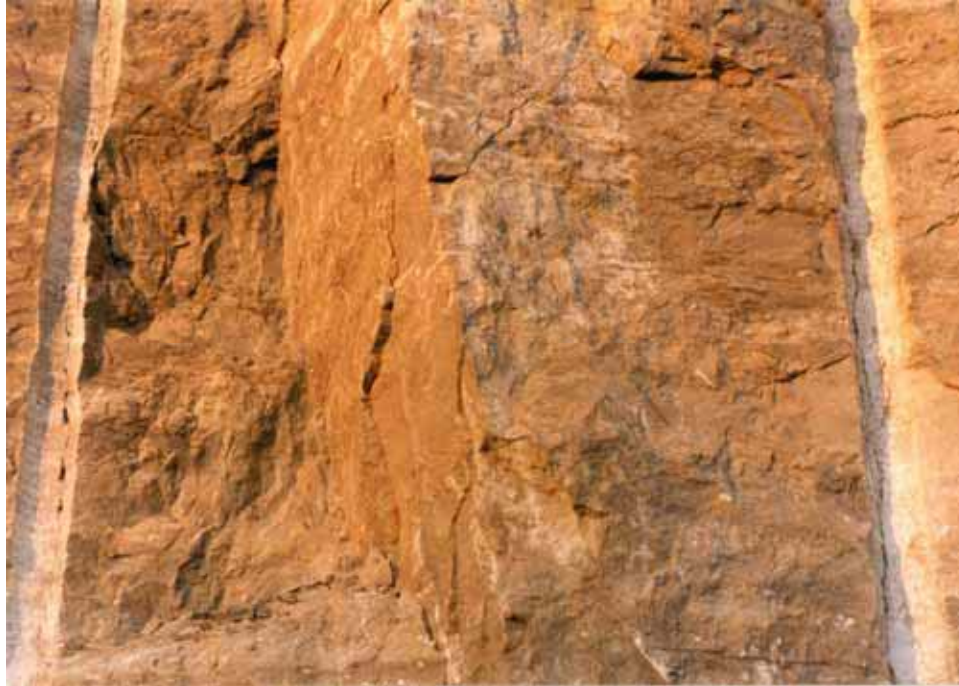
Figure 23. Sandusky Quarry, Parkertown, OH, blasting fractures along blastholes (after Rock Products Consultants 1995)

Sandusky Quarry primarily produces Columbus formation limestone aggregates with a production capacity of up to 1,800,000 kg (2,000 tons) per hour. Armor stone is currently taken from the west side top bench of the quarry. The spacing of blast holes as measured in the quarry face ranges from 2.1 to 2.7 m (7 to 9 ft), and the blast holes are 17 cm (6.75 in.) in diameter (Figure 22). The bench height is approximately 15 m (50 ft). As evidenced by the blasting fractures within the blast holes (Figure 23) and the large block of the Venice

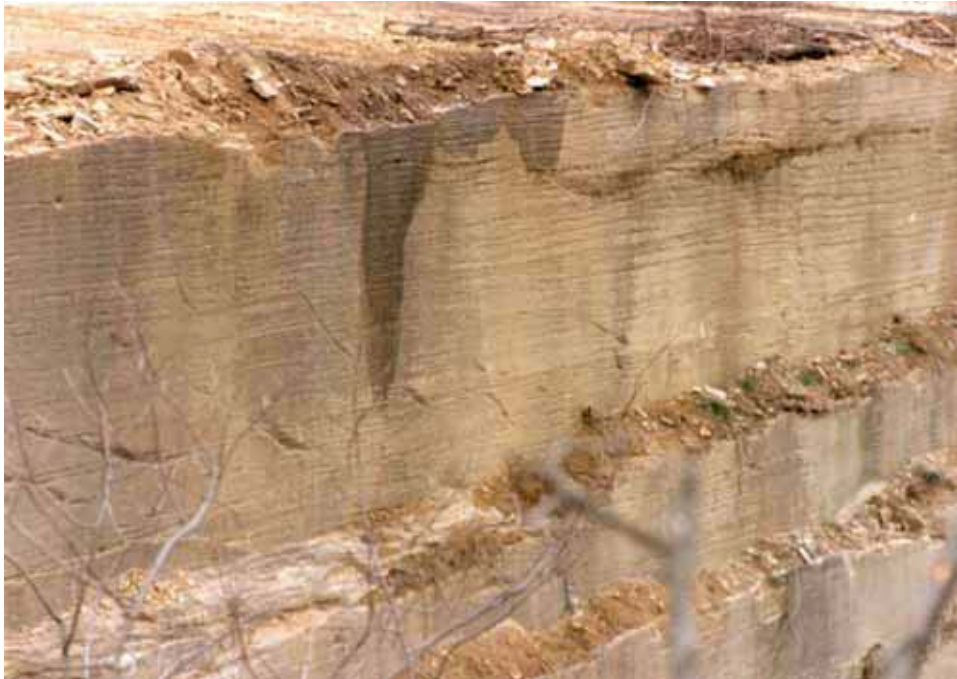
Figure 30. Johnson Quarry, Kipton, OH, thin-bedded upper unit on north side of quarry (after Rock Products Consultants 1995)

The quarrrystone lithofacies forms a blanket that contains isolated elongate bodies of pure sandstone. These bodies appear as topographic highs, and it is one of these elongate bodies in which the Johnson Quarry is situated. The uppermost unit in the Johnson Quarry is a thin-bedded, laminated sandstone (Figure 30), about 5.5-m (18-ft) thick, with a lag deposit of clay siderite cobbles along a disconformable contact with a more massive unit below. Figure 31 is a close-up of the thin-bedded sandstone. This more massive unit is about 1.5 m (5 ft) thick but pinches out toward the western portion of this face. Below this is about a 30-cm- (1-ft-) thick carbonaceous somewhat argillaceous sandstone, and then a massive coarse-grained sandstone down to the waterline (Figure 32). The primary facies is deltaic with subfacies of delta front and channel (Units 1, 2, and 4) and overbank (Unit 3).

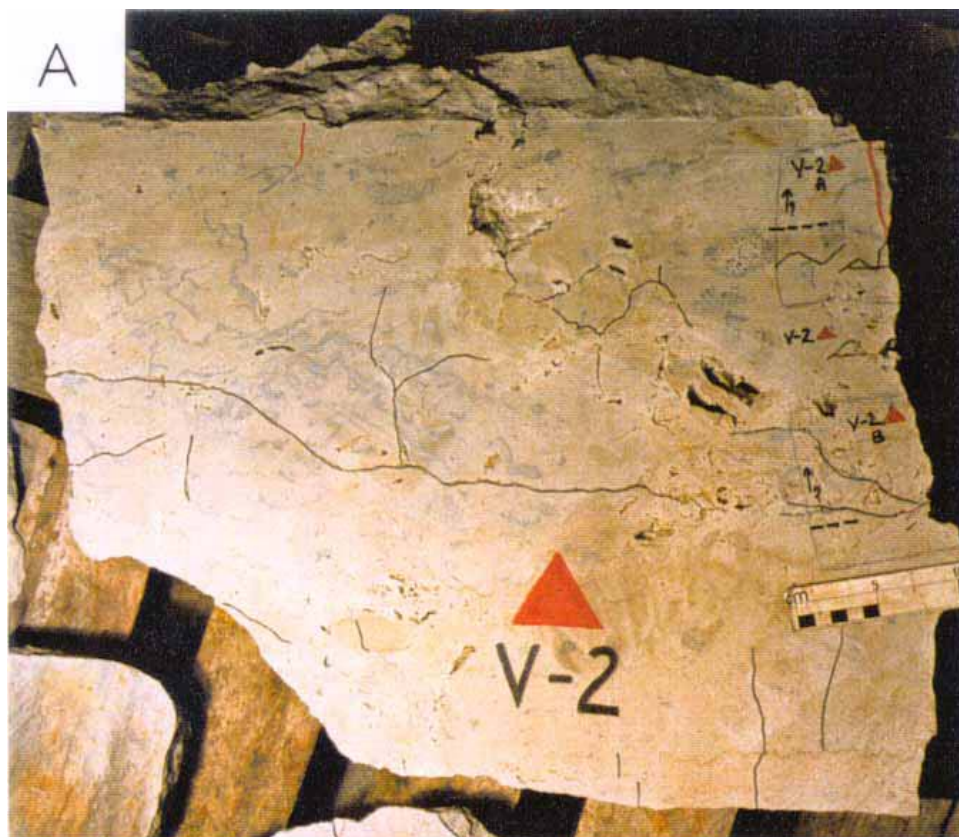
Figure 62. Valders Quarry Test Block V-2-FT sample locations. Arrows show direction perpendicular to interpreted bedding planes based on clay seams and associated stylolites (after Agar 1998)

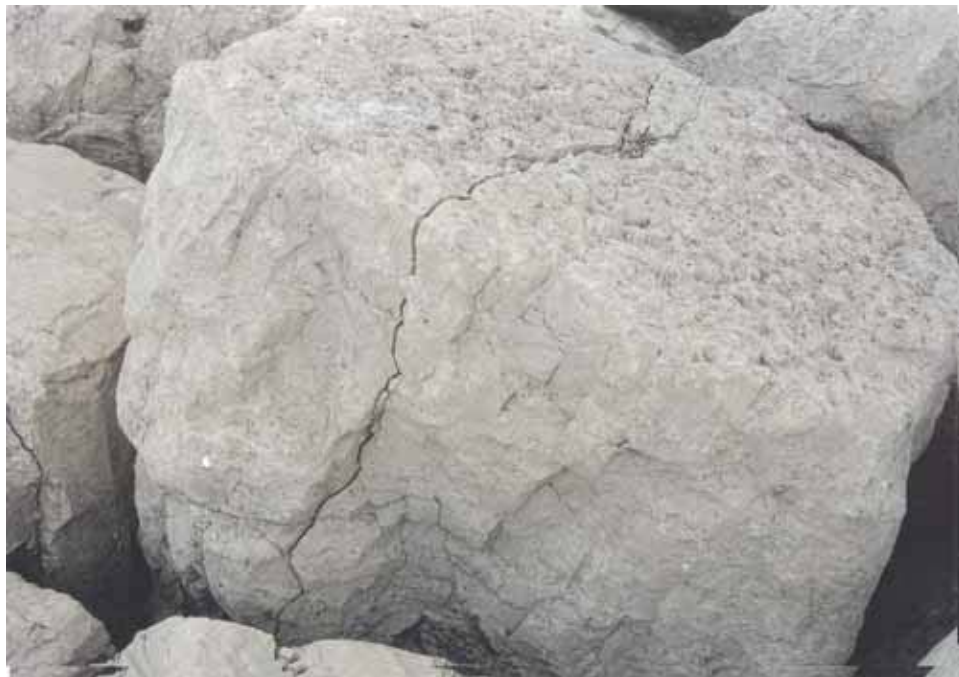
Figure 101. Calumet Harbor CDF, McCook Quarry high energy blasted dolomite. Dolomitic reef rock with somewhat brecciated appearance and a fracture normal to bedding. The fracture could either be blast-related or simply mechanical (Rock Products Consultants 1995)

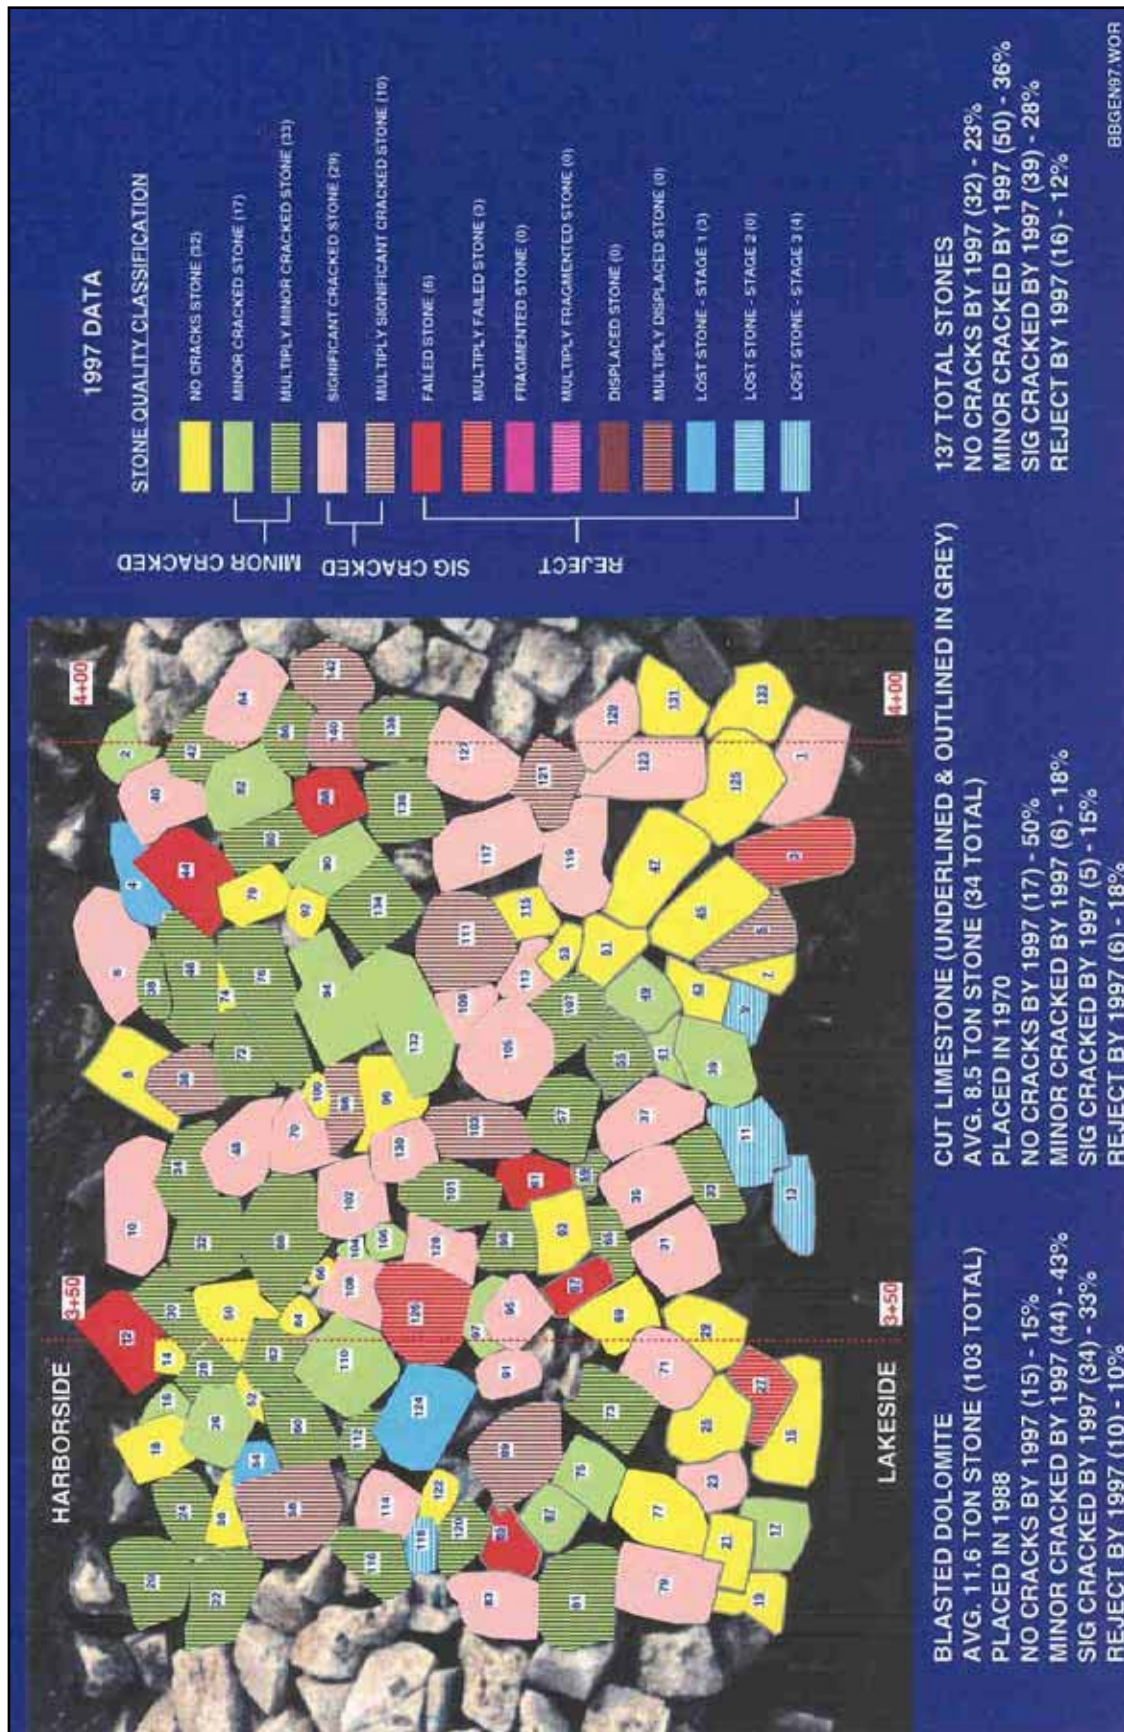
Figure 126. Burns Harbor breakwater (Big Burn section), sta 3+30 to sta 4+10, stone quality classification, end of 1997

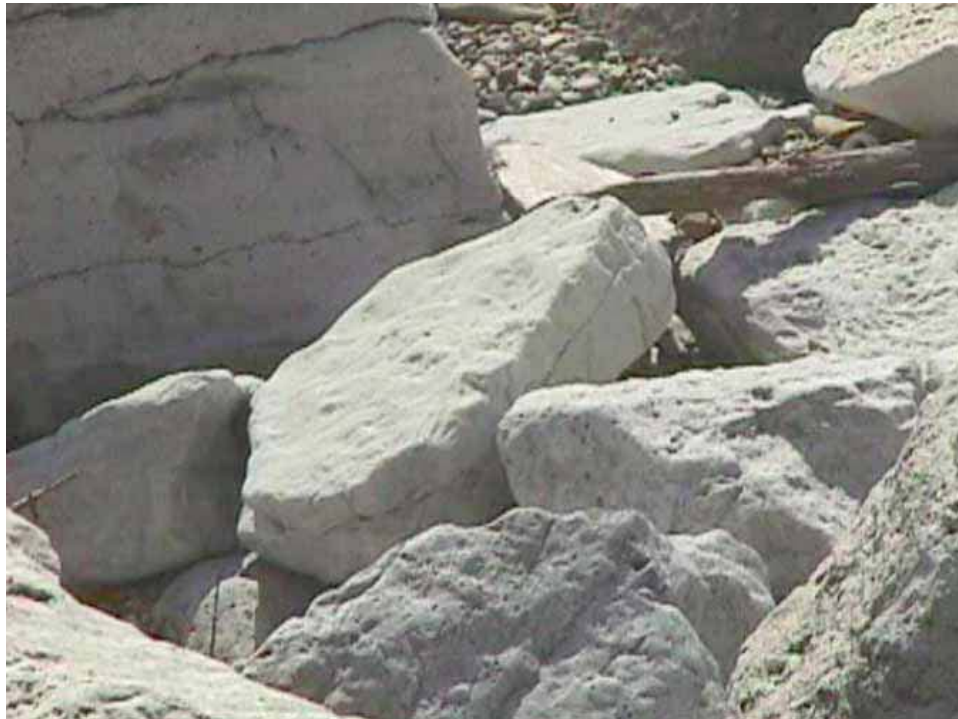
Figure A3. Dolomite armorstones showing stylolites in various degrees of separation

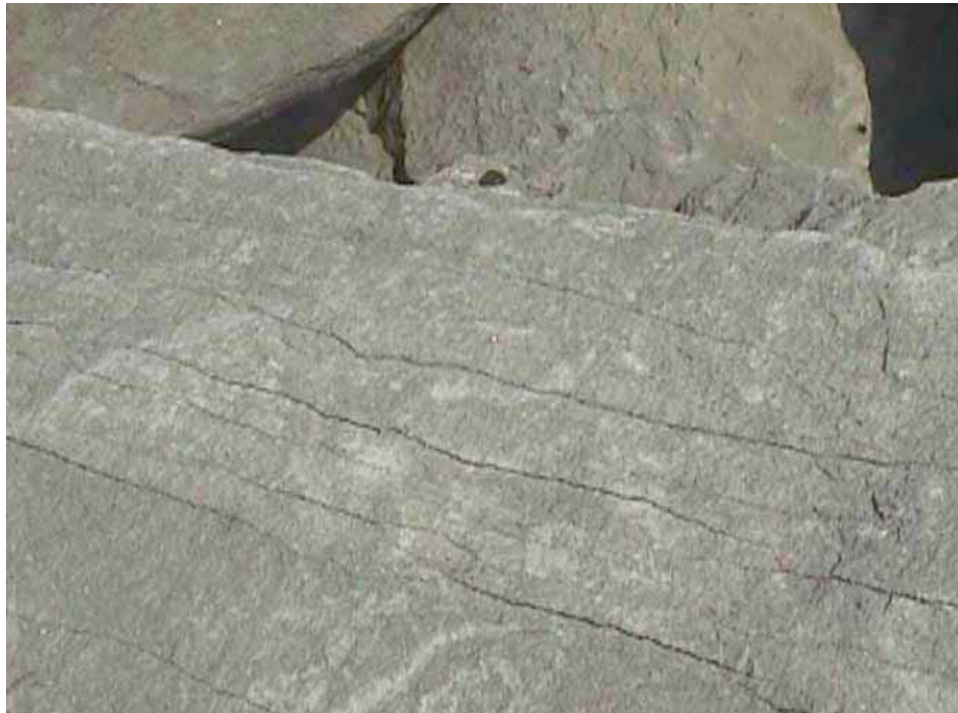
Figure A4. Bedding planes in limestone armor stone on Chicago shoreline showing separation

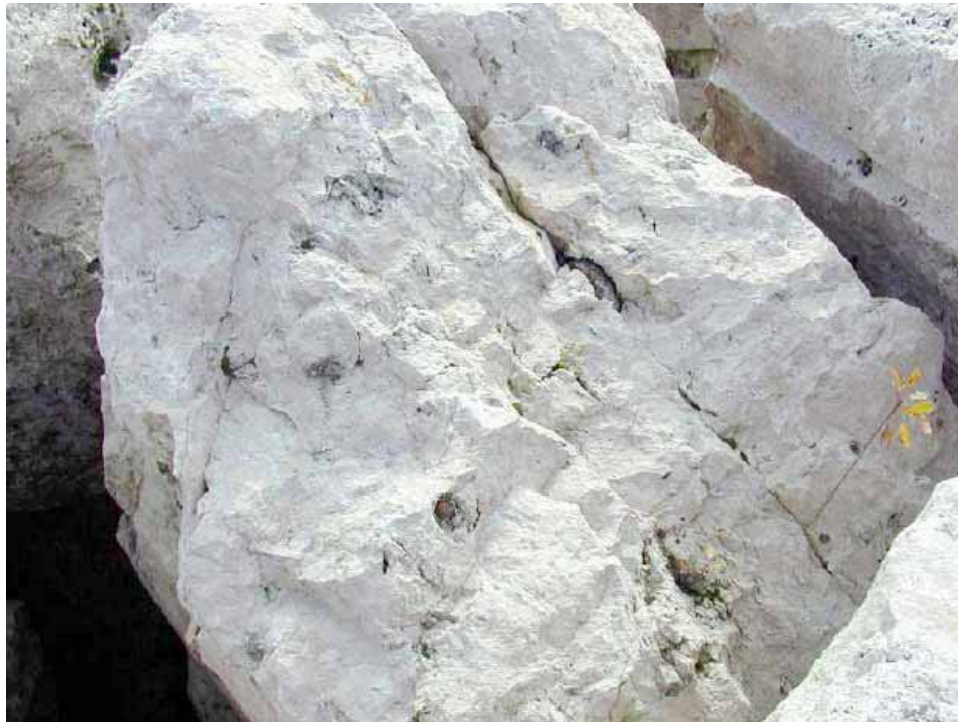
Figure A6. Even with QA/QC practices, this armor stone and others like it appear in Reach 5 breakwater. Note separations occurring at planar weaknesses
